# Revised Initial Abatement Report & Underground Storage Tank Closure Report

Parcel 186, Former City of Greenville Property  
1011 Dickinson Avenue  
Greenville, Pitt County, North Carolina

State Project No. U-3315

Description: Stantonsburg Road/Tenth Street Connector from Memorial Drive (US 13)  
to Evans Street

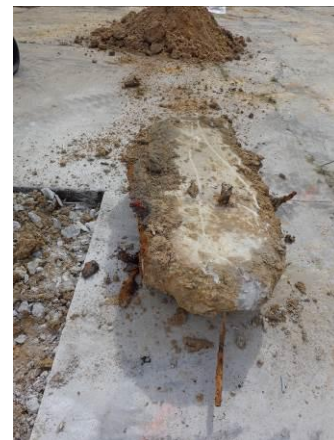
**Photo #6** Concrete and Metallic Mass Initially Identified during GPR

- The western possible USTs identified during Terracon's PSA activities was determined to be buried construction/demolition debris. On August 20, 2014, exploratory excavation of the possible UST location uncovered a large mass of concrete and metal that matched the size and shape delineated by Ground Penetrating Radar (GPR). No visual or odorous evidence of a release was observed during excavation of the concrete and metal mass. The concrete and metal mass was removed and documented prior to the excavation being extended downward to confirm the absence of a UST. No UST was found at this location (See Photo Log, Exhibit 3). The eastern possible UST was confirmed to be an approximately 1,000-gallon UST and is the subject of this Closure Report.

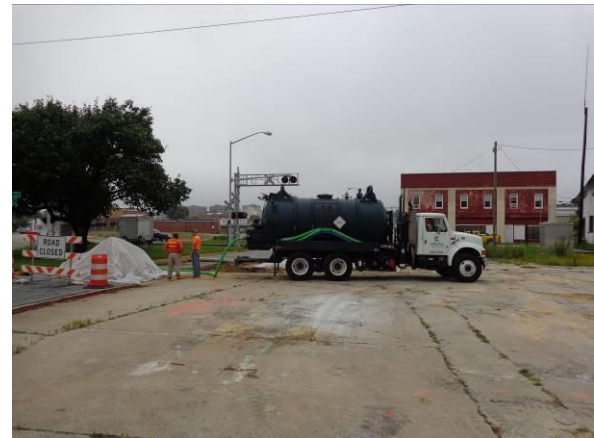
**Photo #12** Vacuum Truck used to Empty Tank of Residual Fluids

- Approximately 100 gallons of liquid was removed from the tank with a vacuum truck prior to removing the UST from the ground. The liquid was transported by CCI to Garco, Inc. in Asheboro, North Carolina for disposal. A copy of the service receipt is included in Appendix D.
- During the excavation, discolored and odorous soils were observed beneath the UST. Based on site observations and field soil screening readings, the area of contamination appeared to be confined to a localized area within the east and north portions of the tank excavation.

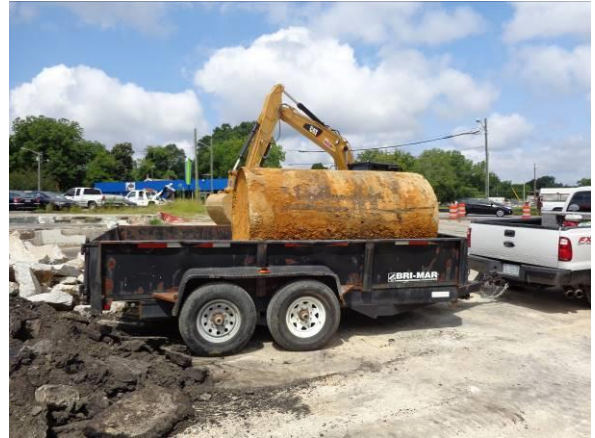
**Photo #14** UST Removed and Loaded onto Trailer for Disposal

- Following purging of the UST, CCI began to excavate soil from the sides of the tank. The empty tank was removed from the tank pit and placed adjacent to the excavation pit for further inspection. Terracon observed minor areas of pitting and corrosion; however, the UST remained intact and exhibited limited petroleum odors at the time of the tank removal.

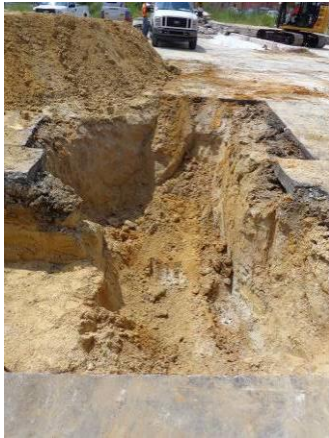
**Photo #15** Empty Excavation after UST Removal

- During the UST removal, visual and olfactory evidence of a release was observed directly beneath the UST.
