Preliminary Site Assessment

1017 Chestnut Street
Parcel #74, Wachovia Bank
Vacant Residential
Greenville, Pitt County, North Carolina

State Project No.: U-3315

GEOPHYSICAL INVESTIGATION REPORT

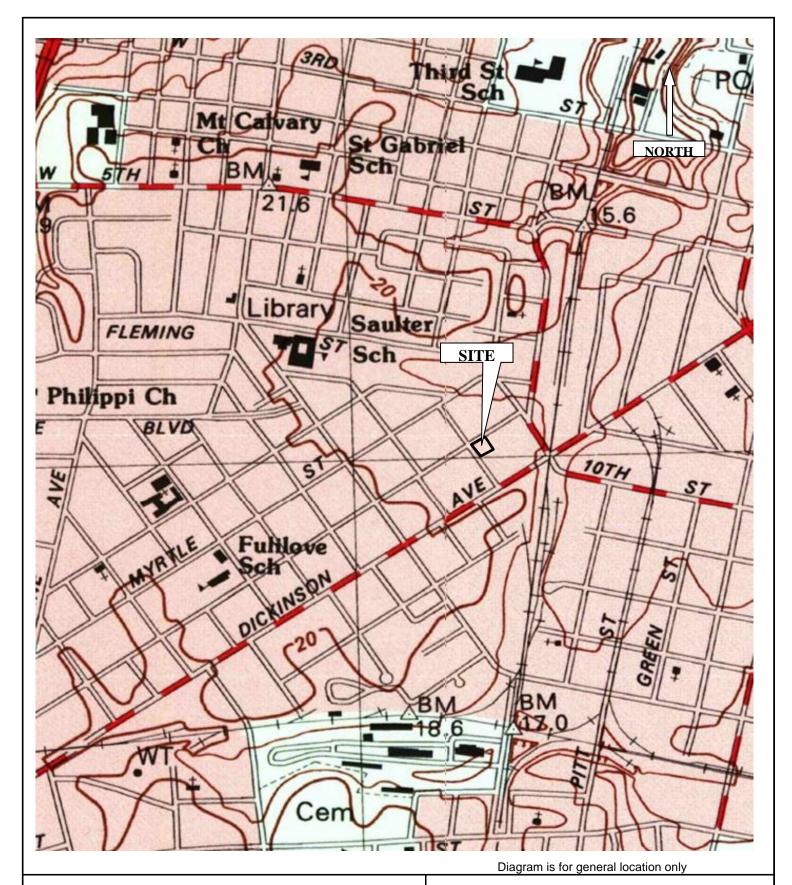
PROJECT NO.:	70127335
DATE: 10/2/12	CONTOUR INT: 2 meters
DRAWN: MDP	CHECK: LCH
SCALE: NTS	Exhibit 1

The following PSA activities are presented in the order that they were conducted in the field on August 17, and 24 and September 6, 2012. Exhibit 1 presents the general boundaries and topography of the site on portions of the USGS topographic quadrangle map of Greenville SW, North Carolina dated 1998. Exhibit 2 is a site layout plan that indicates the approximate locations of the site features.

Site Vicinity Map
Parcel # 74
1017 Chestnut Street
Greenville, Pitt County, North Carolina

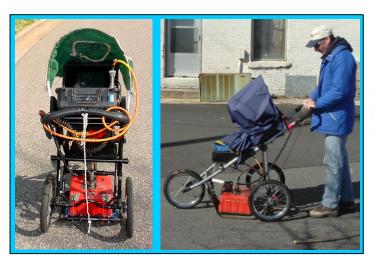
The photographs show the SIR-2000 GPR system equipped with a 400 MHz antenna that were used to conduct the ground penetrating radar investigation across selected EM61 differential anomalies at the Parcel 74 site on August 24, 2012.

The GPR investigation was conducted across selected EM61 differential anomalies using a GSSI SIR-2000 unit equipped with a 400 MHz antenna. Data were digitally collected in a continuous mode along X-axis and/or Y-axis survey lines, spaced 2.5 to 5.0 feet apart using a vertical scan of 512 samples, at a rate of 48 scans per second. A 70 MHz high pass filter and an 800 MHz low pass filter were used during data acquisition with the 400 MHz antenna. GPR data were collected down to a maximum depth of approximately 5 feet, based on an estimated two-way travel time of 8 nanoseconds per foot.

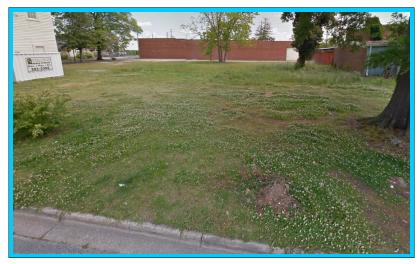
The Certain Hope Ministries property consists of a vacant house surrounded by grass-covered yards. The proposed ROW area is located in the open back yard immediately southeast of the vacant house. The geophysical survey area that encompasses the proposed ROW area has a maximum length and width of 120 feet and 72 feet, respectively.

The photograph shows the proposed Right-of-Way area at the Certain Hope Ministries property (Parcel 74) located at 1017 Chestnut Street in Greenville, North Carolina. The photograph is viewed in a northeasterly direction.

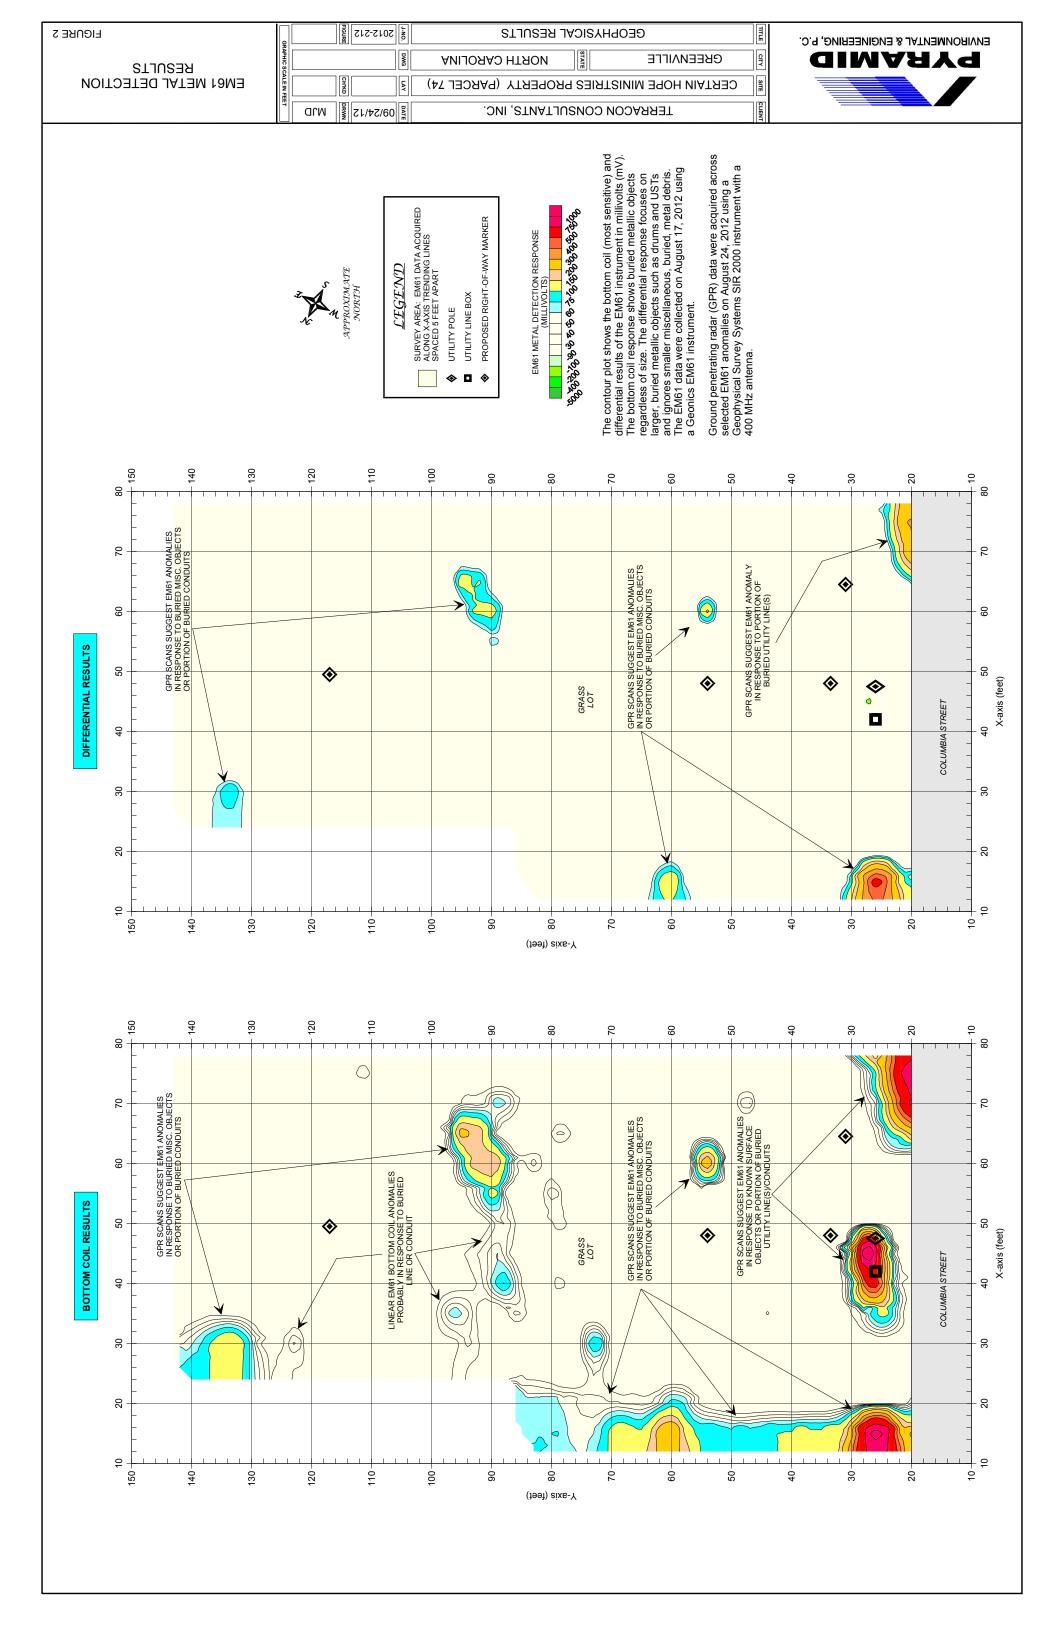
Contour plots of the EM61 bottom coil and differential results are presented in **Figure 2.** The bottom coil results represent the most sensitive component of the EM61 instrument and detect metal objects regardless of size. The bottom coil response can be used to delineate metal conduits or utility lines, small, isolated metal objects, and areas containing insignificant metal debris. The differential results are obtained from the difference between the top and bottom coils of the EM61 instrument. The differential results focus on the larger metal objects such as drum and UST-size objects and ignore the smaller insignificant metal objects.

The linear EM61 bottom coil anomalies intersecting grid coordinates X=14 Y=50 and X=40 Y=87 are probably in response to buried conduits and/or miscellaneous metal debris/objects. GPR data suggest the EM61 differential anomalies centered near grid coordinates X=14 Y=26, X=14 Y=60,

X=40 Y=26, X=60 Y=54, and X=74 Y=22 are in response to known surface objects, portions of buried conduits, and/or buried miscellaneous metal objects/debris. Similarly, GPR data suggest the EM61 differential anomalies centered near grid coordinates X=29 Y=133 and X=64 Y=92 are in response to buried miscellaneous metal objects/debris.

The remaining EM61 anomalies shown in Figure 2 are probably in response to known surface objects, conduits, or to small, insignificant metal debris/objects. The geophysical investigation suggests that the proposed ROW area at Parcel 74 does not contain metallic USTs within the surveyed portion of the site.
