Preliminary Site Assessment

115 Grande Avenue
Parcel #82, Corey, Herbert S.
Greenville, Pitt County, North Carolina

State Project No. U-3315

Terracon Project No. 70127335

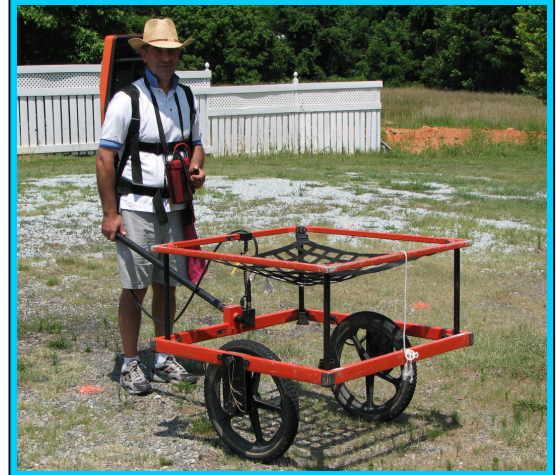
The photographs show the SIR-2000 GPR system equipped with a 400 MHz antenna that were used to conduct the ground penetrating radar investigation across the areas containing steel reinforced concrete and selected EM61 differential anomalies at Parcels, 79, 80, 81, 82, 187, & 188 on August 23 & 29, 2012.

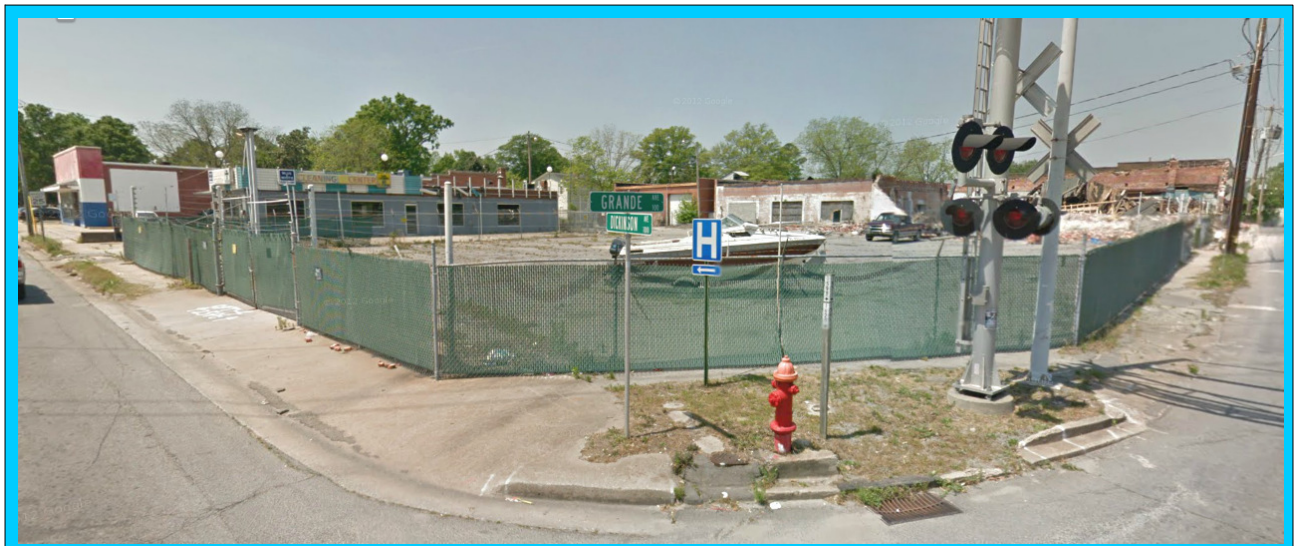
The photograph shows the eastern portions of the Corey, Hannan, Gatlin and Holloman properties located adjacent to the intersection of Dickinson Avenue and Grande Avenue in Greenville, North Carolina. The photograph is viewed in a northwesterly direction.

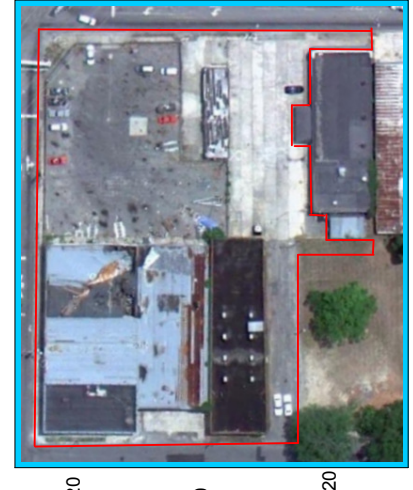
Note: The map shows the geophysical survey area at Parcels 79, 80, 81, 82, 187, and 188. The red dots represent the EM61 metal detection survey lines that were acquired on August 22, 2012 using a Geonics EM61 metal detection instrument. Each dot represents an EM61 data point.

The solid purple lines represent the ground penetrating radar (GPR) survey lines that were acquired across areas containing steel reinforced concrete and selected EM61 metal detection anomalies. The GPR investigation was conducted on August 23 and 29, 2012, using a Geophysical Survey Systems SIR-2000 unit with a 400 MHz antenna.

The red polygon in the aerial photograph represents the approximate outer perimeter of the geophysical survey at the subject parcels.

Due to the steel reinforced concrete pavement encountered within the areas of interest at Parcels 80, 82, 187, and 188, the geophysical investigation was limited to GPR surveys. GPR data were continuously collected along X-axis and Y-axis survey lines spaced 5 feet apart across the specified areas at each parcel using the same GPR equipment and settings that were discussed above. Locations of the EM61 metal detection survey lines and the GPR survey lines for the six parcels are shown as red dots and purple lines, respectively in **Figure 2**. Each red dot represents an EM61 data point.

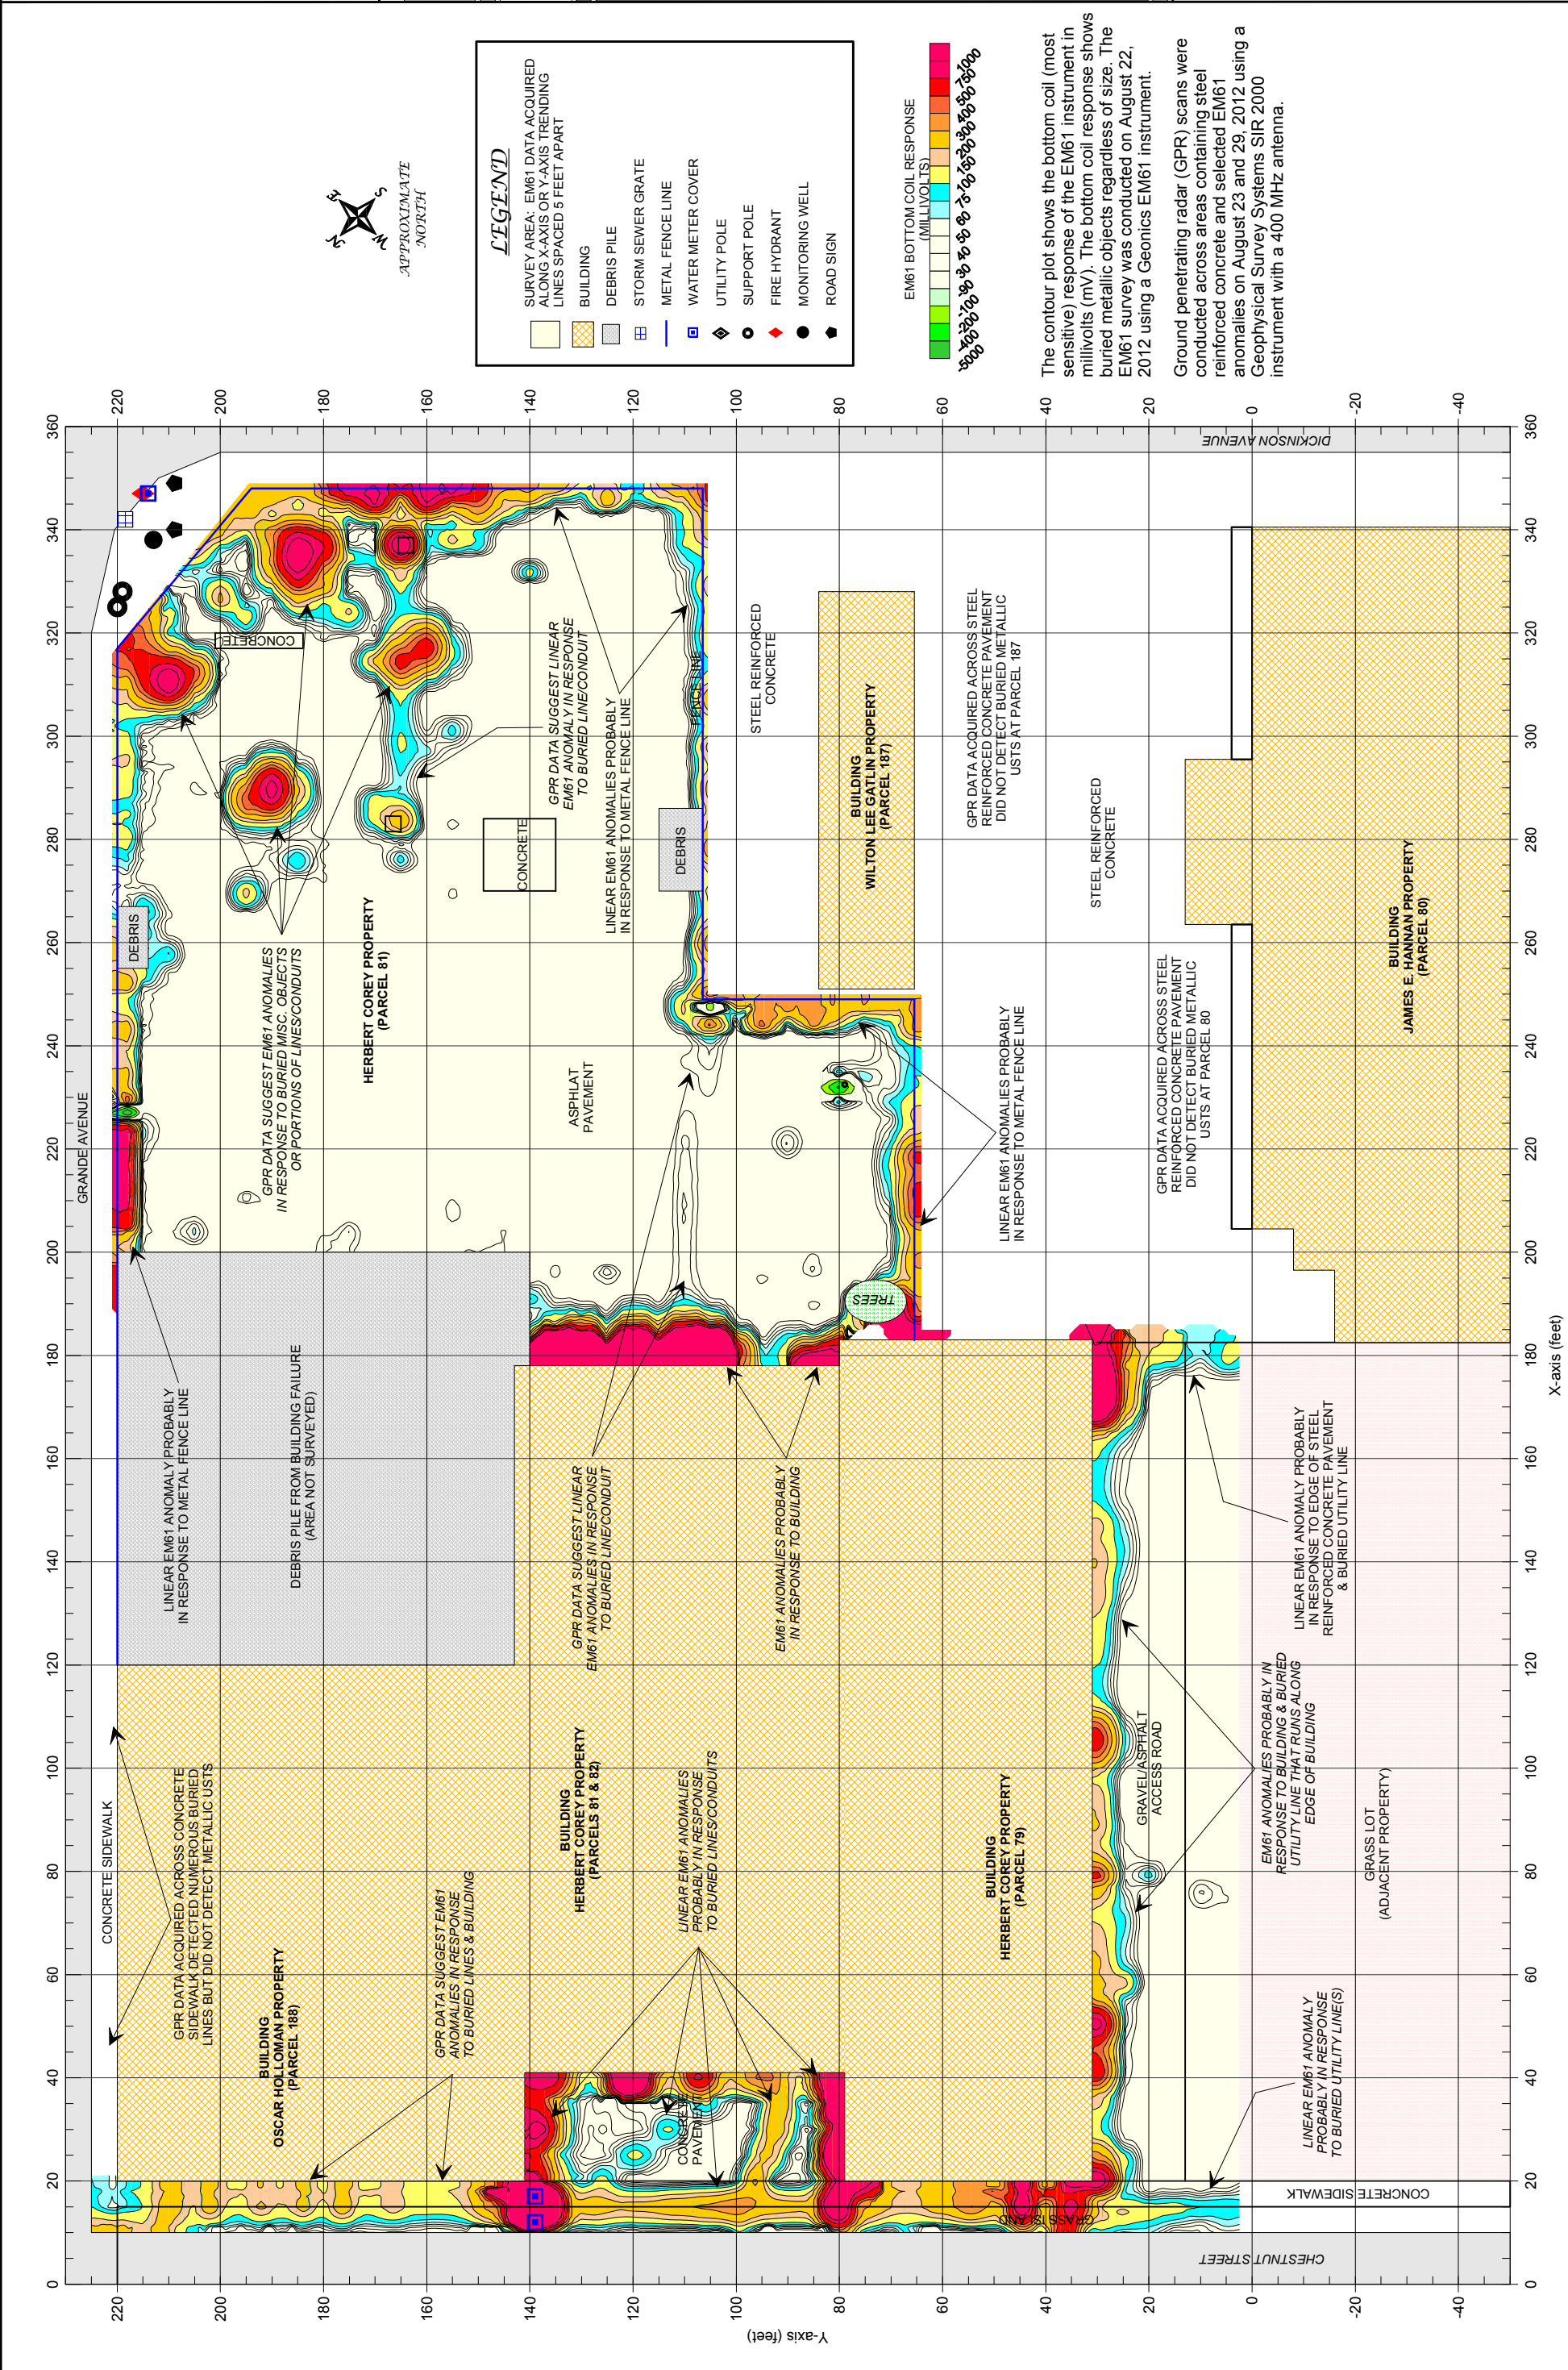
EM61 METAL DETECTION (BOTTOM COIL RESULTS)

The contour plot shows the bottom coil (most sensitive) response of the EM61 instrument in millivolts (mV). The bottom coil response shows buried metallic objects regardless of size. The EM61 survey was conducted on August 22, 2012 using a Geonics EM61 instrument.

Ground penetrating radar (GPR) scans were conducted across areas containing steel reinforced concrete and selected EM61 anomalies on August 23 and 29, 2012 using a Geophysical Survey Systems SIR 2000 instrument with a 400 MHz antenna.

The geophysical investigation conducted across the accessible portions of Parcels 79, 80, 81, 82, 187, and 188 suggest the areas do not contain buried metallic USTs.
