Preliminary Site Assessment

1003 Chestnut Street
Parcel #188, Holloman, Oscar
Historical Dry Cleaning Facility
Greenville, Pitt County, North Carolina

State Project No. U-3315

Terracon Project No. 70127335

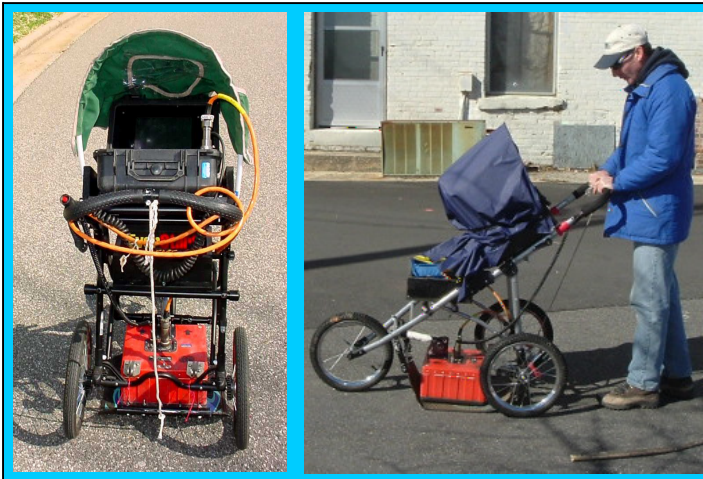
The photographs show the SIR-2000 GPR system equipped with a 400 MHz antenna that were used to conduct the ground penetrating radar investigation across the areas containing steel reinforced concrete and selected EM61 differential anomalies at Parcels, 79, 80, 81, 82, 187, & 188 on August 23 & 29, 2012.
