PSA REPORT

**PRELIMINARY SITE ASSESSMENT
PARCEL #34
ROBERT & JANICE ASHLEY PROPERTY
410 ELKIN HIGHWAY
WILKESBORO, WILKES COUNTY, NC
STATE PROJECT R-2603
WBS ELEMENT 36001.1.2**

North Carolina Department of Transportation
Geotechnical Engineering Unit
Geoenvironmental Section
Century Center Complex, Building B
1020 Birch Ridge Drive
Raleigh, NC 27610
Tel. (919) 250-4088

July 31, 2013

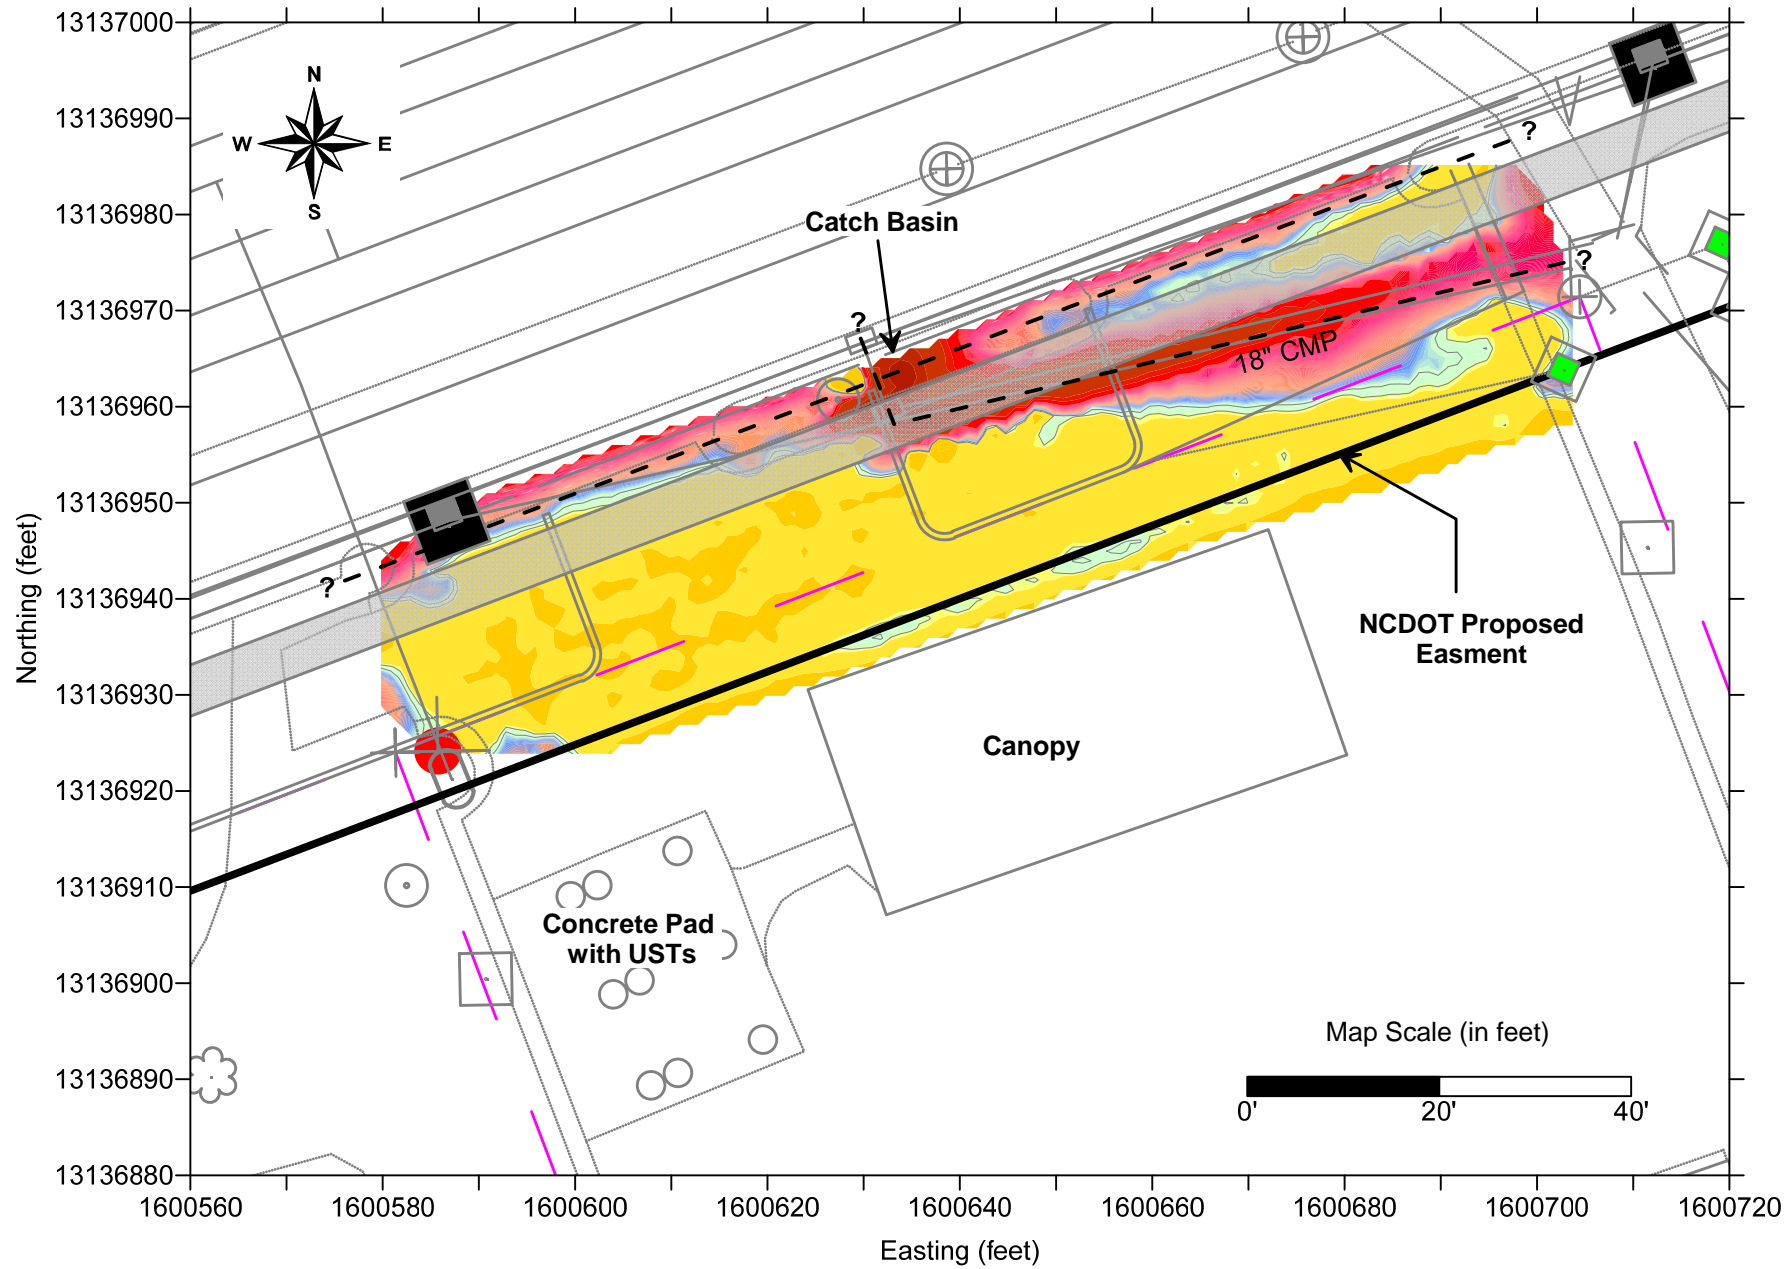
The EM-61 Channel 1 and differential response results are provided as plan view, color-enhanced contour maps in **Figures 3** and **4**, respectively. The results presented in **Figures 3** and **4** are superimposed on the parcel base drawing provided by NCDOT. The interpreted background response is represented by the light blue to light green contours and corresponds to the range of -5 to 20 milliVolts (mV).

The Channel 1 results in **Figure 3** indicate high response anomalies, red in color, where known metallic features exist. Features of note include a catch basin cover and a section of 18-inch corrugated metal pipe on the northeastern portion of the surveyed area.

In addition, Channel 1 results in **Figure 3** indicate an increase in negative response values across the surveyed area. This increase in negative response values is indicated in **Figure 3** by the yellow contours. Because the ground surface consists of asphalt across this portion of the site, the localized increase in negative response values suggests a slightly elevated background metallic signature of the materials beneath the asphalt. These near-surface conditions may include sub-base or fill materials with a relatively higher metallic mineral content. The effects of these conditions appear to be more prevalent in the Channel 1 data (**Figure 3**) compared to the differential response data (**Figure 4**).

EM-61 MKII Channel 1 Response (millivolts)
