Pyramid Environmental & Engineering, P.C. Project # 2014-093
Preliminary Site Assessment (PSA) – Parcel 001, Kenneth Etheridge

PRELIMINARY SITE ASSESSMENT
PARCEL 001 – KENNETH ETHERIDGE
375 BAGLEY ROAD
KENLY, JOHNSTON COUNTY, NORTH CAROLINA
NC PIN: 264600-83-2660
STATE PROJECT: I-3318BB
WBS ELEMENT: 34182.2.1
JUNE 27, 2014

**PRELIMINARY SITE ASSESSMENT
PARCEL 001, KENNETH ETHERIDGE
375 BAGLEY ROAD
KENLY, JOHNSTON COUNTY, NORTH CAROLINA**

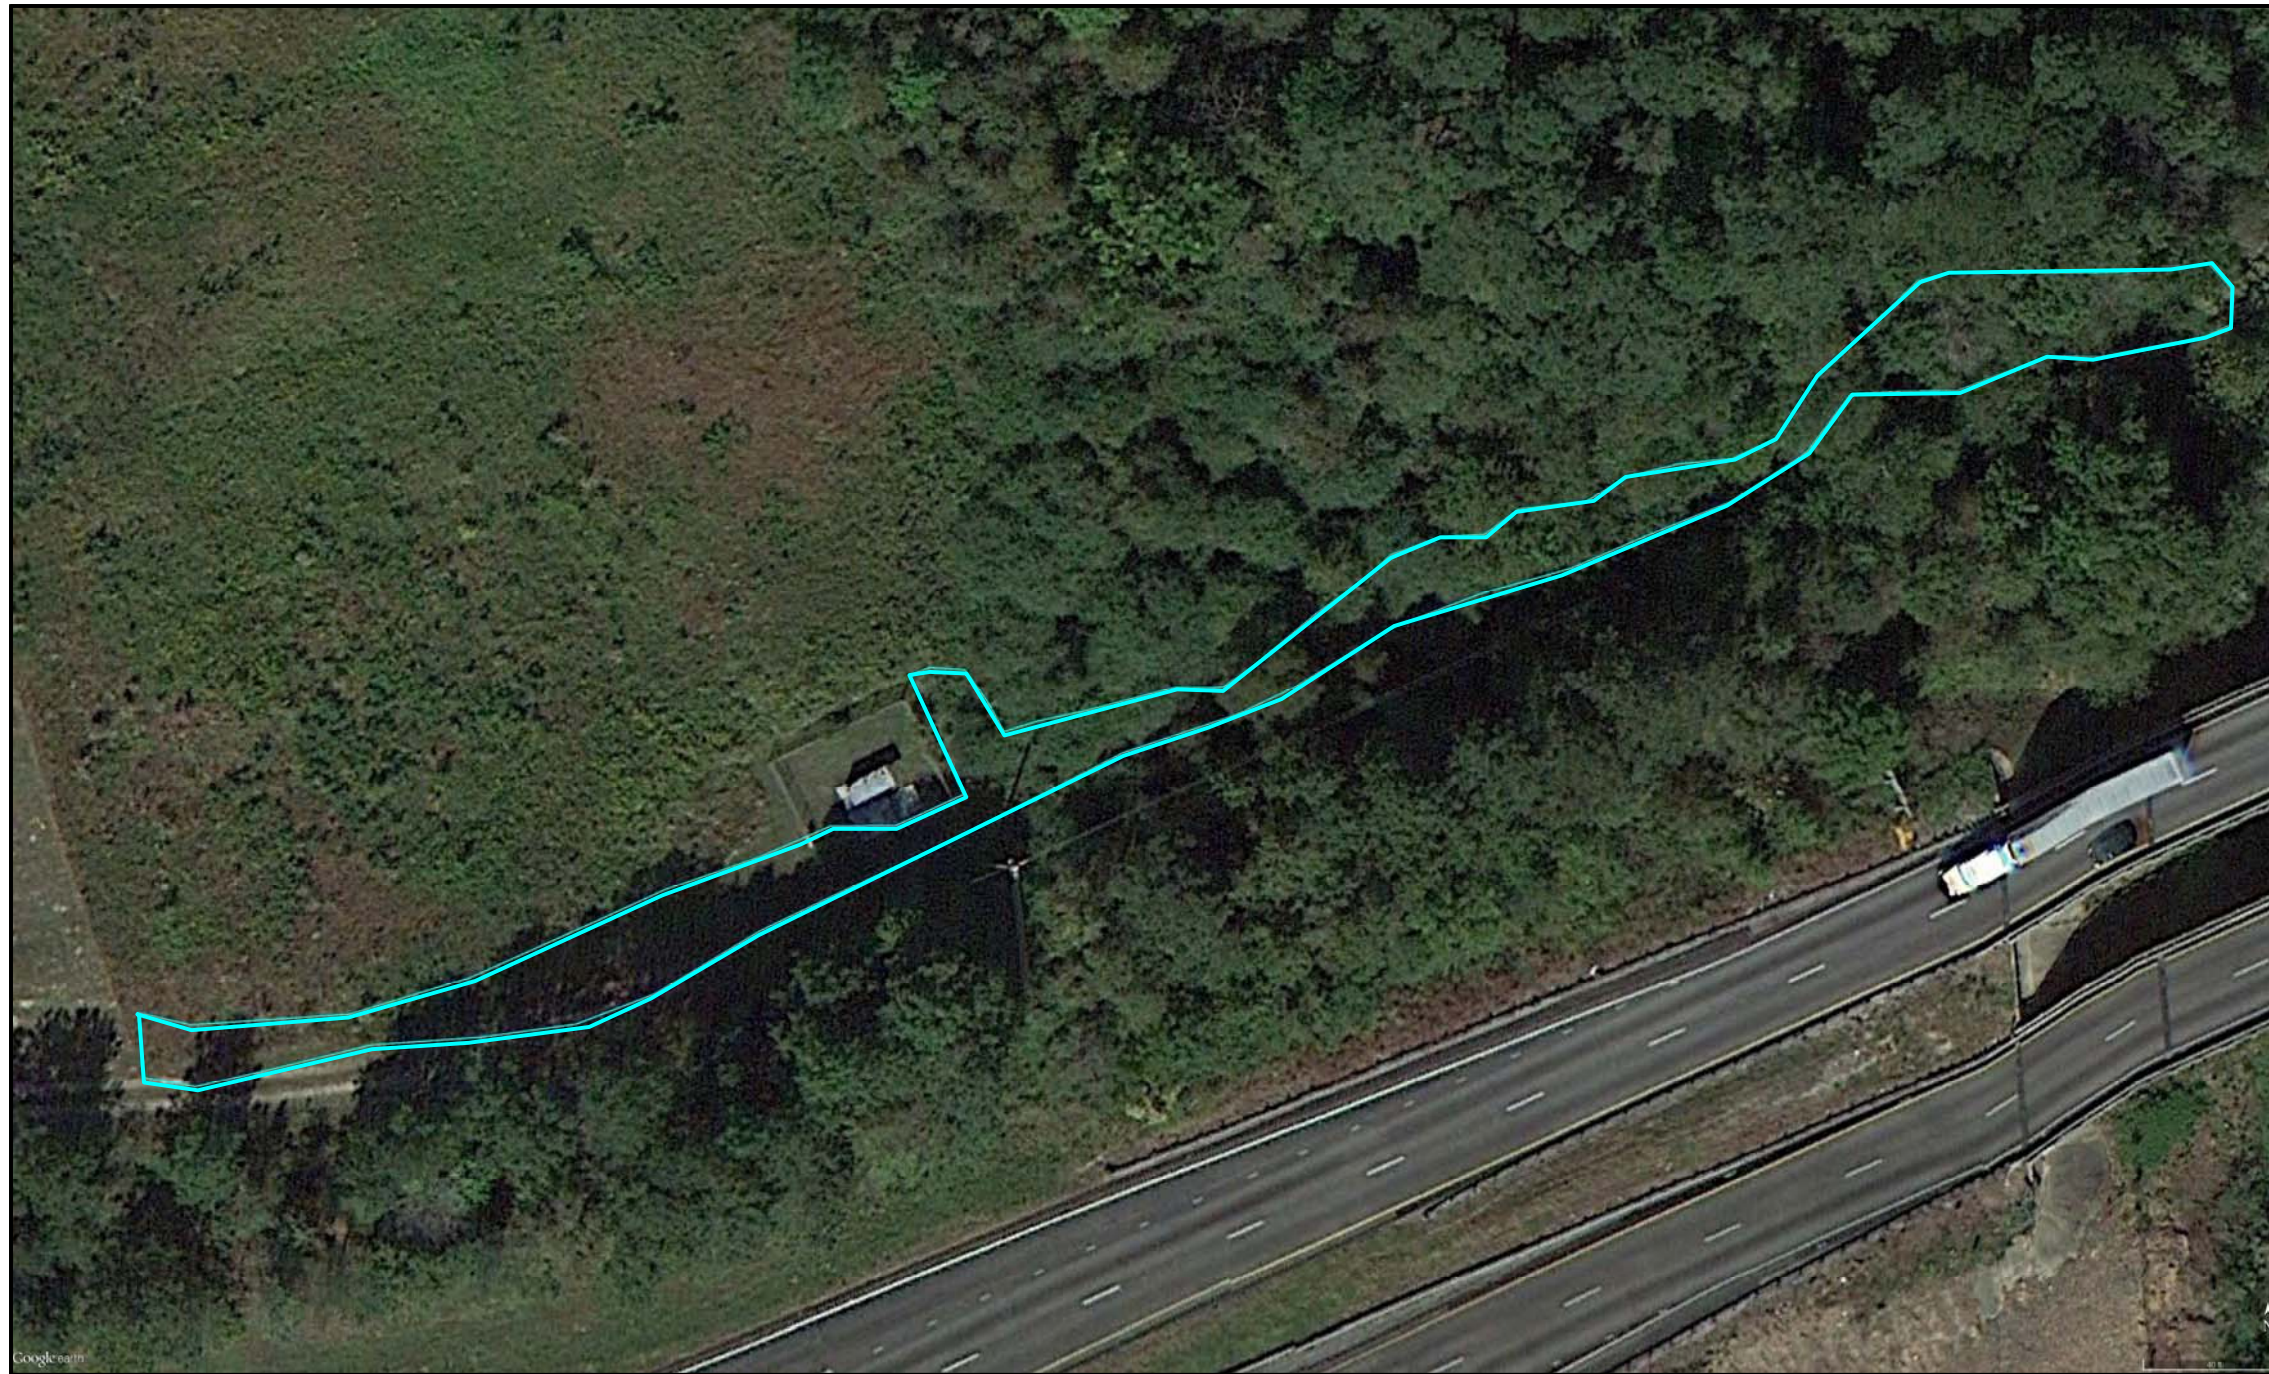
Approximate Boundaries of Geophysical Survey Area

The parcel operated as a Waste Management facility. The main structures associated with the facility were to the west of the geophysical survey area. The survey area itself contained a utility lift station and a dirt access road surrounded by grass and dense vegetation/forest. It should be noted that a large portion of the parcel that was within the proposed ROW and/or easements was not accessible by the geophysical equipment due to the vegetation. Surveys were performed in all accessible areas. Aerial photographs showing the survey area boundaries and ground-level photographs are shown in **Figure 1**.

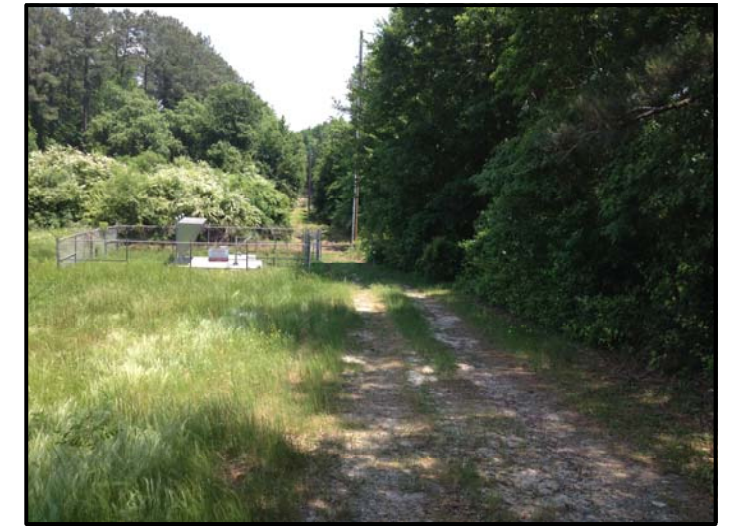
View of West Portion of Survey Area
(Facing Approximately East)

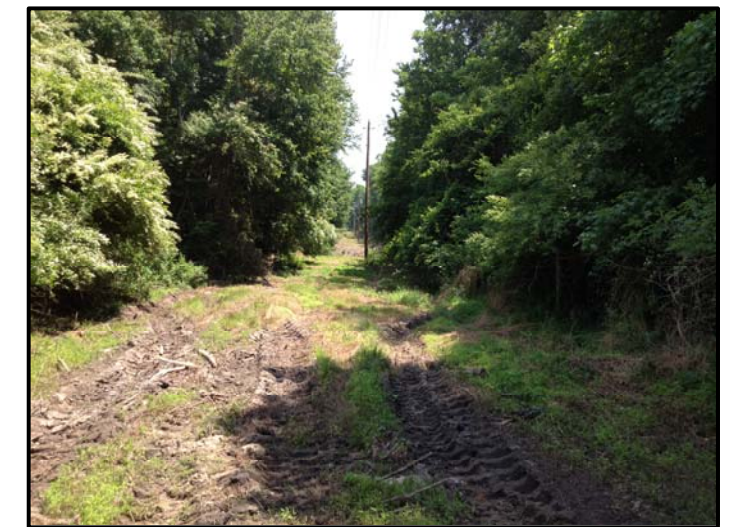
View of East Portion of Survey Area
(Facing Approximately East)

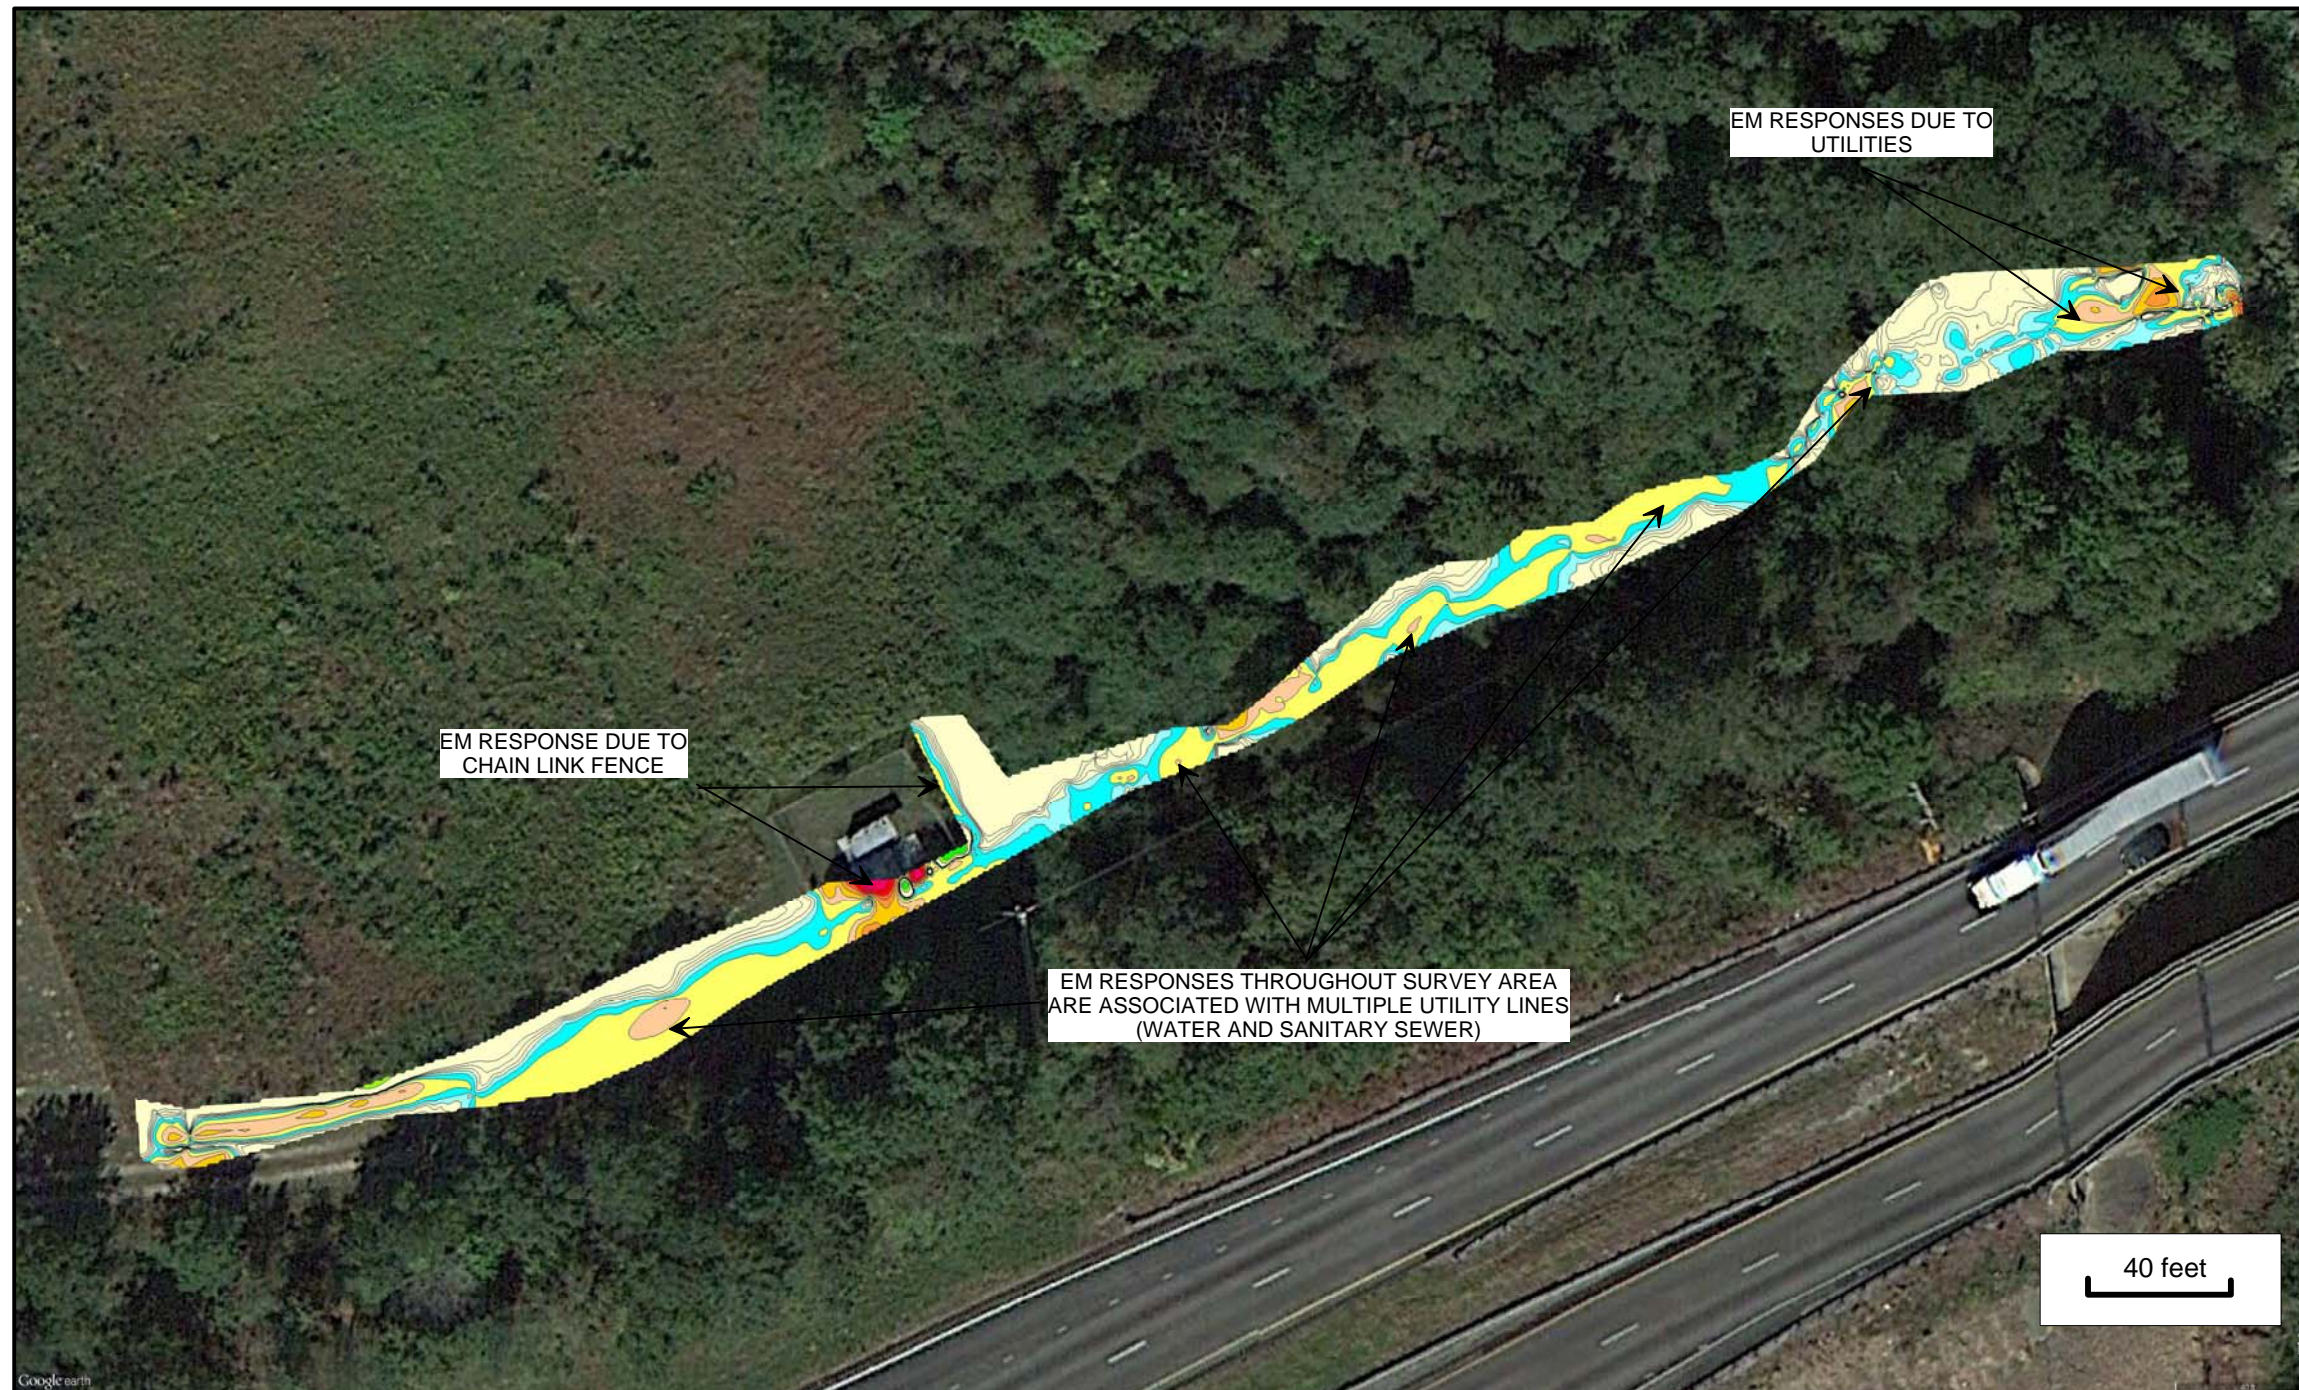
503 INDUSTRIAL AVENUE GREENSBORO, NC 27460 (336) 335-3174 (p) (336) 691-0648 (f) License # C1251 Eng. / License # C257 Geology
DATE	6/19/2014	CLIENT NCDOT
PYRAMID PROJECT #:	2014-093	FIGURE 2

NO EVIDENCE OF METALLIC USTs OBSERVED

The contour plot shows the differential results of the EM61 instrument in millivolts (mV). The differential response focuses on larger, buried metallic objects such as drums and USTs and ignores smaller miscellaneous buried, metal debris. The EM61 data were collected on May 21, 2014, using a Geonics EM61 instrument. Ground penetrating radar (GPR) data were not required due to all EM anomalies being directly attributed to cultural features.

A large portion of the parcel was inaccessible due to dense/tall vegetation and forest. All of the EM61 anomalies detected could be attributed to visible objects at the ground surface such as fences, or marked underground utilities. The geophysical investigation did not record evidence of metallic USTs at the property.

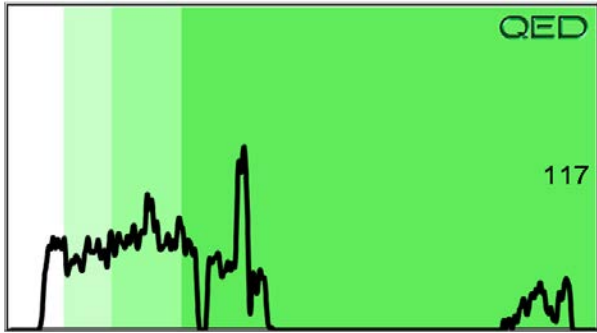
1-7 (2-4)

Deg.Fuel Residue (FCM) 48.5%
