SEE SHEET 6 FOR -L- PROFILE  
SEE SHEET 5 FOR DETOUR  
SEE SHEETS S-1 THRU S-23  
FOR STRUCTURE PLANS

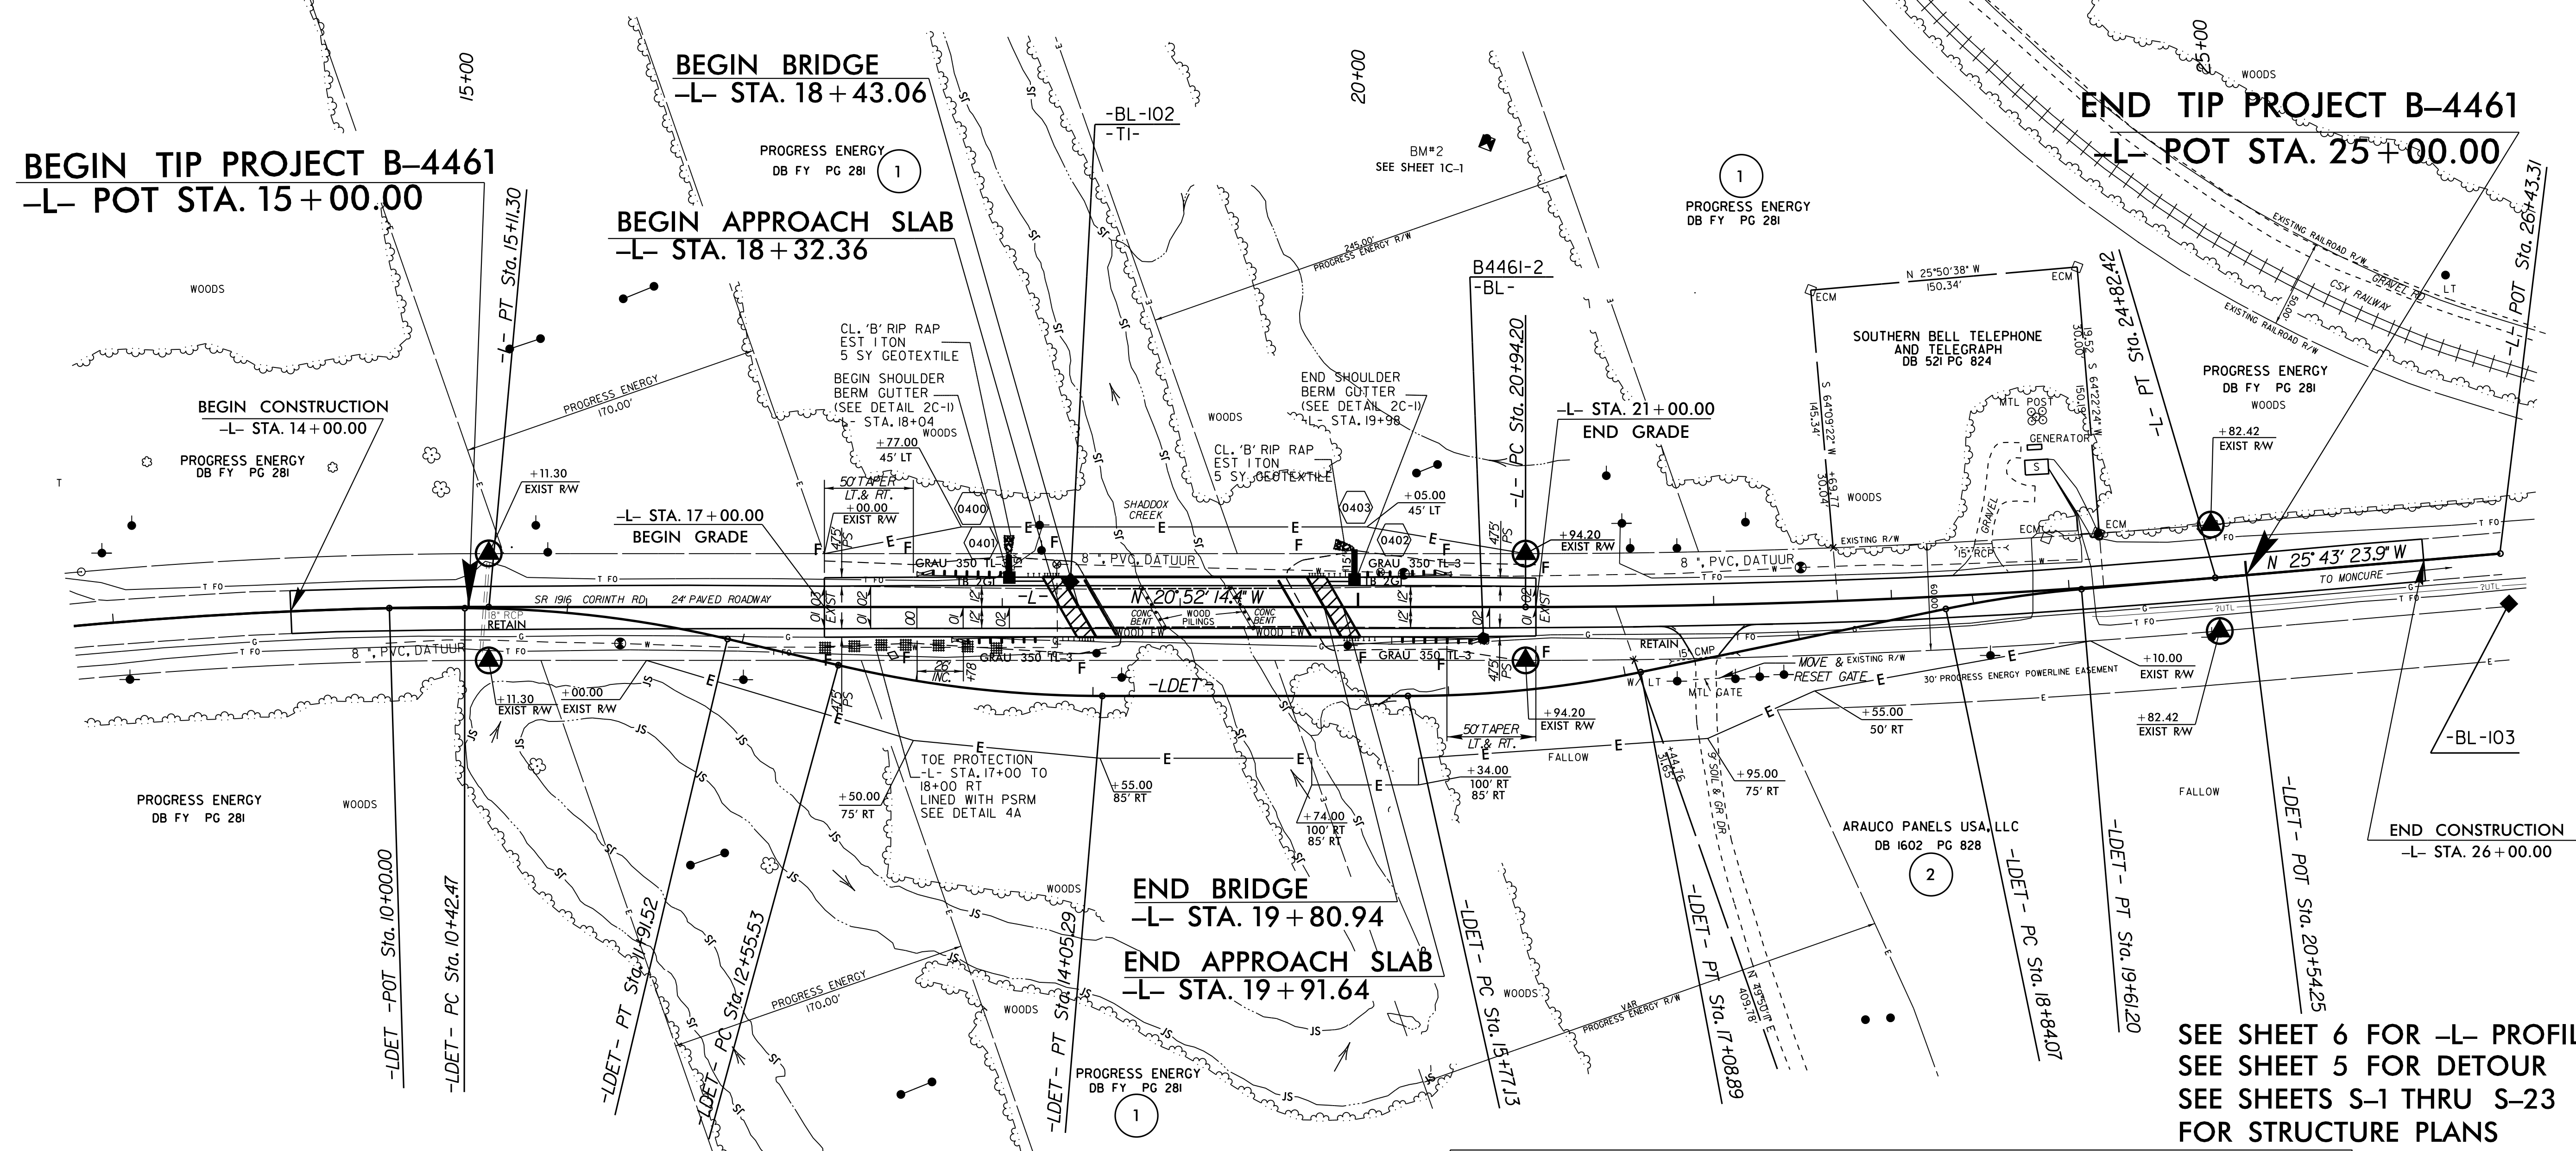
| -L- | | -LDET- | | | |
|---|---|--|--|--|--|
| PI Sta 13+43.59<br>Δ = 7° 33' 27.0" (RT)<br>D = 2' 15' 00.0"<br>L = 335.89'<br>T = 168.19'<br>R = 2,546.48'<br>SE = SEE PLANS | PI Sta 22+88.43<br>Δ = 4° 51' 09.5" (LT)<br>D = 1' 15' 00.0"<br>L = 388.21'<br>T = 194.22'<br>R = 4,583.66'<br>SE = SEE PLANS | PI Sta 11+17.33<br>Δ = 13° 14' 27.4" (RT)<br>D = 8° 52' 59.0"<br>L = 149.06'<br>T = 74.86'<br>R = 645.00'<br>SE = 0.04<br>RO = 80' | PI Sta 13+30.75<br>Δ = 13° 18' 09.2" (LT)<br>D = 8° 52' 59.0"<br>L = 149.75'<br>T = 75.21'<br>R = 645.00'<br>SE = 0.04<br>RO = 80' | PI Sta 16+43.24<br>Δ = 11° 42' 14.8" (LT)<br>D = 8° 52' 59.0"<br>L = 131.76'<br>T = 66.11'<br>R = 645.00'<br>SE = 0.04<br>RO = 80' | PI Sta 19+22.68<br>Δ = 6° 51' 05.3" (RT)<br>D = 8° 52' 59.0"<br>L = 77.13'<br>T = 38.61'<br>R = 645.00'<br>SE = 0.04<br>RO = 80' |
