## **PRELIMINARY SITE ASSESSMENT**

**WILCOHESS (PARCEL #19)  
850 Capital Boulevard  
Raleigh, North Carolina  
State Project: B-5121 & B-5317  
WBS Element: 42263.1.1  
F&R Project #66T-0097**

**Subject: Preliminary Site Assessment  
Parcel #19 – WilcoHess (WilcoHess #211)**  
850 Capital Blvd  
Raleigh, North Carolina  
F&R Project #66T-0097

**Preliminary Site Assessment Report  
WilcoHess Property (Parcel #19)  
Raleigh, Wake County, North Carolina  
F&R Project No. 66T-0097**

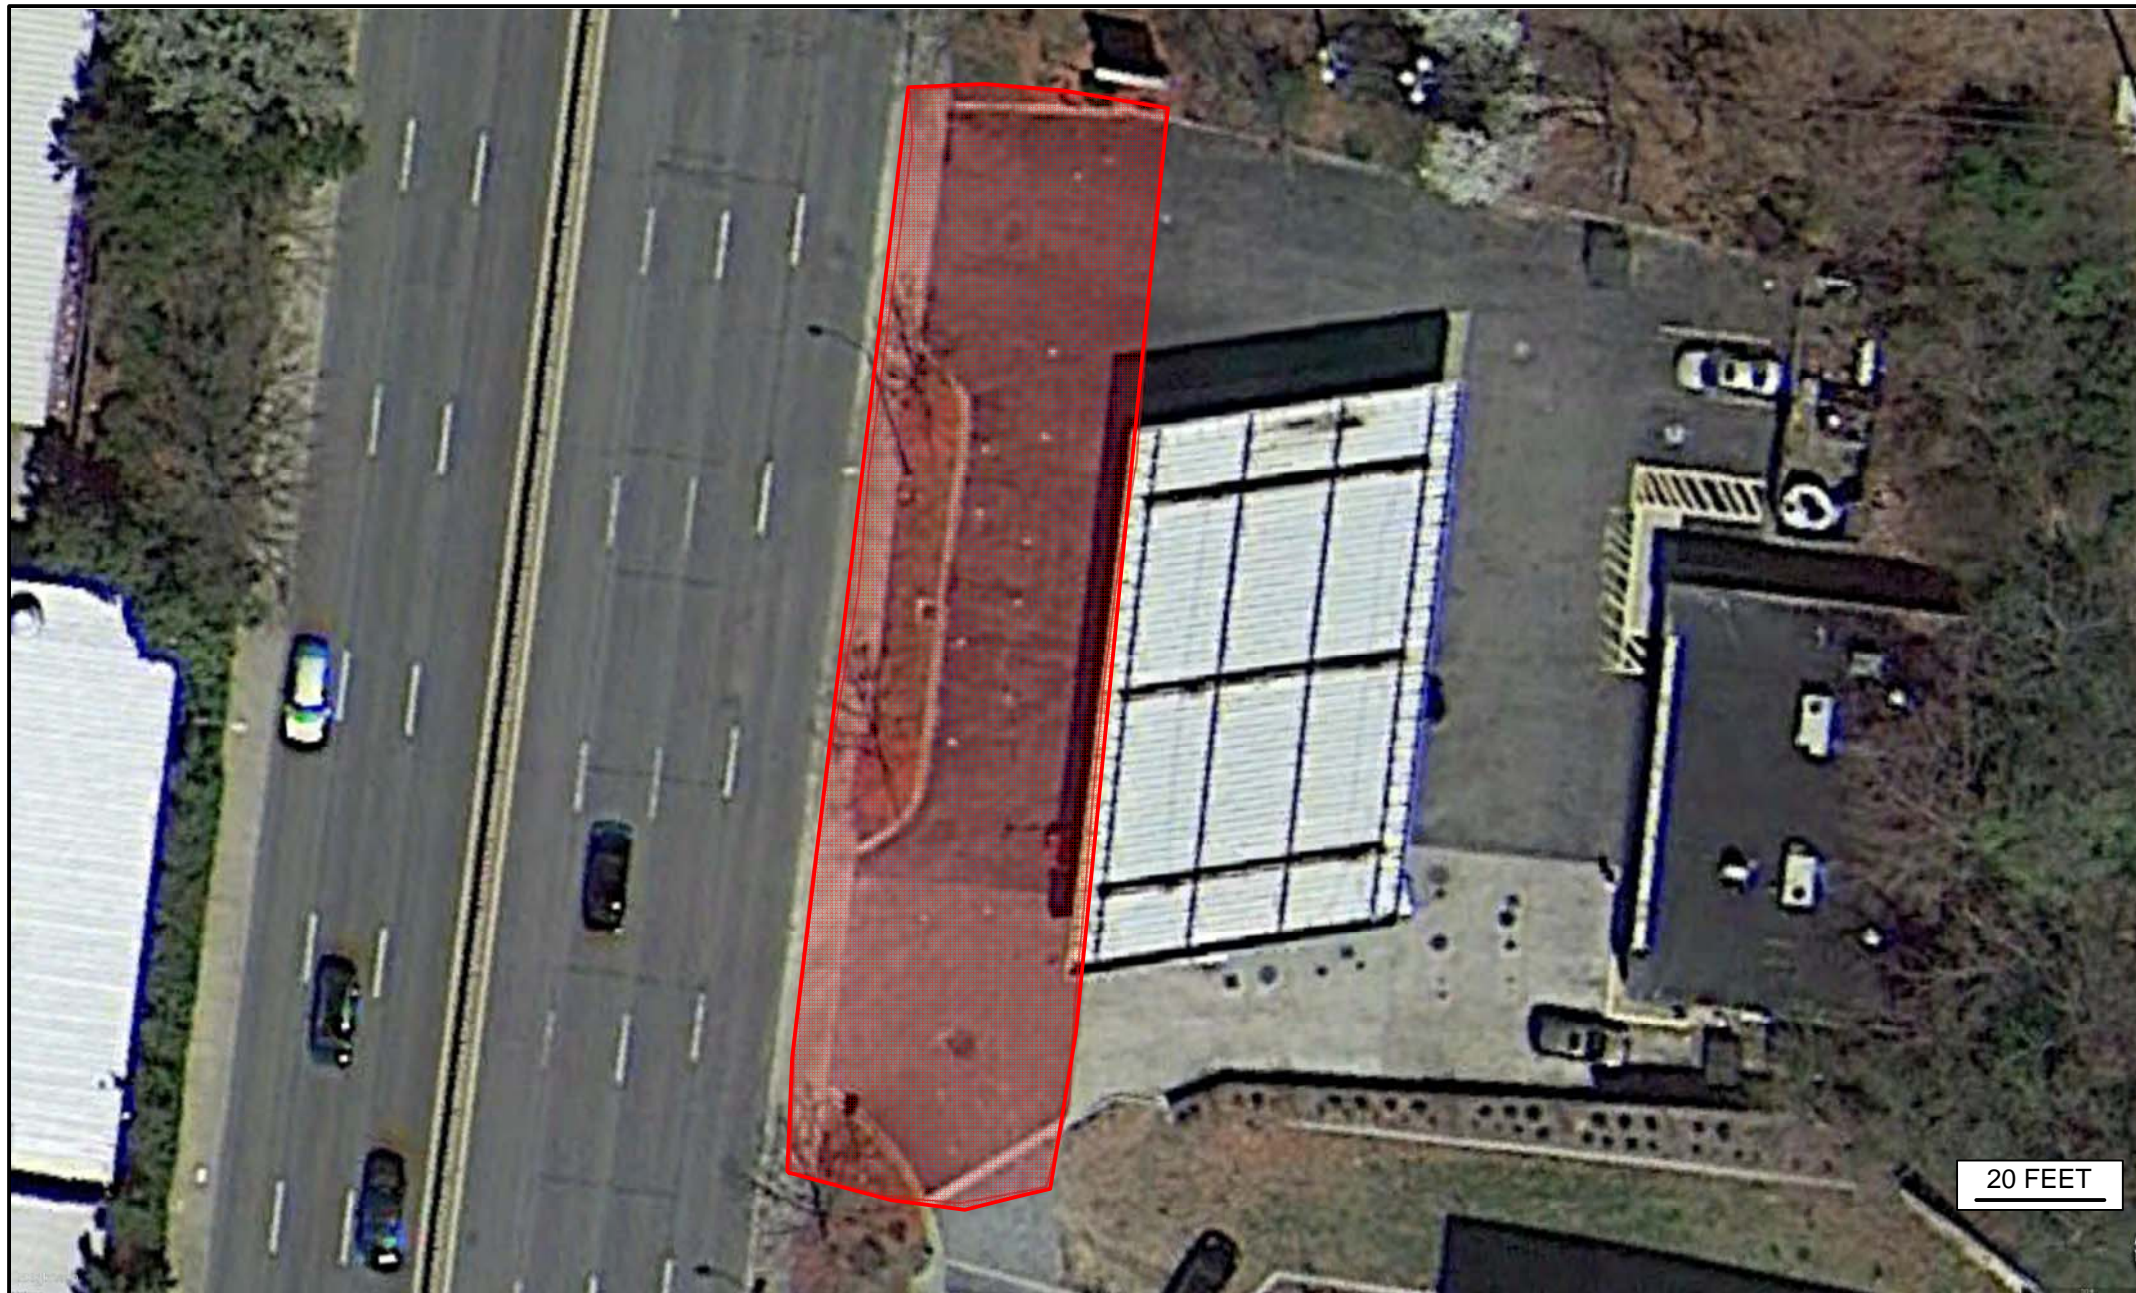
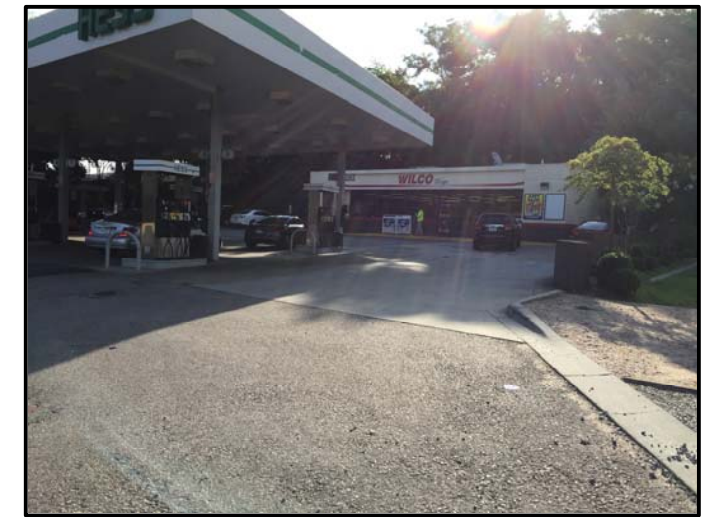
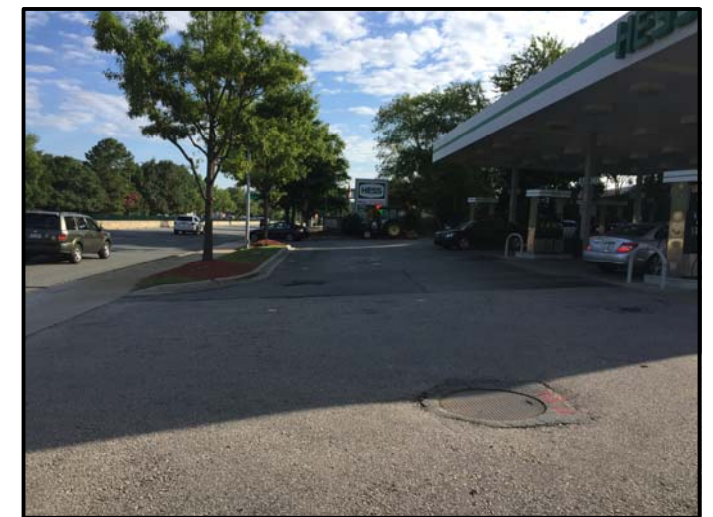
TITLE	PARCEL 19 - 850 CAPITAL BLVD. GEOPHYSICAL SURVEY BOUNDARIES AND SITE PHOTOGRAPHS	
PROJECT	METALLIC UST INVESTIGATION NCDOT B-5121/B-5317, RALEIGH, NC

APPROXIMATE BOUNDARIES OF GEOPHYSICAL SURVEY AREA

View of Survey Area  
(Facing Approximately Northeast)

View of Survey Area  
(Facing Approximately North)

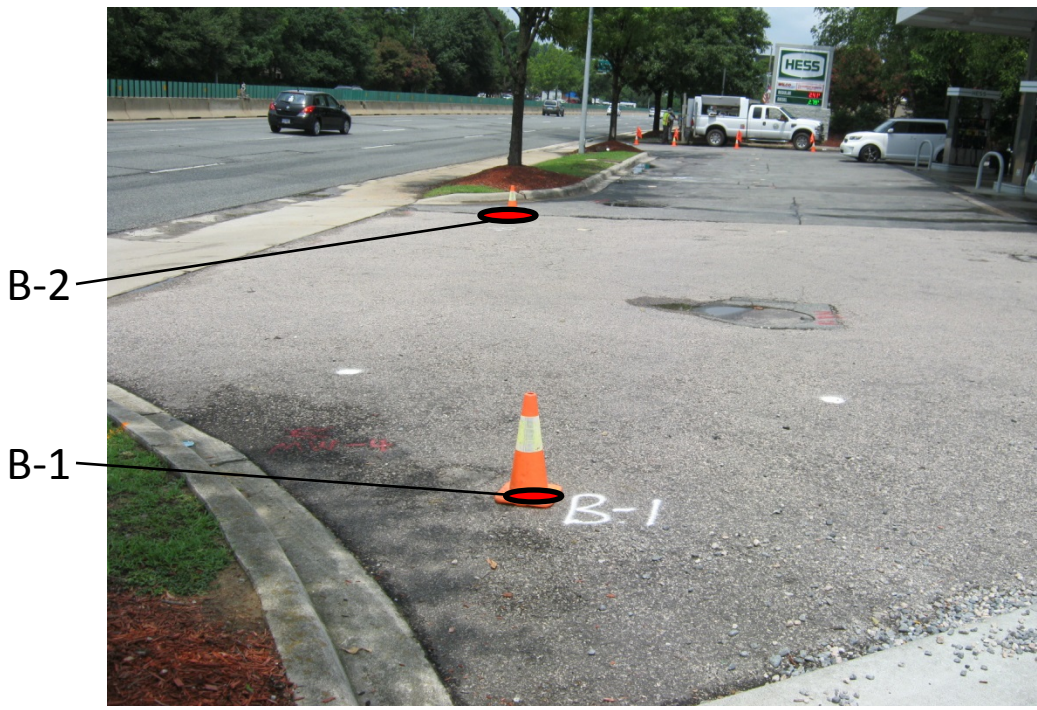
**Photo #1:** A view of Borings B-1 and B-2, facing north.

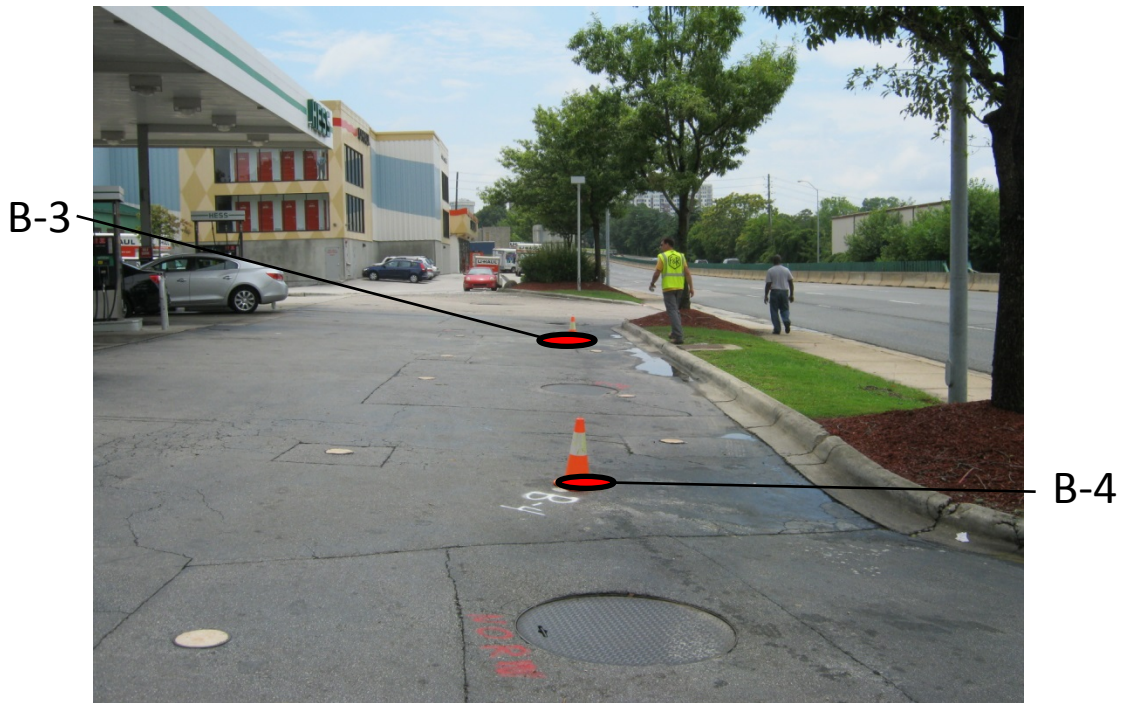
**Photo #2:** A view of Borings B-3 and B-4, facing south

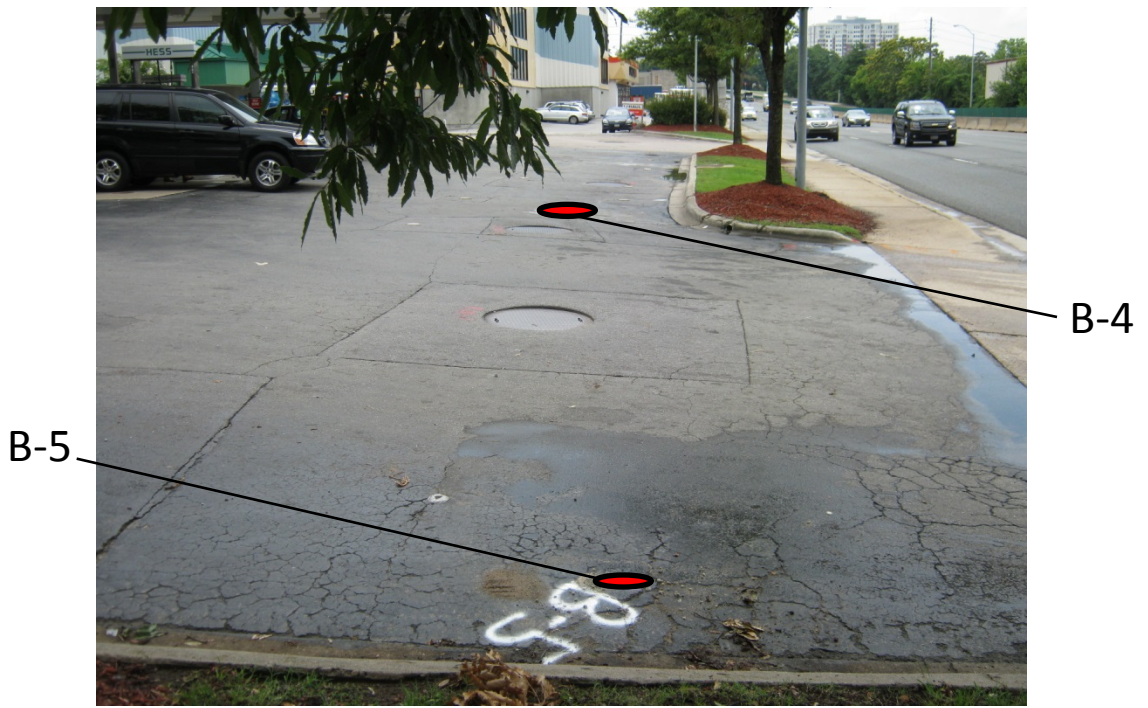
**Photo #3:** Boring locations B-4 and B-5, facing south.

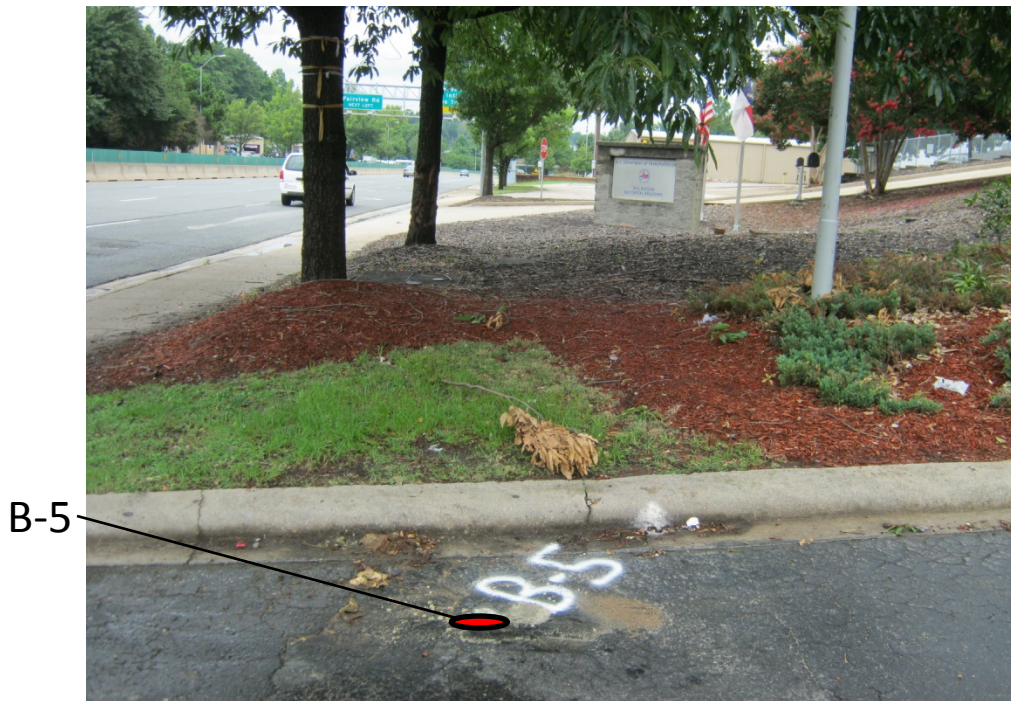
**Photo #4:** A view of boring location B-5, facing north.
