PRELIMINARY SITE ASSESSMENT

Second District Religious Educational Charitable Dev., Inc. (Parcel #6)

State Project: B-5121 & B-5317

August 21, 2015

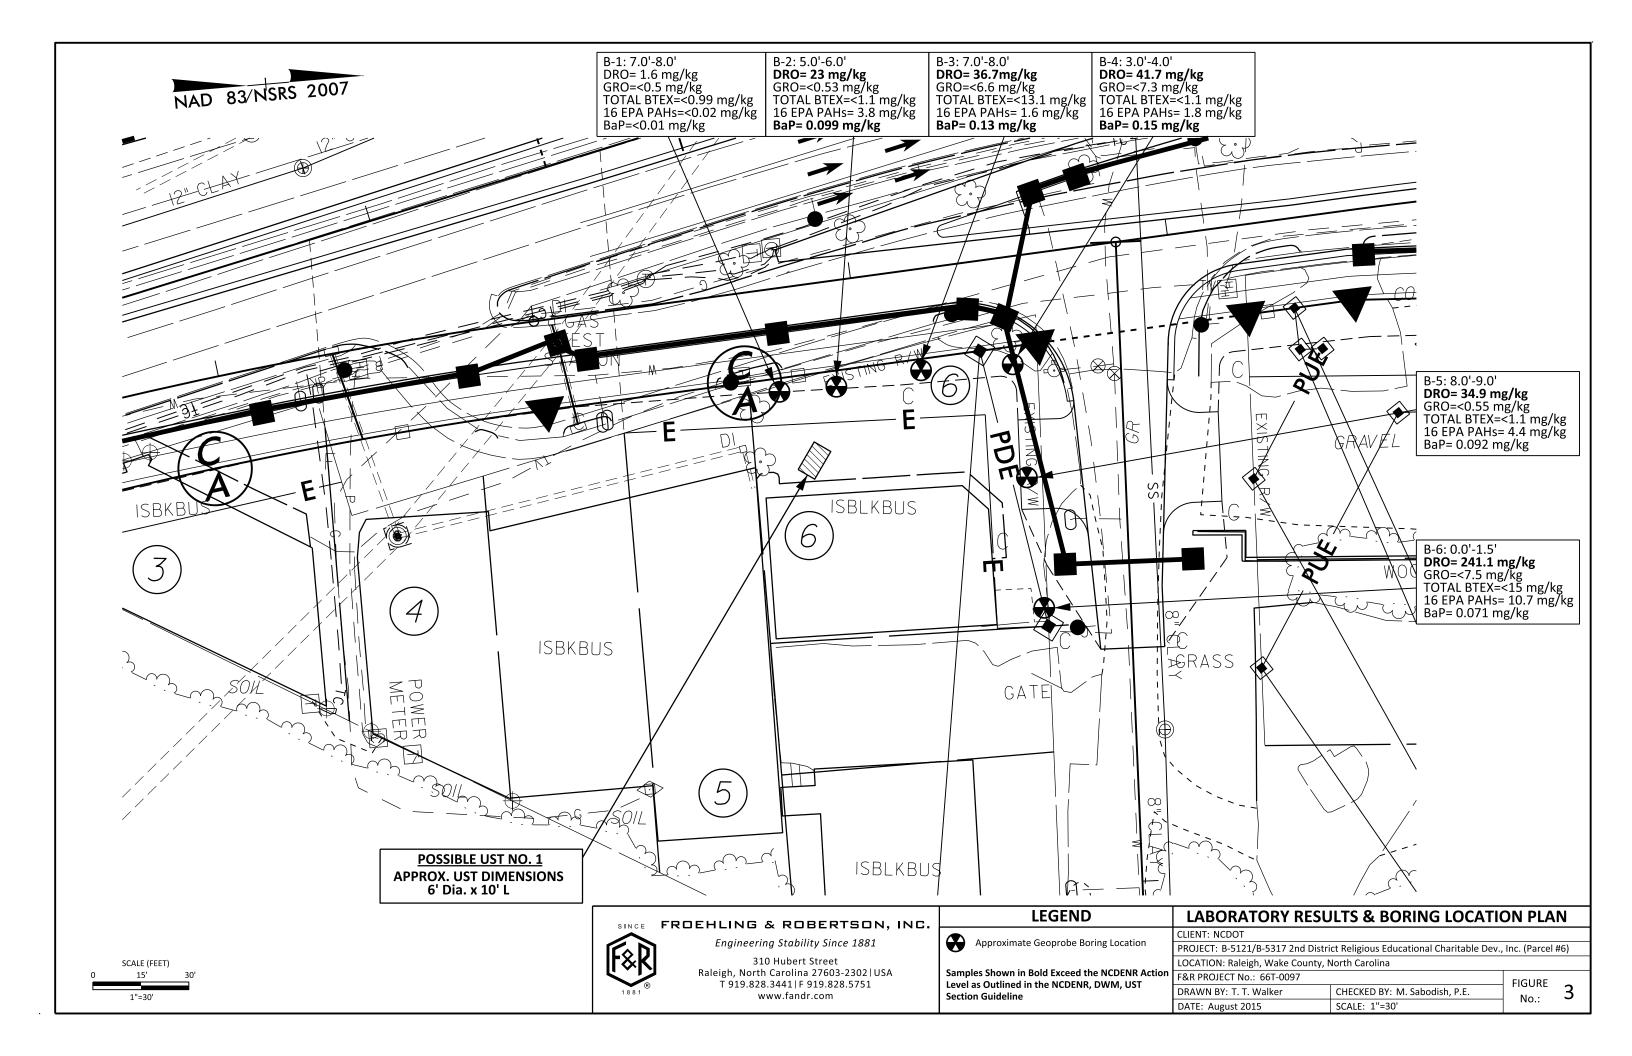
Figure No. 3 – LABORATORY RESULTS & BORING LOCATION PLAN

therefore, F&R did not assess the area immediately surrounding the Possible UST (Appendix I, Figure 3). The borings were generally advanced to the proposed depth of 10 feet bgs. However, Boring B-6 was terminated at 3 feet bgs, where Geoprobe refusal was encountered due to very dense sands.

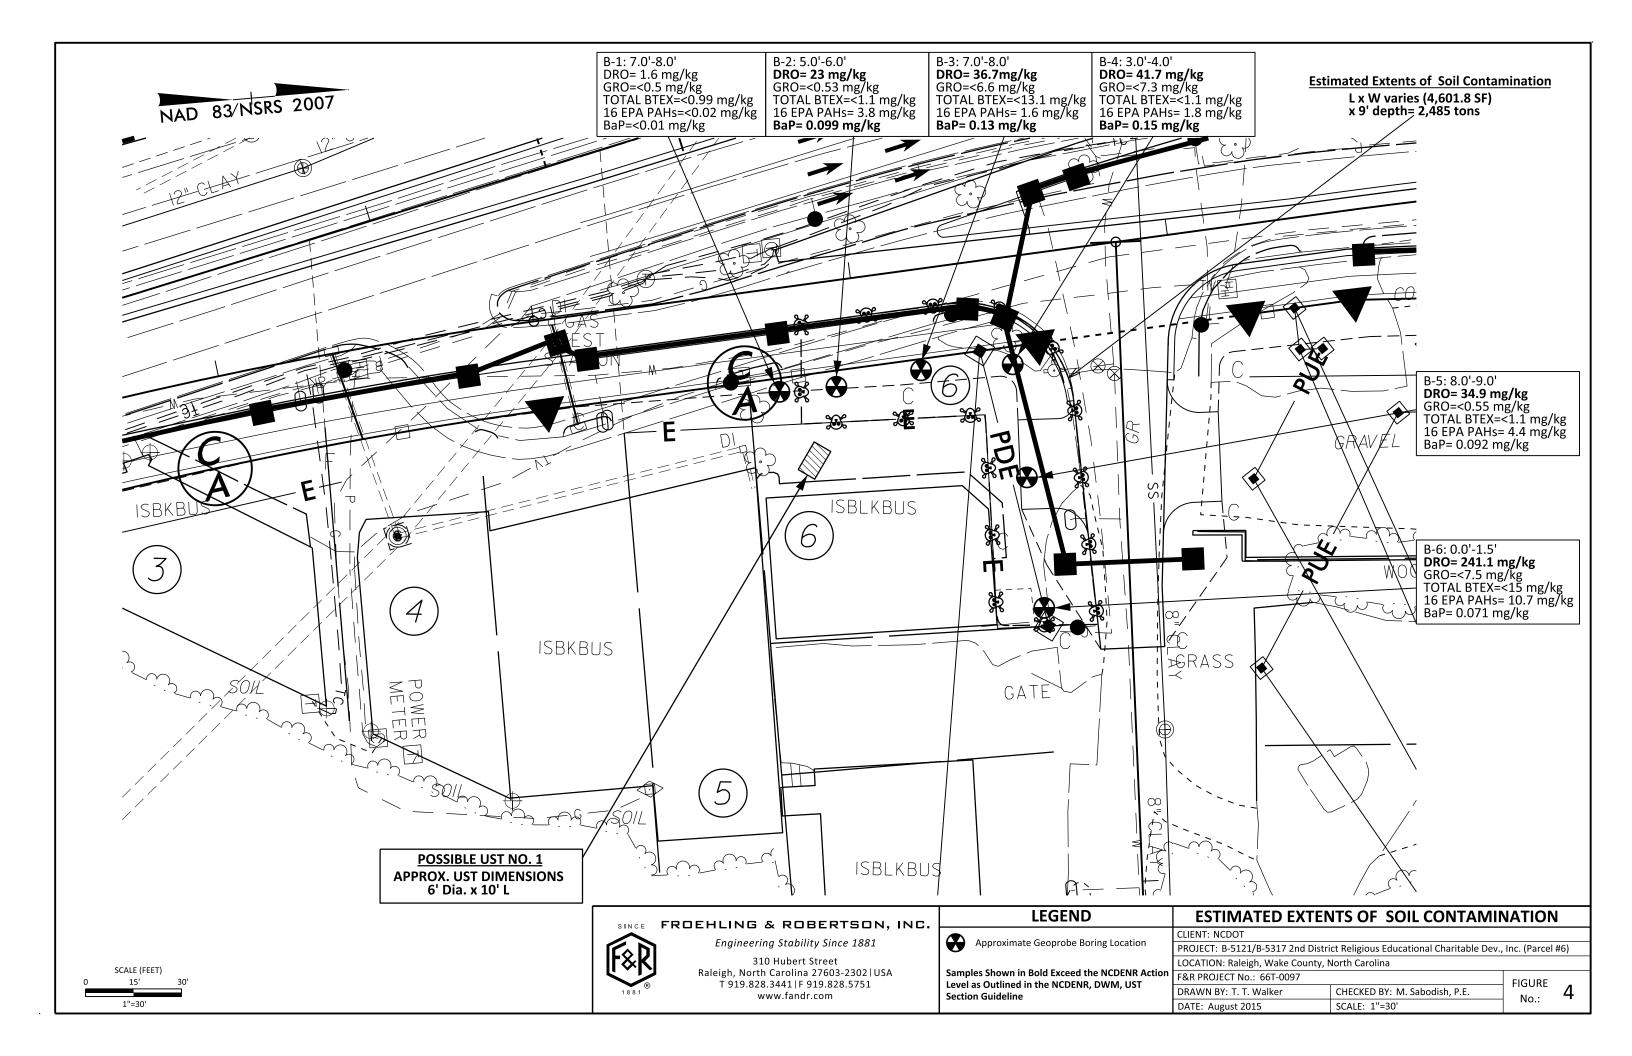
Figure No. 4 – ESTIMATED EXTENTS OF SOIL CONTAMINATION

Six Geoprobe borings were advanced during the assessment within the proposed right-of-way, where grading activities are proposed in association with the Peace Street Bridge, Wade Avenue Bridge and Capital Boulevard improvements. Based on the results of laboratory testing and observed PID readings, petroleum impacted soils were found at concentrations above the NCDENR Action Level of 10 mg/kg at boring locations B-2 through B-6. Therefore, it is estimated that petroleum impacted soils, at concentrations above the NCDENR Action Level, are present from existing ground surface to a depth of at least nine feet below existing ground surface in the vicinity of Borings B-2 through B-6.

No below grade utilities appear on the proposed improvement plans. However, a realignment of the Capital Boulevard access road is depicted, which will likely require re-grading of the existing ground surface during the construction. For the purpose of this assessment, we have estimated an average petroleum-impacted area of 4,601.8 square feet, extending to a depth of nine feet bgs. This area accounts for impacted soils that may be generated during re-grading activities and for unknown below grade utilities that may be installed during construction. The area was determined by averaging distances between the proposed right-of-way and the proposed edge of pavement on the construction drawings (Appendix I, Figure 4).

It should be noted that a delineation of the soil contamination was not performed, as this was not included in the proposed scope of work. The above estimates are based on interpretations of soil analytical results, PID readings and our experience with petroleum UST releases. In order to generate estimated quantities of petroleum impacted soils, we have inferred that the contamination has occurred between the existing ground surface and the sample collection depth. The amount of impacted soil can only be determined after excavation or by advancing additional borings and performing additional laboratory analysis to delineate the extents (horizontal and vertical) of contamination.

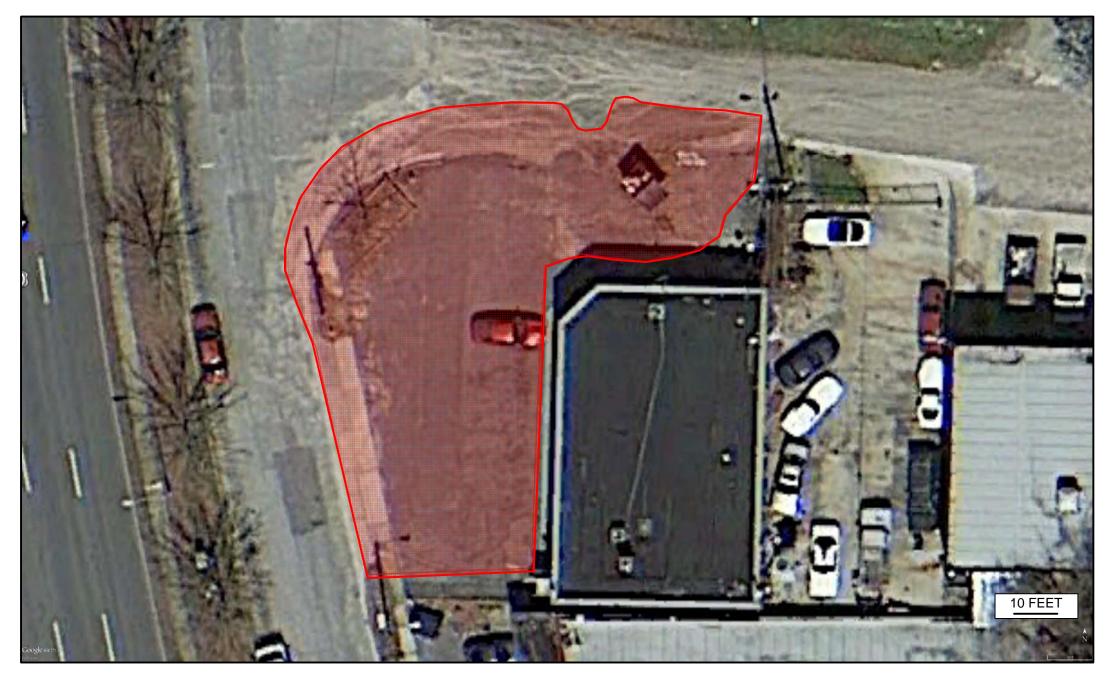
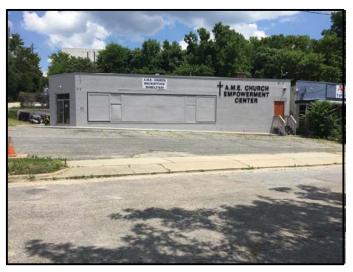
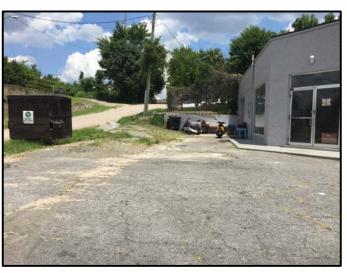
GEOPHYSICAL SURVEY BOUNDARIES AND SITE PHOTOGRAPHS

The site included a charitable shelter building surrounded by asphalt parking areas. Aerial photographs showing the survey area boundaries and ground-level photographs are shown in **Figure 1**.

APPROXIMATE BOUNDARIES OF GEOPHYSICAL SURVEY AREAS.

View of Survey Area (Facing Approximately East)

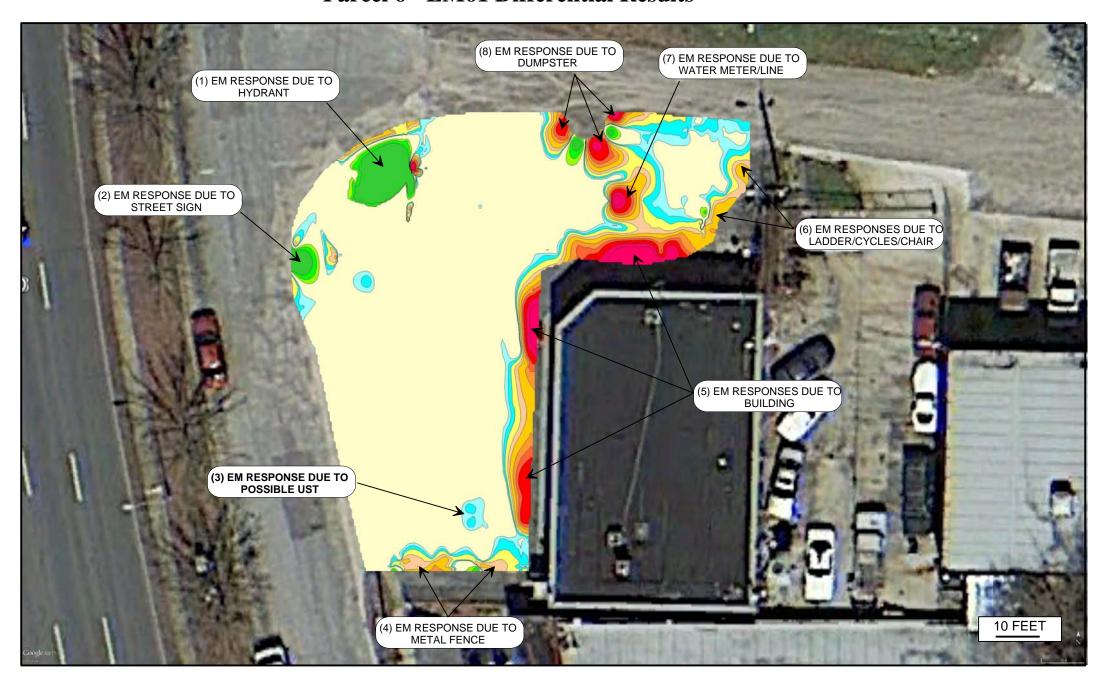
Parcel 6 - EM61 Differential Results

A contour plot of the EM61 results obtained across the survey area at the property is presented in **Figure 2**. Each EM anomaly is numbered for reference to the figure. The following table presents the list of EM anomalies and the cause of the metallic response, if known:

Isolated EM anomalies located around the northwest corner of the survey area (Anomaly #1 and #2) were the result of a hydrant and light pole near the roadway. A metal fence was located along the south boundary of the survey area, resulting in Anomaly #4. The EM response surrounding the perimeter of the building (Anomaly #5) was likely the result of the siding and/or reinforcement in the building foundation. A collection of metal items at the northeast corner of the survey area resulted in an EM response (Anomaly #6), and a suspected metal water line and adjacent dumpster resulted in Anomaly #7 and #8.

One unknown EM feature was recorded near the south boundary of the survey area in the asphalt parking lot that was not associated with any visible cultural features (Anomaly #3). This feature was investigated further with the GPR.

Locations of metallic anomalies detected by the EM61 survey. Numbers correspond to descriptive Table in report.

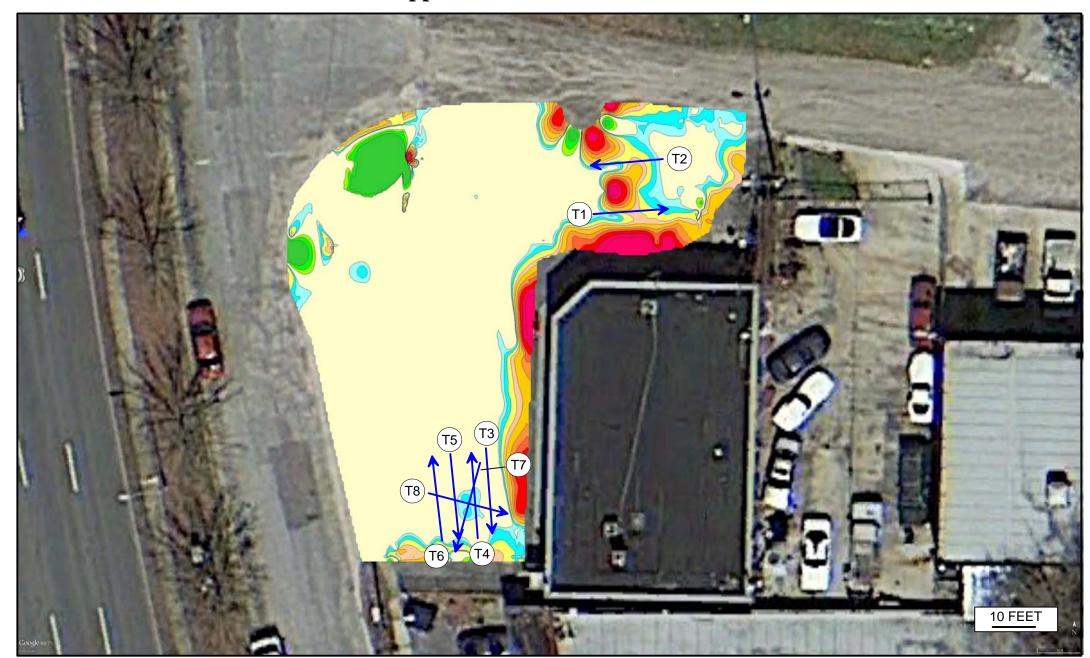
Parcel 6 - Approximate Locations of GPR Transects

Figure 3 presents the locations of the formal GPR transects performed at the property, as well as select transect images. A total of 8 formal GPR transects were performed at the property. GPR transects 1-2 were performed across the EM anomaly #7 on the north side of the survey area that was suspected to be associated with a utility. These GPR scans verified the presence of a conduit/utility extending from north to south across the area. The utility was traced to a water meter, indicating it was likely a water line.

GPR transects 3-8 were performed in the vicinity of the unknown EM feature (Anomaly #3) near the south boundary of the survey area. These GPR scans recorded an area containing laterally distinct reflectors that were suggestive of a subsurface structure such as a UST. GPR transect 7 recorded an apparent, but not well-defined, hyperbolic reflector that is characteristic of the width of a UST. The combination of the metallic anomaly detected by the EM survey and the apparent structure evidenced by the GPR survey results in the classification of this feature as a possible metallic UST. This possible UST was approximately 6 feet wide and 10 feet long at a depth of approximately 2 feet below the ground surface. No evidence of additional USTs was observed at the site.

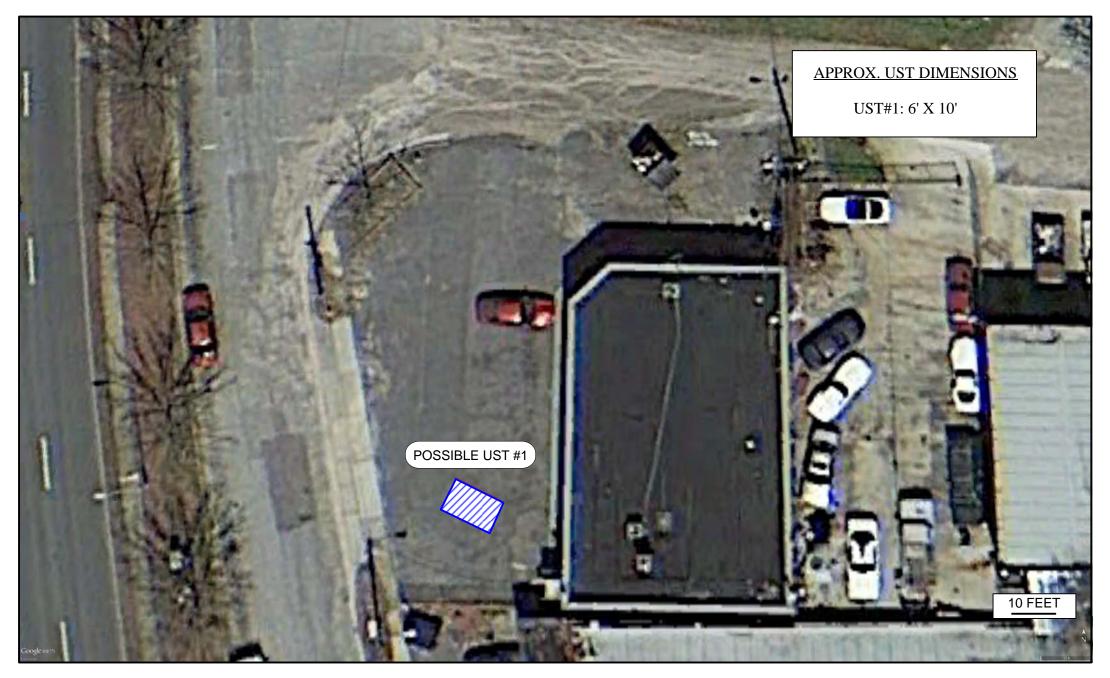
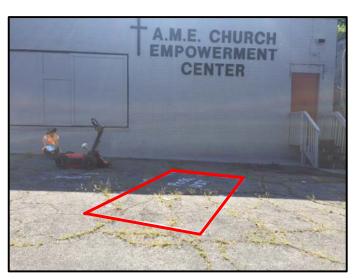
- o The possible UST was approximately 6 feet wide and 10 feet long at a depth of approximately 2 feet below the ground surface.
- Additional GPR scans verified the presence of a utility on the north side of the building. No evidence of additional USTs was observed.

APPROXIMATE LOCATION OF POSSIBLE METALLIC UST.

Approximate Location of Possible UST

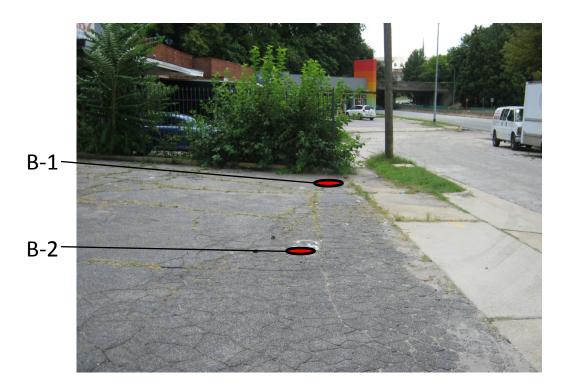
Photo #1: A view of Borings B-1 and B-2, facing south.

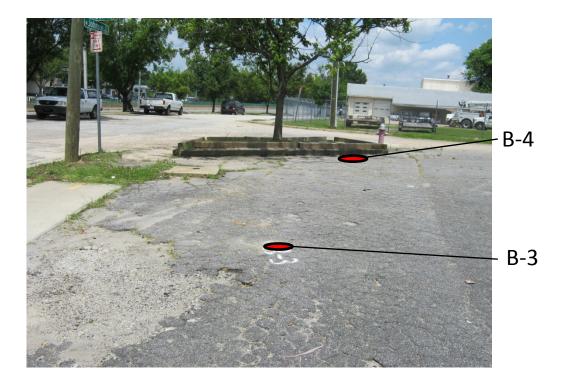
Photo #2: A view of Borings B-3 and B-4, facing north.

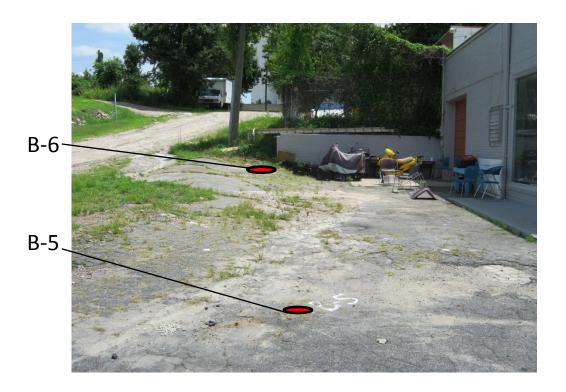
Photo #3: Boring locations B-5 and B-6, facing east.

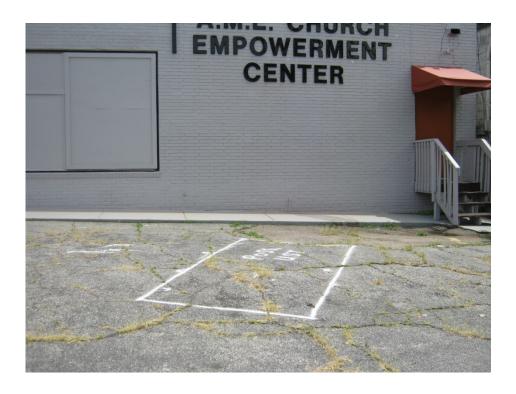
Photo #4: A view of the Possible UST location adjacent to the structure, facing east.
