**Preliminary Site Assessment Report
For Highway 221 Widening Project, Ashe County,
State Project: R-2915C
WBS Element: 34518.1.4**

**Parcel 039, John B. Cox Property
Jack and Dean's Comm. Corner Mart AKA: Doyle's
8742 Highway 221 South Fleetwood, NC 28626
Facility I.D. #: 0-000454, 0-028118, 0-34269, Incident 13684**

May 22, 2015 (Revised 6-2-15)

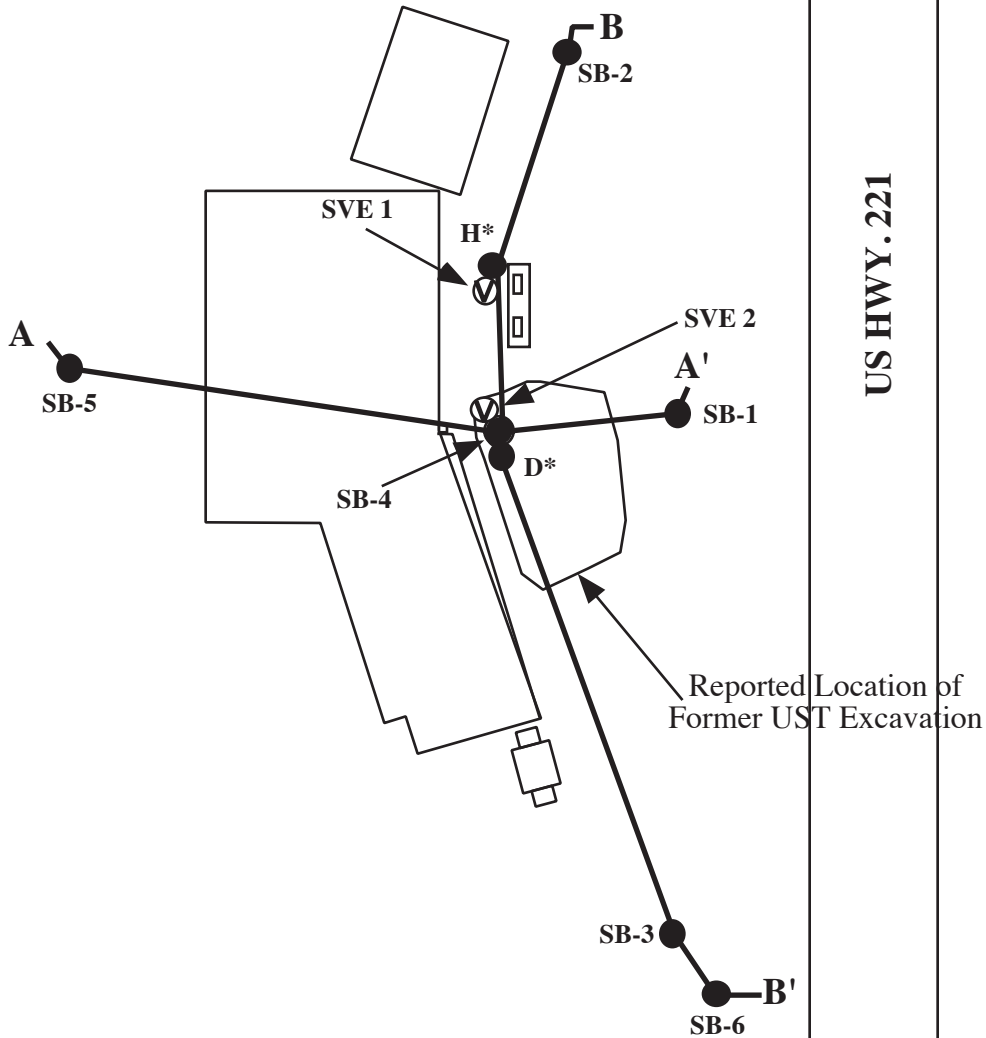
FIGURE 6

- -- Approx. Location of Soil Boring
- A A' -- Location of Cross-Section Lines (See Figures 7 & 8)
- ⊙ -- Approx. Location of Soil Vapor Extraction Wells (not in use)
