PRELIMINARY SITE ASSESSMENT REPORT

**10069 NC Hwy. 107
James A. Smith and
Wife Helen C. Smith Property, Parcel 078
Tuckasegee, North Carolina
State Project R-4753
WBS Element #39999.1.1
Jackson County**

June 26, 2014

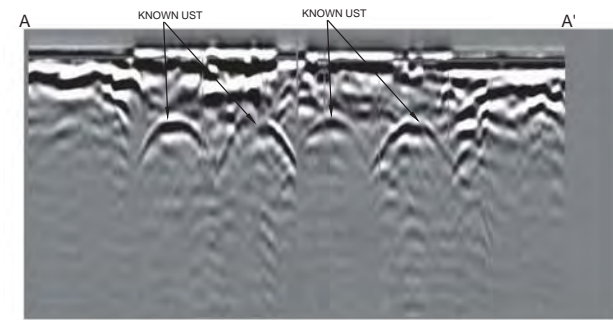
GPR Data Parcel 78

The TDEM and GPR data, as well as visual evidence, indicated the presence of four "Known USTs" in the subsurface of the investigation area, as shown in Figures 3 and 4, and in Photograph 1 in Appendix 1. Additionally, there was visual evidence of a "Known UST" outside the investigation area, near the southwestern corner of the convenience store, as shown in Photograph 1 and in Figure 4.

As shown in Figure 3 and in Photograph 3 in Appendix I, two GPR anomalies were identified within the investigation area south of the onsite "Known USTs" adjacent to the pump island. The EM-61 data did not indicate the presence of any metallic objects in the subsurface within either anomaly. Both anomaly areas were penetrated to a depth of 5 feet below ground surface (bgs) using direct push technology (DPT), but no USTs were encountered. The owner of the site also indicated that he knew of no operating or abandoned USTs in vicinity of the two identified anomalies.

Much of EM-61 imagery shown in Figure 3 was in response to metallic features associated with storm water drainage at the site, including area drains and manholes. and a subsurface corrugated metal or RCP storm sewer along the eastern edge of NC Hwy. 107. The area where EM-61 imagery is shown in Figure 3 in the southwestern corner of the site, near the intersection of NC Hwy. 107 and NC Hwy. 281 was penetrated with a DPT probe in several locations. Concrete was encountered at a depth of approximately 2 feet bgs at each probe location.

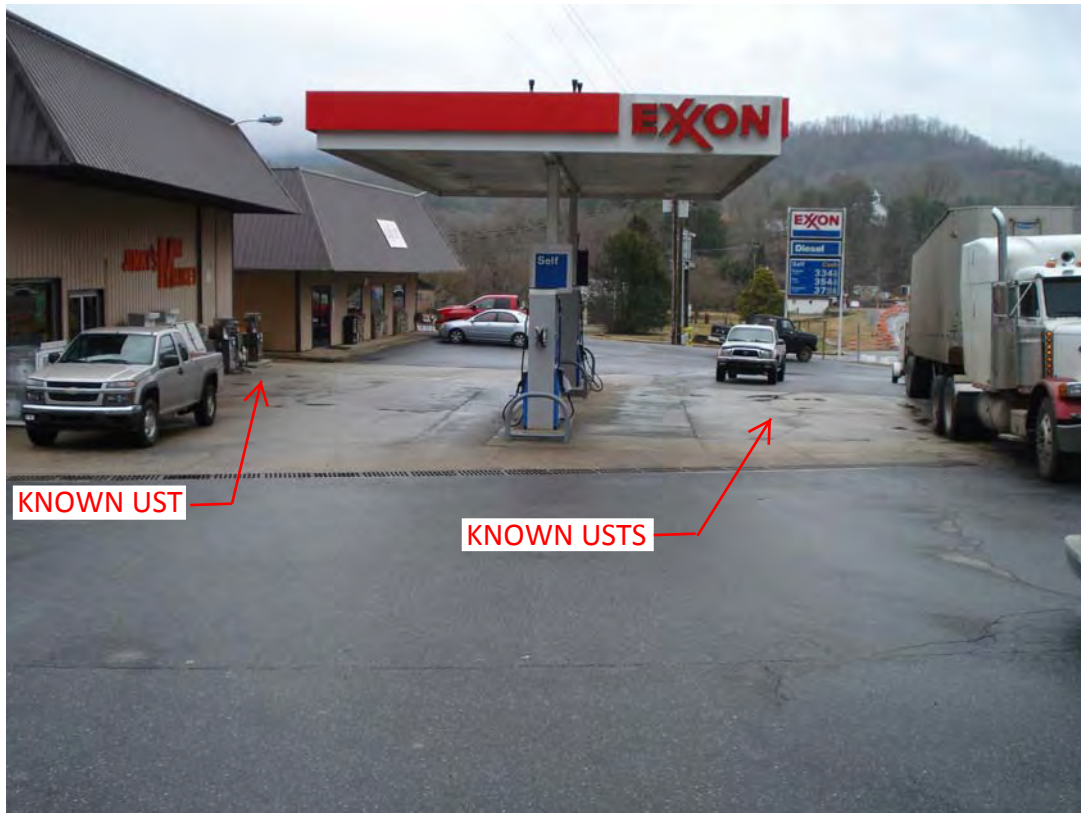
Photograph 1: View looking south at “Known USTs.” Onsite café (Café 107) is shown in the background.

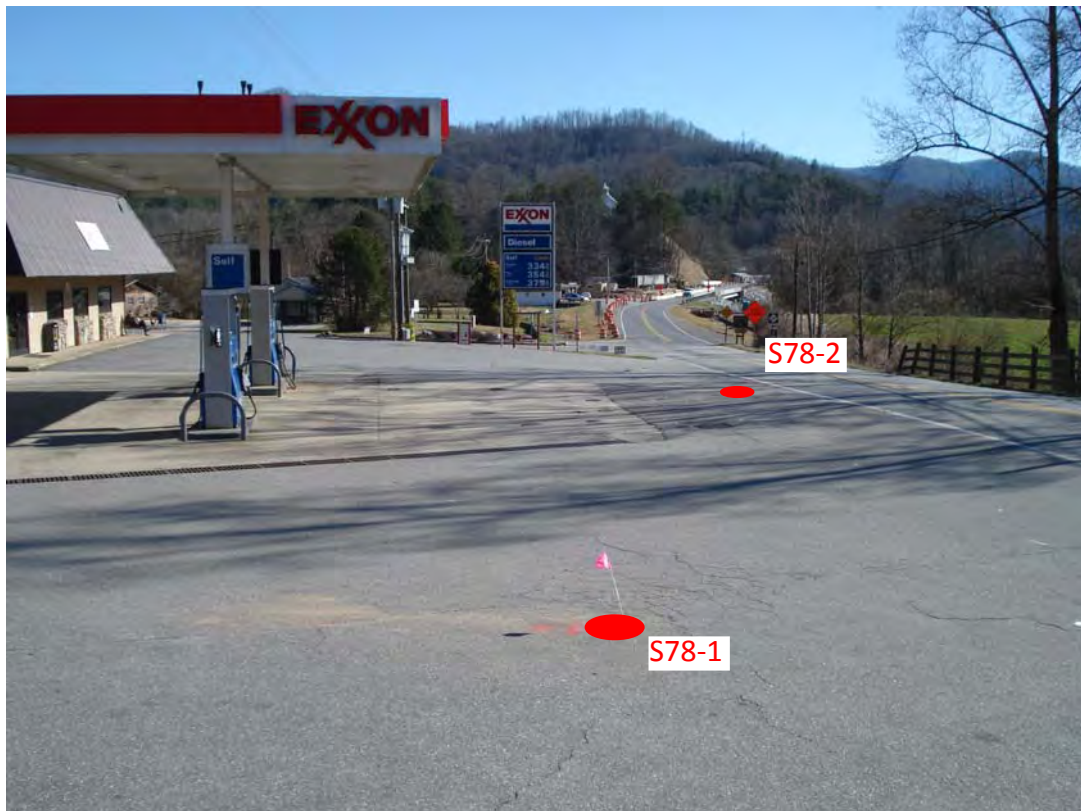
Photograph 2: View looking south at locations of soil boring locations S78-1 and S78-2.

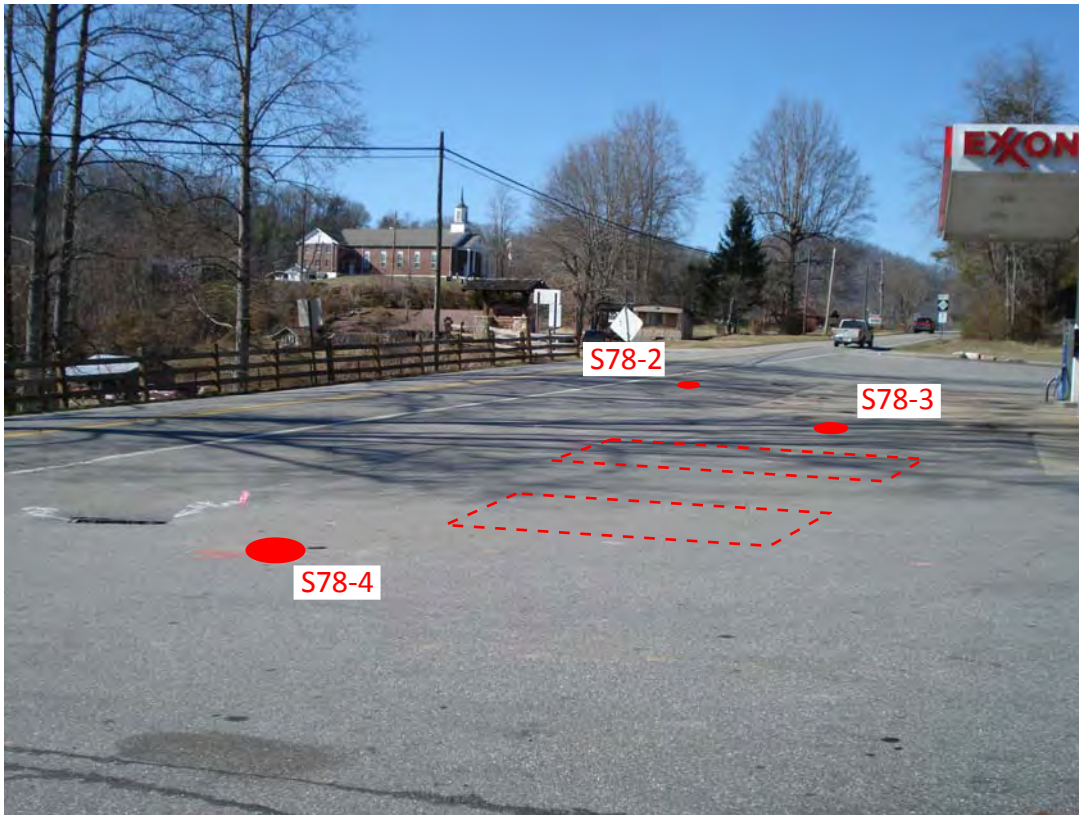
Photograph 3: View looking northwest at locations of soil borings S78-2, S78-3 and S78-4, and two GPR anomalies (red dashed rectangles).

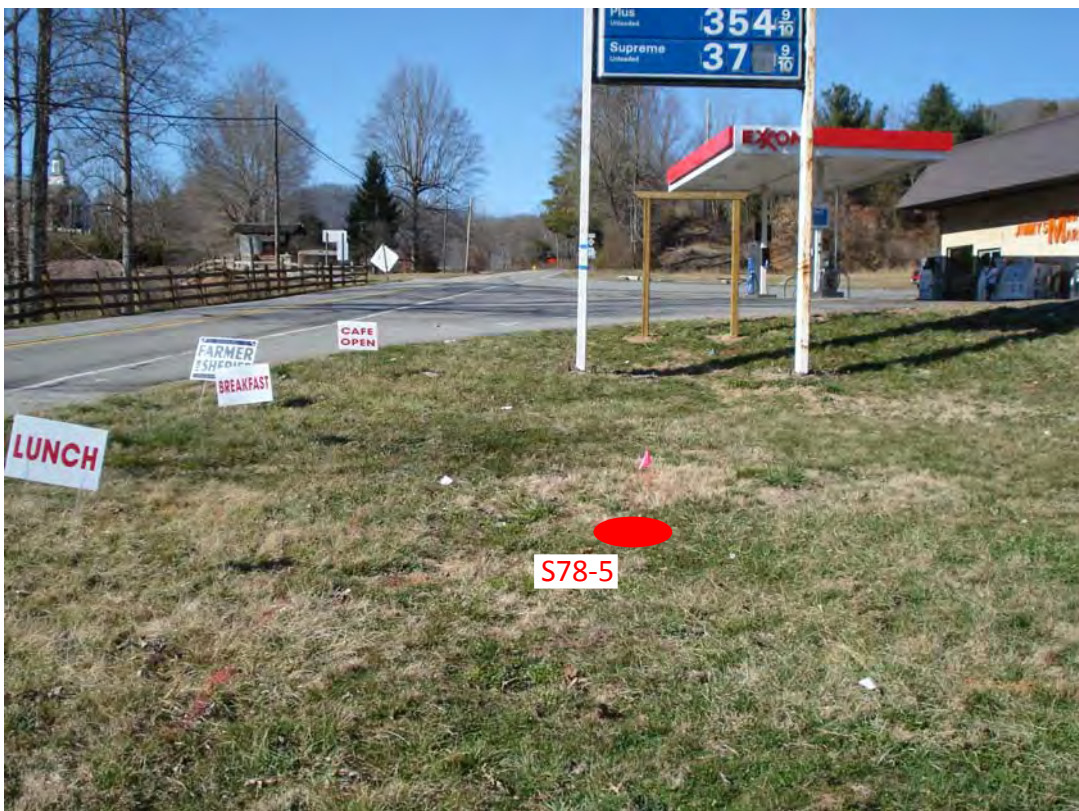
Photograph 4: View looking north at location of soil boring S78-5.

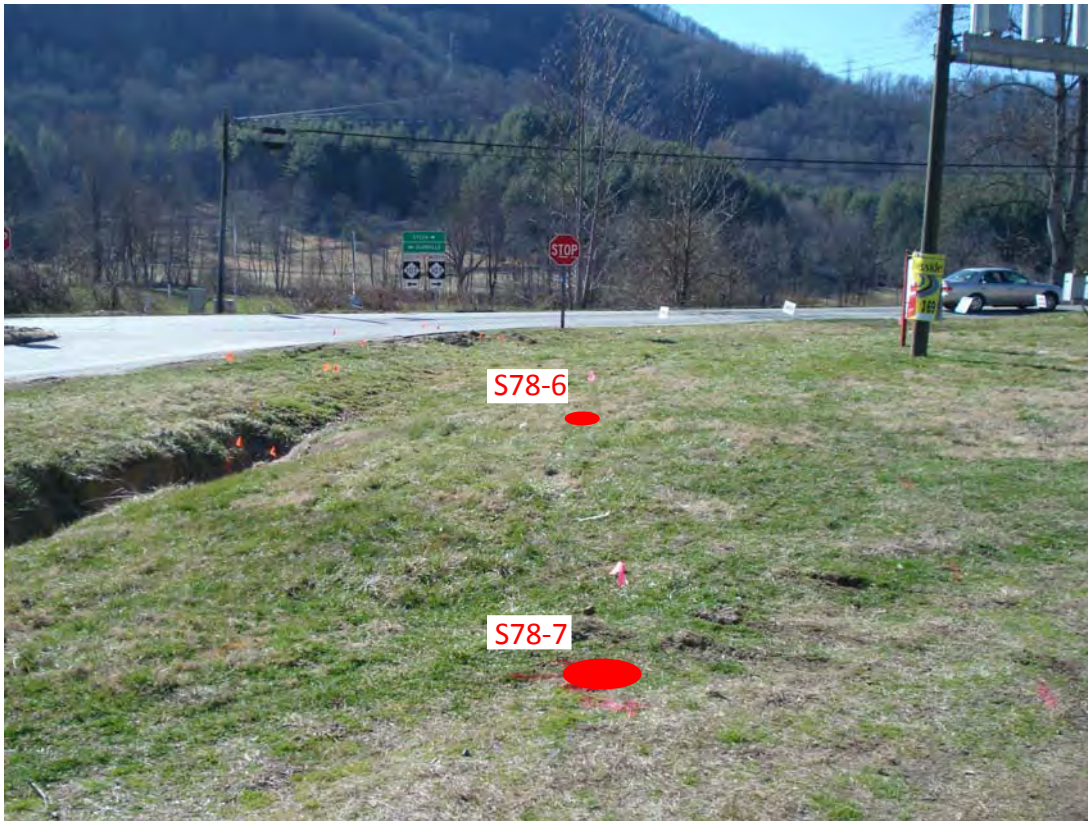
Photograph 5: View looking west at soil boring locations S78-6 and S78-7. Canada Road (NC Hwy. 281) is shown on the left.

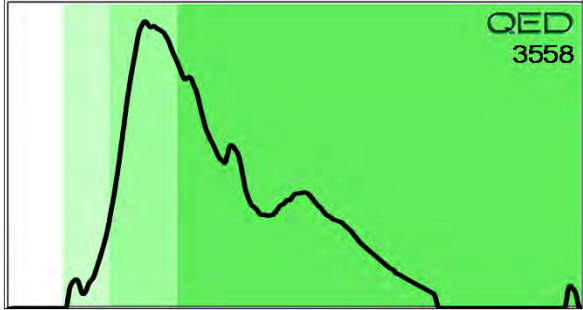
V.Deg.PHC 96.8% S78-1

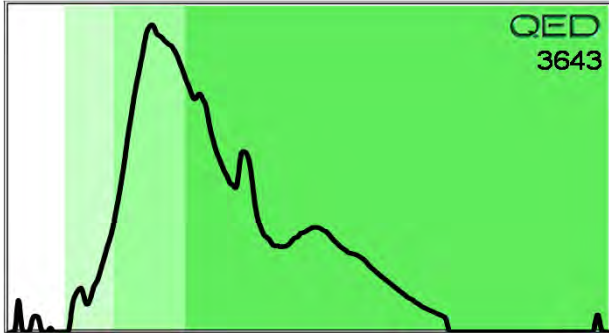
V.Deg.PHC 86.5% S78-3
