PRELIMINARY SITE ASSESSMENT REPORT

**9320 NC Hwy. 107
James Richard Russell Living
Trust U/A Property, Parcel 053
Cullowhee, North Carolina
State Project R-4753
WBS Element #39999.1.1
Jackson County**

June 16, 2014

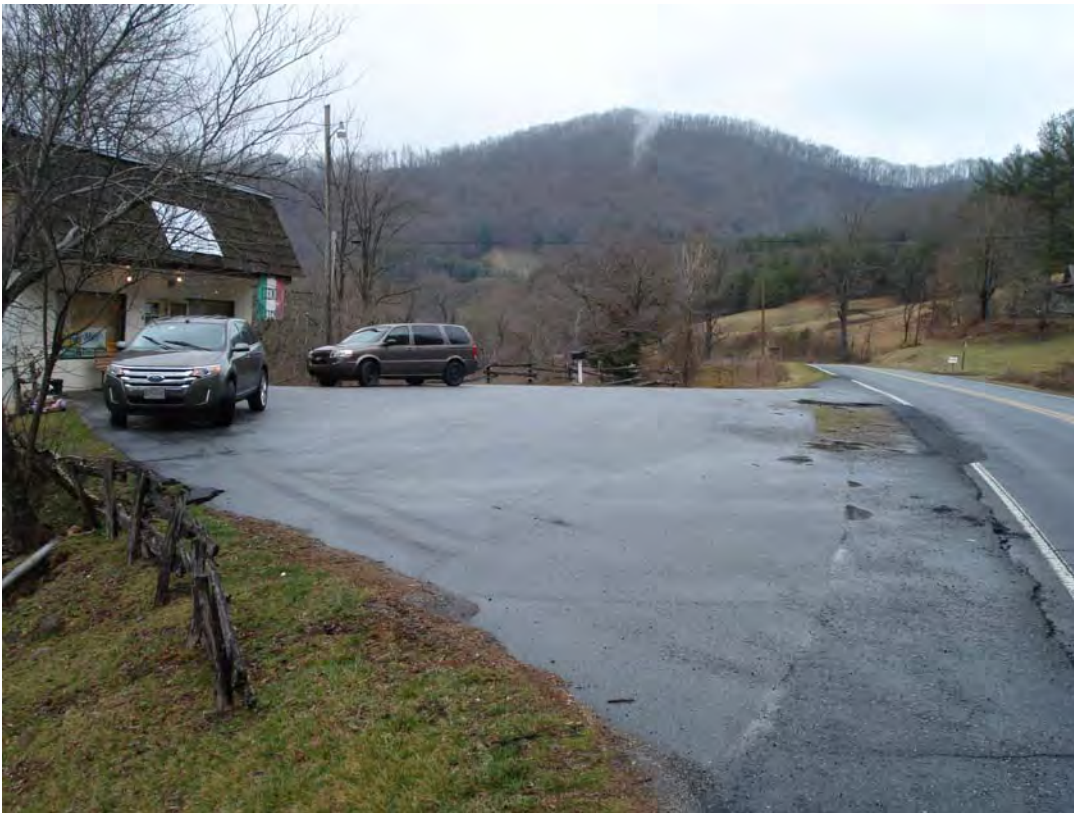
Photograph 1: View looking north at investigation area for Parcel 053.

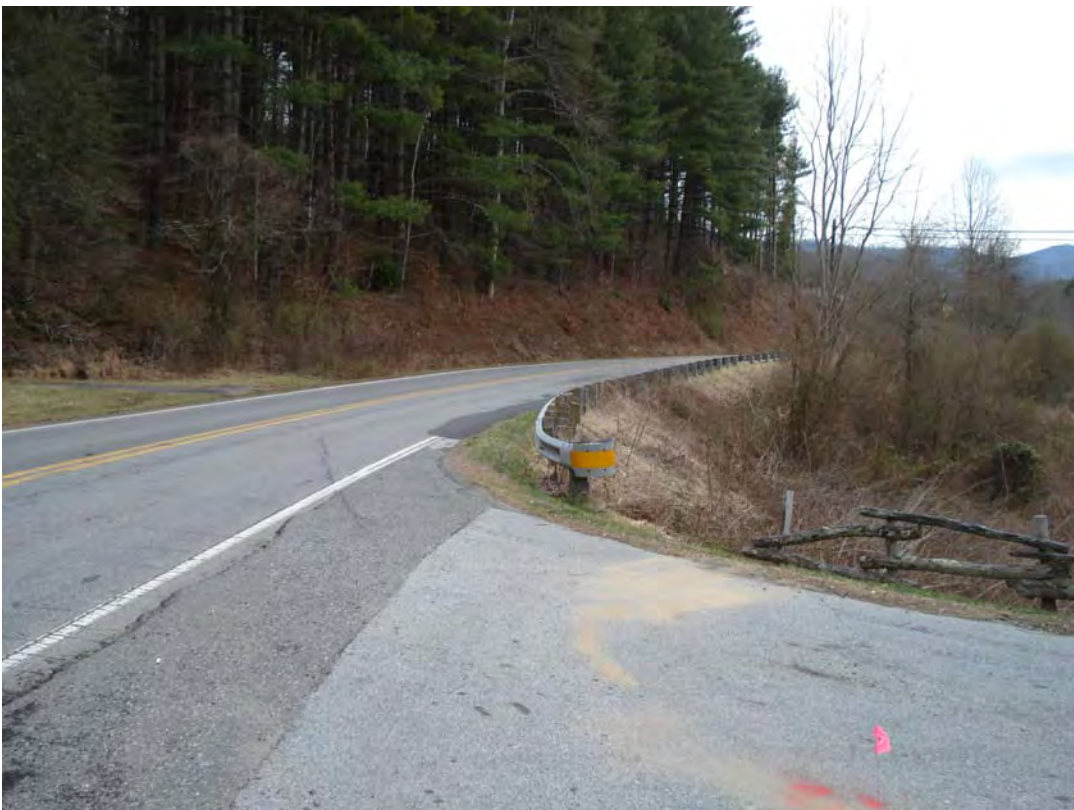
Photograph 2: View looking south at frontage for Parcel 053 extending beyond pavement that was not included in the subsurface investigation due to inaccessibility and no indication of previous development.

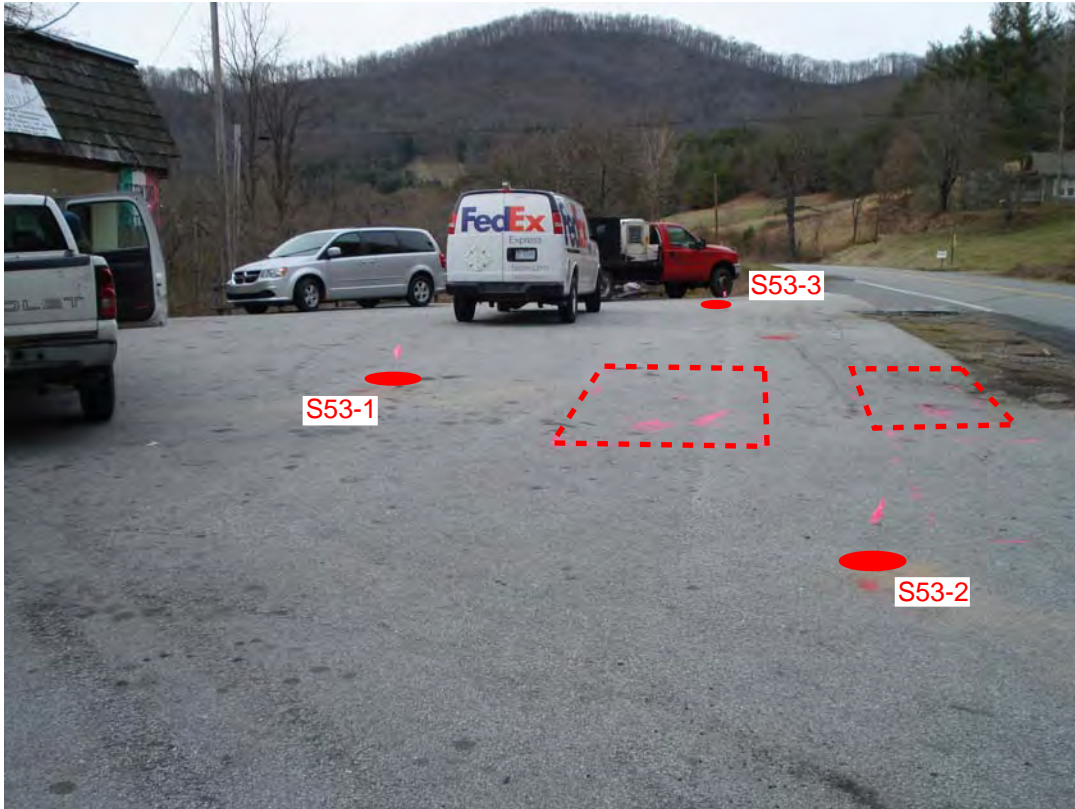
As shown in Figure 3 and Photograph 3 in Appendix I, two GPR anomalies were identified within the investigation area near the western edge of NC Hwy 107. The EM-61 data did not indicate the presence of any metallic objects in the subsurface within either anomaly. Both anomaly areas were penetrated to a depth of 5 feet below ground surface (bgs) using direct push technology (DPT), but no USTs were encountered. The two identified anomalies may represent differences in lithology compared to surrounding soils resulting from fill material that may have been emplaced following the possible previous removal of USTs.

Photograph 3: View looking south at locations of soil borings S53-1, S53-2, and S53-3, and locations of two identified GPR anomalies (dashed rectangles).
