Preliminary Site Assessment Report

Donald and Sue Barkley Property

Parcel # 015

I-85/US 321 Geometric Safety Improvements to Interchange

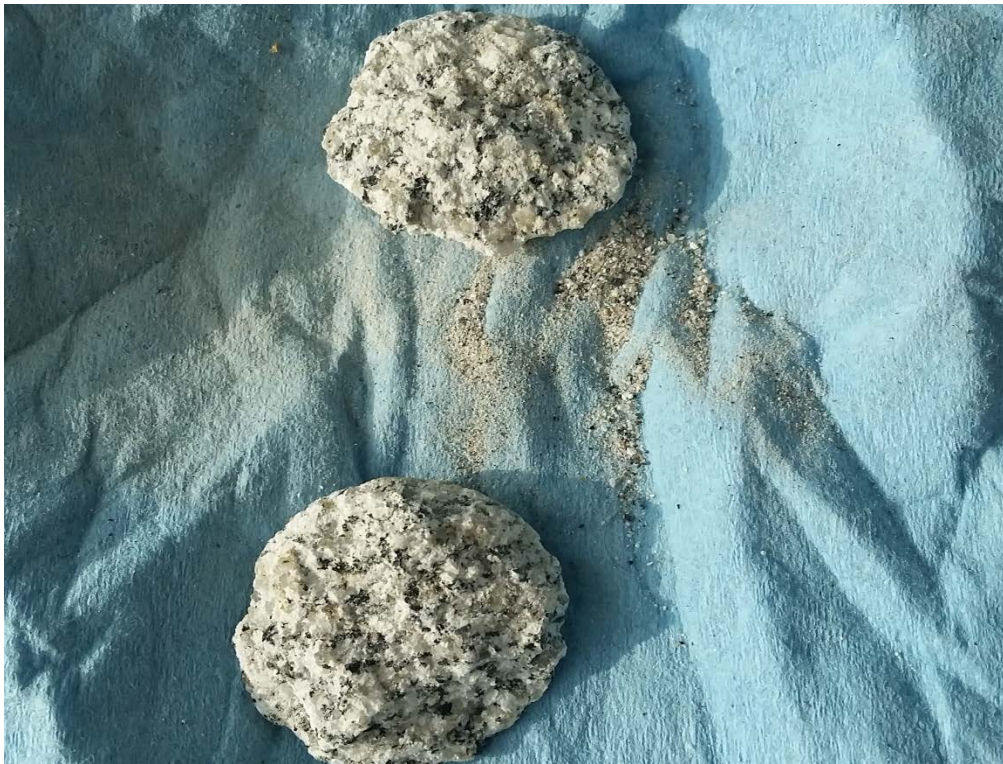
Photo 5

Viewing partially weathered rock (PWR) encountered during direct push drilling activities. PWR was encountered predominantly on the southern third of the parcel.

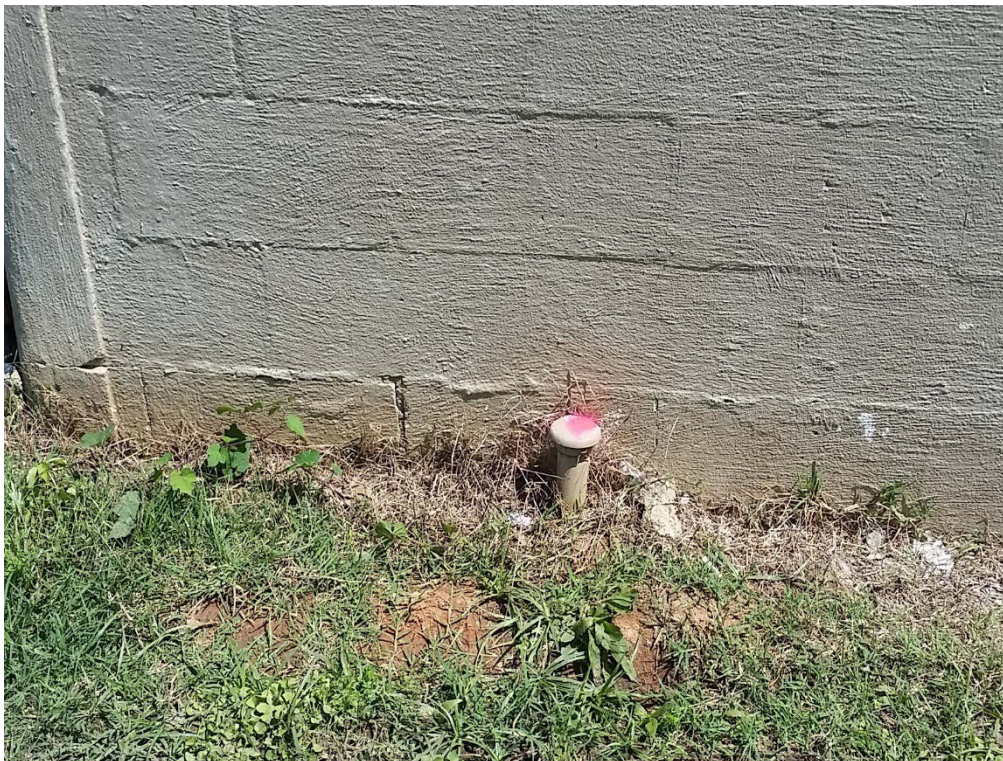
Photo 6

Viewing vent pipe located near the southwestern corner of the northern building. ESP did not find evidence of a UST during the geophysical survey and the owner of the parcel indicated that the USTs associated with this vent pipe had previously been removed.

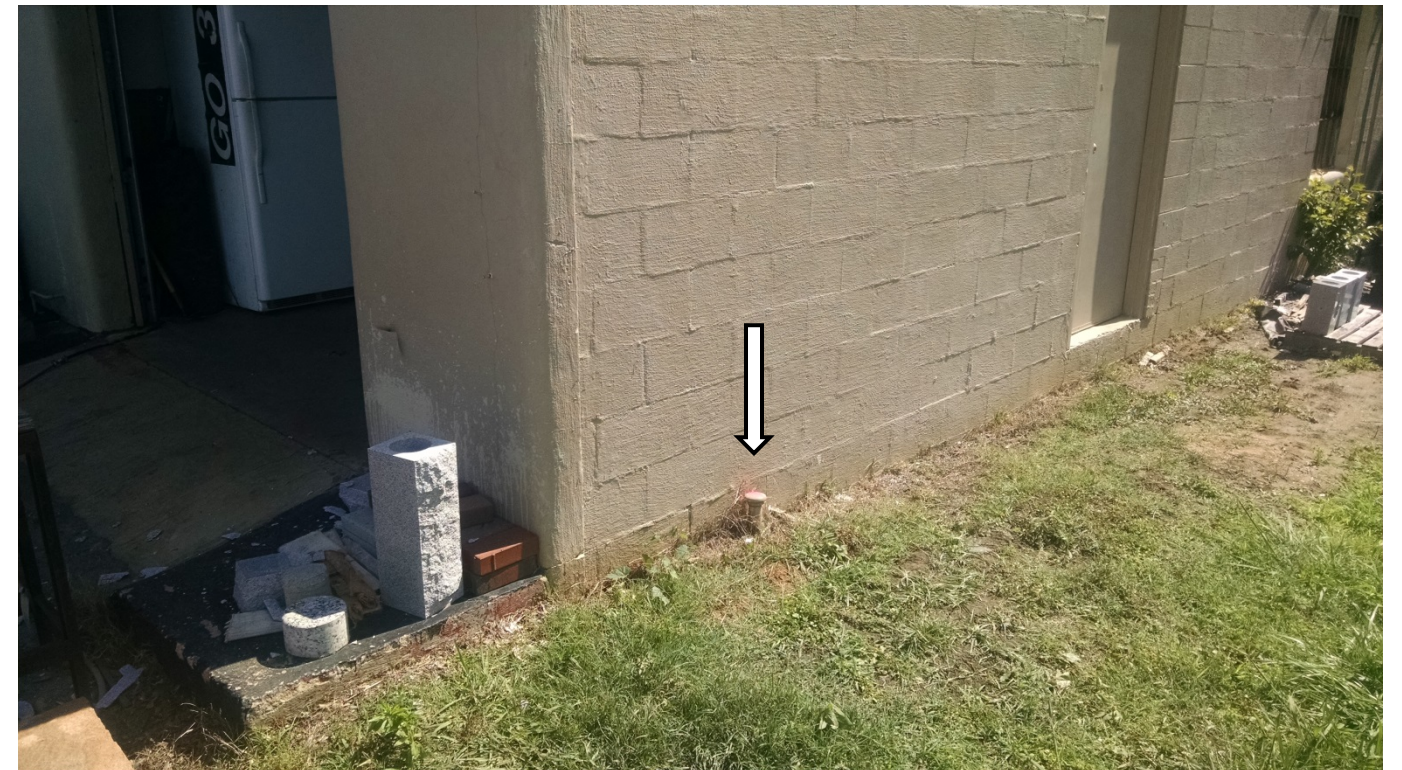
We collected GPR data over four EM61 differential anomalies around the three buildings within the parcel. The GPR data over these anomalies did not indicate possible USTs and were likely caused by adjacent metallic site features such as metal doors, reinforced concrete, or buried metallic debris. We collected GPR data in the vicinity of the possible vent pipe, located by the southwest corner of the northern building (former gas station), as shown on Figure 1, Image D. The GPR data did not indicate a UST in the vicinity of the possible vent pipe.

D. Photo of possible vent pipe (arrow) located by southwest corner of Wyant & Son Monument Co.
