STATE OF NORTH CAROLINA
DEPARTMENT OF TRANSPORTATION

TIP NO: 46136.1.1
WBS: W-5313
COUNTY: Rowan
DIVISION 9
DESCRIPTION: SR 1221 (Old Beatty Ford Road) from SR 1337 (Lentz Road) to
SR 2335 (Lower Stone Church Road)

SUBJECT: **Geotechnical Report for Planning**

Hazardous Materials Report

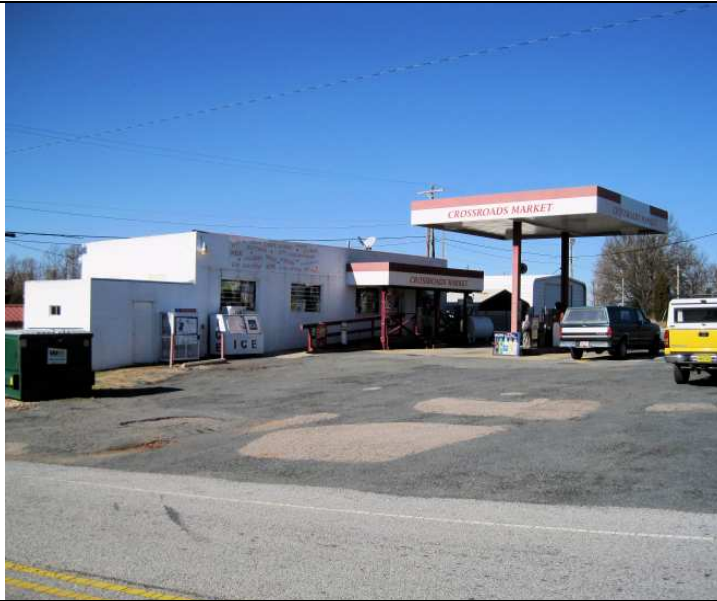
This facility currently operates as a convenience store & gas station. It is located in the fork between Old Beatty Ford Road and Lentz Road. The tank bed is located approximately 45 feet from the Lentz Road centerline. According to the UST Section registry there are two tanks currently in use. A groundwater incident occurred in April 1992 while under the ownership of the Carolina Oil Company. The site has since received a No Further Action and the incident closed out in May 1992. There are no monitoring wells on site. **This site is anticipated to present low geoenvironmental impacts to the project.**

Site 1: Crossroads Market. View to the north.

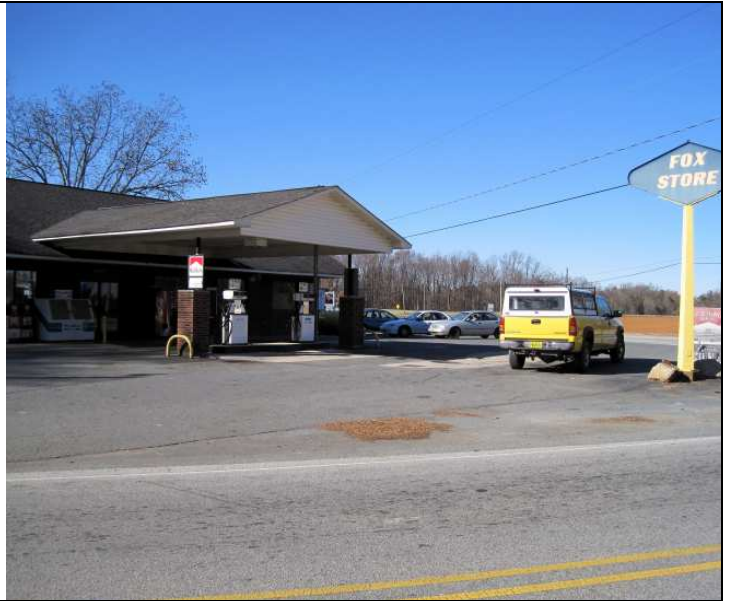
This facility currently operates as a convenience store & gas station. It is located in the southwest quadrant of Old Beatty Ford Road and Old Concord Road intersection. The tank bed is located approximately 40 feet from the Old Beatty Ford Road centerline. According to the UST Section registry there are two tanks currently in use. Four tanks were removed in 1993. There are monitoring wells on site and Ground Water Incident # 08516 has been assigned to this facility. **This site is anticipated to present low geoenvironmental impacts to the project.**

Site 2: Fox General Store. View to the northwest.

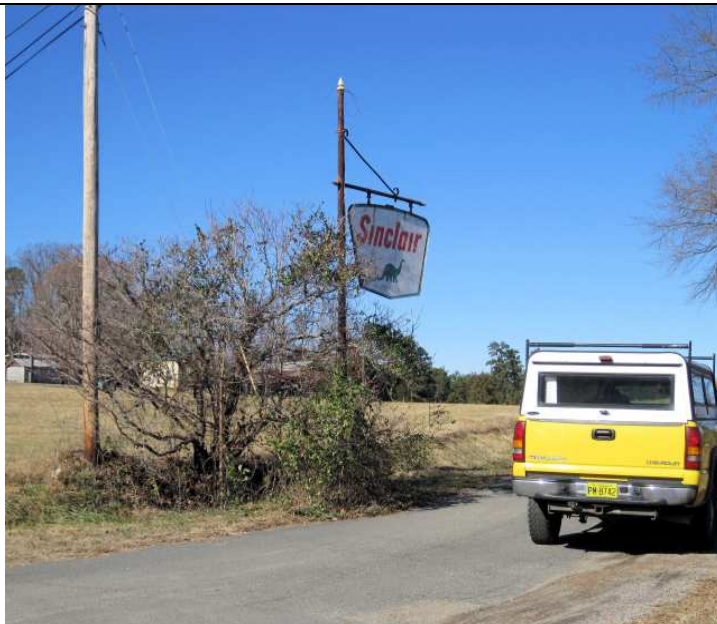
The parcel currently operates as a farm tractor repair shop which is located several hundred feet north of the highway. The entrance is 450 feet west of Log Barn Farm Drive. A Sinclair Gas sign is located at the entrance and 80 feet north of the Old Beatty Ford Road centerline. According to the UST Section registry four tanks were removed from this parcel in 1985. A groundwater incident occurred in March 1990 and the incident closed out in April 1990. There are no monitoring wells on site. **This site is anticipated to present low geoenvironmental impacts to the project.**

Site 3: Former gas station site. View to the north.

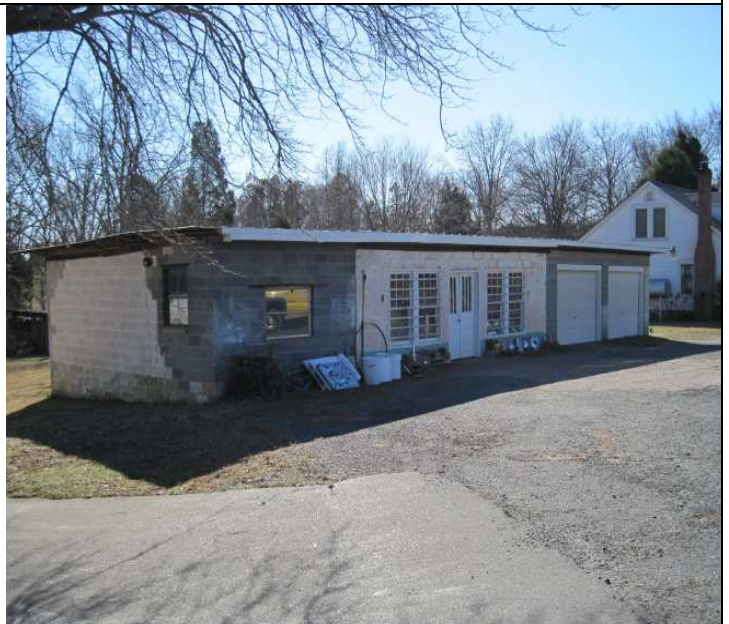
This storage building once operated as a gas station as confirmed by local residents. It is located in the south side of Old Beatty Ford Road and approximately 600 feet east of Phaniel Church Road. The front of the structure is 50 feet from the Old Beatty Ford centerline. This facility does not appear on the UST Section registry and no monitoring wells were noted. **This site is anticipated to present low geoenvironmental impacts to the project.**

Site 4: Former gas station. View to the south.

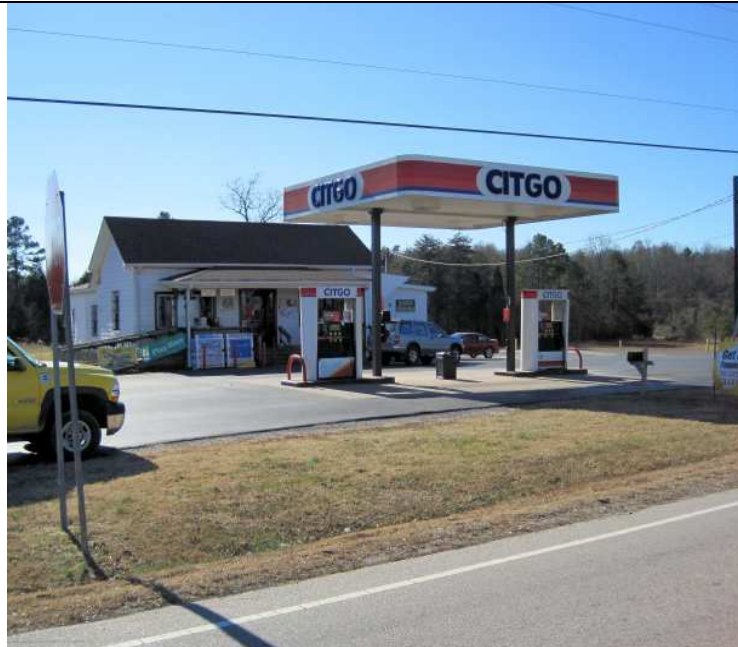
This facility currently operates as a convenience store & gas station. It is located in the south quadrant of Old Beatty Road and Organ Church Road intersection. The tank bed is located approximately 100 feet from the center of the intersection. According to the UST Section registry there are four tanks currently in use. There are no monitoring wells on site and no ground water incidents associated with this facility. **This site is anticipated to present low geoenvironmental impacts to the project.**

Site 5: Cheeseman's Grocery. View to the southwest.
