Preliminary Site Assessment Report

State Project: B-5864

Celo Investment Partners Property

Parcel #004

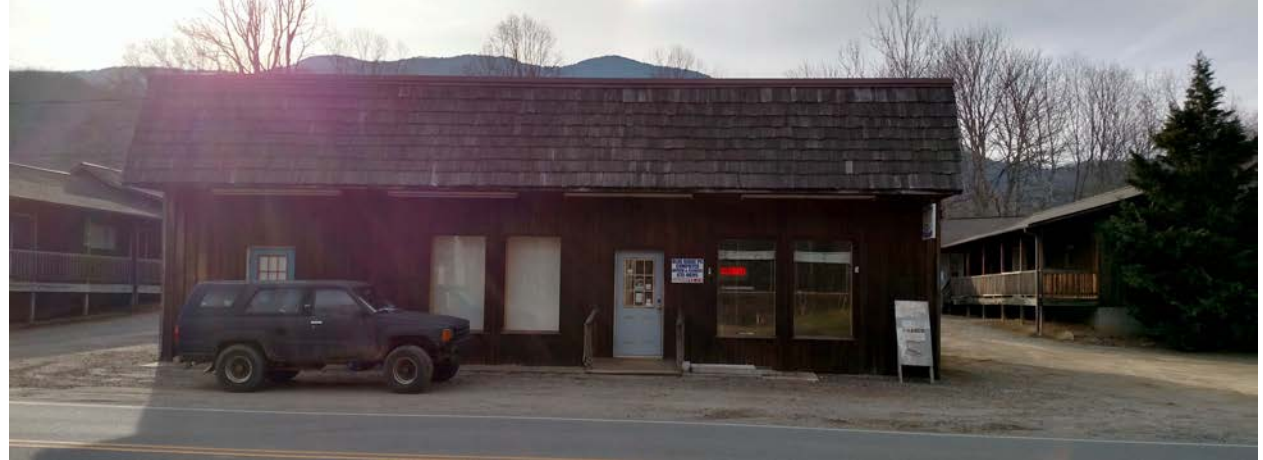
View to the west showing front of former general store. Dispenser pad is to the right of the door.

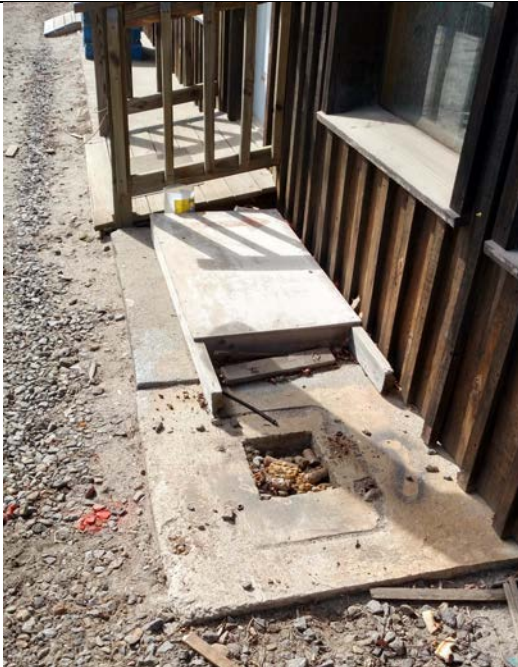
Concrete pad showing outline of former gasoline dispenser and product line (in hole).

Seramur and Associates reviewed the Hazardous Materials Report prepared by Kleinfelder on July 15, 2013. They had located a suspicious concrete pad that appeared to have been a former gasoline dispenser. The NCDEQ UST database has no record of a UST system on the property.

The concrete pad for a fuel dispenser remains in front of the former general store. The geophysical surveys imaged the product line extending from the dispenser, north into an area of homogenous fill material. This area is interpreted to be the former tank pit for the UST system. A second linear anomaly that extends from the tank pit back to the building could be a vent pipe. Seramur & Associates did not find any evidence of petroleum USTs remaining within the right of way or construction easements.

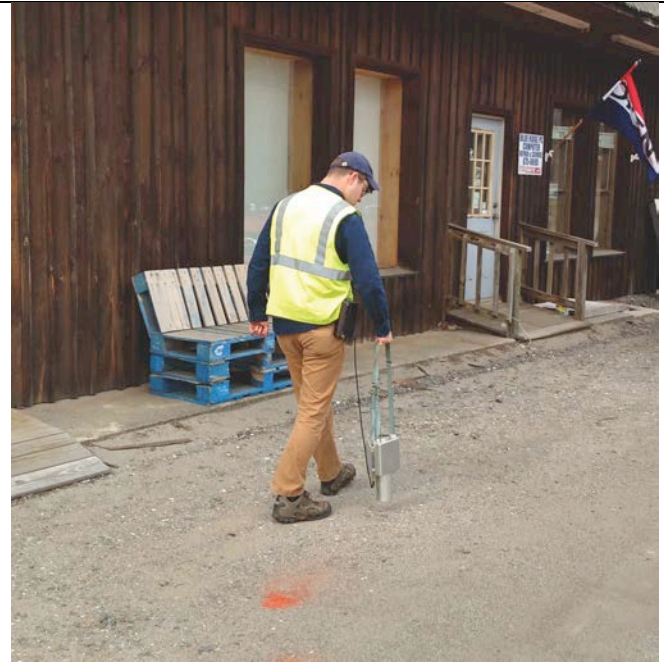
Magnetometer data collection in Grid 2 along front of former general store.
