BRIDGE INSPECTION REPORT

INSPECTION TYPE: ELECTRICAL - NORMAL SCHEDULED

ROUTE 065 US017 ACROSS CAPE FEAR RIVER M.P. _____

LOCATION CAPE FEAR MEMORIAL BRIDGE - WILMINGTON

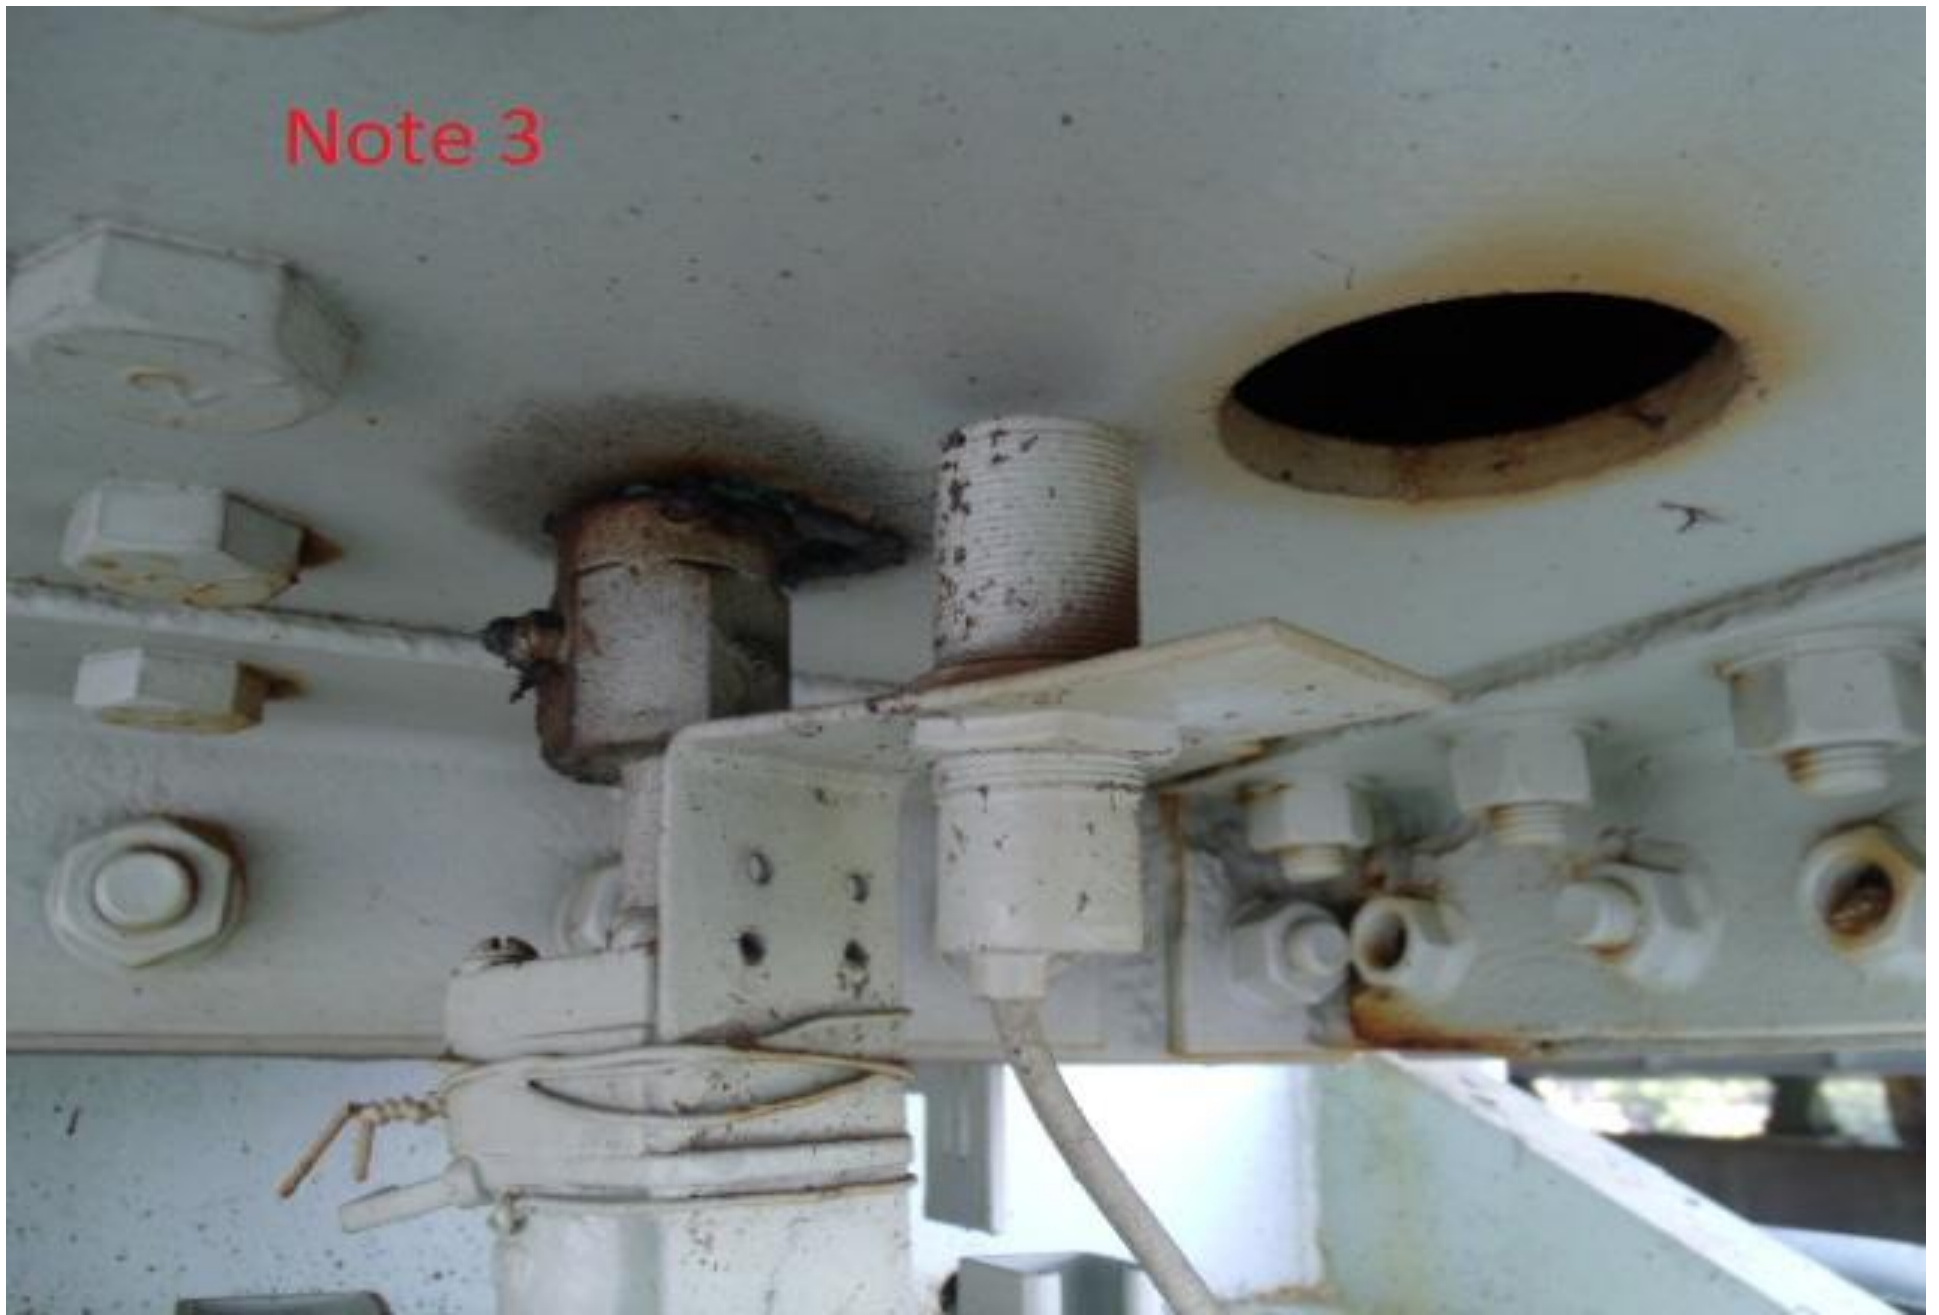
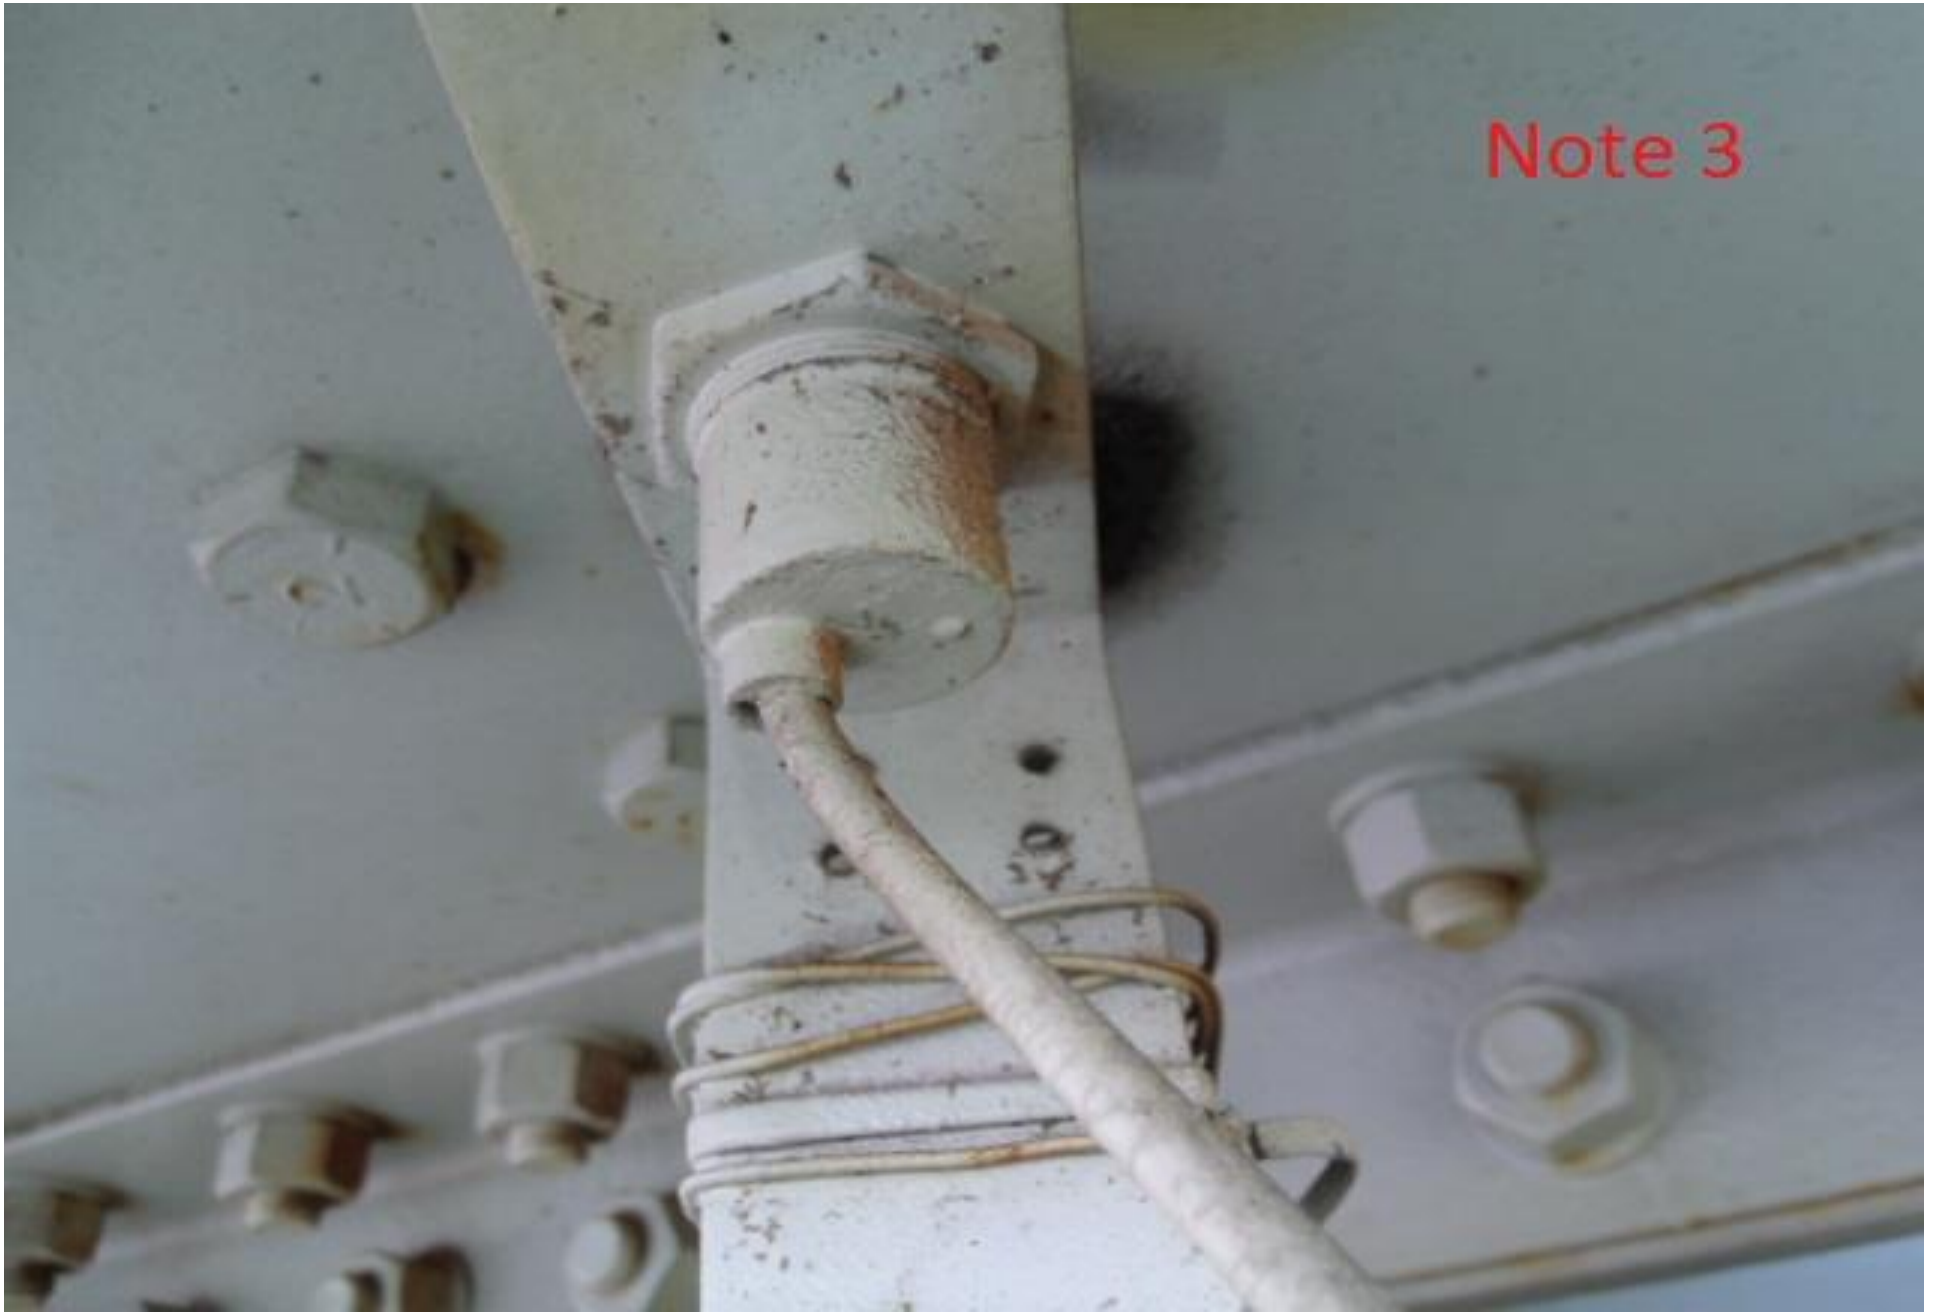
2.9.3.1	Seating proximities damaged	<p>Note 3 - All four seating proximity switches show signs of damage or deterioration due to the sand blasting and/or painting of the bridge structure. Recommend replacing all switches.</p>
