**North Carolina Department of Transportation
Preliminary Site Assessment
State Project: U-5114
WBS Element: 42376.1.R2
Parcel Number: 26
Mecklenburg County**

**Parcel 26
Vernon L. Krause Property
13825 Statesville Road
Huntersville, North Carolina
June 23, 2017**

**Amec Foster Wheeler Environment and Infrastructure, Inc.
Project: 1530U5114**

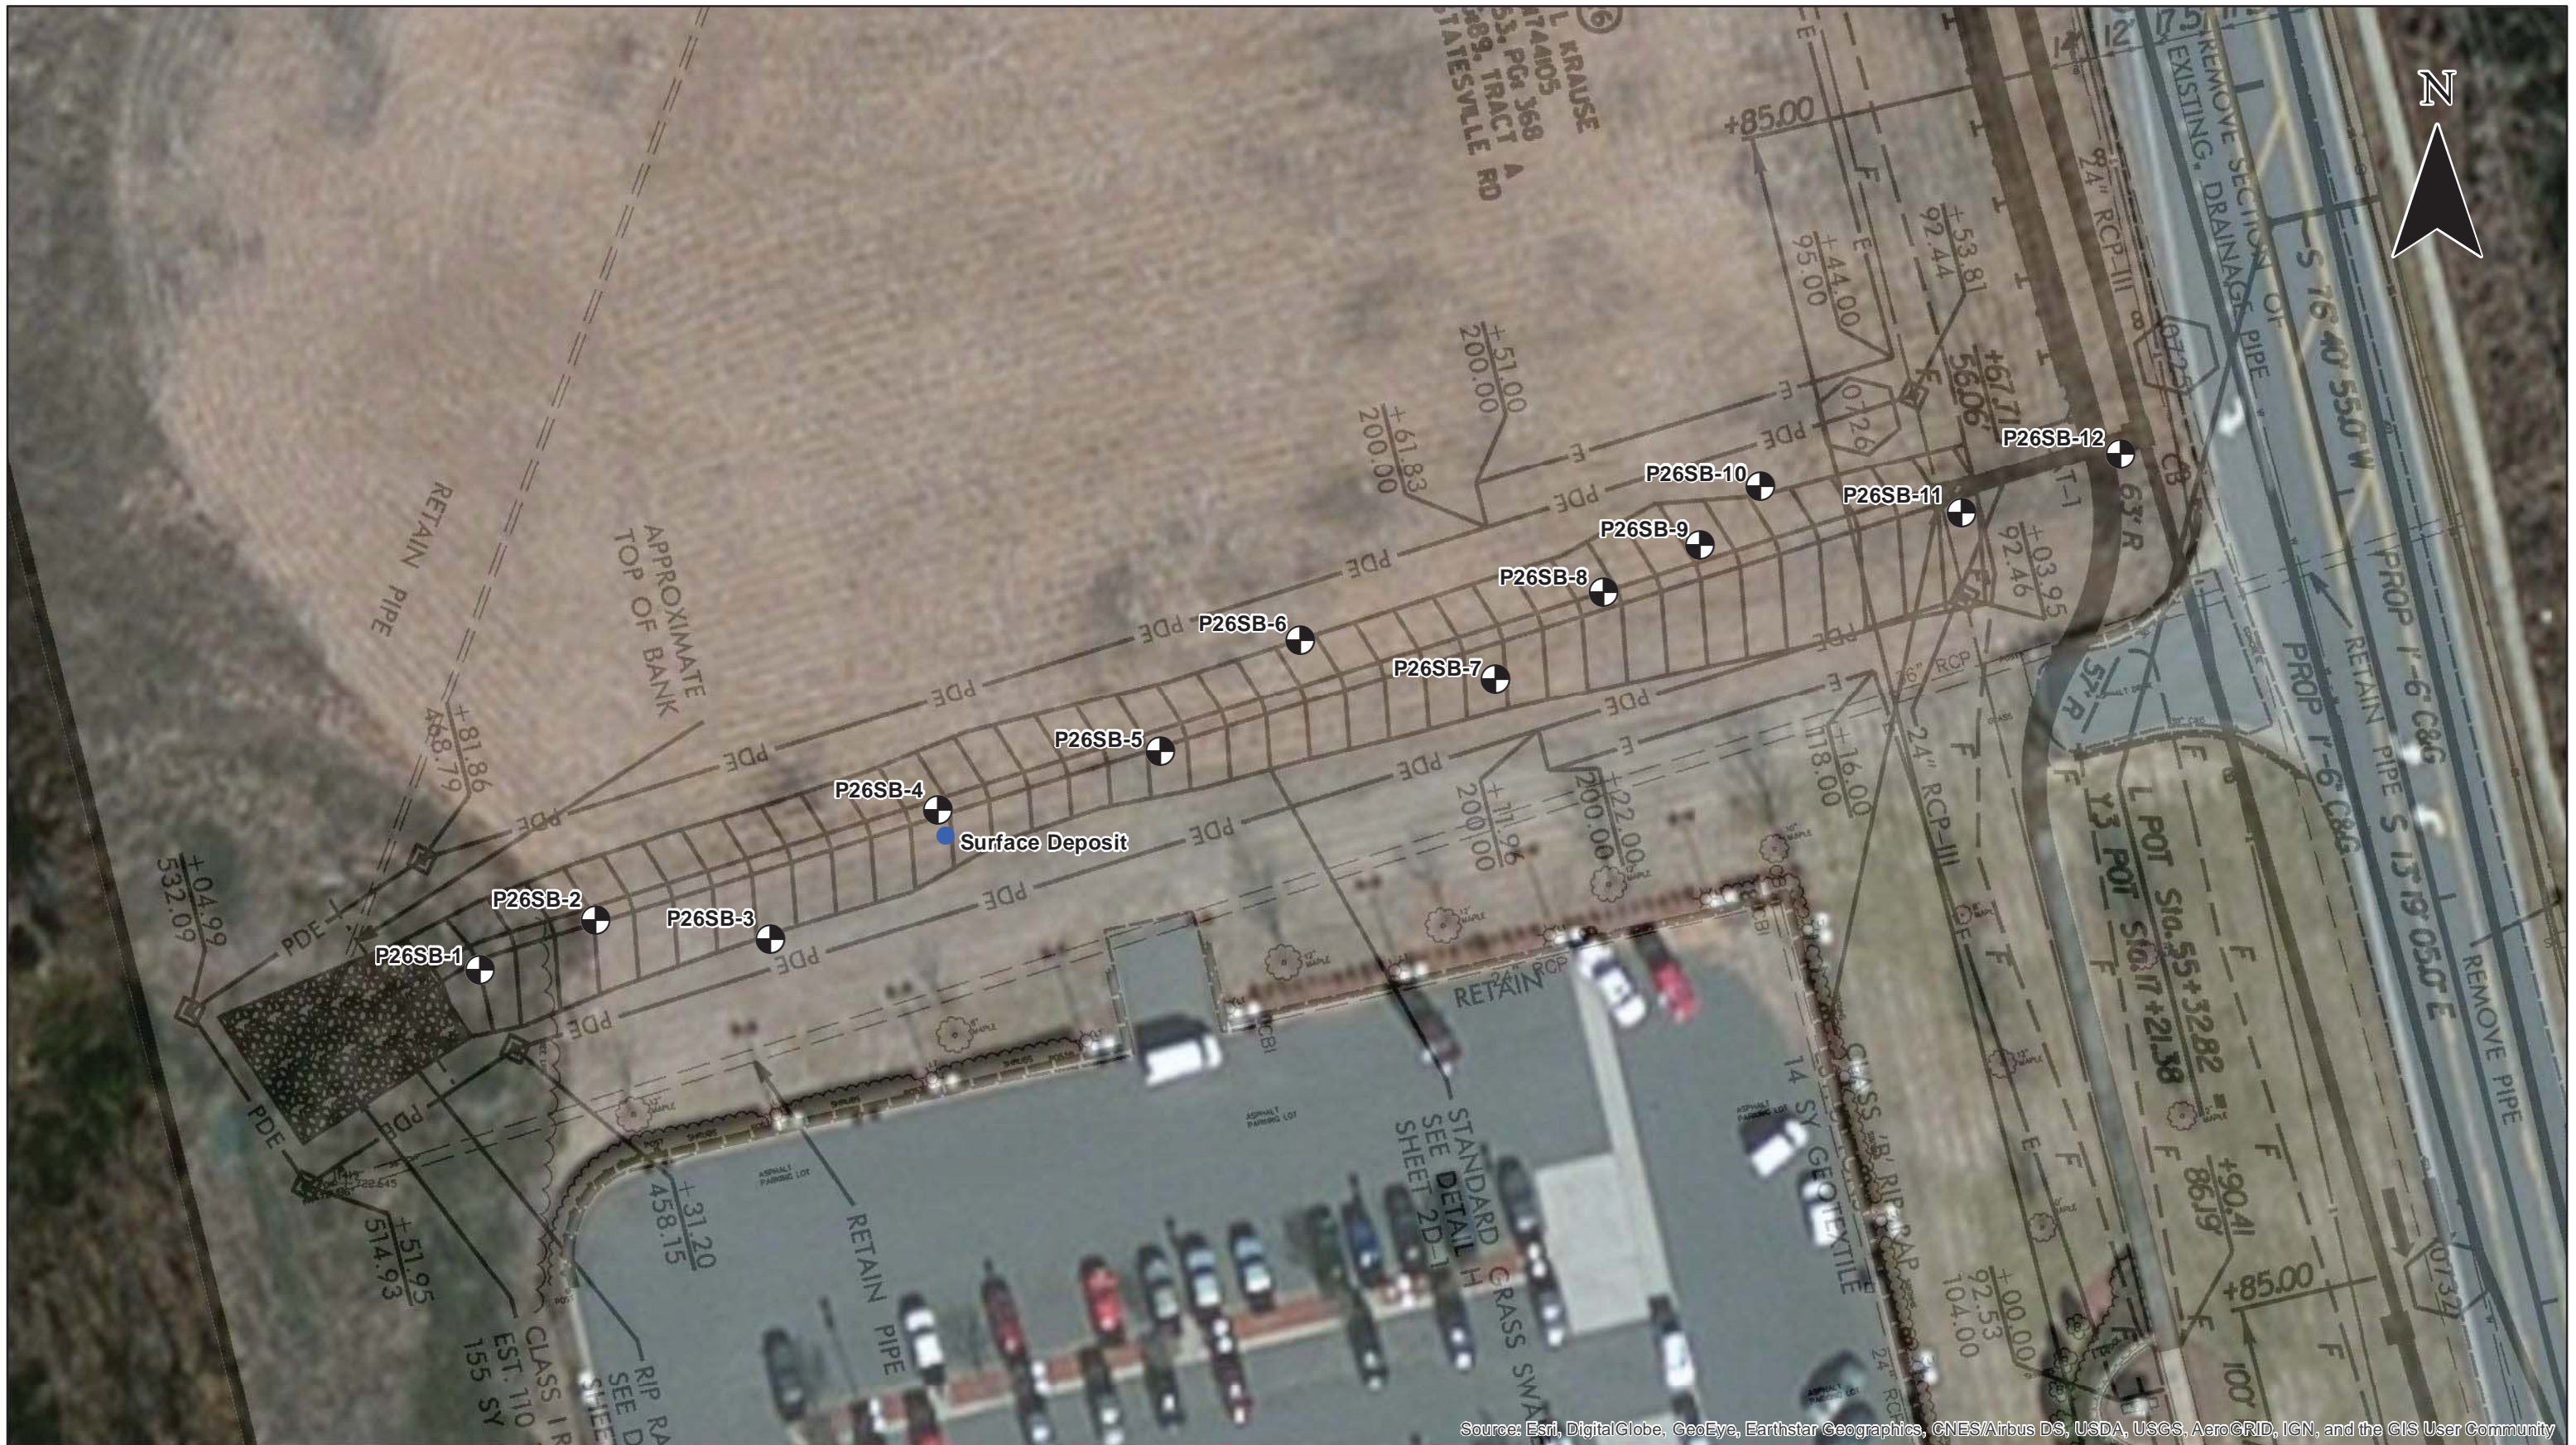
| | | SITE MAP AND SOIL BORING LOCATIONS PARCEL 26 13825 STATESVILLE ROAD HUNTERSVILLE, NORTH CAROLINA | | | |

Site geology was observed through the drilling of 12 shallow direct push probe soil borings (SB). **Figure 2** presents the boring locations and site layout. Borings did not exceed a total depth of 20 feet bgs. Fill material was observed in each of the 12 borings. Fill material was observed to be composed of silt or fly ash. Fly ash fill material was observed in 11 of the 12 borings. Additional site geologic information is discussed in Section 4, Soil Sampling Results. Boring logs are presented in **Appendix B**.

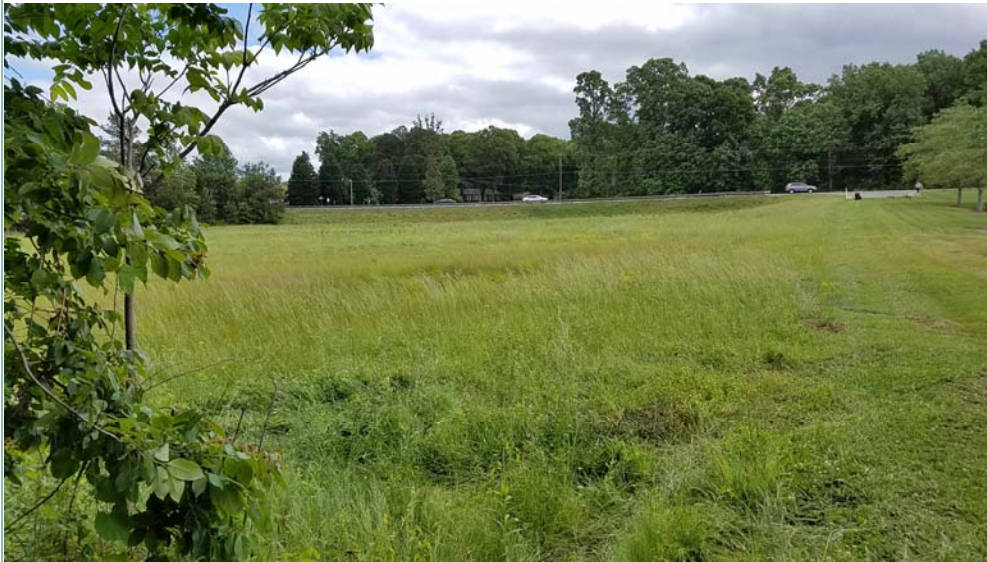
Photo 3

View east along the proposed drainage feature in the northern portion of Parcel 26.

Based on these PSA results, Amec Foster Wheeler does not recommend further assessment or soil sampling in the area of investigation; however, special handling should be performed during excavation and construction for the drainage ditch feature. The confirmed fly ash is considered a coal combustion residual, which should be handled by a qualified specialty contractor. Such qualified specialty contractor may differ from the selected U-5114 roadway contractor. A qualified specialty contractor should take into account factors such as, but not limited to the following: moisture management and dust control; erosion control planning; soil stabilization; possible overexcavation with suitable fill import for base material; worker safety; personal protective equipment; community perception; and proper hauling with lining and containment suitable for fly ash. Amec Foster Wheeler can assist with qualified specialty contractor selected and/or oversight.

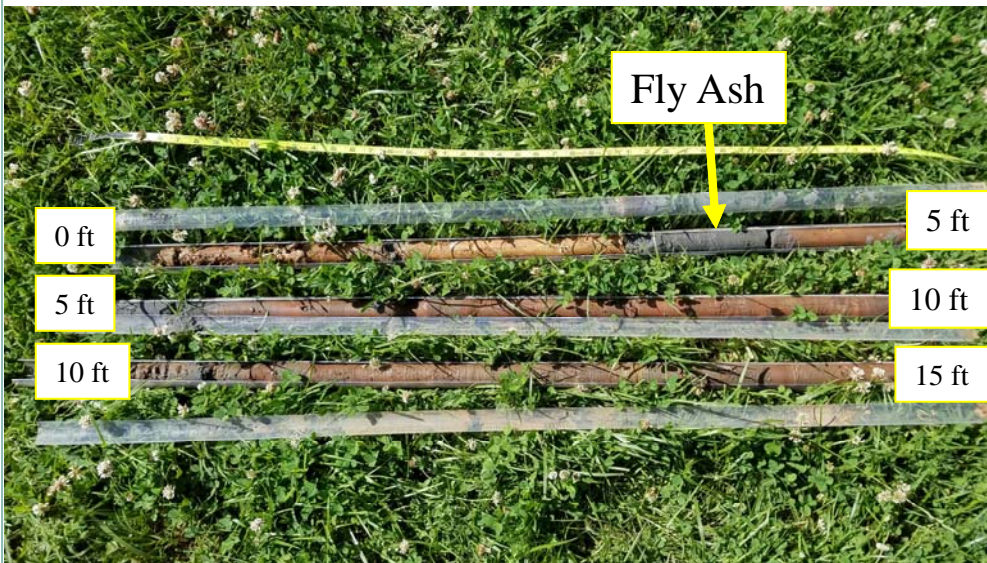
Photo 4

View of soil cores extracted from boring P26SB-1. Depths listed in feet below ground surface (bgs).

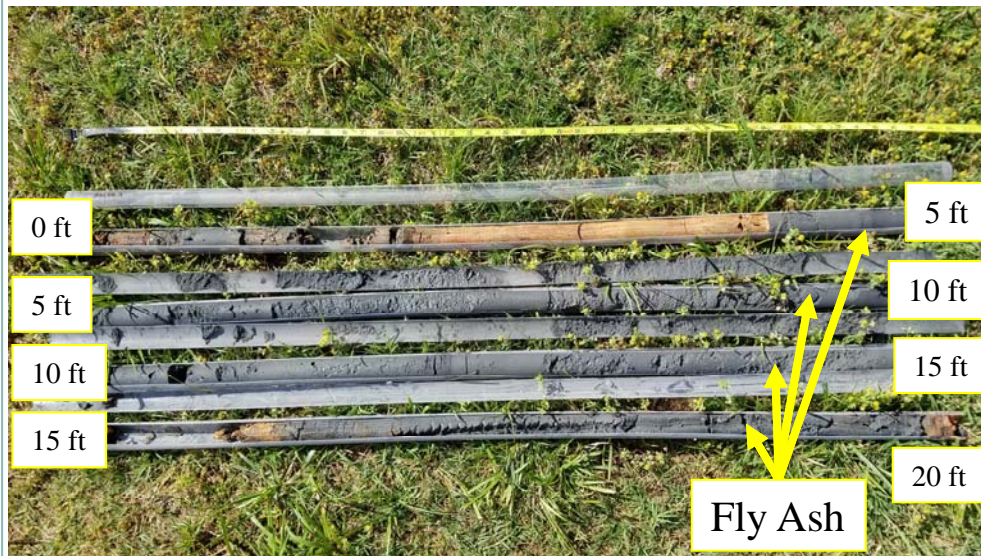
Photo 5

View of soil cores extracted from boring P26SB-3. Depths listed in feet bgs.

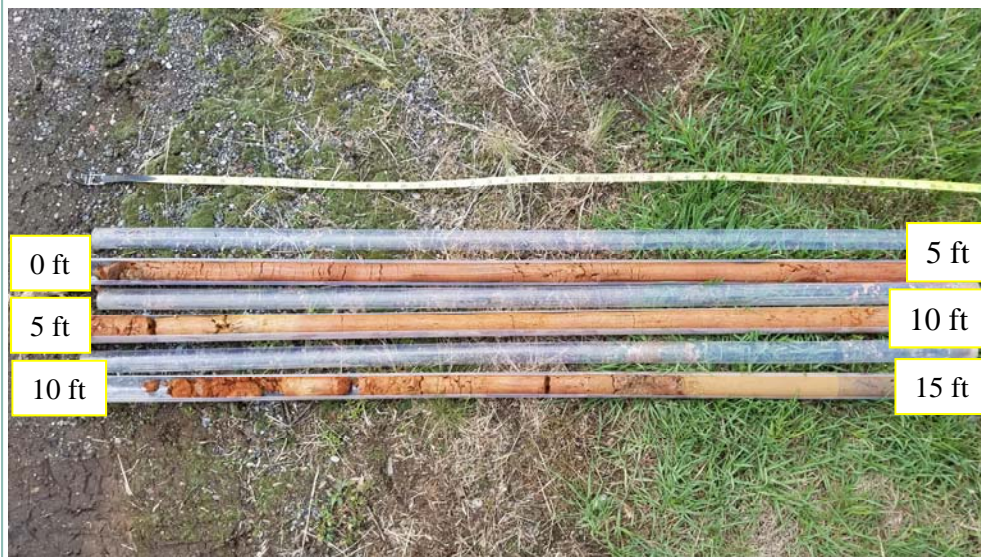
Photo 6

View of soil cores extracted from boring P26SB-12. Depths listed in feet bgs.

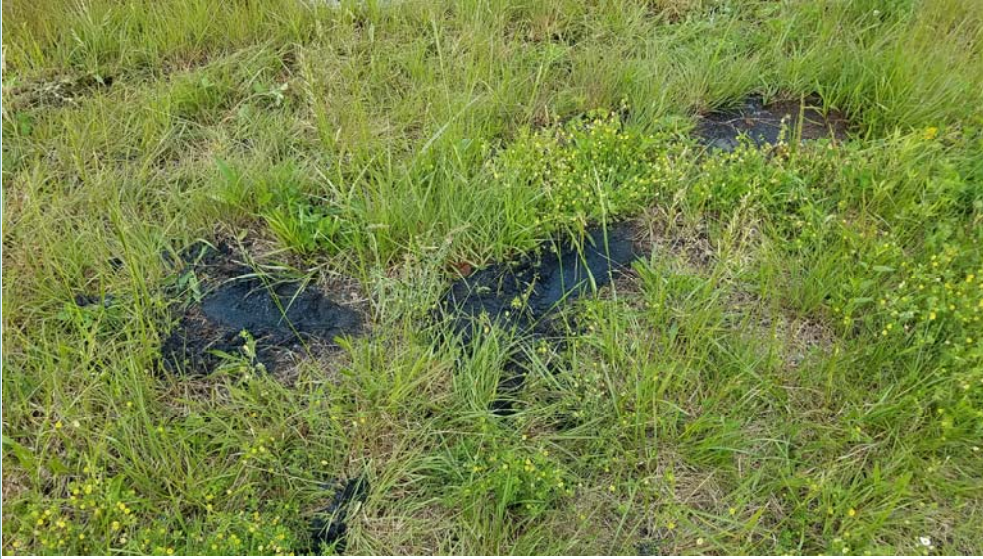
Photo 7

A surface deposit of unidentified material was observed in the grass field on the western side of the site within the proposed drainage easement. The material was observed to be black, sandy, and included blue paint chips. The material covers an area of approximately 40 square feet (eight feet by five feet) and is approximately four inches thick.

-
- One sample was collected from the surface deposit of unidentified material. Analytical results indicate an exceedance of the chrome VI Industrial/ Commercial Health Based PSRG in this sample.
 - Two soil samples with fly ash (P26SB-6 and P26SB-10-1) were analyzed for TCLP RCRA eight metals. Arsenic, Barium, and Selenium were detected in one or more samples at concentrations above laboratory reporting limits. No reported concentrations exceeded US EPA Regulatory Levels for hazardous toxicity.

View of the surface deposit of unidentified black material near boring P26SB-4 on the eastern side of Parcel 26.
