Reference: **Preliminary Site Assessment**
RREF II BB-NC LLC Property (Parcel #220)
4299 Raeford Road
Fayetteville, Cumberland County, North Carolina
State Project: U-4405
WBS Element 39049.1.1
SIES Project No. 2016.0054.NDOT

METALLIC UST INVESTIGATION: PARCEL 220 – RREF II BB-NC, LLC NCDOT PROJECT U-4405

GEOPHYSICAL INVESTIGATION REPORT
Parcel 220 – 4299 Raeford Road
Fayetteville, Cumberland County, North Carolina

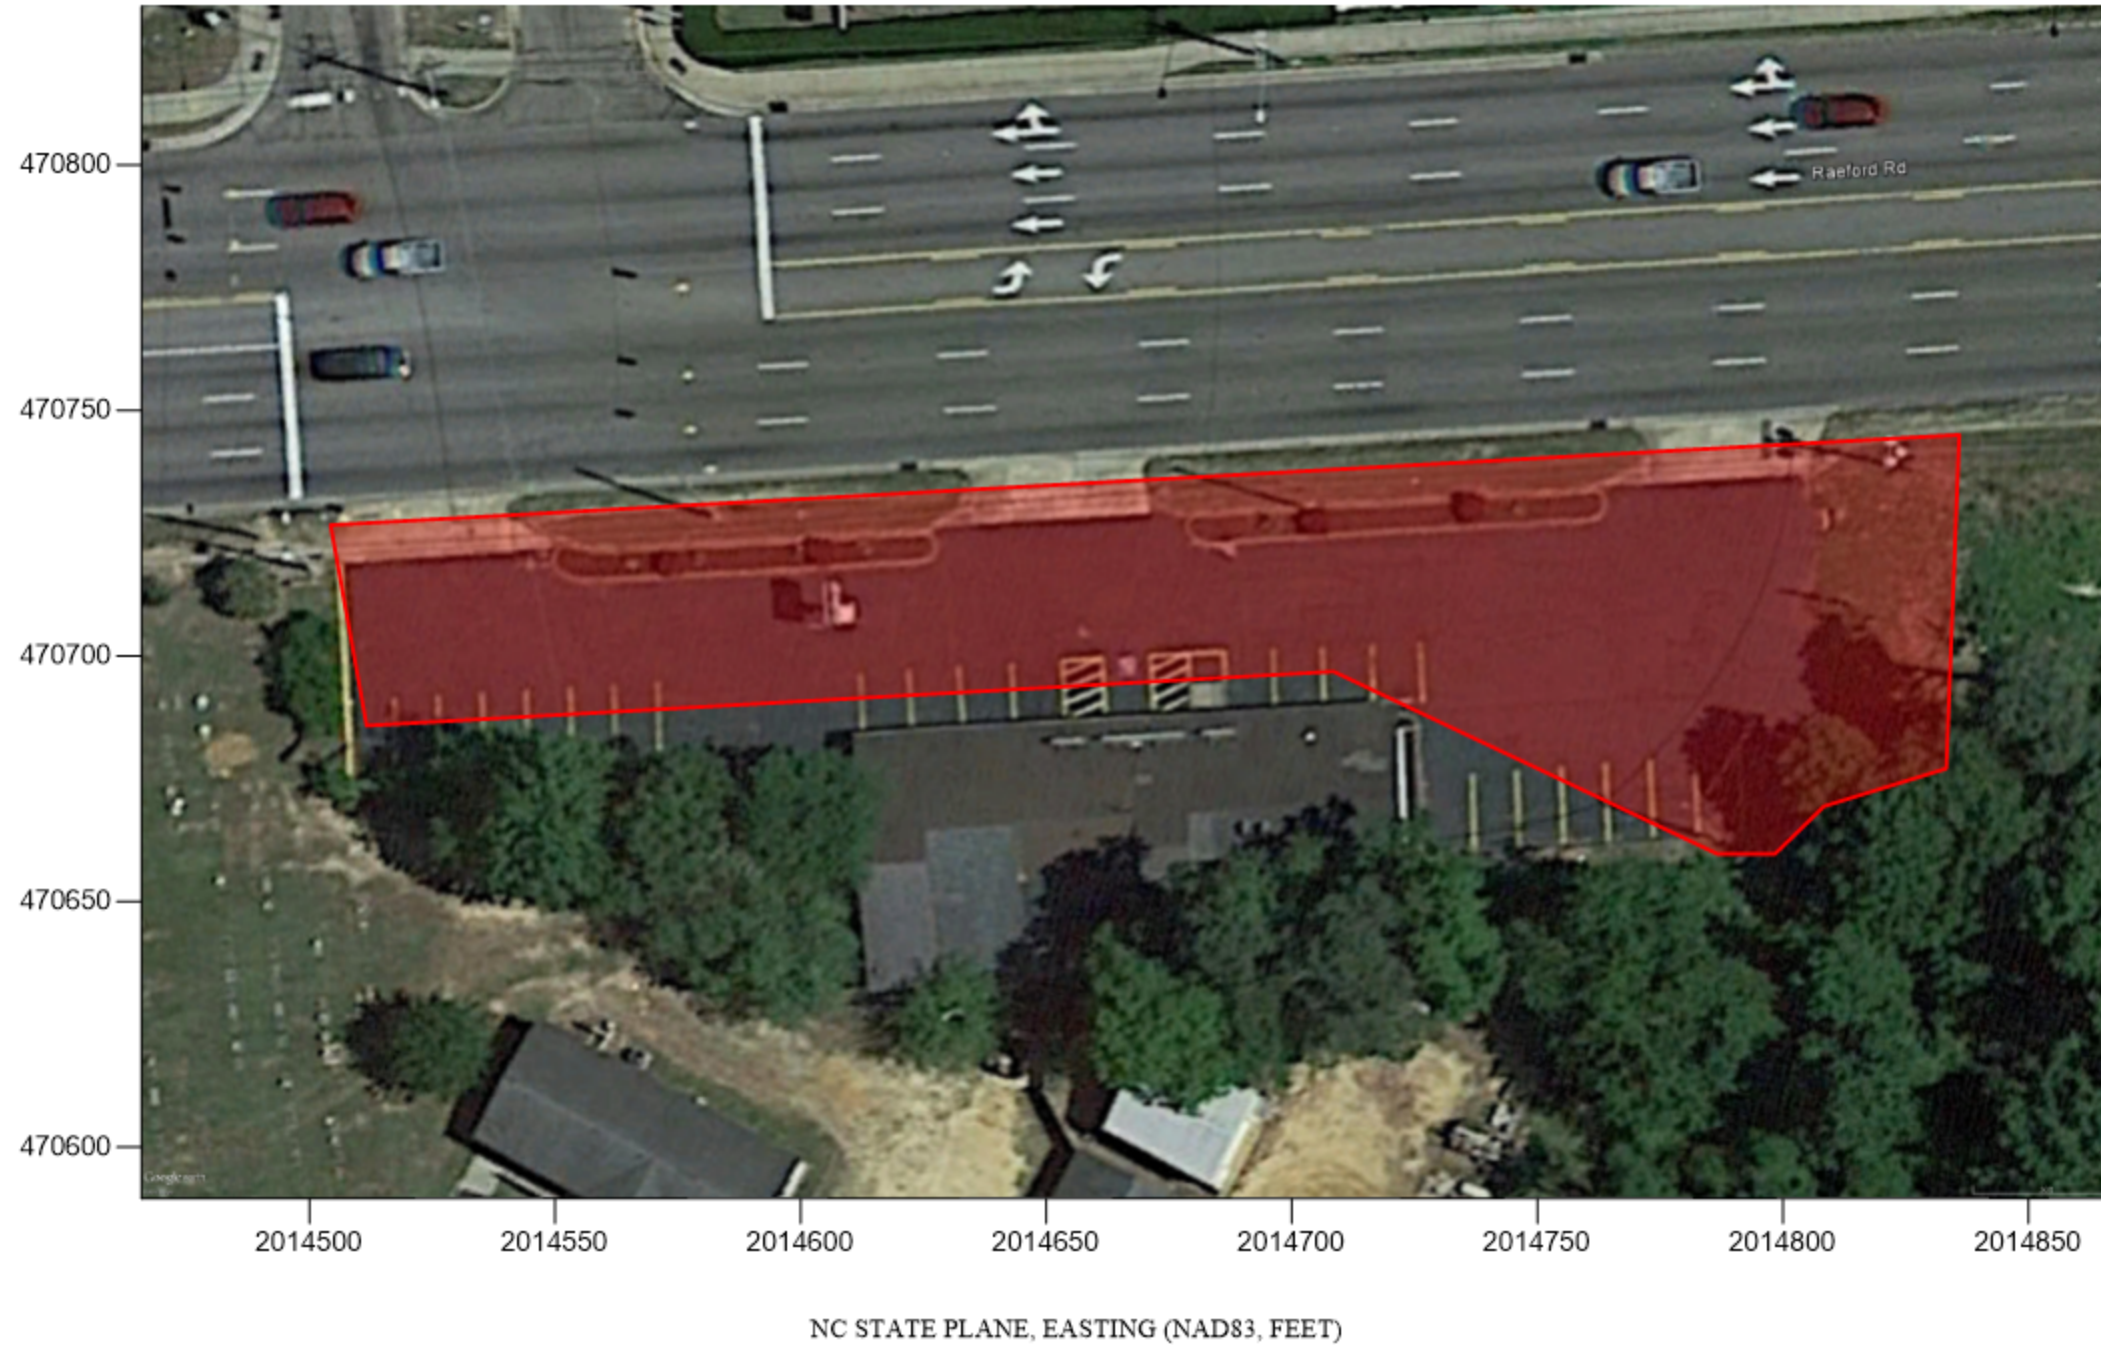
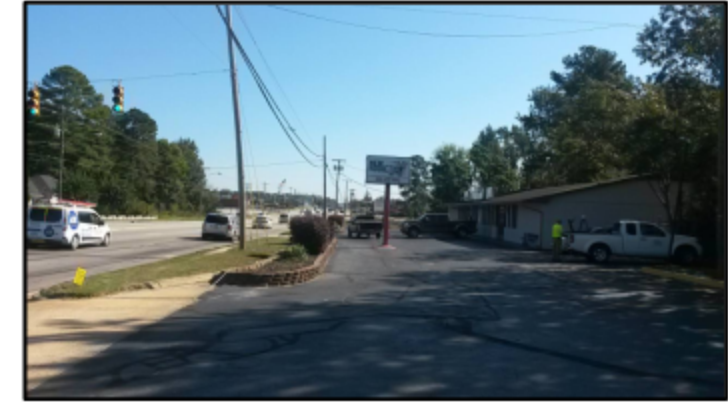
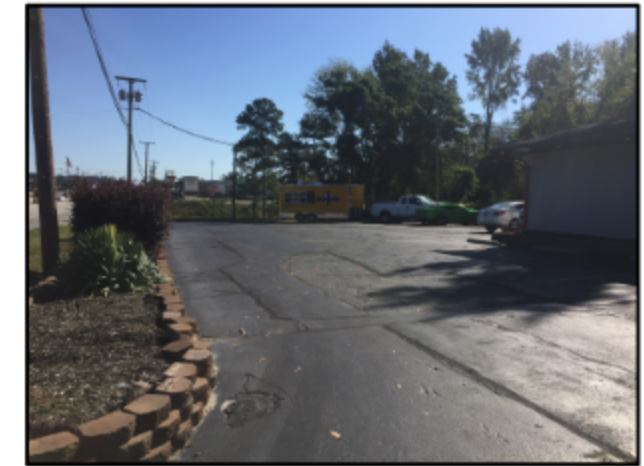
TITLE		PARCEL 220 - GEOPHYSICAL SURVEY BOUNDARIES AND SITE PHOTOGRAPHS	
PROJECT		4299 RAEFORD ROAD FAYETTEVILLE, NORTH CAROLINA NCDOT PROJECT U-4405

The site included a commercial building with an asphalt parking lot and grass medians. Aerial photographs showing the survey area boundaries and ground-level photographs are shown in **Figure 1**.

APPROXIMATE BOUNDARIES OF GEOPHYSICAL SURVEY AREA

View of Survey Area
(Facing Approximately East)

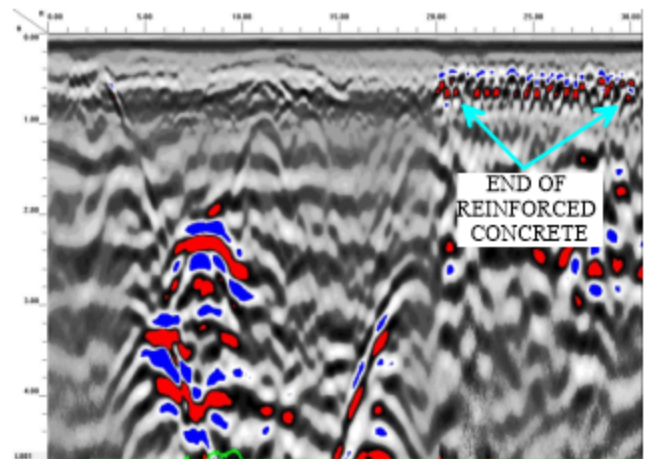
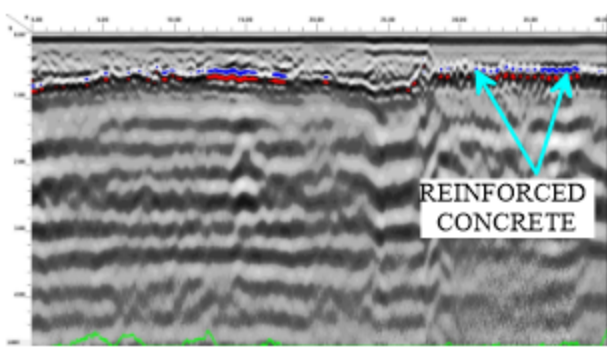
503 INDUSTRIAL AVENUE GREENSBORO, NC 27460 (336) 335-3174 (p) (336) 691-0648 (f) License # C1251 Eng. / License # C257 Geology	
DATE	10/31/2016	CLIENT	SOLUTIONS, IES
PYRAMID PROJECT #:	2016-265	FIGURE 3

Figure 3 presents the locations of the formal GPR transects performed at the property, as well as select transect images. A total of 23 GPR transects were performed at the site across the areas containing reinforced concrete. The 23 transects all verified the presence of metal reinforcement in the concrete. No evidence of significant structures beneath the reinforcement such as USTs was observed.

LOCATIONS OF GPR TRANSECTS

GPR TRANSECT 18 (T18)

GPR TRANSECT 1 (T1)

GPR TRANSECT 14 (T14)
