Preliminary Site Assessment Report

Edith S. Smith Property
Parcel # 15
1710 N. William Street
Goldsboro, Wayne County, North Carolina
US 117 Alternate from US 70 Bypass to Belfast
TIP Number: U-2714
WBS Element: 38979.1.2

GEOPHYSICAL SURVEY

METALLIC UST INVESTIGATION: PARCEL 015 NCDOT PROJECT U-2714

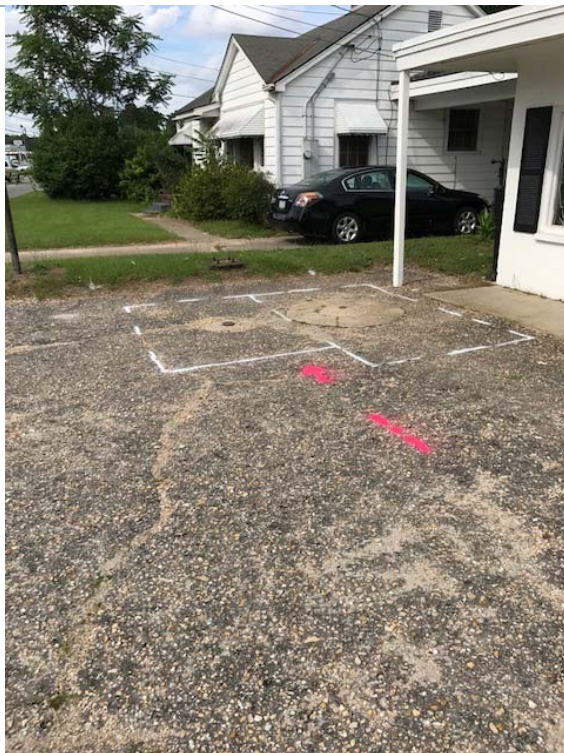
Photo 2

Two Probable USTs Identified in Front of the Building.

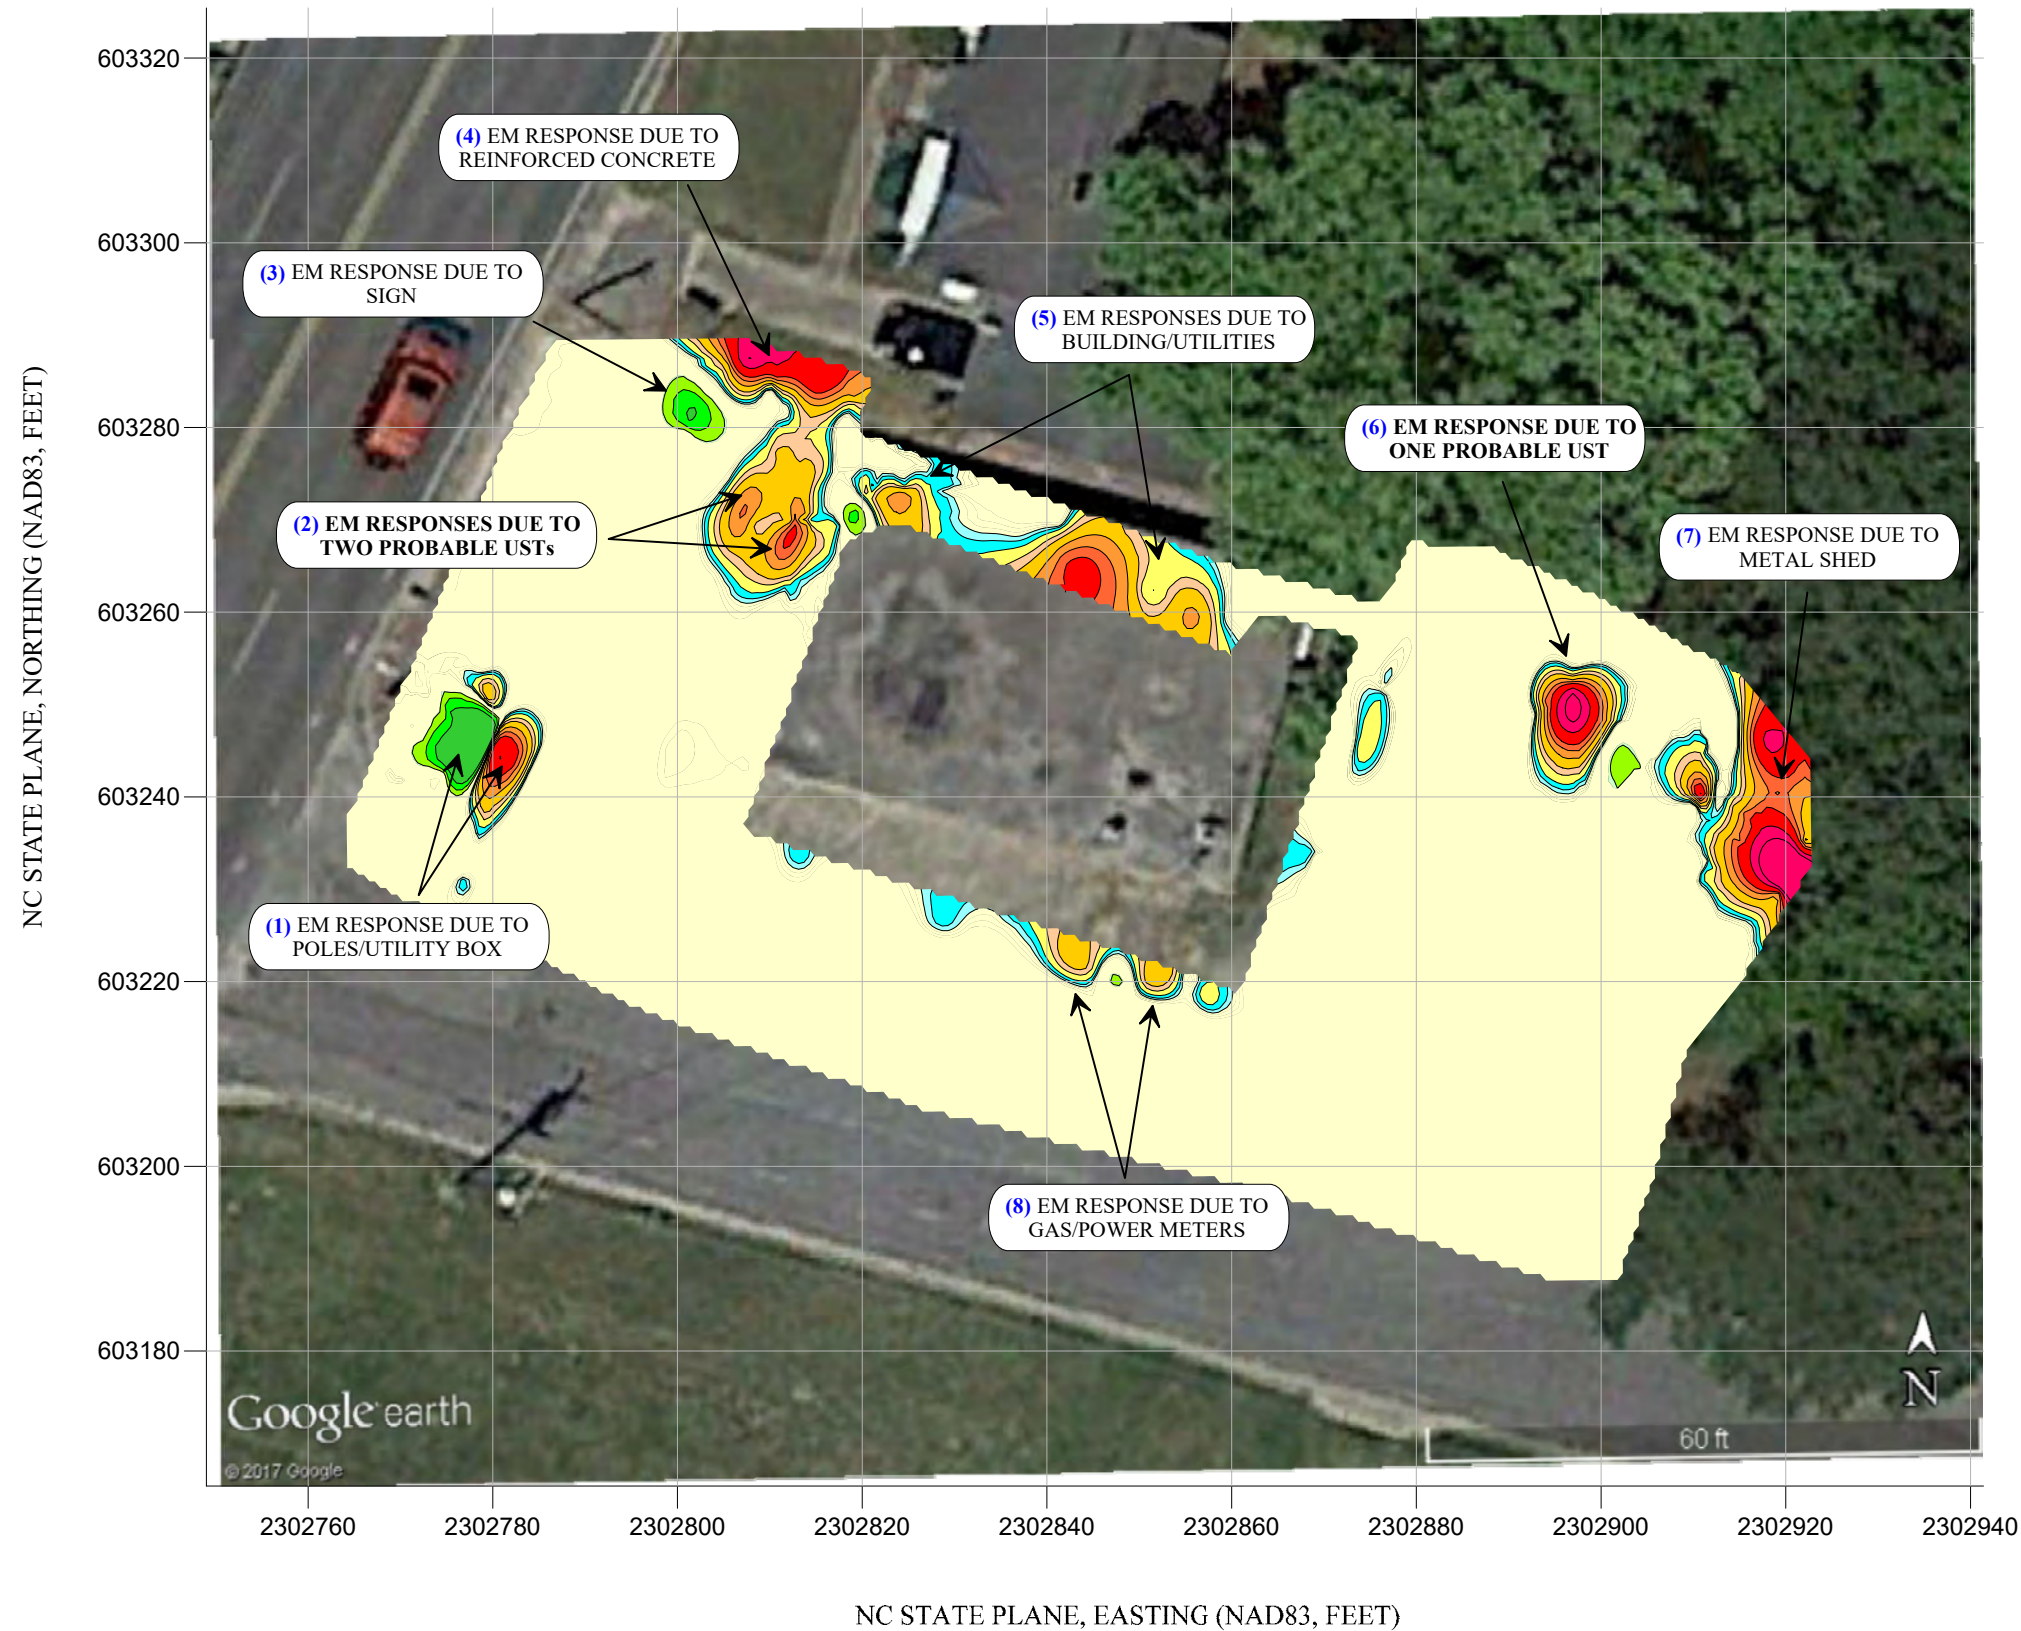
EM61 METAL DETECTION RESULTS

A contour plot of the EM61 results obtained across the survey area at the property is presented in **Figure 2**. Each EM anomaly is numbered for reference in the figure. The following table presents the list of EM anomalies and the cause of the metallic response, if known:

Metallic Anomaly #	Cause of Anomaly	Investigated with GPR
1	Poles/utility box	
2	Two probable USTs	☑
3	Sign	
4	Reinforced concrete	
5	Building/utilities	
6	One probable UST	☑
7	Metal Shed	
8	Gas/power meters

EVIDENCE OF THREE PROBABLE METALLIC USTs OBSERVED.

The contour plot shows the differential results of the EM61 instrument in millivolts (mV). The differential results focus on larger metallic objects such as USTs and drums. The EM61 data were collected on June 6, 2017, using a Geonics EM61 instrument. Verification GPR data were collected using a GSSI UtilityScan DF instrument with a dual frequency 300/800 MHz antenna on June 6-7, 2017.

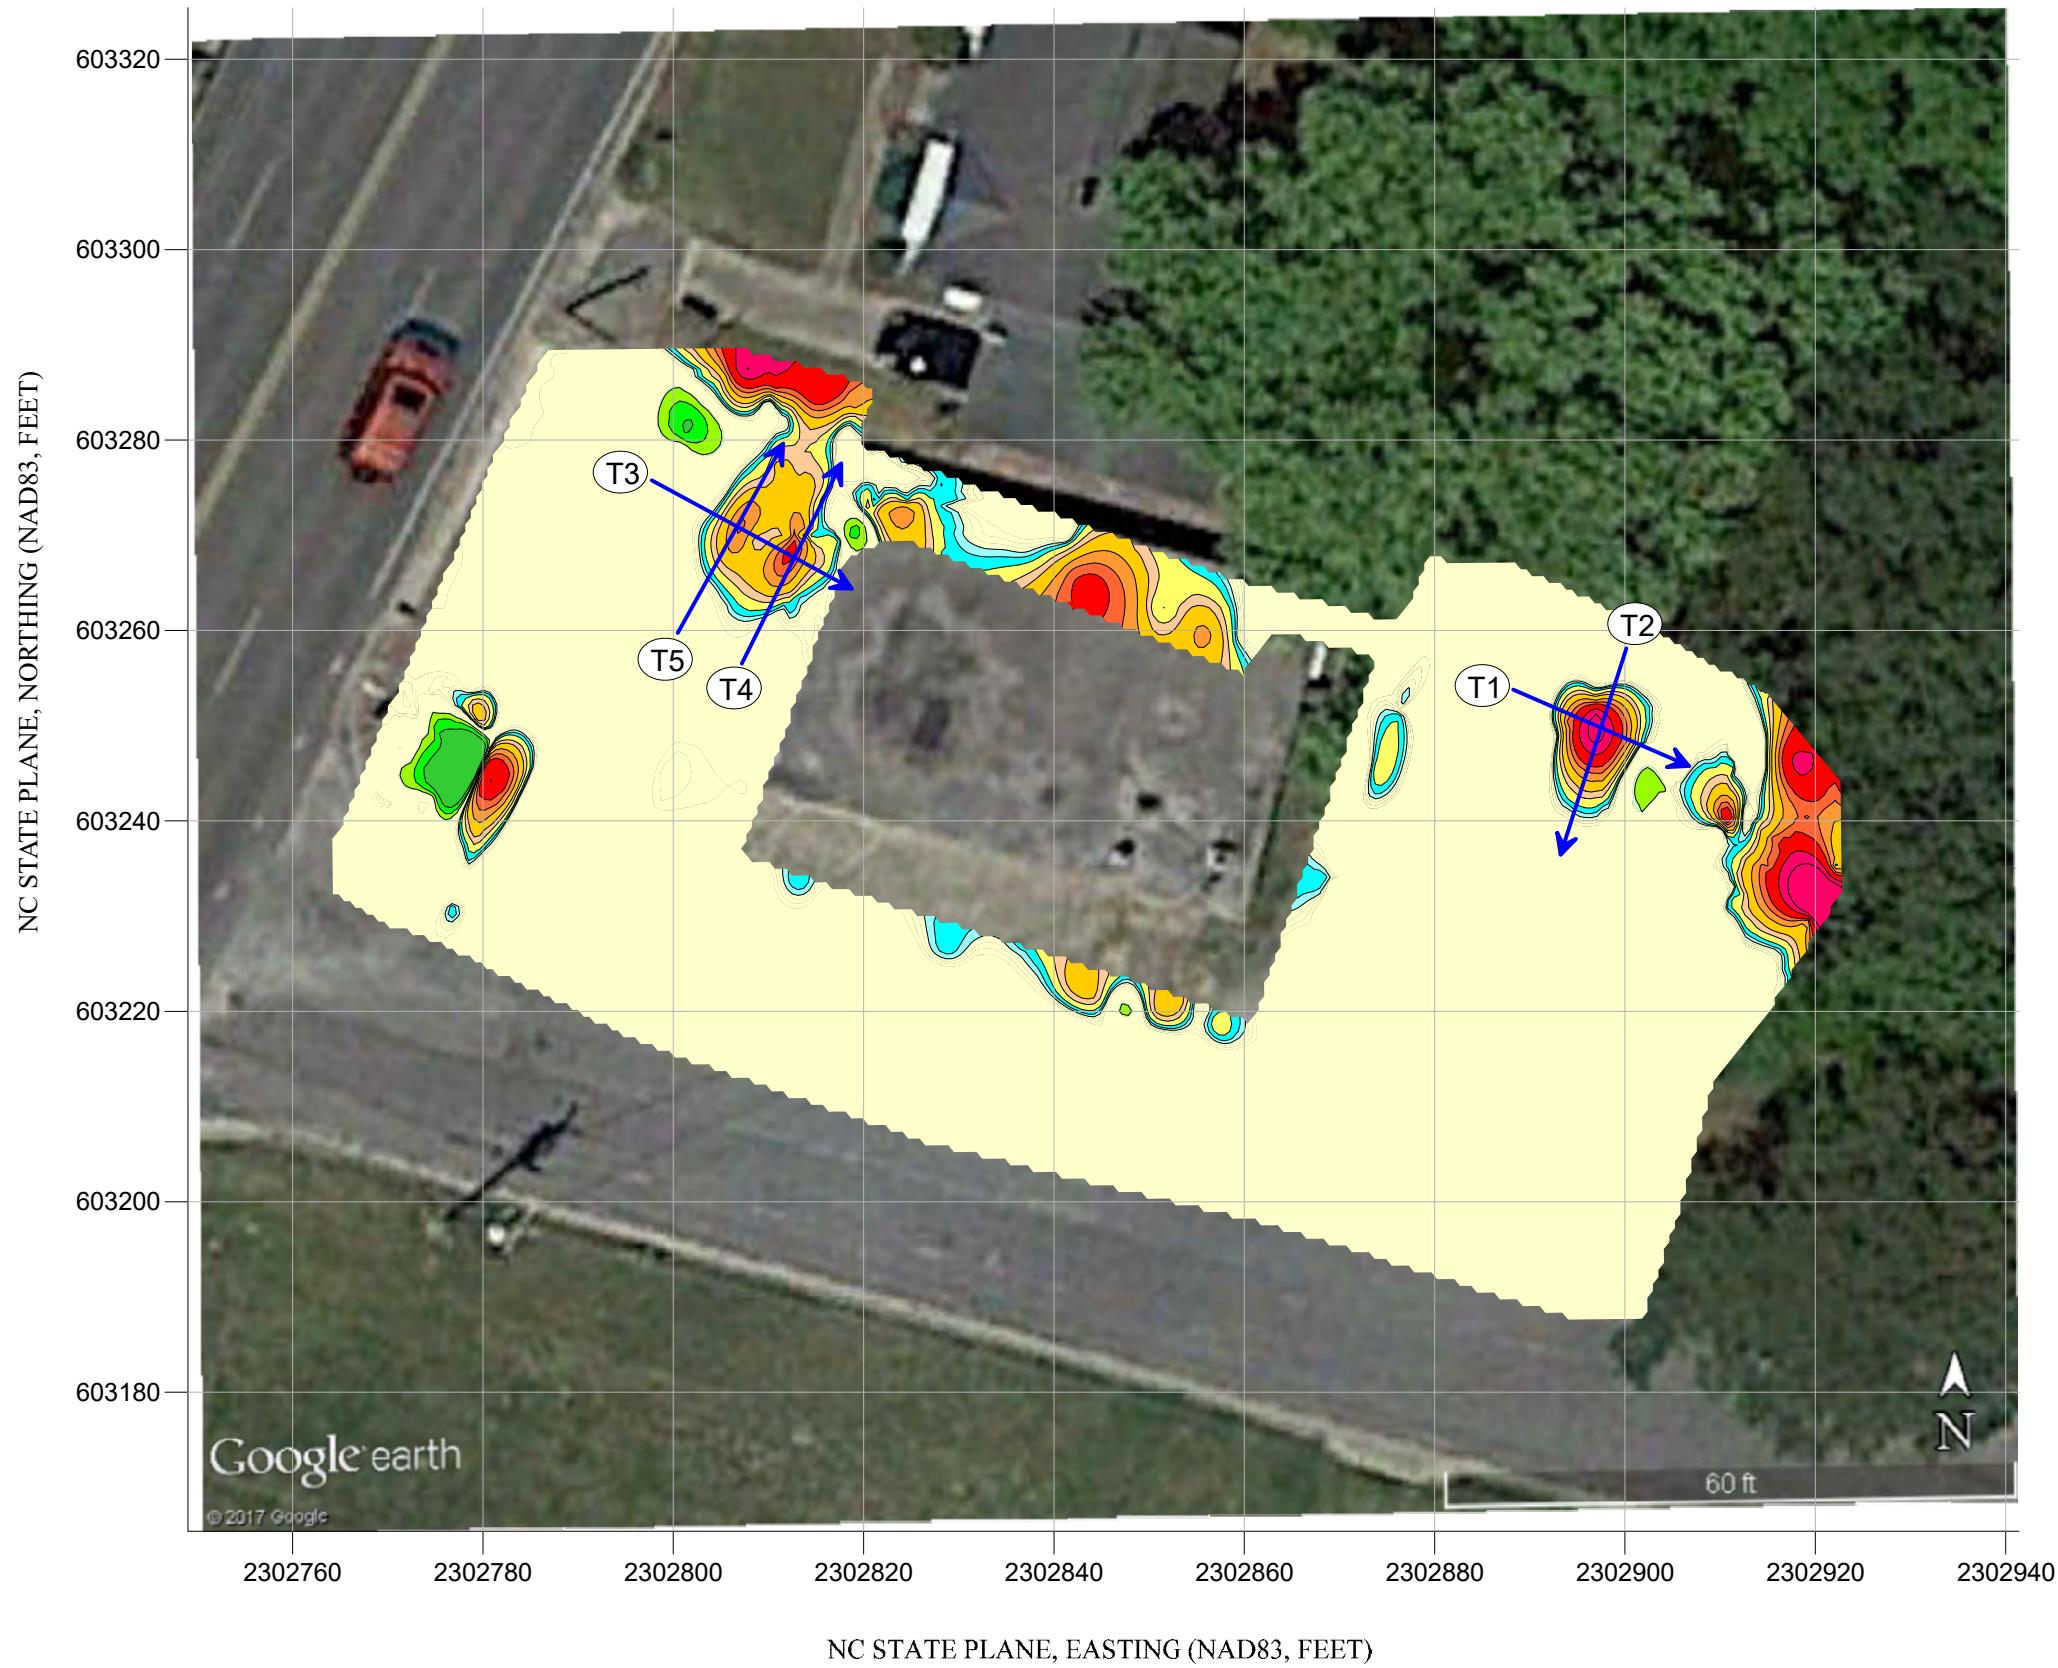
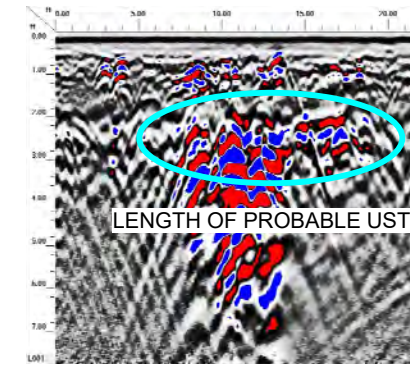
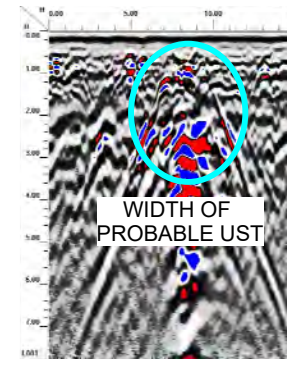
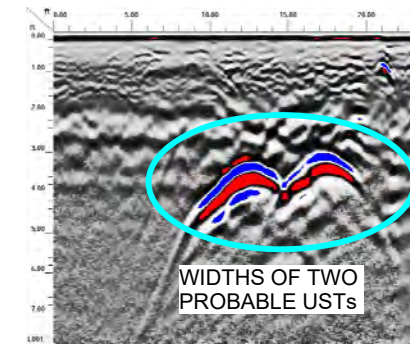
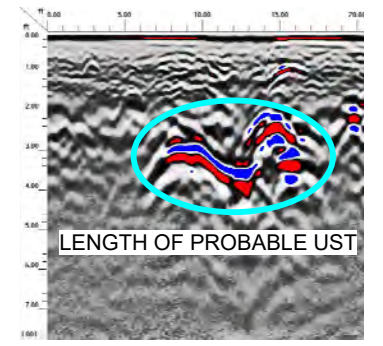
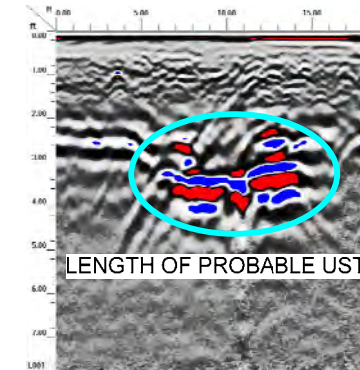
TITLE	PARCEL 015 - GPR TRANSECT LOCATIONS AND IMAGES	
PROJECT	PARCEL 015 GOLDSBORO, NORTH CAROLINA NCDOT PROJECT U-2714

LOCATIONS OF GPR TRANSECTS

GPR TRANSECT 1 (T1)

GPR TRANSECT 2 (T2)

GPR TRANSECT 3 (T3)

GPR TRANSECT 4 (T4)

GPR TRANSECT 5 (T5)

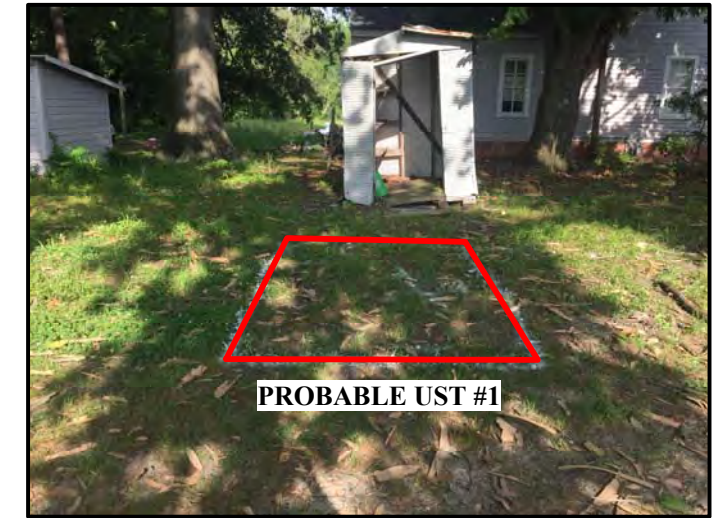
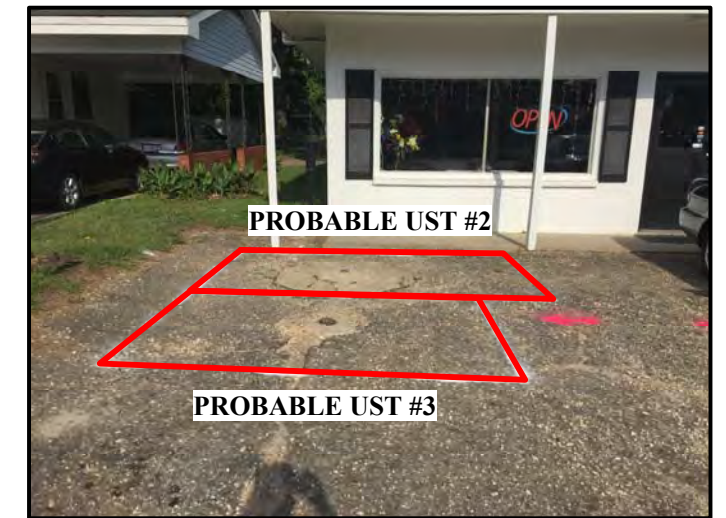
TITLE	PARCEL 015 - LOCATIONS AND SIZES OF PROBABLE USTs	
PROJECT	PARCEL 015 GOLDSBORO, NORTH CAROLINA NCDOT PROJECT U-2714

Collectively, the geophysical data recorded evidence of three probable metallic USTs at Parcel 015. **Figure 4** shows the locations and sizes of all probable USTs identified by the survey. **Figure 5** provides an overlay of the geophysical survey area onto the NCDOT MicroStation engineering plans (proposed ROW and easements) for reference.

LOCATIONS OF PROBABLE METALLIC USTs

PROBABLE UST #1
(FACING APPROXIMATELY EAST)

PROBABLE USTs #2 & #3
(FACING APPROXIMATELY EAST)
