## Preliminary Site Assessment Report

Eagle's Nest, LLC. Property  
Parcel # 18  
1003 Beaman Street  
Clinton, Sampson County, North Carolina  
Replace Bridge 378 over Williams Old Mill Branch on SR 1838  
TIP Number: B-3507  
WBS Element: 46021.1.1

**Table 1**  
**UVF Onsite Hydrocarbon Analytical Soil and Groundwater Data from June 2017**  
**B-5307, Parcel 18, Eagle's Nest LLC., Property**  
**Clinton, North Carolina**

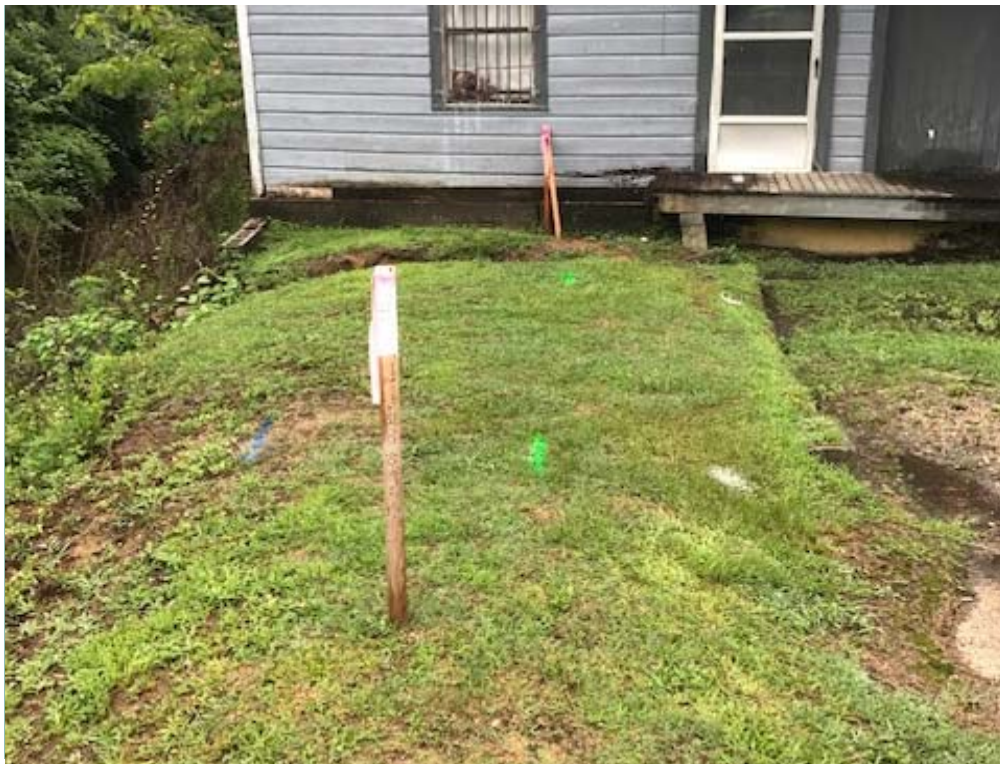
**Photo 2**

View ROW markers and utility mark-outs in the southern end of the investigation area.

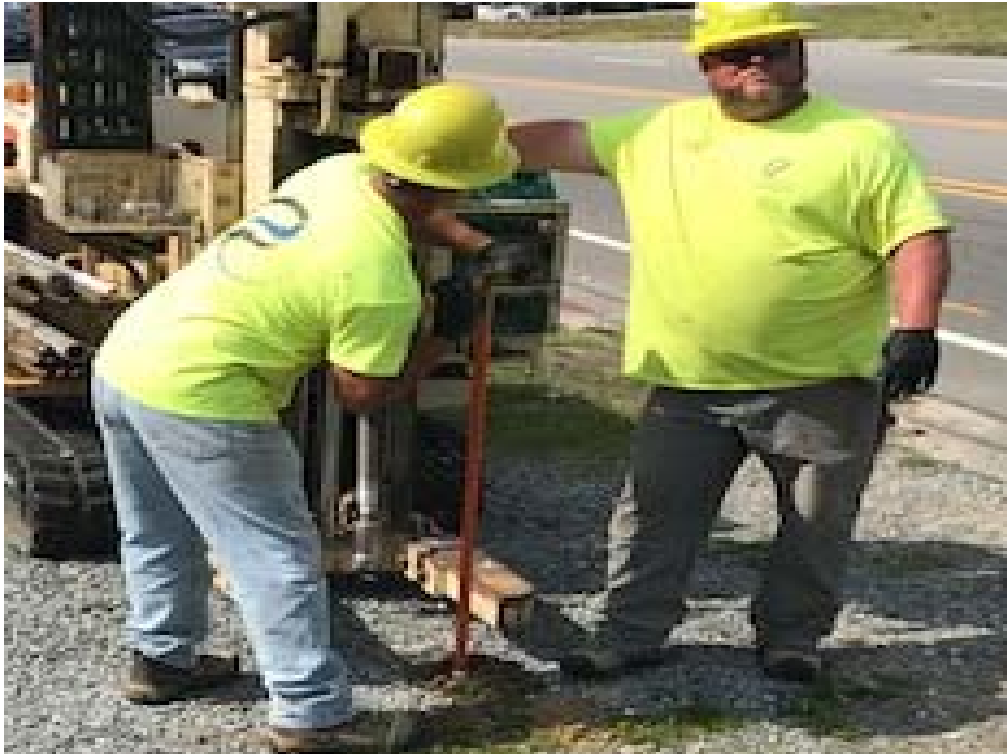
**Photo 4**

View of CSI preparing to drill.
