Pyramid Environmental & Engineering, P.C. Project # 2018-242
Preliminary Site Assessment (PSA) – Parcel 003 – QUALITY OIL

PRELIMINARY SITE ASSESSMENT
PARCEL 003 – QUALITY OIL
1126 MEBANE OAKS ROAD
MEBANE, ALAMANCE COUNTY, NORTH CAROLINA
STATE PROJECT: I-5711
WBS ELEMENT: 50401.1.FS1
OCTOBER 22, 2018

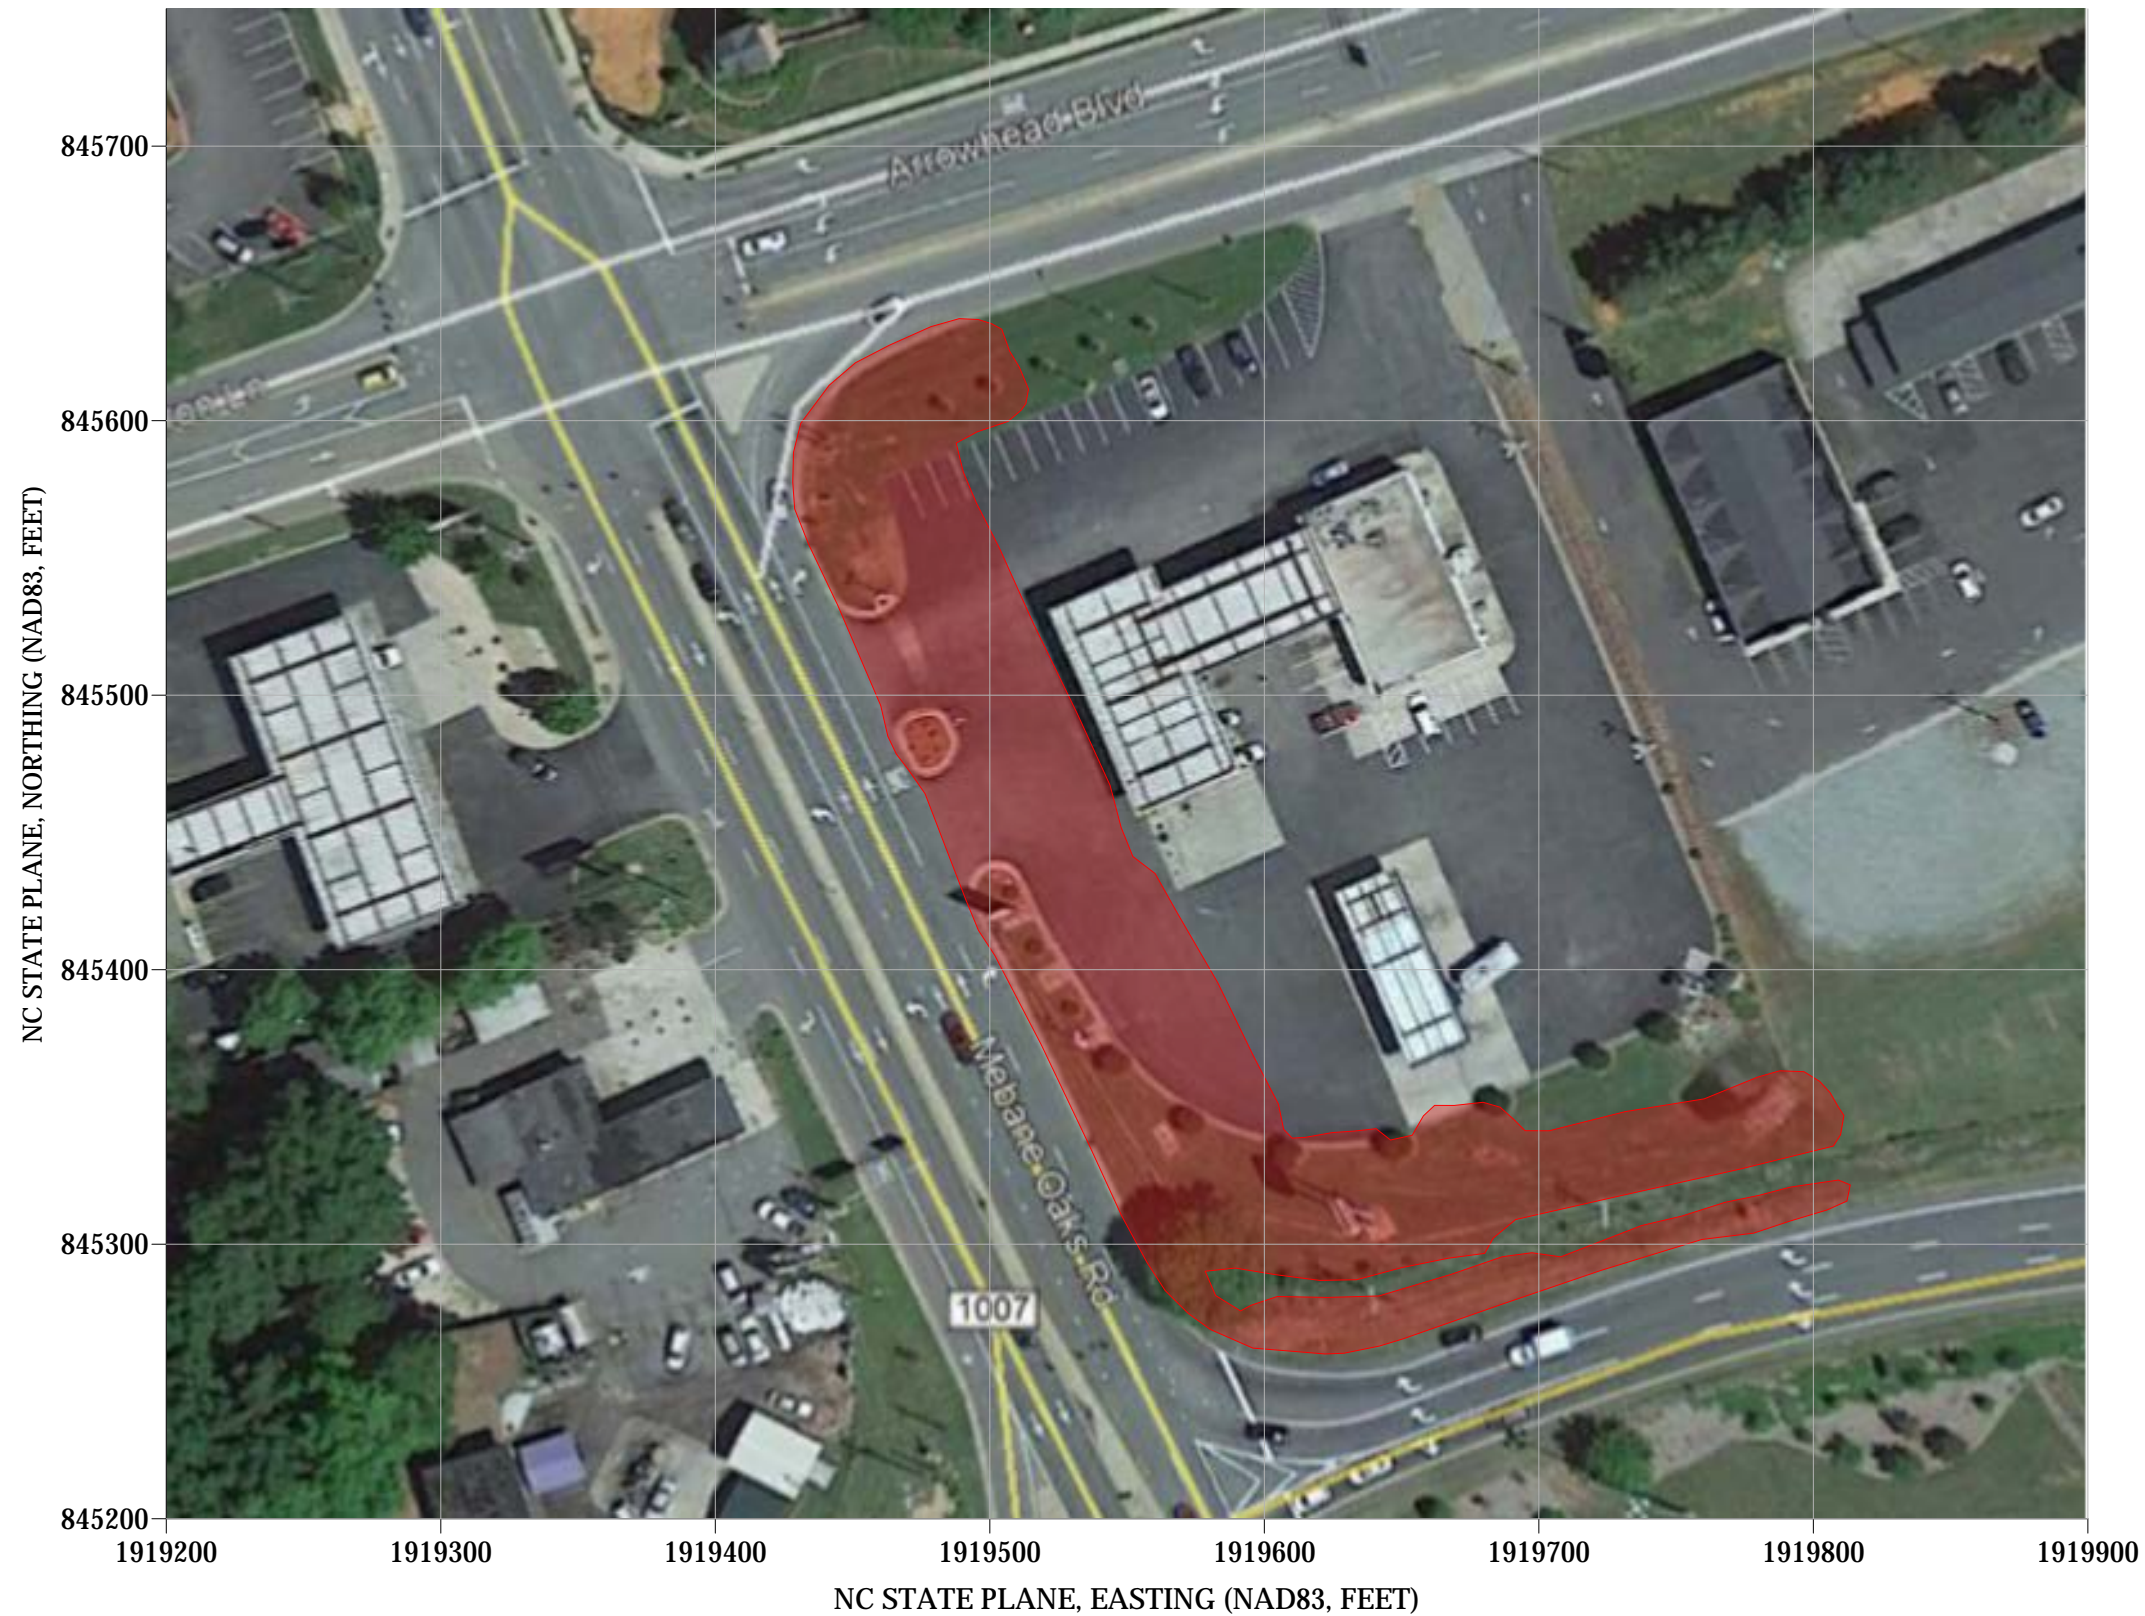
APPROXIMATE BOUNDARIES OF GEOPHYSICAL SURVEY AREA

The site included an active gas station surrounded by concrete, asphalt, and grass surfaces. Two known USTs were observed to be within the geophysical survey area. Additional known USTs were observed outside of the geophysical survey area at the southwest side of the main gas station canopy. An aerial photograph showing the survey area boundaries and ground-level photographs are shown in **Figure 1**.

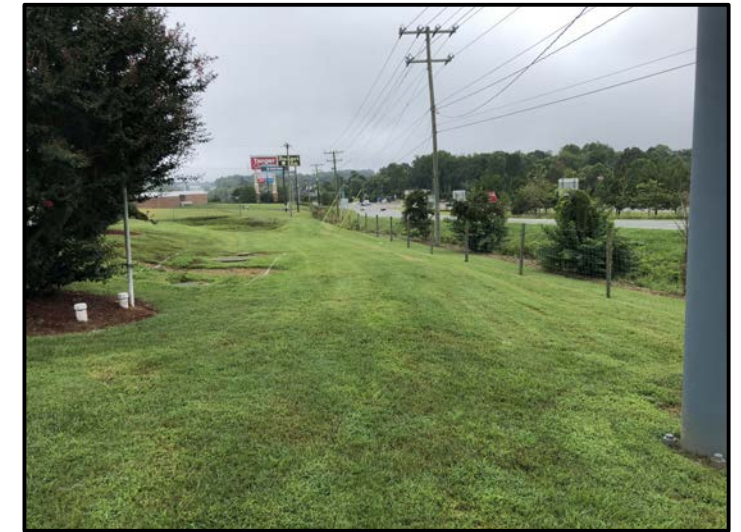
View of Survey Area
(Facing Approximately East)

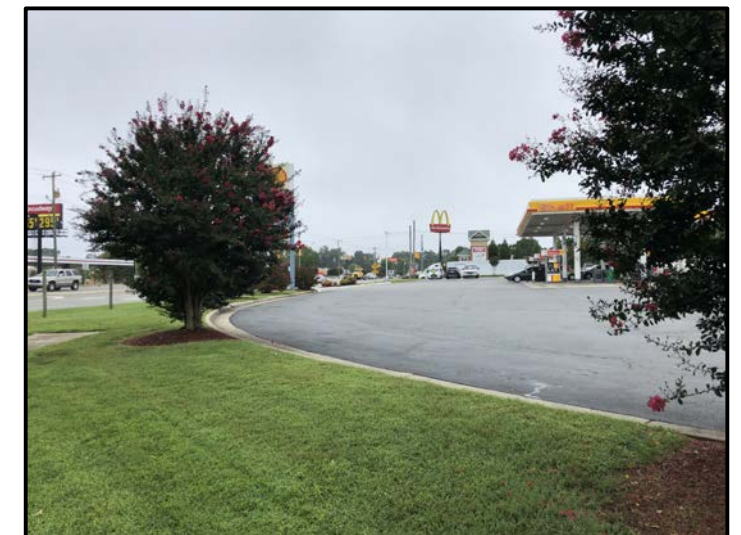
View of Survey Area
(Facing Approximately North)

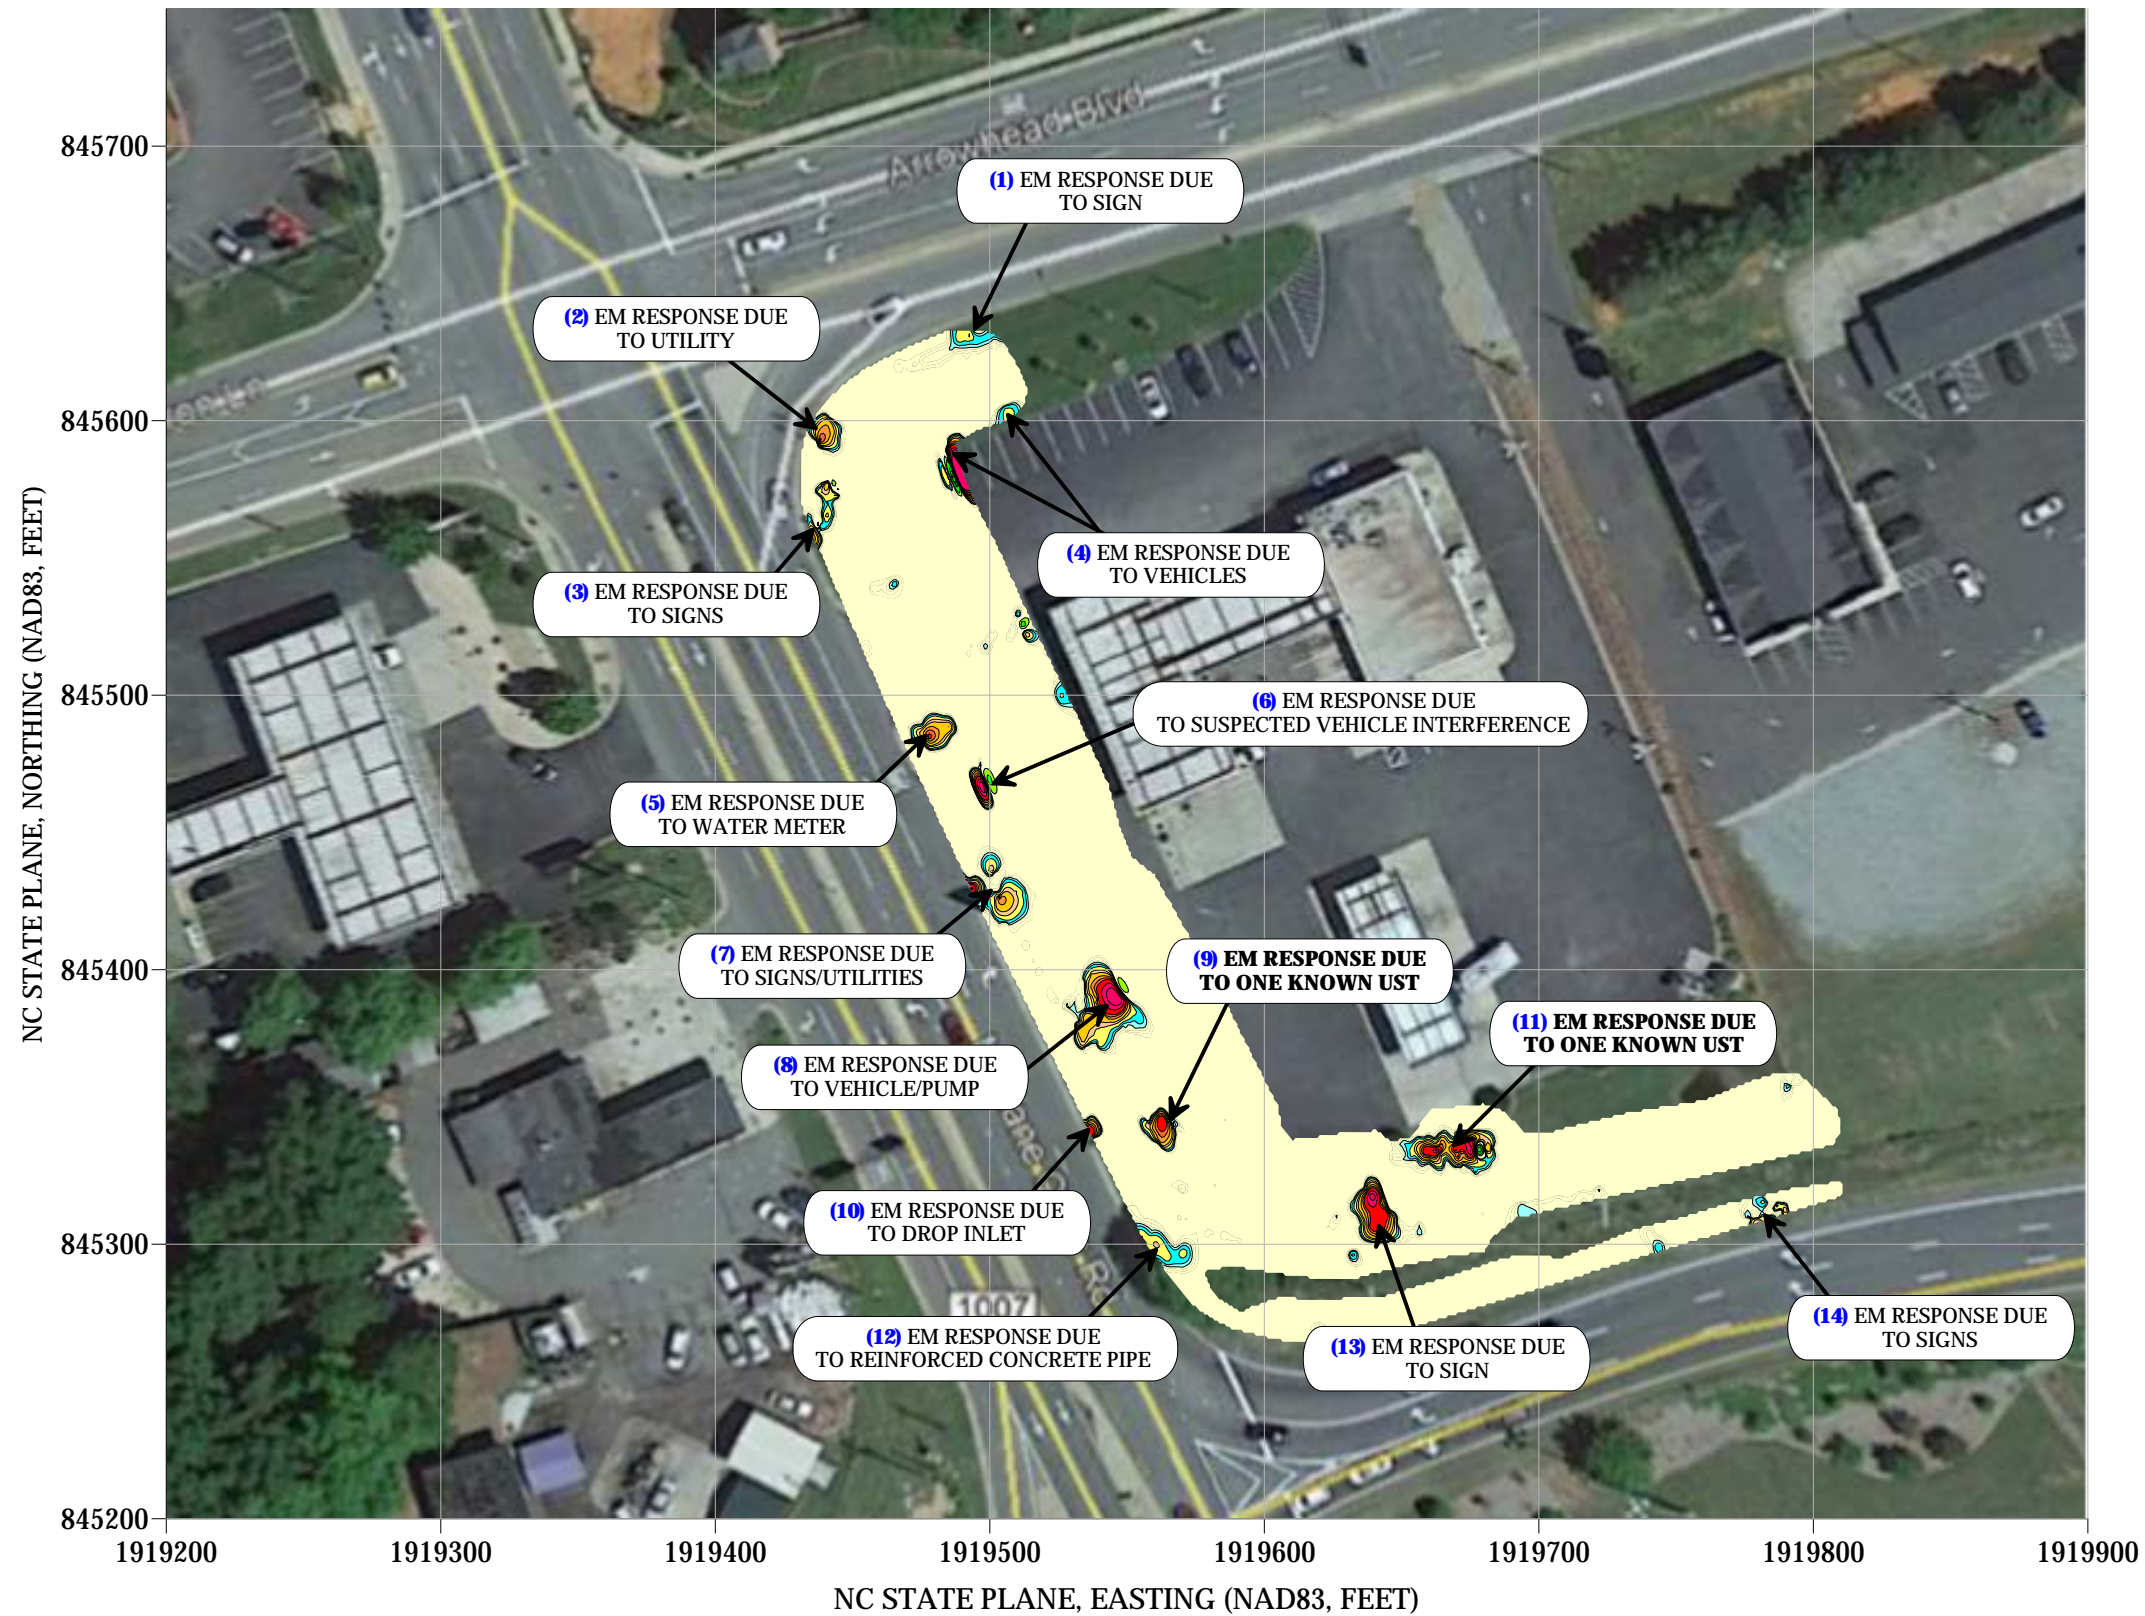
EM61 METAL DETECTION RESULTS

A contour plot of the EM61 results obtained across the survey area at the property is presented in **Figure 2**. Each EM anomaly is numbered for reference in the figure. The following table presents the list of EM anomalies and the cause of the metallic response, if known:

Metallic Anomaly #	Cause of Anomaly	Investigated with GPR
1	Sign	
2	Utility	
3	Signs	
4	Vehicles	
5	Water Meter	
6	Suspected Vehicle Interference	☑
7	Signs/Utilities	
8	Vehicle/Pump	
9	One Known UST	☑
10	Drop Inlet	
11	One Known UST	☑
12	Reinforced Concrete Pipe	
13	Sign	
14	Signs

EVIDENCE OF TWO KNOWN USTs OBSERVED.

The contour plot shows the differential results of the EM61 instrument in millivolts (mV). The differential results focus on larger metallic objects such as USTs and drums. The EM61 data were collected on September 10, 2018, using a Geonics EM61 instrument. Verification GPR data were collected using a GSSI UtilityScan DF instrument with a dual frequency 300/800 MHz antenna on September 12, 2018.

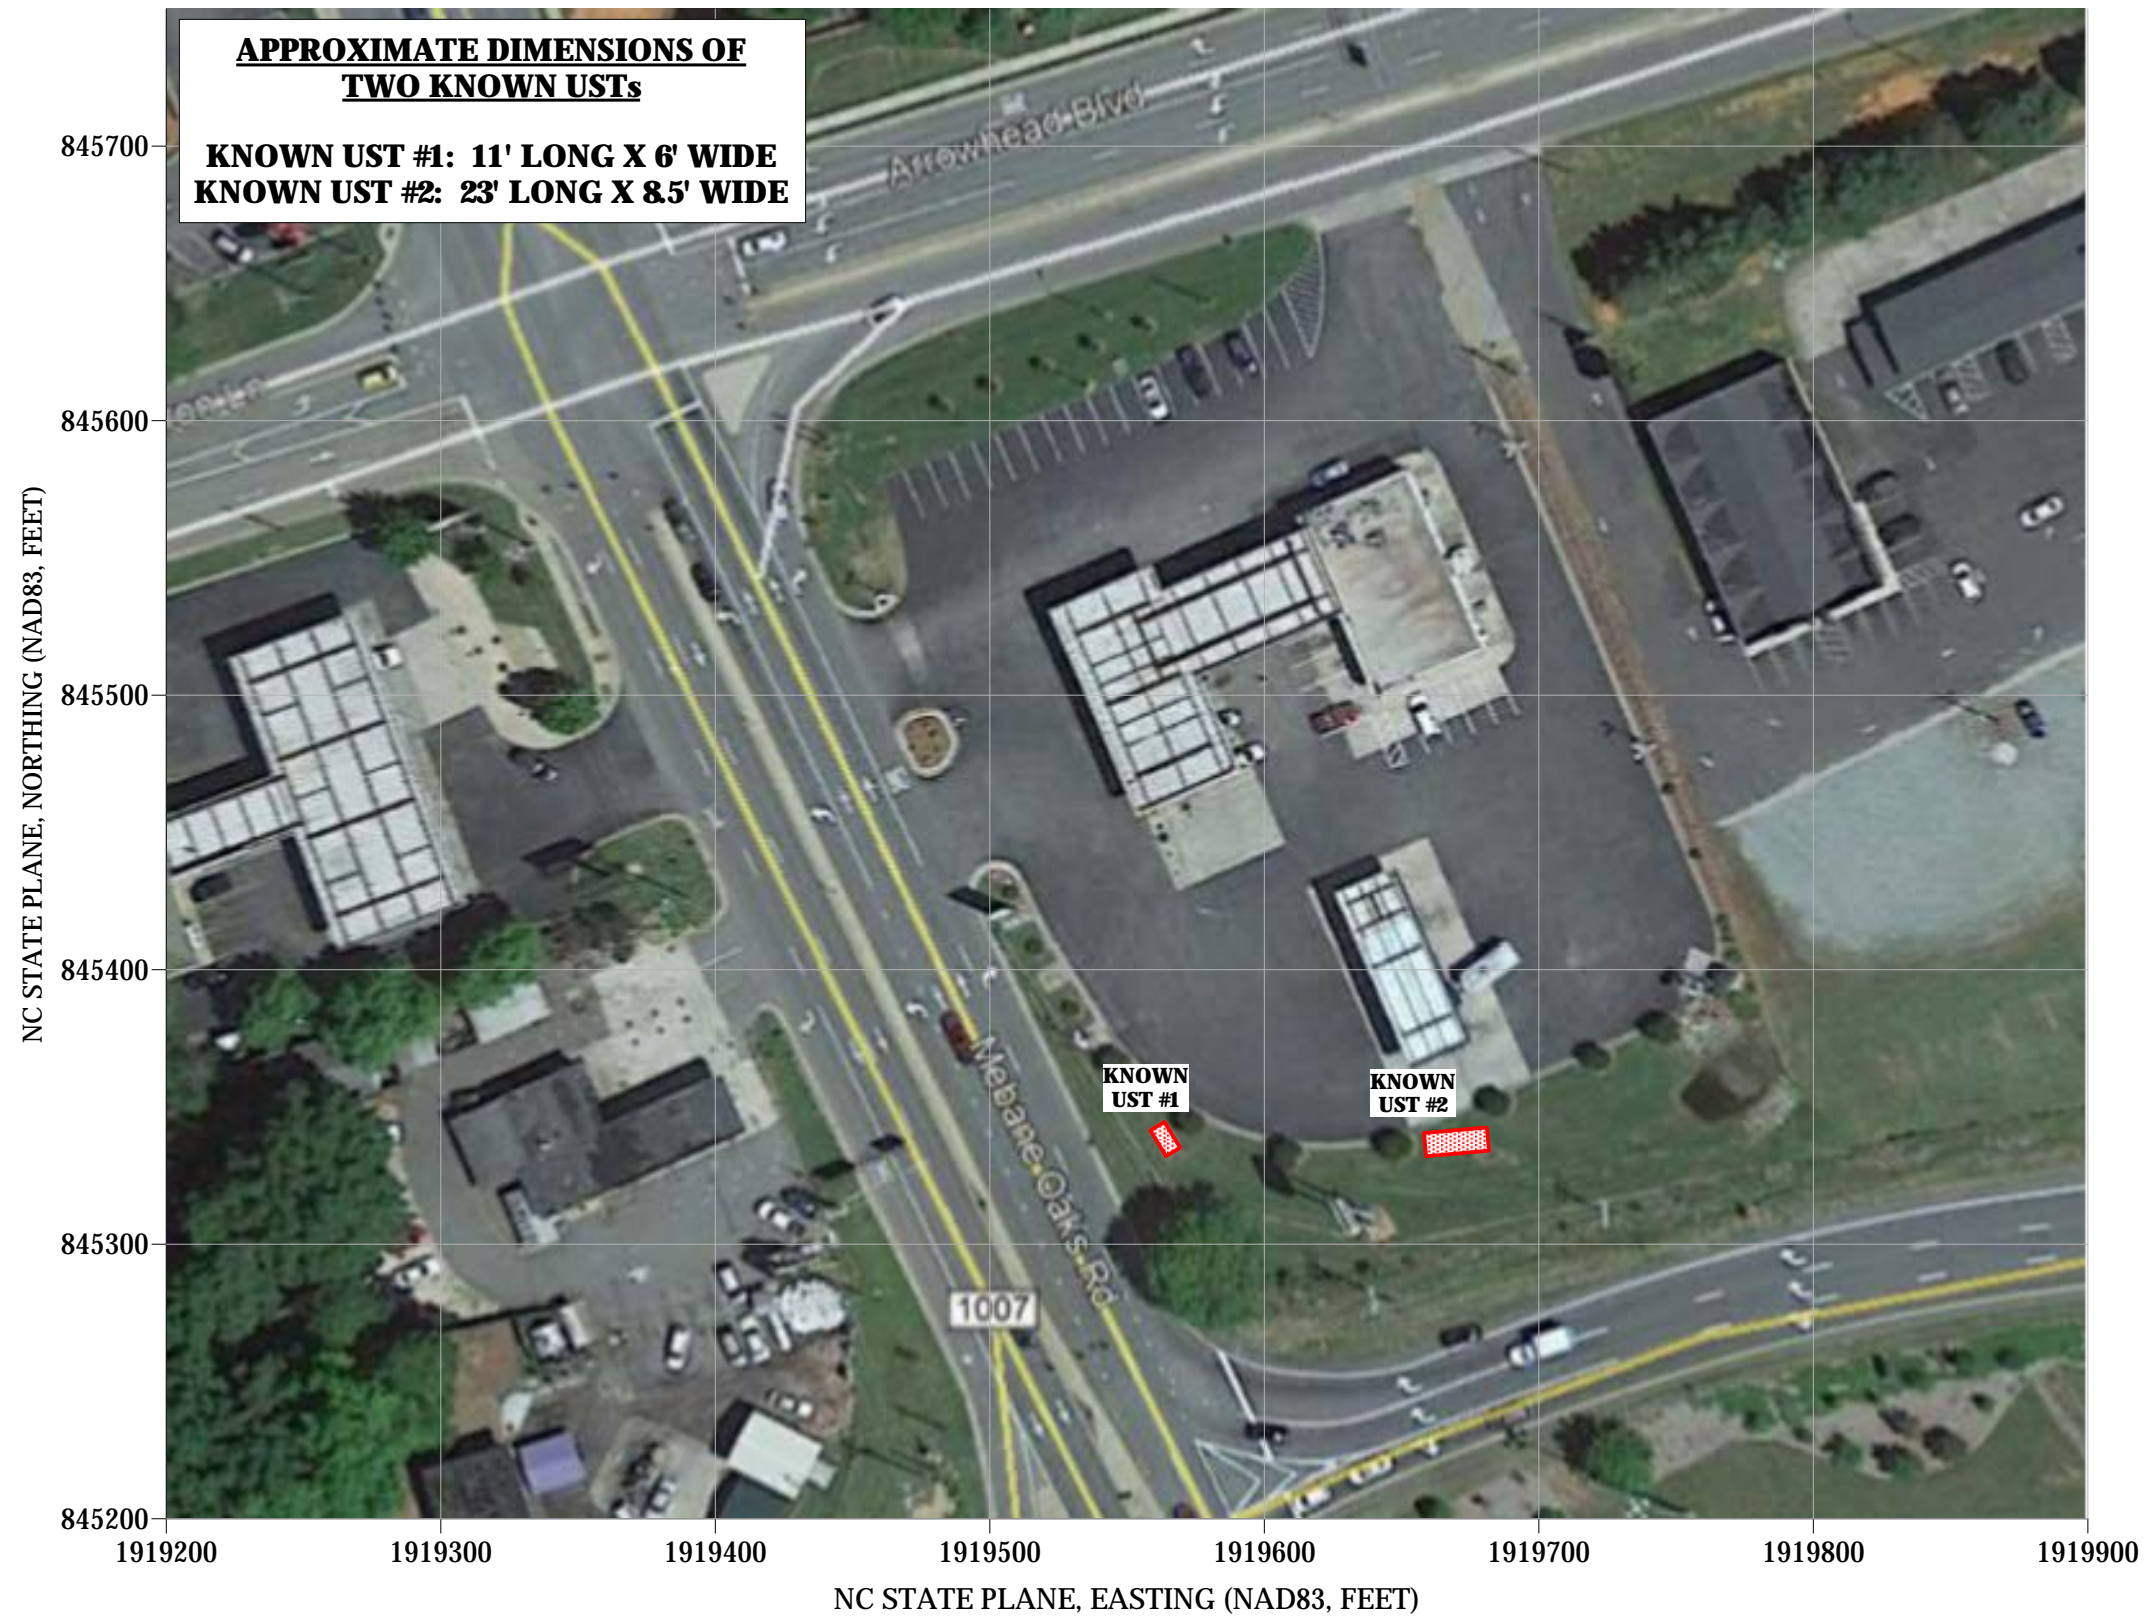
LOCATIONS OF TWO KNOWN USTs

Collectively, the geophysical data recorded evidence of two known USTs within the survey area at Parcel 3. It should be noted that additional known USTs are present at the parcel outside of the survey area on the southwest side of the main gas station canopy. **Figure 5** provides an overlay of the geophysical survey area and the locations of the known USTs onto the NCDOT MicroStation engineering plans for reference.

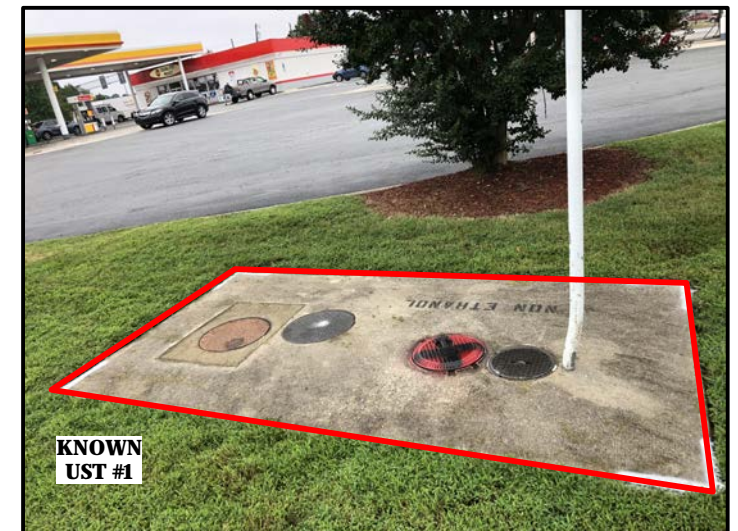
View of One Known UST Facing Approximately East

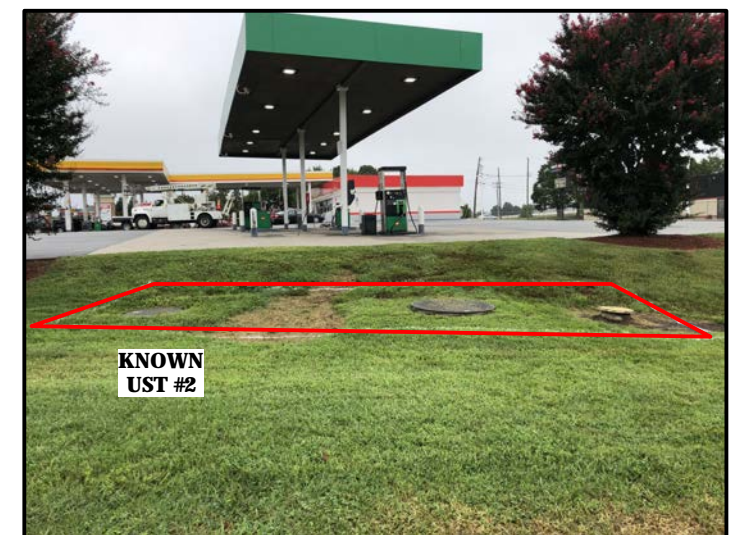
View of One Known UST Facing Approximately North
