PRELIMINARY SITE ASSESSMENT
PARCEL 005 - EAC INVESTMENTS, LLC
1105 MEBANE OAKS ROAD
MEBANE, ALAMANCE COUNTY, NORTH CAROLINA
STATE PROJECT: I-5711
WBS ELEMENT: 50401.1.FS1
OCTOBER 20, 2018

**PRELIMINARY SITE ASSESSMENT
PARCEL 005 - EAC INVESTMENTS, LLC
1105 MEBANE OAKS ROAD
MEBANE, ALAMANCE COUNTY, NORTH CAROLINA**

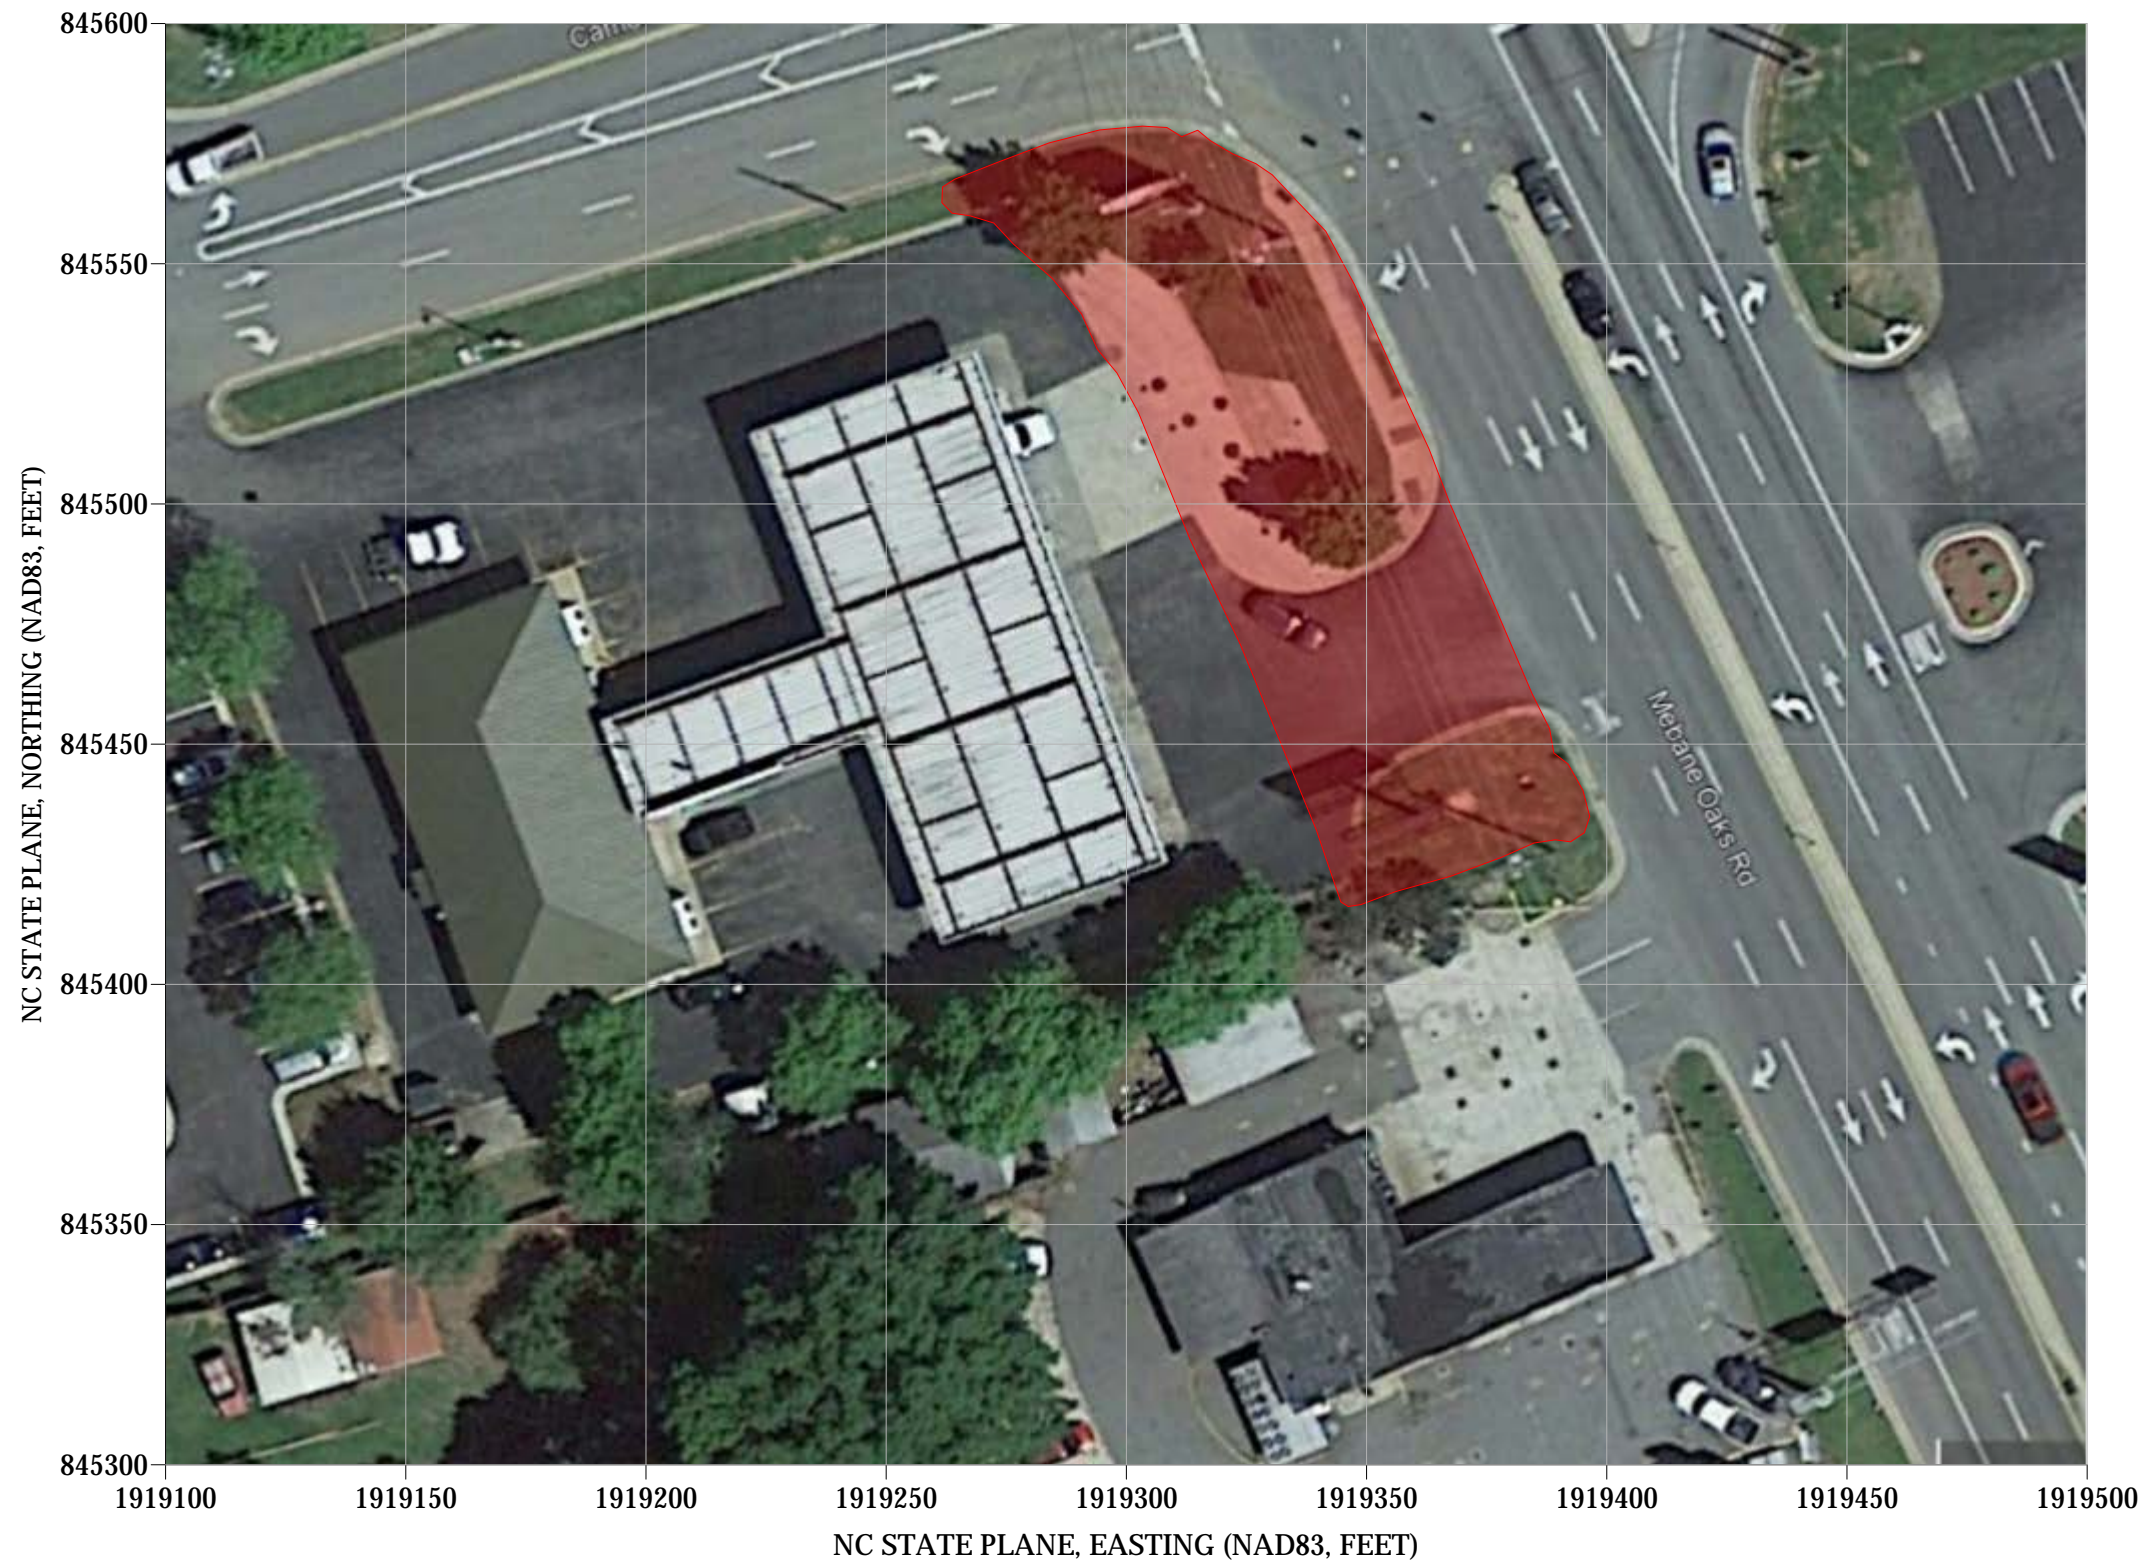
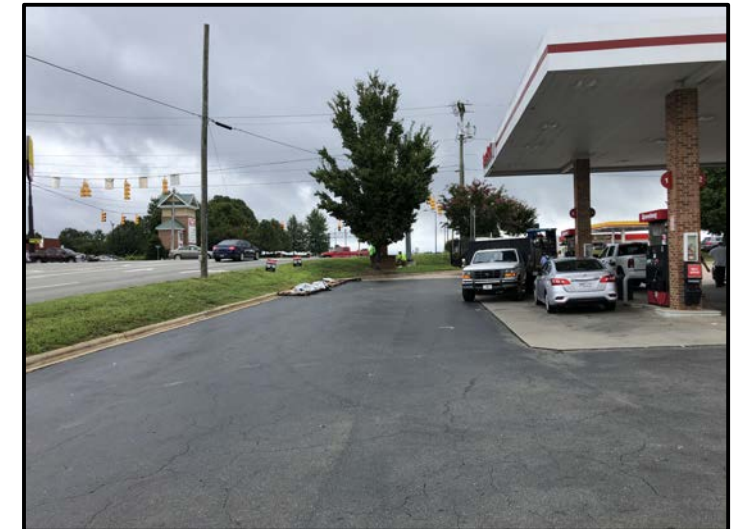
The site included an active gas station surrounded by concrete, asphalt, and grass surfaces. Three known USTs were observed within the geophysical survey area during the investigation. An aerial photograph showing the survey area boundaries and ground-level photographs are shown in **Figure 1**.

APPROXIMATE BOUNDARIES OF GEOPHYSICAL SURVEY AREA

View of Survey Area
(Facing Approximately East)

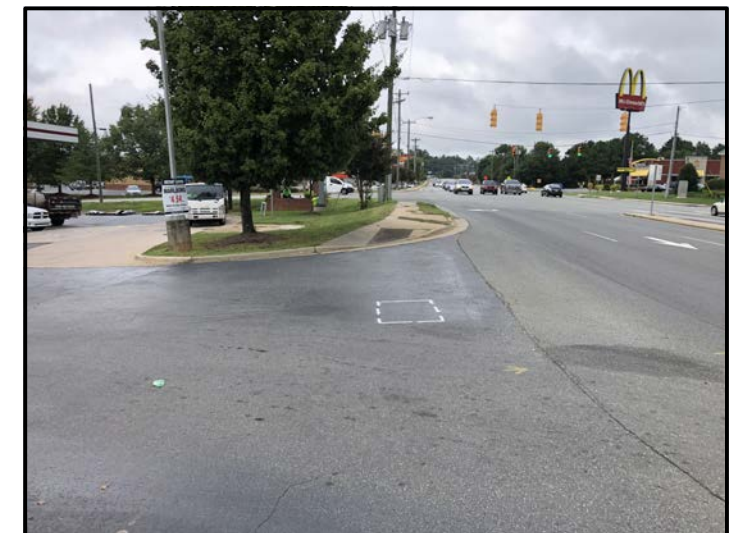
View of Survey Area
(Facing Approximately North)

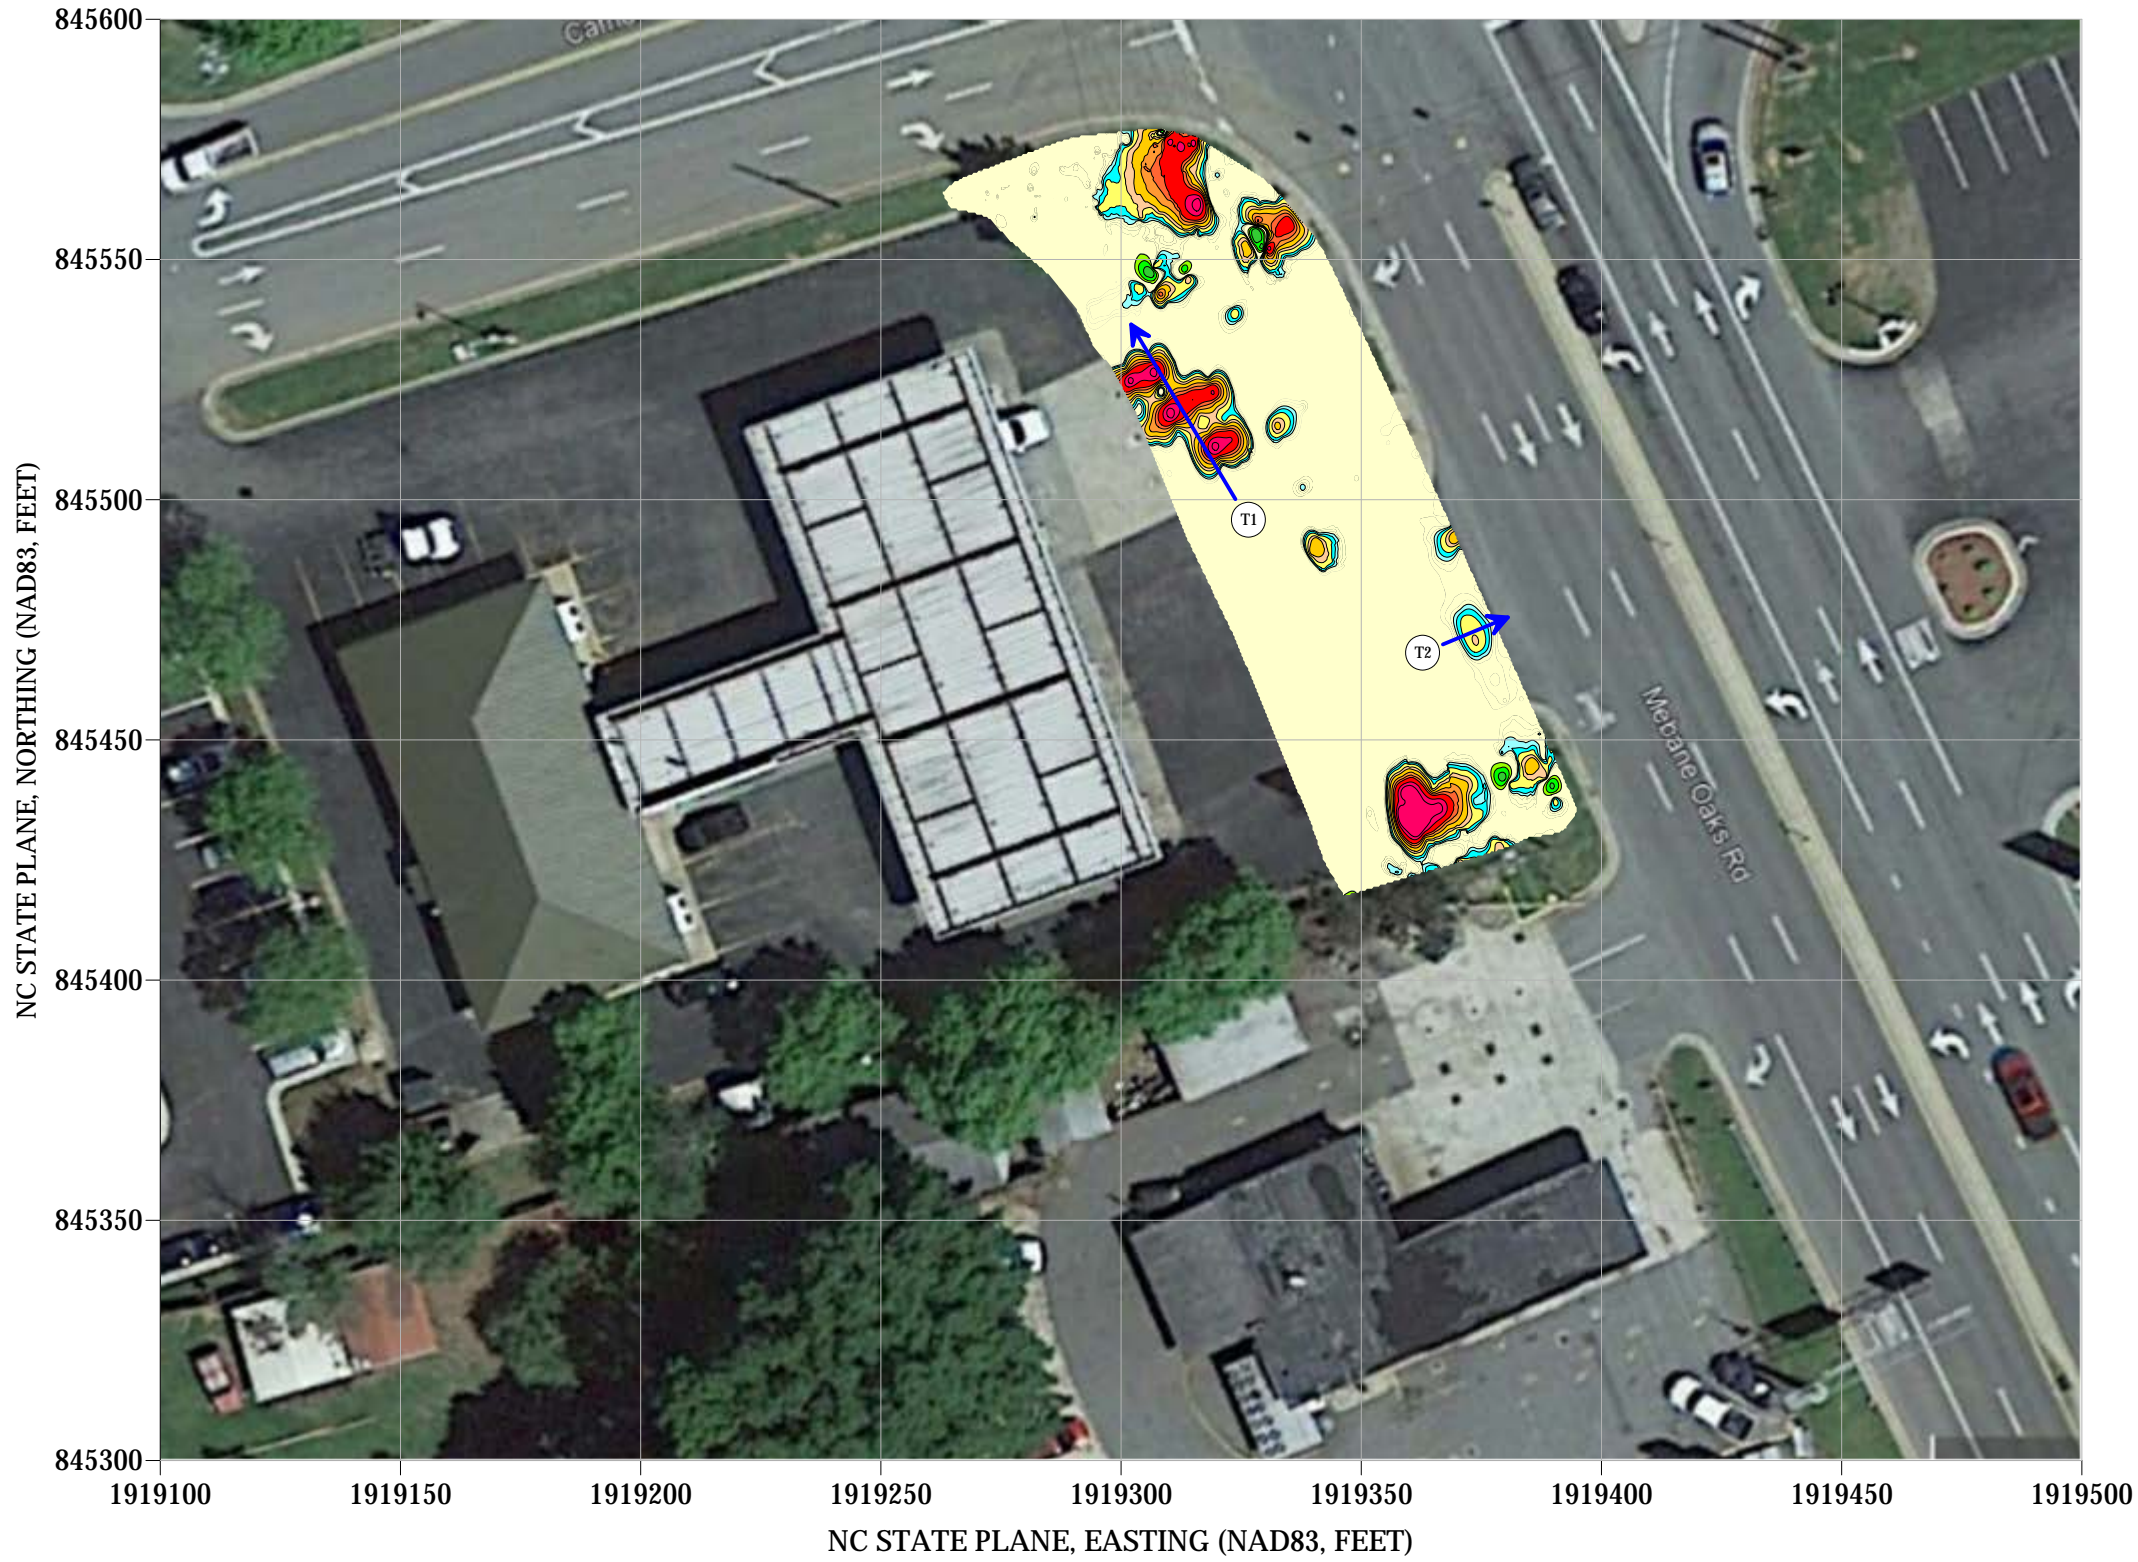
LOCATIONS OF GPR TRANSECTS

*EXTENSIVE GPR SCANS WERE CONDUCTED OVER THE ENTIRE SITE. TRANSECT LINES ON THE MAP ABOVE INDICATE LOCATIONS WHERE DATA WERE SAVED. THESE LOCATIONS WERE CHOSEN TO HIGHLIGHT STRUCTURES IDENTIFIED IN THE SUBSURFACE OR TRANSECTS THAT ARE REPRESENTATIVE OF GENERAL SUBSURFACE CONDITIONS.

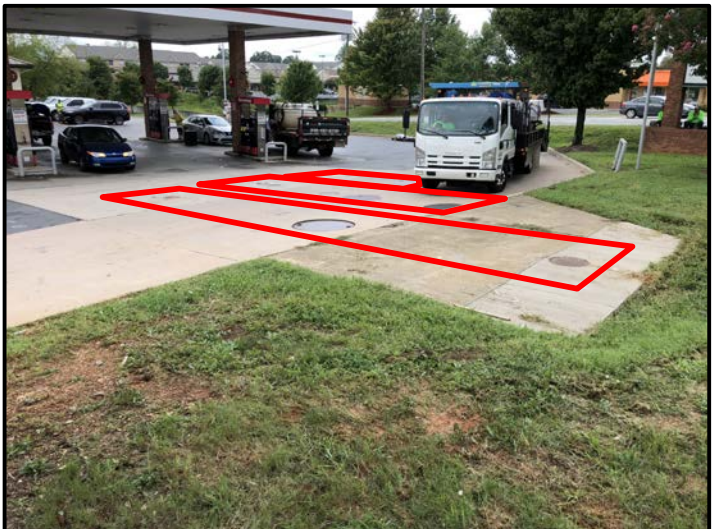
View of Three Known USTs Facing Approximately North

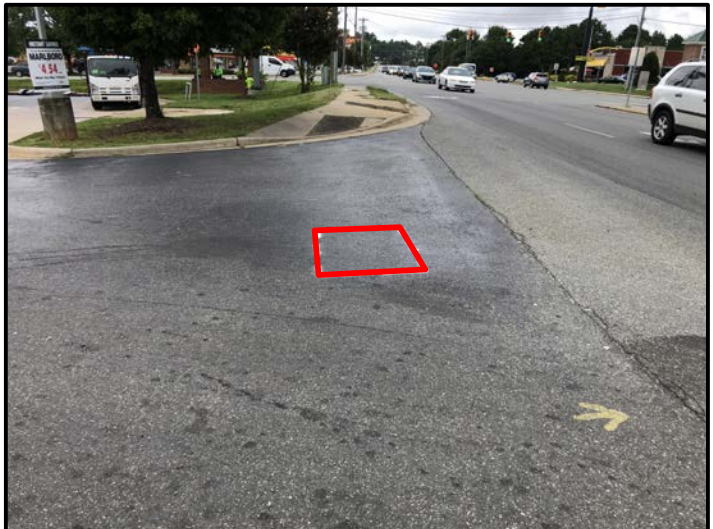
View of One No Confidence Anomaly Facing Approximately North
