Pyramid Environmental & Engineering, P.C. Project # 2018-242  
Preliminary Site Assessment (PSA) – Parcel 014 – MURPHY OIL, USA

**PRELIMINARY SITE ASSESSMENT**  
**PARCEL 014 – MURPHY OIL, USA**  
**1310 MEBANE OAKS ROAD**  
**MEBANE, ALAMANCE COUNTY, NORTH CAROLINA**  
**STATE PROJECT: I-5711**  
**WBS ELEMENT: 50401.1.FS1**  
**OCTOBER 22, 2018**

## METALLIC UST INVESTIGATION: PARCEL 14 NCDOT PROJECT I-5711 (50401.1.FS1)

1310 MEBANE OAKS ROAD, MEBANE, NC  
SEPTEMBER 17, 2018

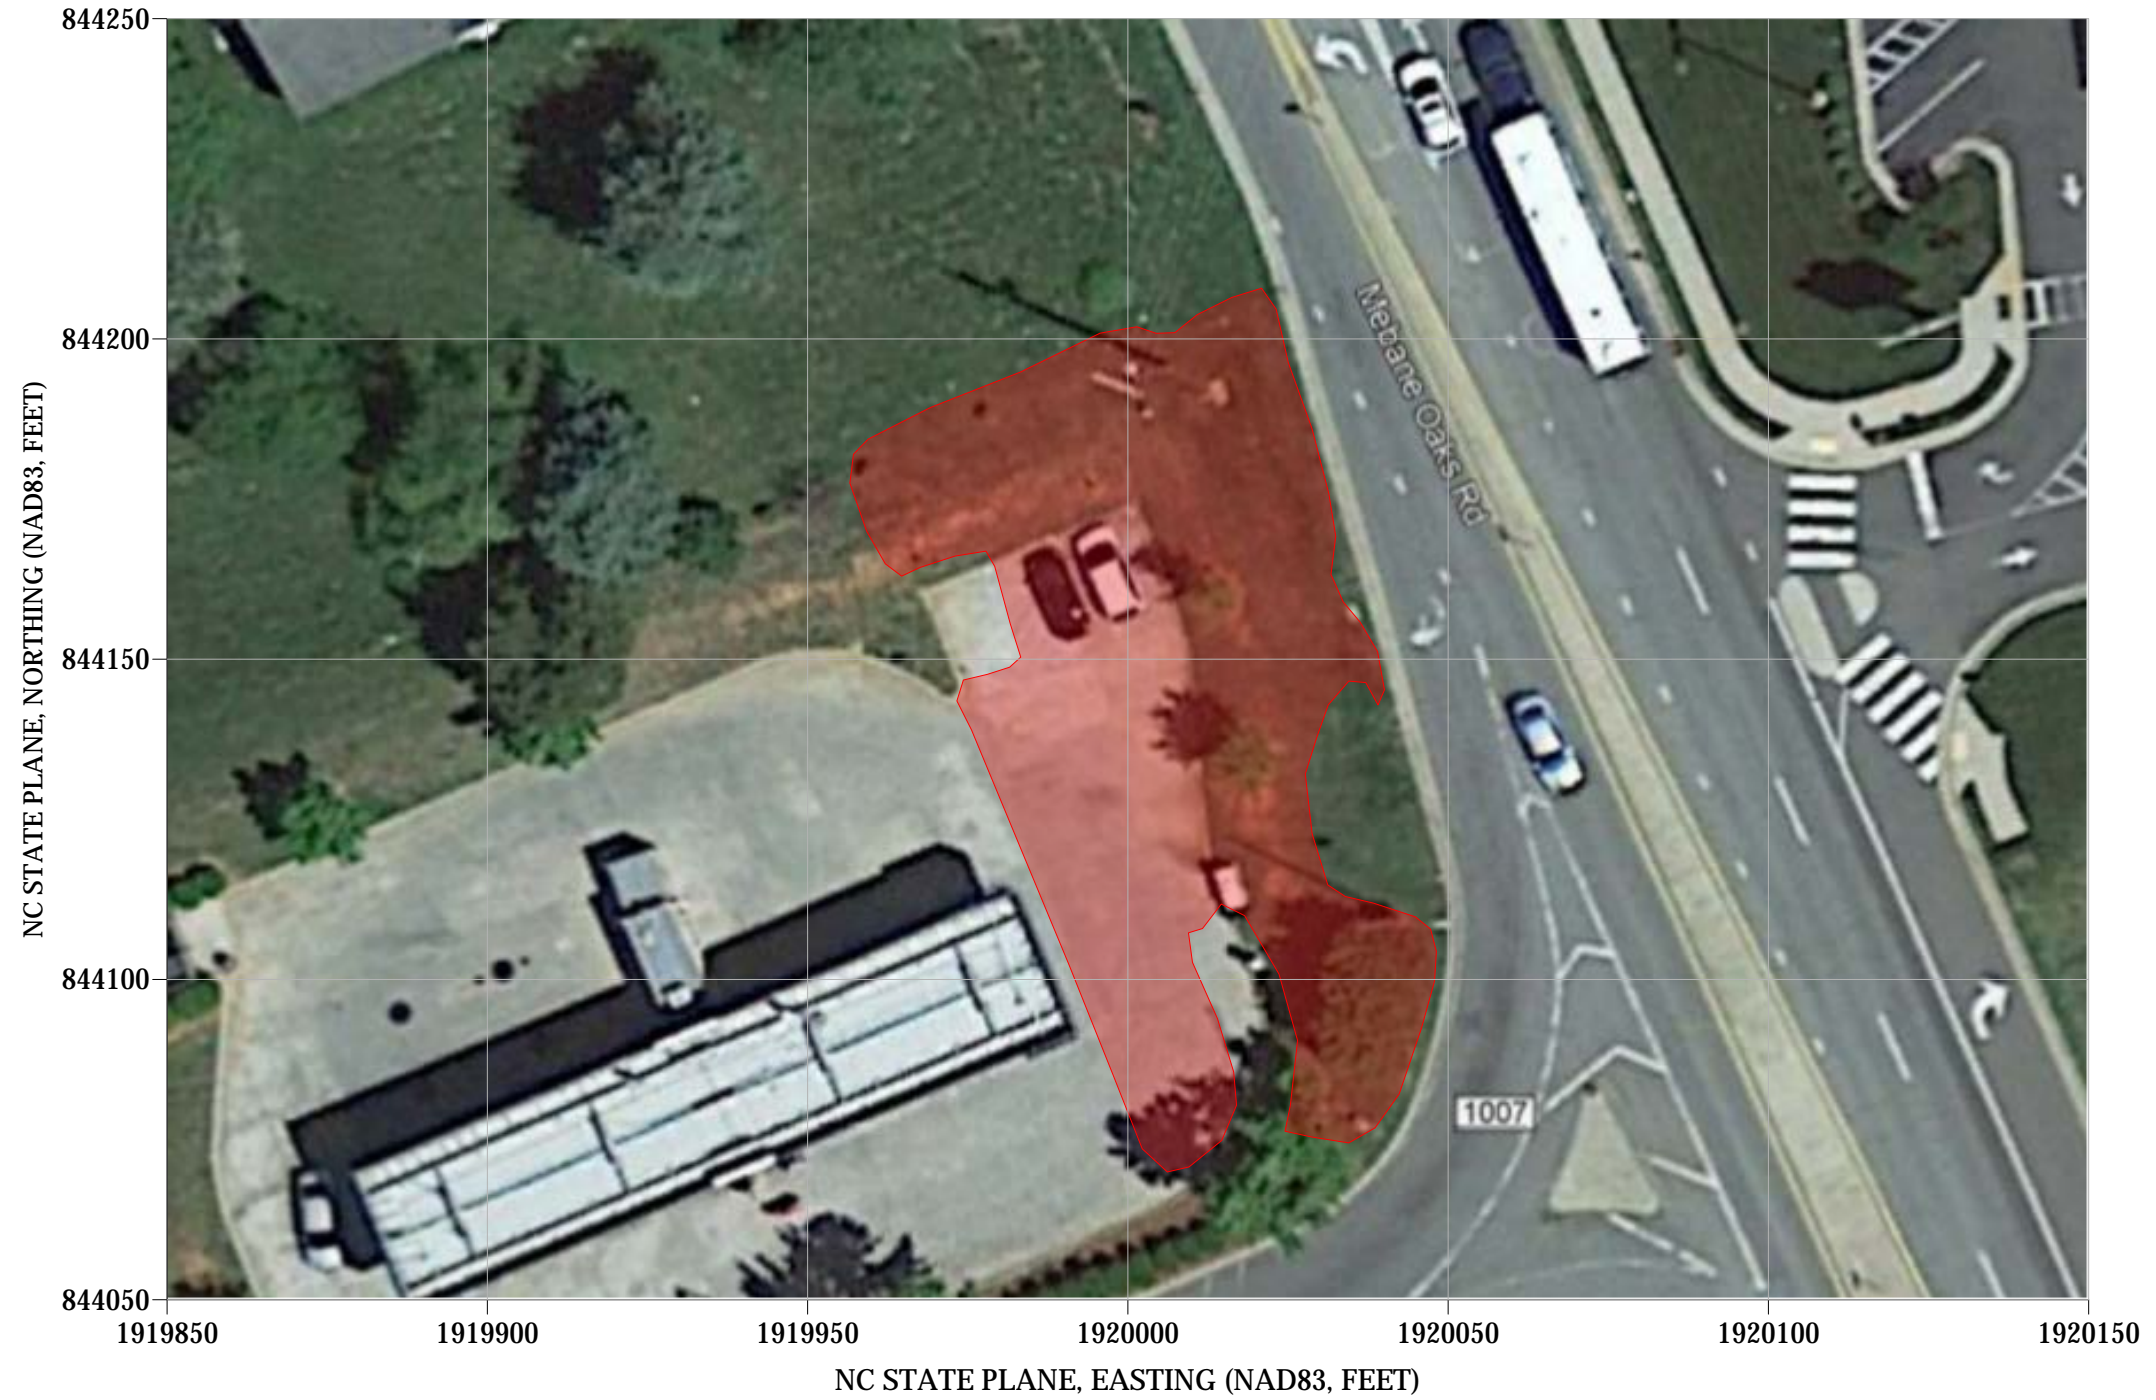
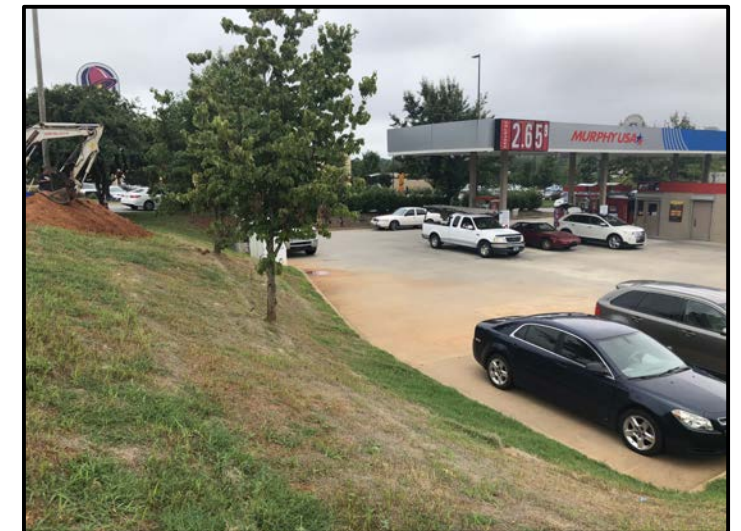
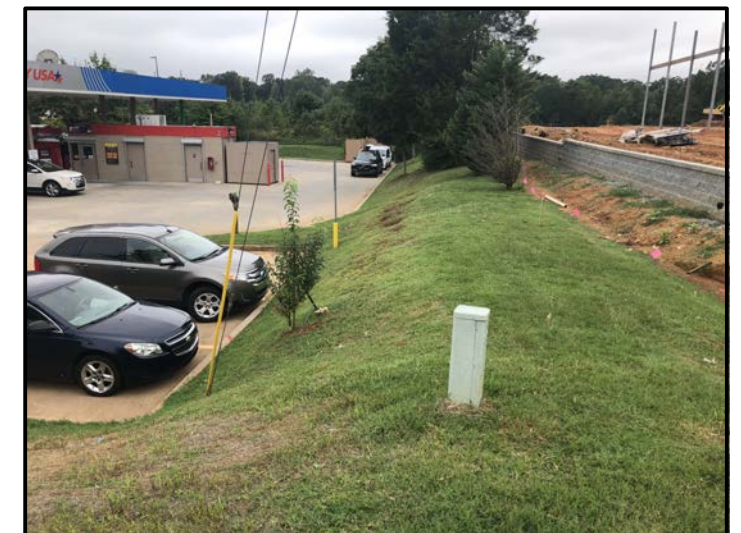
# APPROXIMATE BOUNDARIES OF GEOPHYSICAL SURVEY AREA

View of Survey Area  
(Facing Approximately South)

View of Survey Area  
(Facing Approximately West)

The site included an active gas station surrounded by concrete, asphalt, and grass surfaces. The known, active tanks supplying fuel to the gas station pumps were located outside of the geophysical survey area. It should be noted that construction/utility work and steep slopes prevented comprehensive coverage of the grass areas surrounding the perimeter of the survey area. An aerial photograph showing the survey area boundaries and ground-level photographs are shown in **Figure 1**.

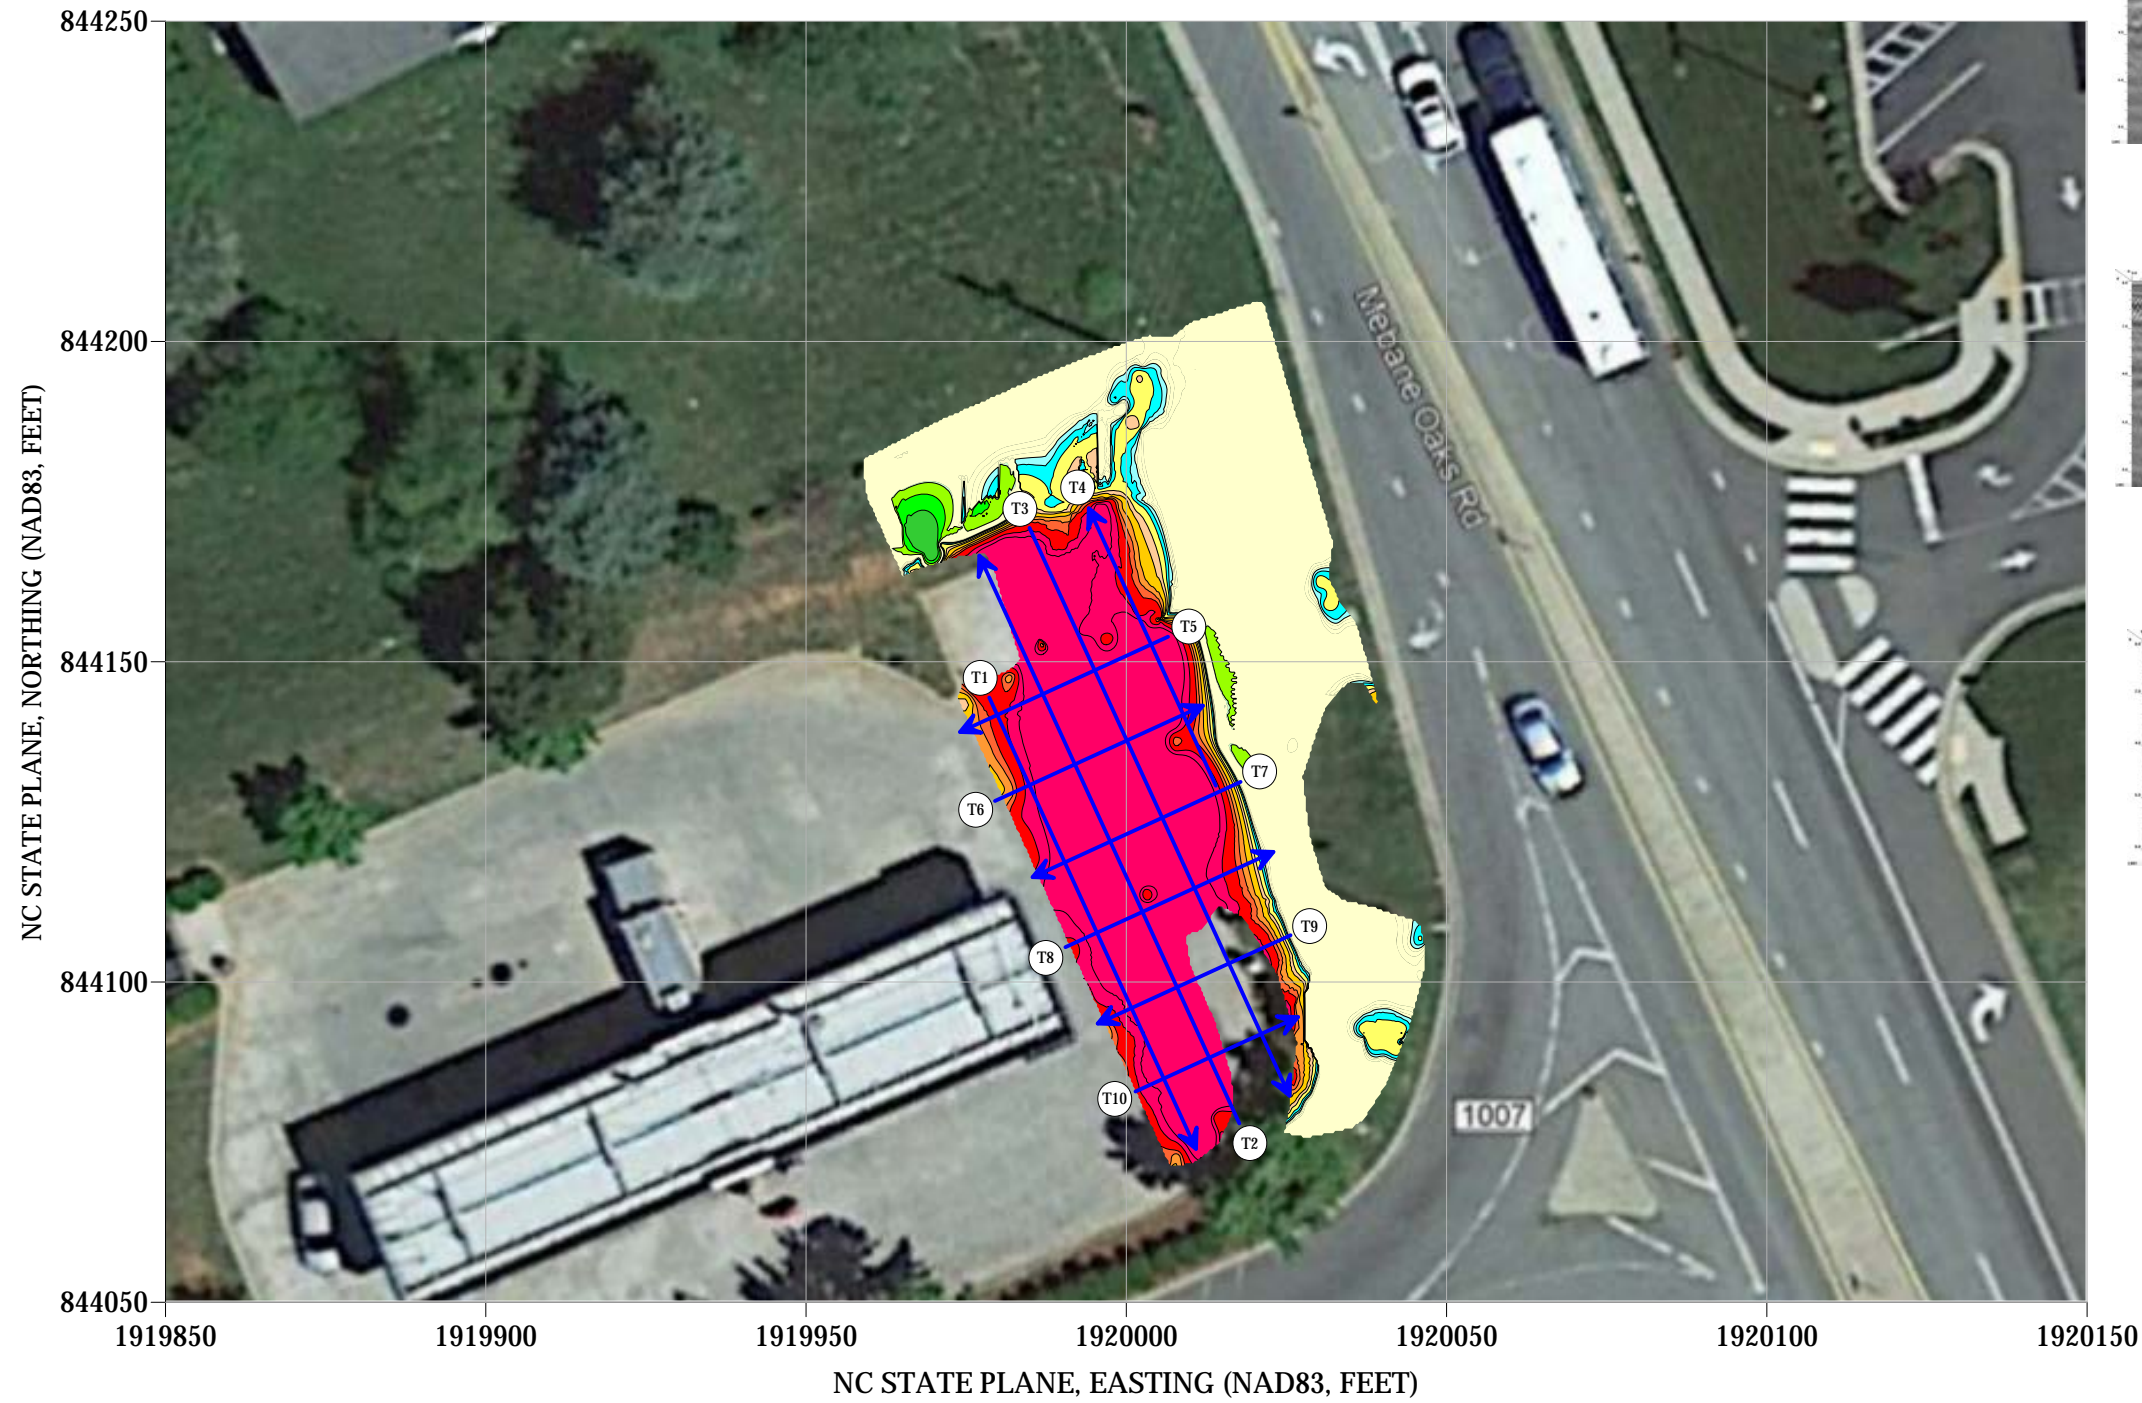
# LOCATIONS OF GPR TRANSECTS

GPR TRANSECT 1 (T1)

GPR TRANSECT 2 (T2)

GPR TRANSECT 3 (T3)

GPR TRANSECT 5 (T5)

\*EXTENSIVE GPR SCANS WERE CONDUCTED OVER THE ENTIRE SITE. TRANSECT LINES ON THE MAP ABOVE INDICATE LOCATIONS WHERE DATA WERE SAVED. THESE LOCATIONS WERE CHOSEN TO HIGHLIGHT STRUCTURES IDENTIFIED IN THE SUBSURFACE OR TRANSECTS THAT ARE REPRESENTATIVE OF GENERAL SUBSURFACE CONDITIONS.

**Figure 3** presents the locations of the formal GPR transects performed at the property, as well as select transect images. A total of ten GPR transects were performed at the site. All of the transect images are included in **Appendix A**. GPR Transects 1-10 were performed across the suspected reinforced concrete associated with EM Anomaly 5. These transects verified the presence of metal reinforcement in the concrete. No evidence of larger structures, such as USTs, was observed.
