# Preliminary Site Assessment Report

Myra Lee Hammonds Property

Parcel # 10

US 701 Bypass (Madisson St-Powell Blvd) from SR 1437 (Virgil Ave) to US 74/76

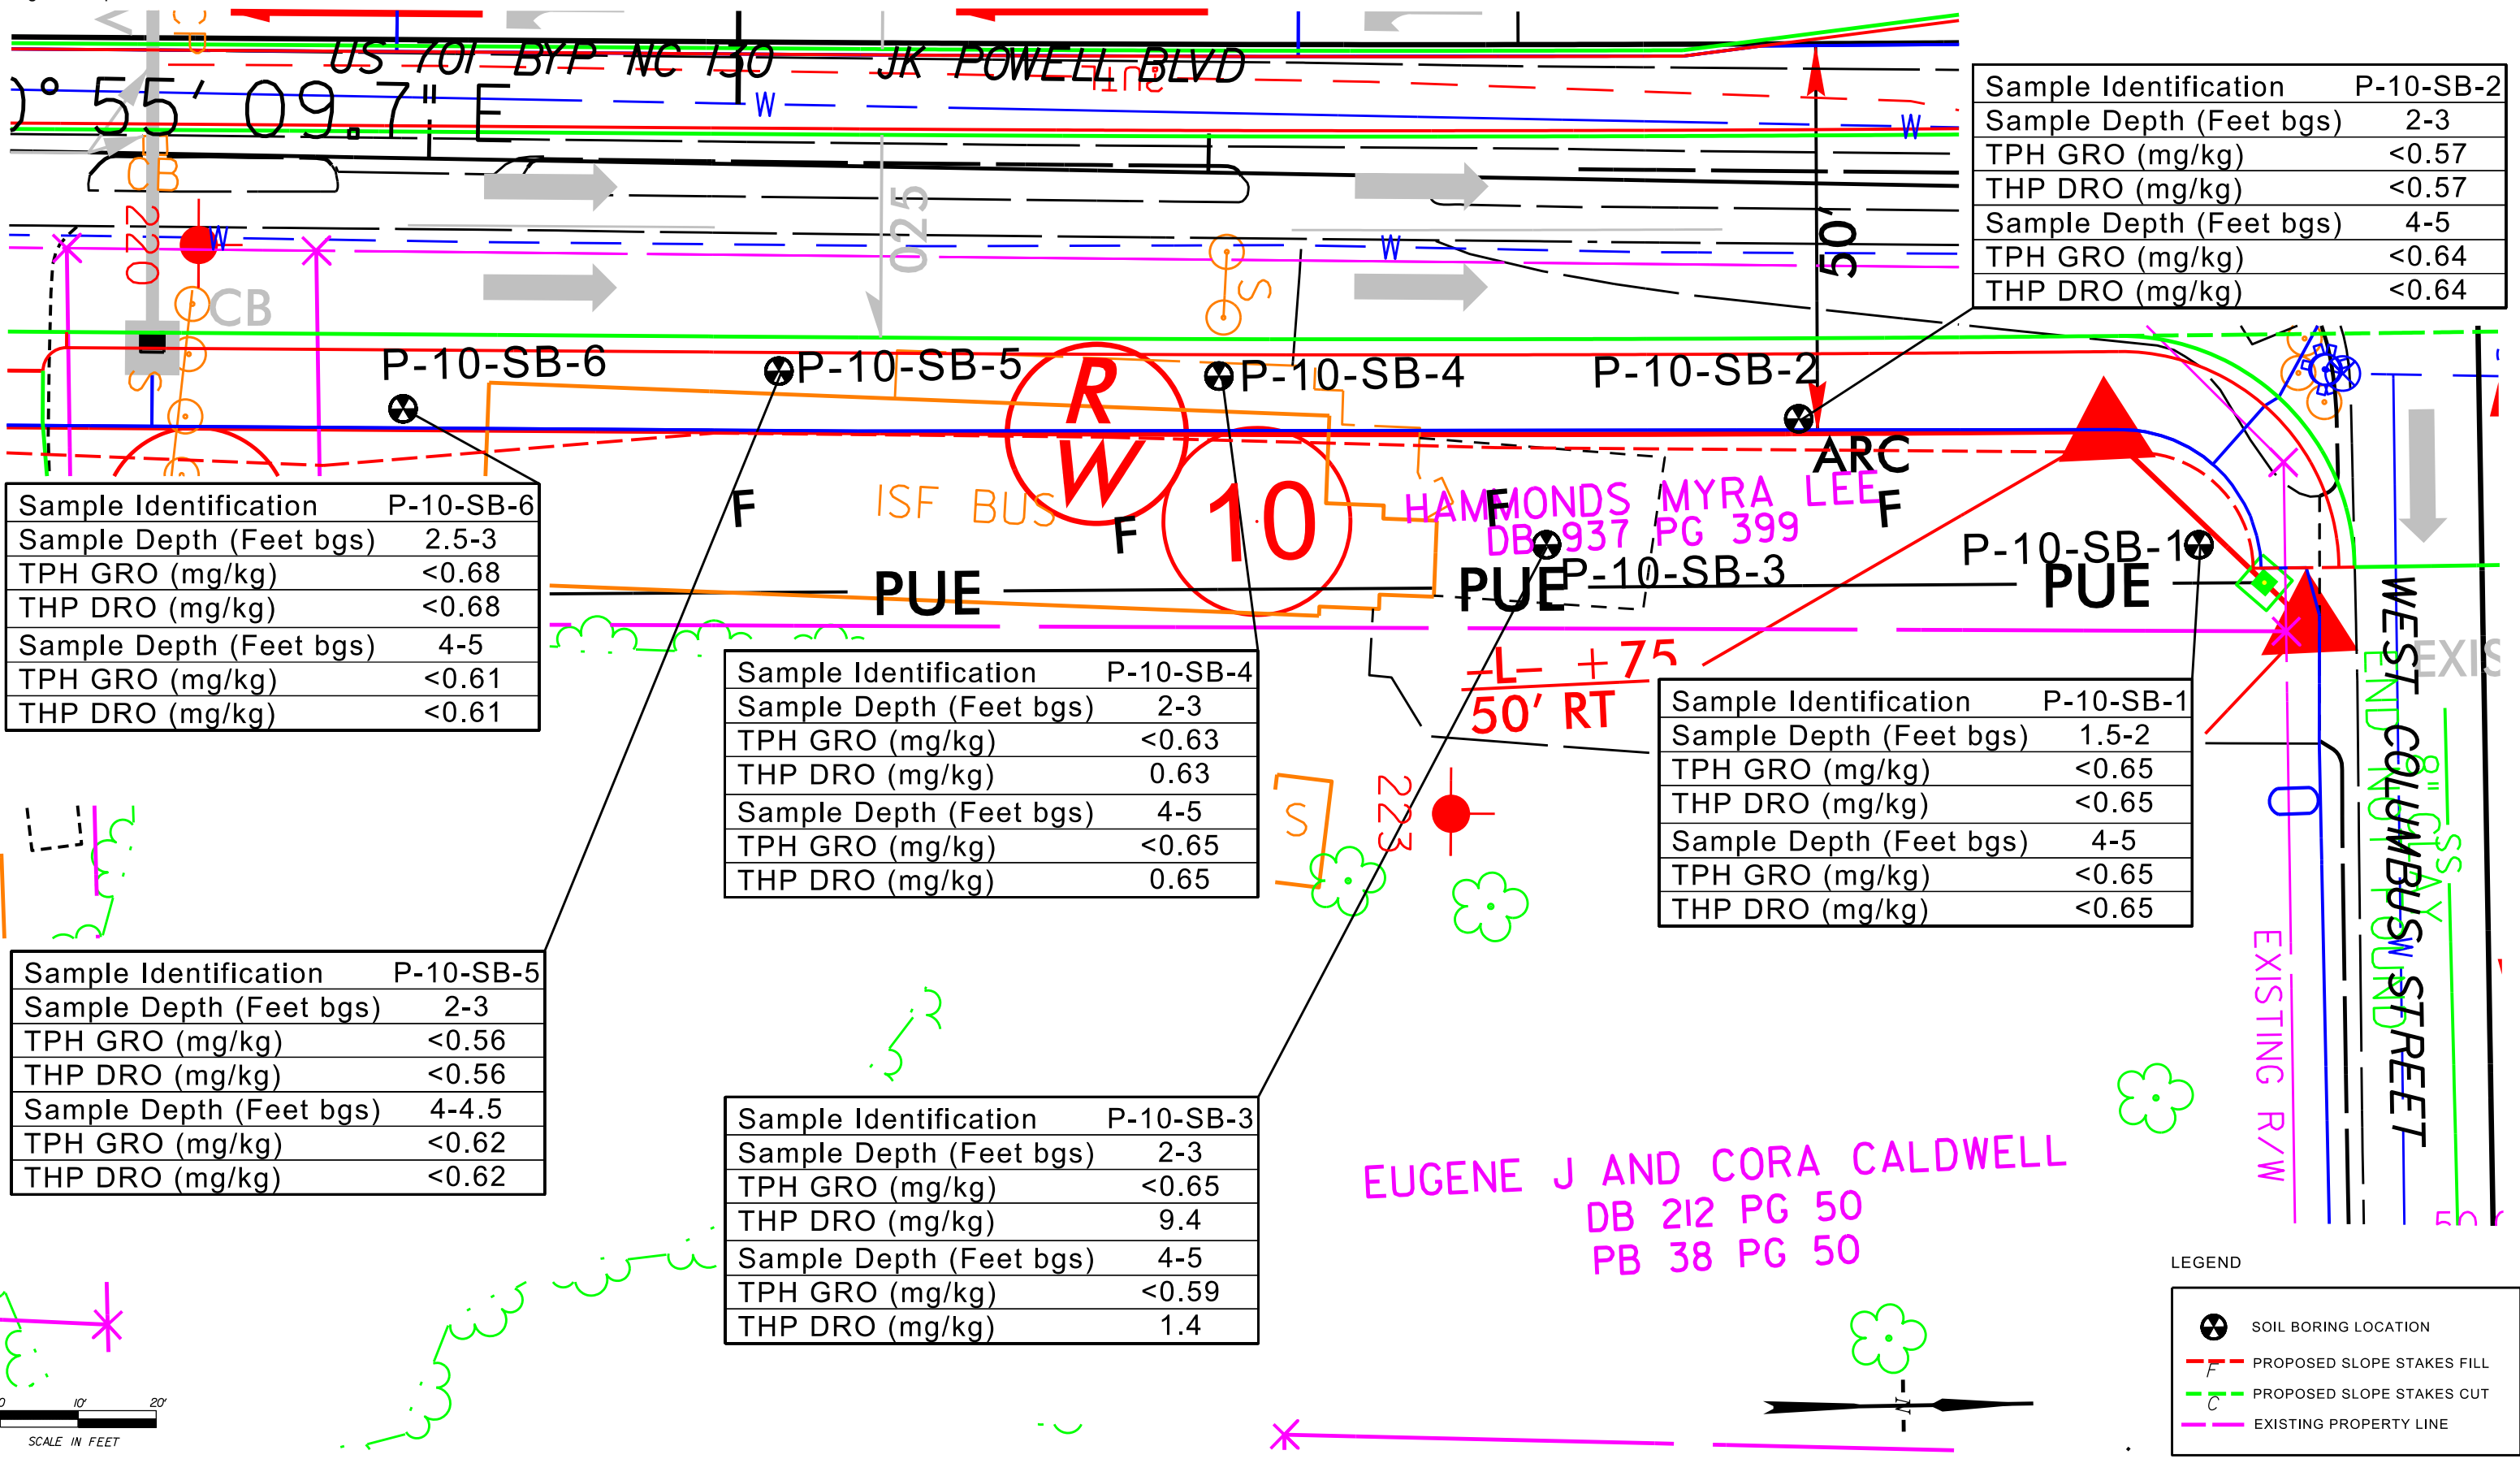
FIGURE 3  
 PARCEL 010  
 407 S. JK. POWELL BLVD.  
 ONSITE UVF HYDROCARBON ANALYSIS RESULTS - SOIL  
 6/7/18

Soil samples which exhibited the highest PID and/or FID concentrations were field analyzed using the UVF instrument for the presence of TPH gasoline range organics (GRO) and diesel range organics (DRO). The UVF analytical results for TPH-GRO and TPH-DRO are presented in **Table 1**. The UVF instrument generated tables and chromatographs in **Appendix D**. **Figure 3** presents the TPH-GRO and TPH-DRO results at each boring.

Based on the UVF analyses, TPH-GRO was not identified on Parcel 10 above detection limits. However, TPH-DRO was identified in soils on Parcel 10 at borings P10-SB3 and P10-SB4. TPH-DRO concentrations ranged from below detectable levels to 9.4 mg/kg (P-10-SB-3) in soils located above the smear zone and TPH-DRO concentrations ranged from below detectable levels to 1.4 mg/kg (P10-SB3) in soils located below the smear zone. TPH-GRO concentrations did not exceed the regulatory action level of 50 mg/kg and the TPH-DRO concentrations did not exceed the regulatory action level of 100 mg/kg.

Sample Identification	P-10-SB-2
Sample Depth (Feet bgs)	2-3
TPH GRO (mg/kg)	<0.57
THP DRO (mg/kg)	<0.57
Sample Depth (Feet bgs)	4-5
TPH GRO (mg/kg)	<0.64
THP DRO (mg/kg)	<0.64

Sample Identification	P-10-SB-6
Sample Depth (Feet bgs)	2.5-3
TPH GRO (mg/kg)	<0.68
THP DRO (mg/kg)	<0.68
Sample Depth (Feet bgs)	4-5
TPH GRO (mg/kg)	<0.61
THP DRO (mg/kg)	<0.61

Sample Identification	P-10-SB-4
Sample Depth (Feet bgs)	2-3
TPH GRO (mg/kg)	<0.63
THP DRO (mg/kg)	0.63
Sample Depth (Feet bgs)	4-5
TPH GRO (mg/kg)	<0.65
THP DRO (mg/kg)	0.65

Sample Identification	P-10-SB-1
Sample Depth (Feet bgs)	1.5-2
TPH GRO (mg/kg)	<0.65
THP DRO (mg/kg)	<0.65
Sample Depth (Feet bgs)	4-5
TPH GRO (mg/kg)	<0.65
THP DRO (mg/kg)	<0.65

Sample Identification	P-10-SB-5
Sample Depth (Feet bgs)	2-3
TPH GRO (mg/kg)	<0.56
THP DRO (mg/kg)	<0.56
Sample Depth (Feet bgs)	4-4.5
TPH GRO (mg/kg)	<0.62
THP DRO (mg/kg)	<0.62

Sample Identification	P-10-SB-3
Sample Depth (Feet bgs)	2-3
TPH GRO (mg/kg)	<0.65
THP DRO (mg/kg)	9.4
Sample Depth (Feet bgs)	4-5
TPH GRO (mg/kg)	<0.59
THP DRO (mg/kg)	1.4

Based on these PSA results, Apex does not recommend further assessment or soil sampling in the area of investigation.

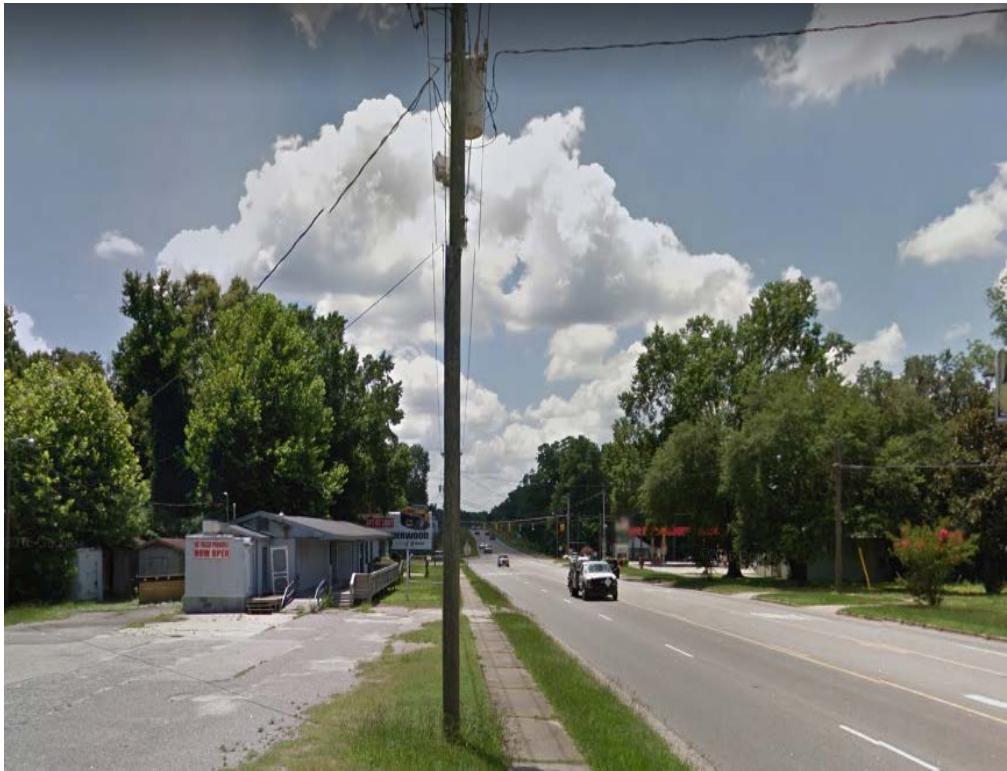
**Photo 1**

Overview of site prior to preliminary site assessment activities.

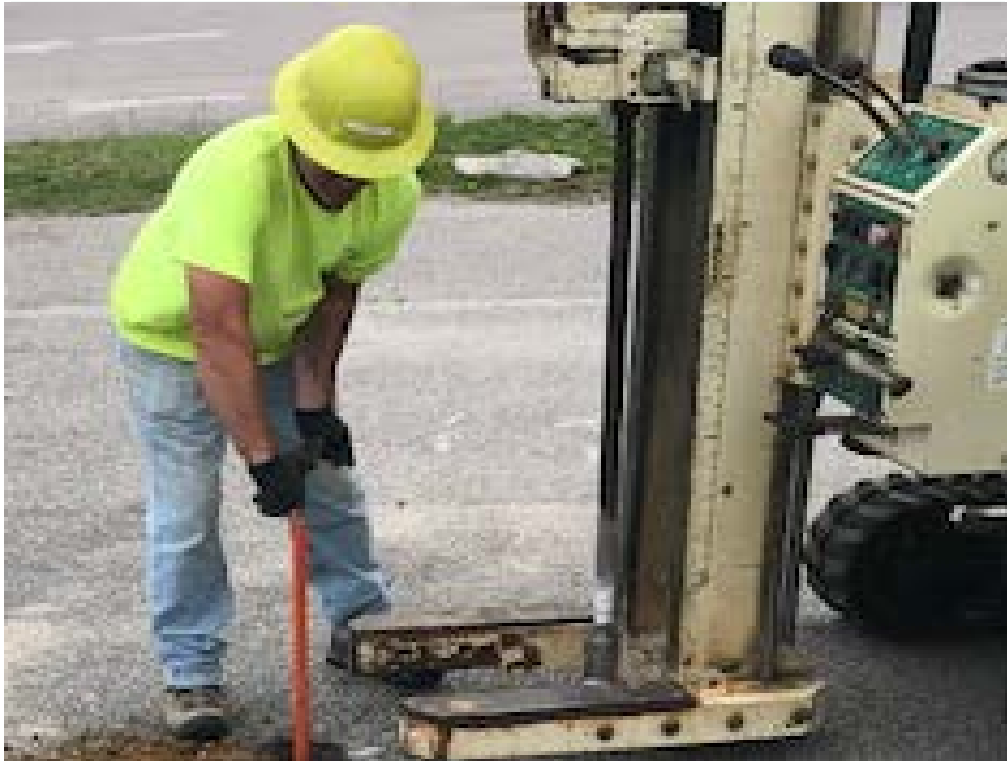
**Photo 2**

View shows CSI clearing for utilities prior to drilling.

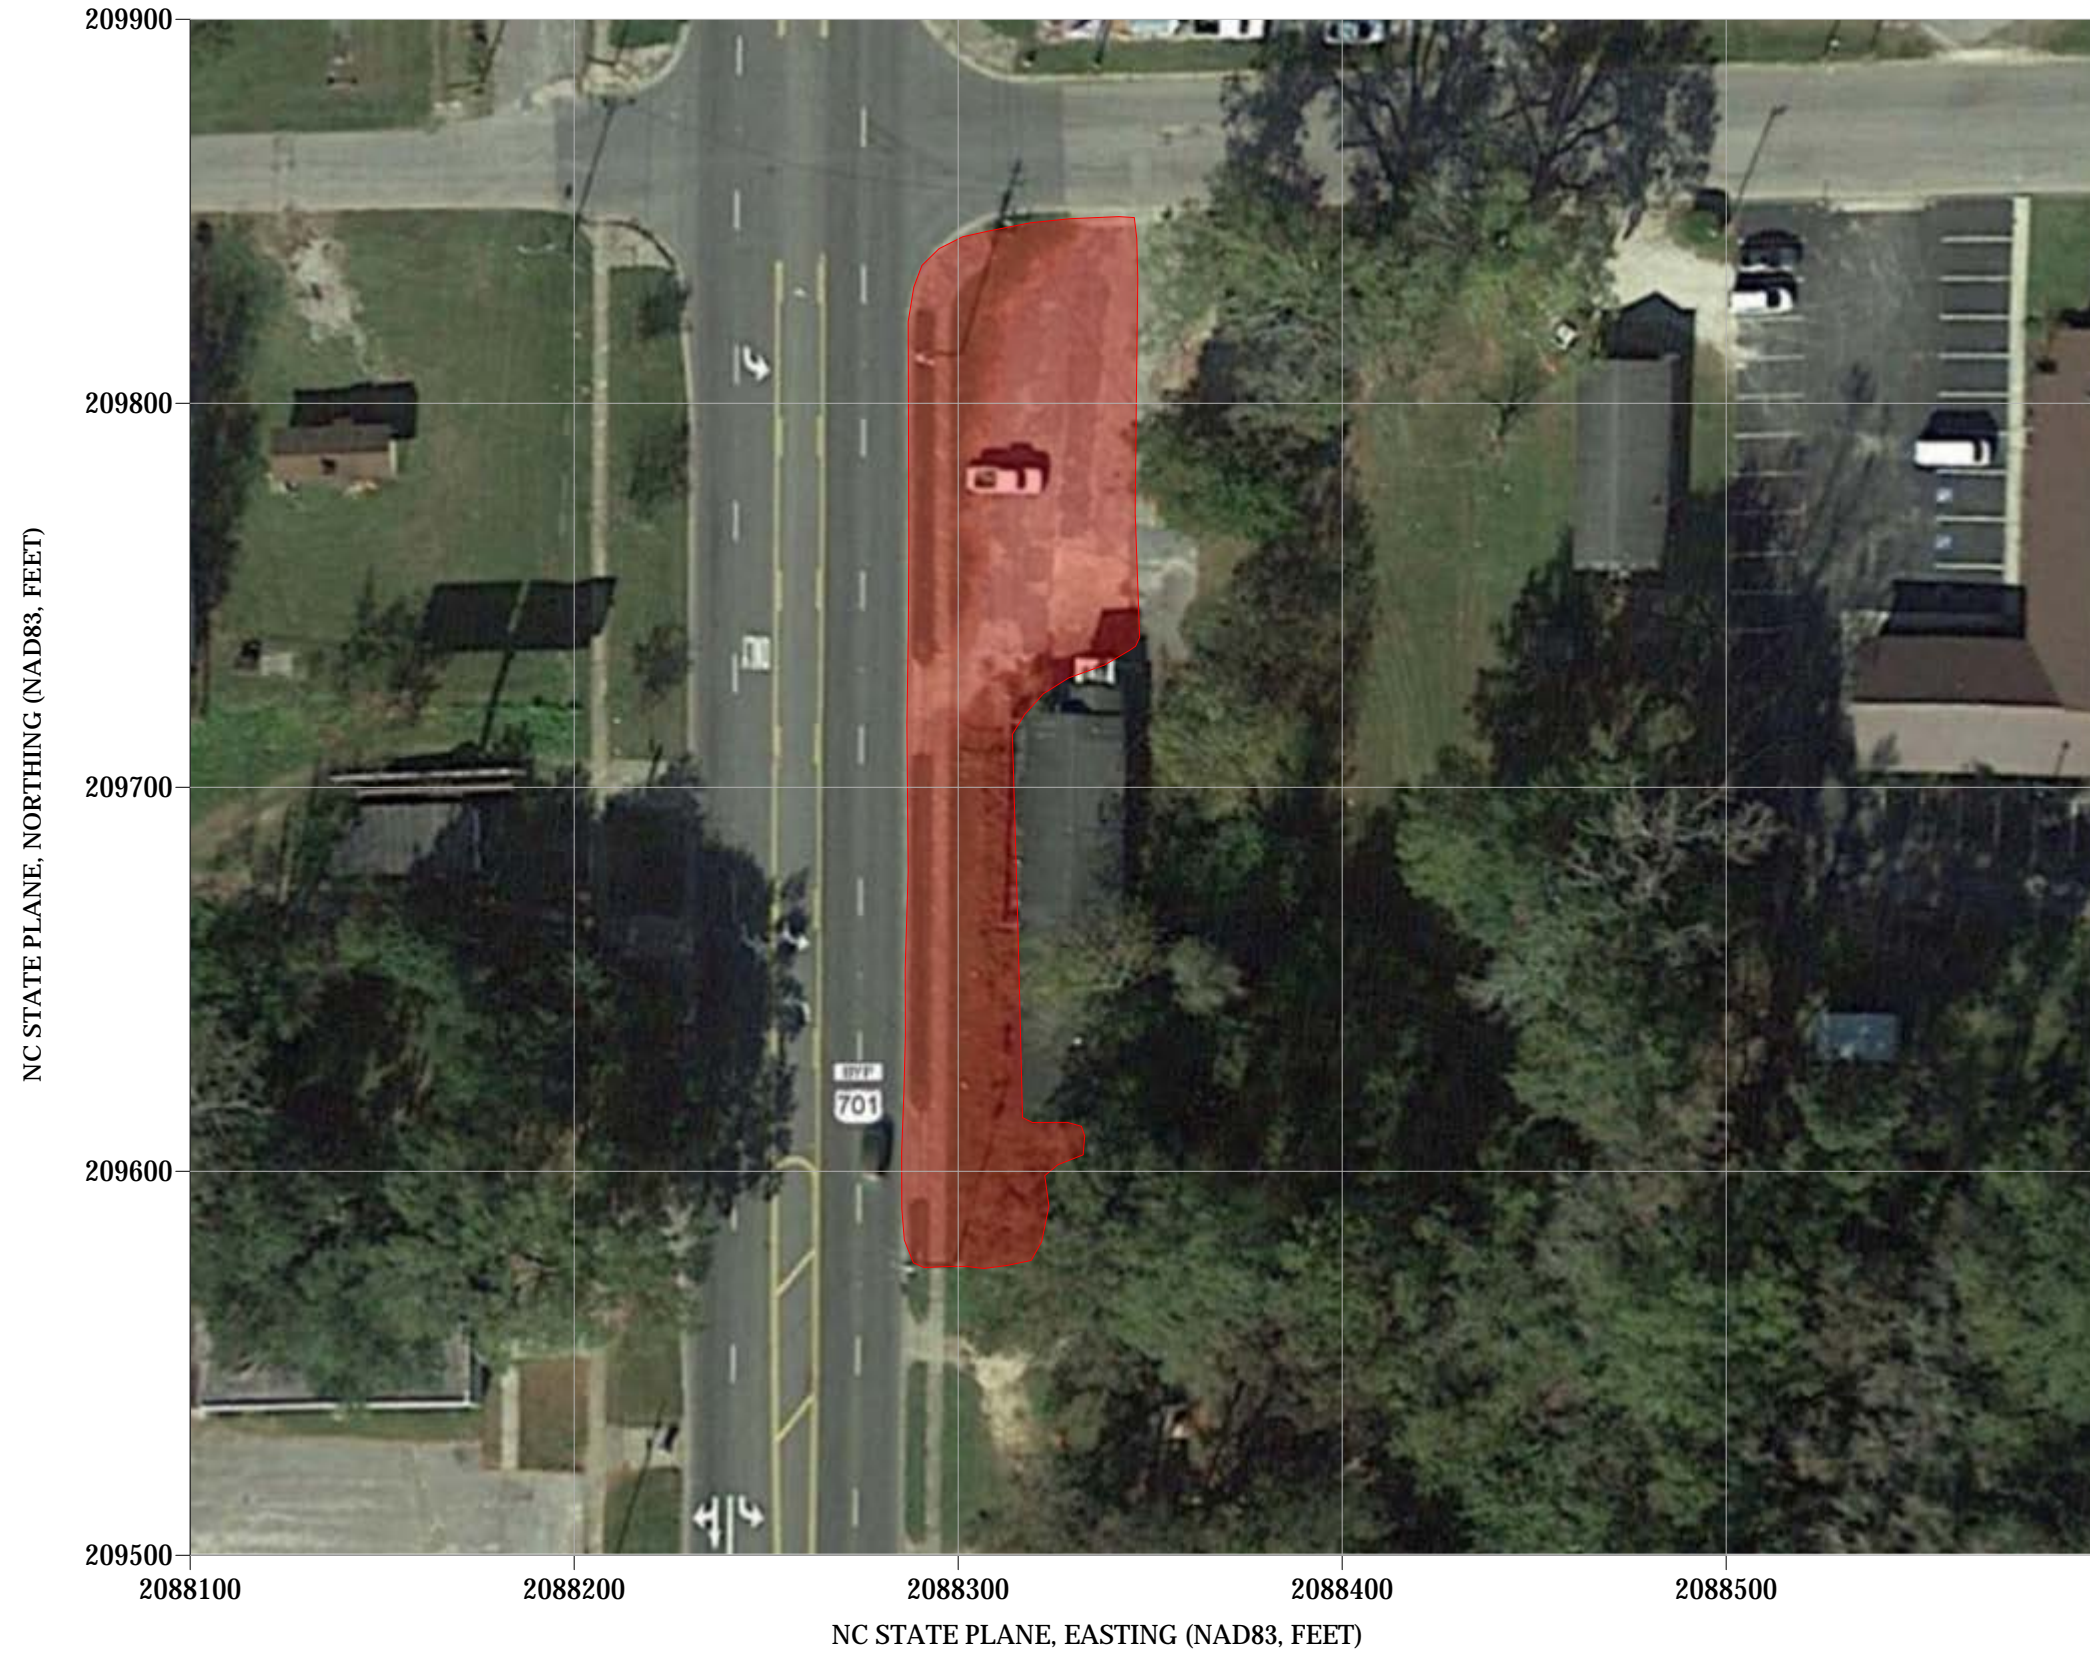
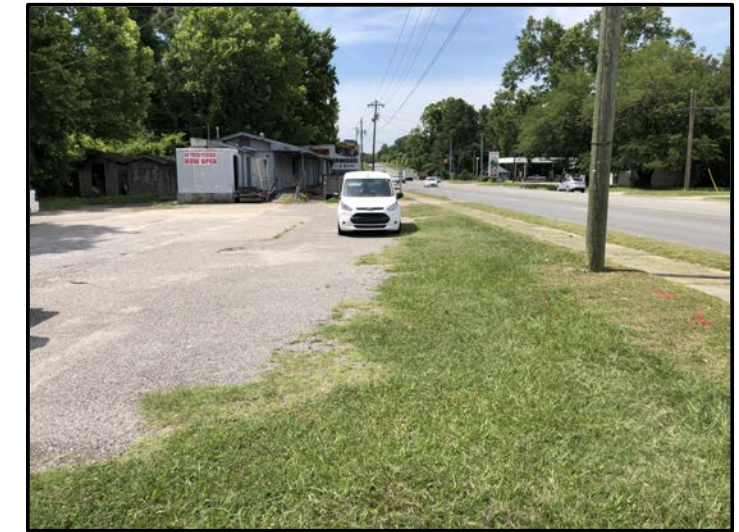
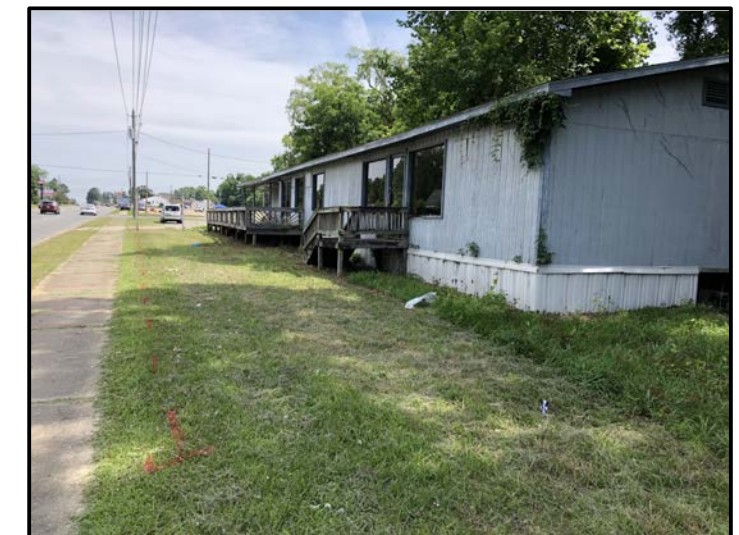
**FIGURE 1**

The site included an apparent former restaurant building surrounded by asphalt and grass surfaces. An aerial photograph showing the survey area boundaries and ground-level photographs are shown in **Figure 1**.

View of Survey Area  
(Facing Approximately South)

View of Survey Area  
(Facing Approximately North)

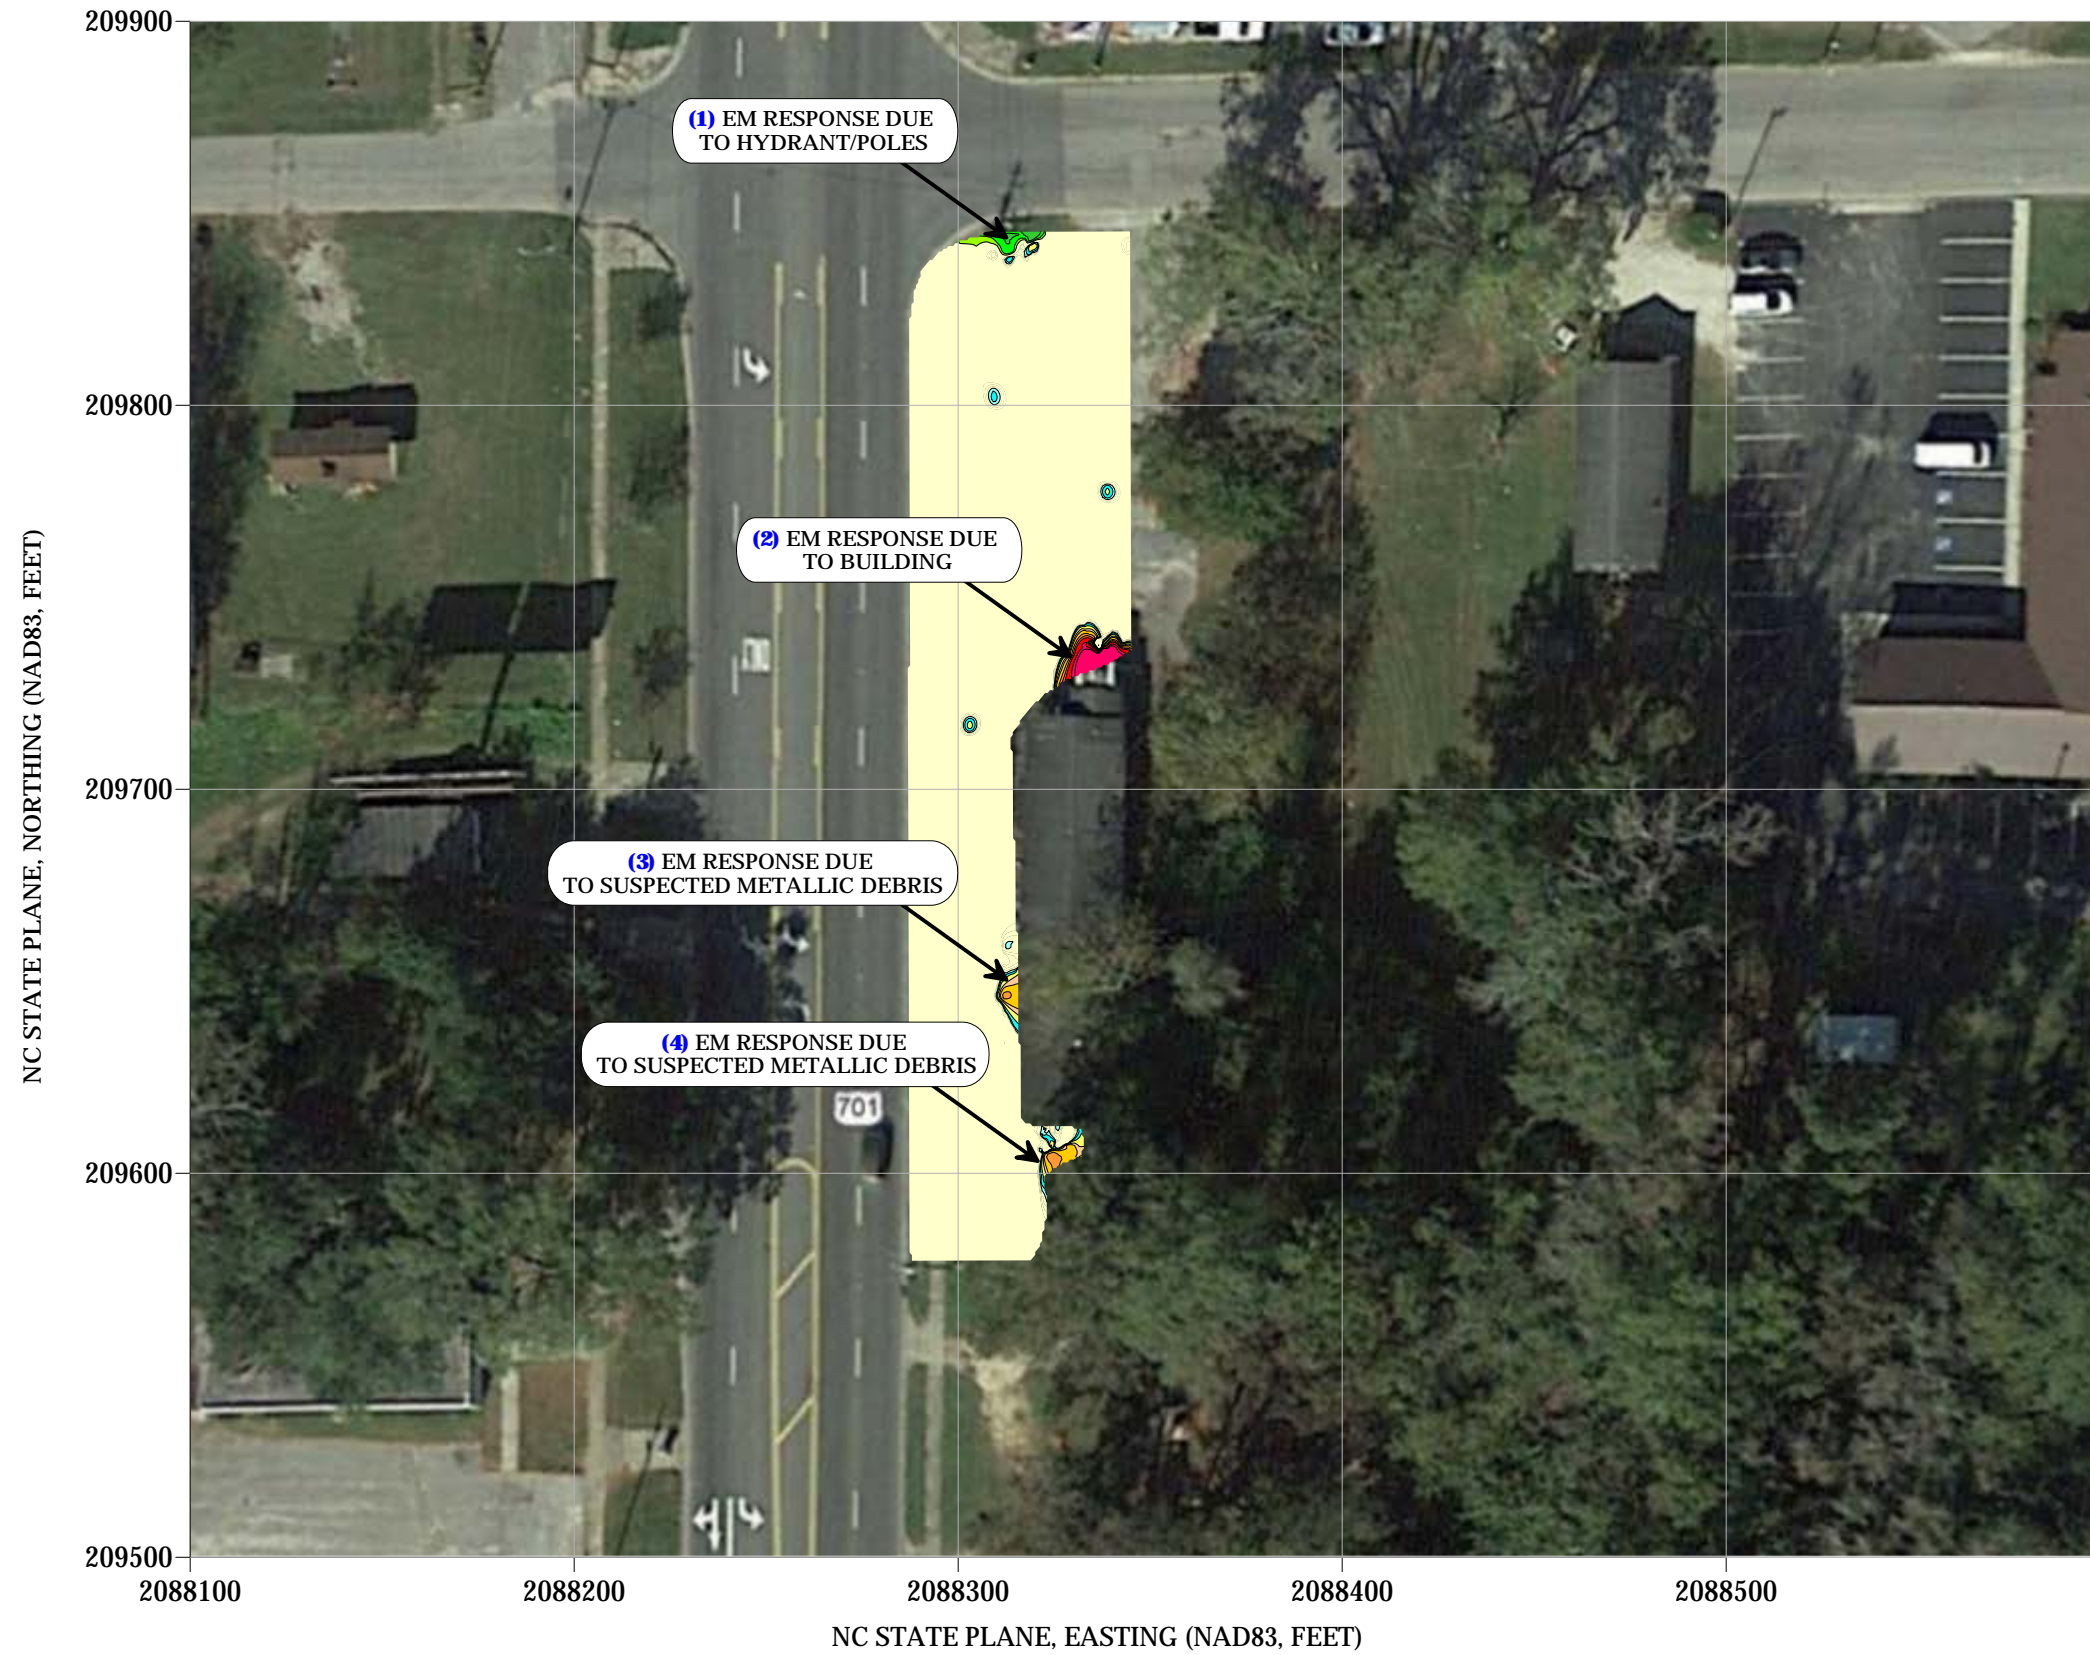
**FIGURE 2**

A contour plot of the EM61 results obtained across the survey area at the property is presented in **Figure 2**. Each EM anomaly is numbered for reference in the figure. The following table presents the list of EM anomalies and the cause of the metallic response, if known:

<b>Metallic Anomaly #</b>	<b>Cause of Anomaly</b>	<b>Investigated with GPR</b>
1	Hydrant/Poles	
2	Building	
3	Suspected Metallic Debris	✓
4	Suspected Metallic Debris	✓

**NO EVIDENCE OF UNKNOWN METALLIC USTs OBSERVED.**

The contour plot shows the differential results of the EM61 instrument in millivolts (mV). The differential results focus on larger metallic objects such as USTs and drums. The EM61 data were collected on May 30, 2018, using a Geonics EM61 instrument. Verification GPR data were collected using a GSSI UtilityScan DF instrument with a dual frequency 300/800 MHz antenna on June 5, 2018.

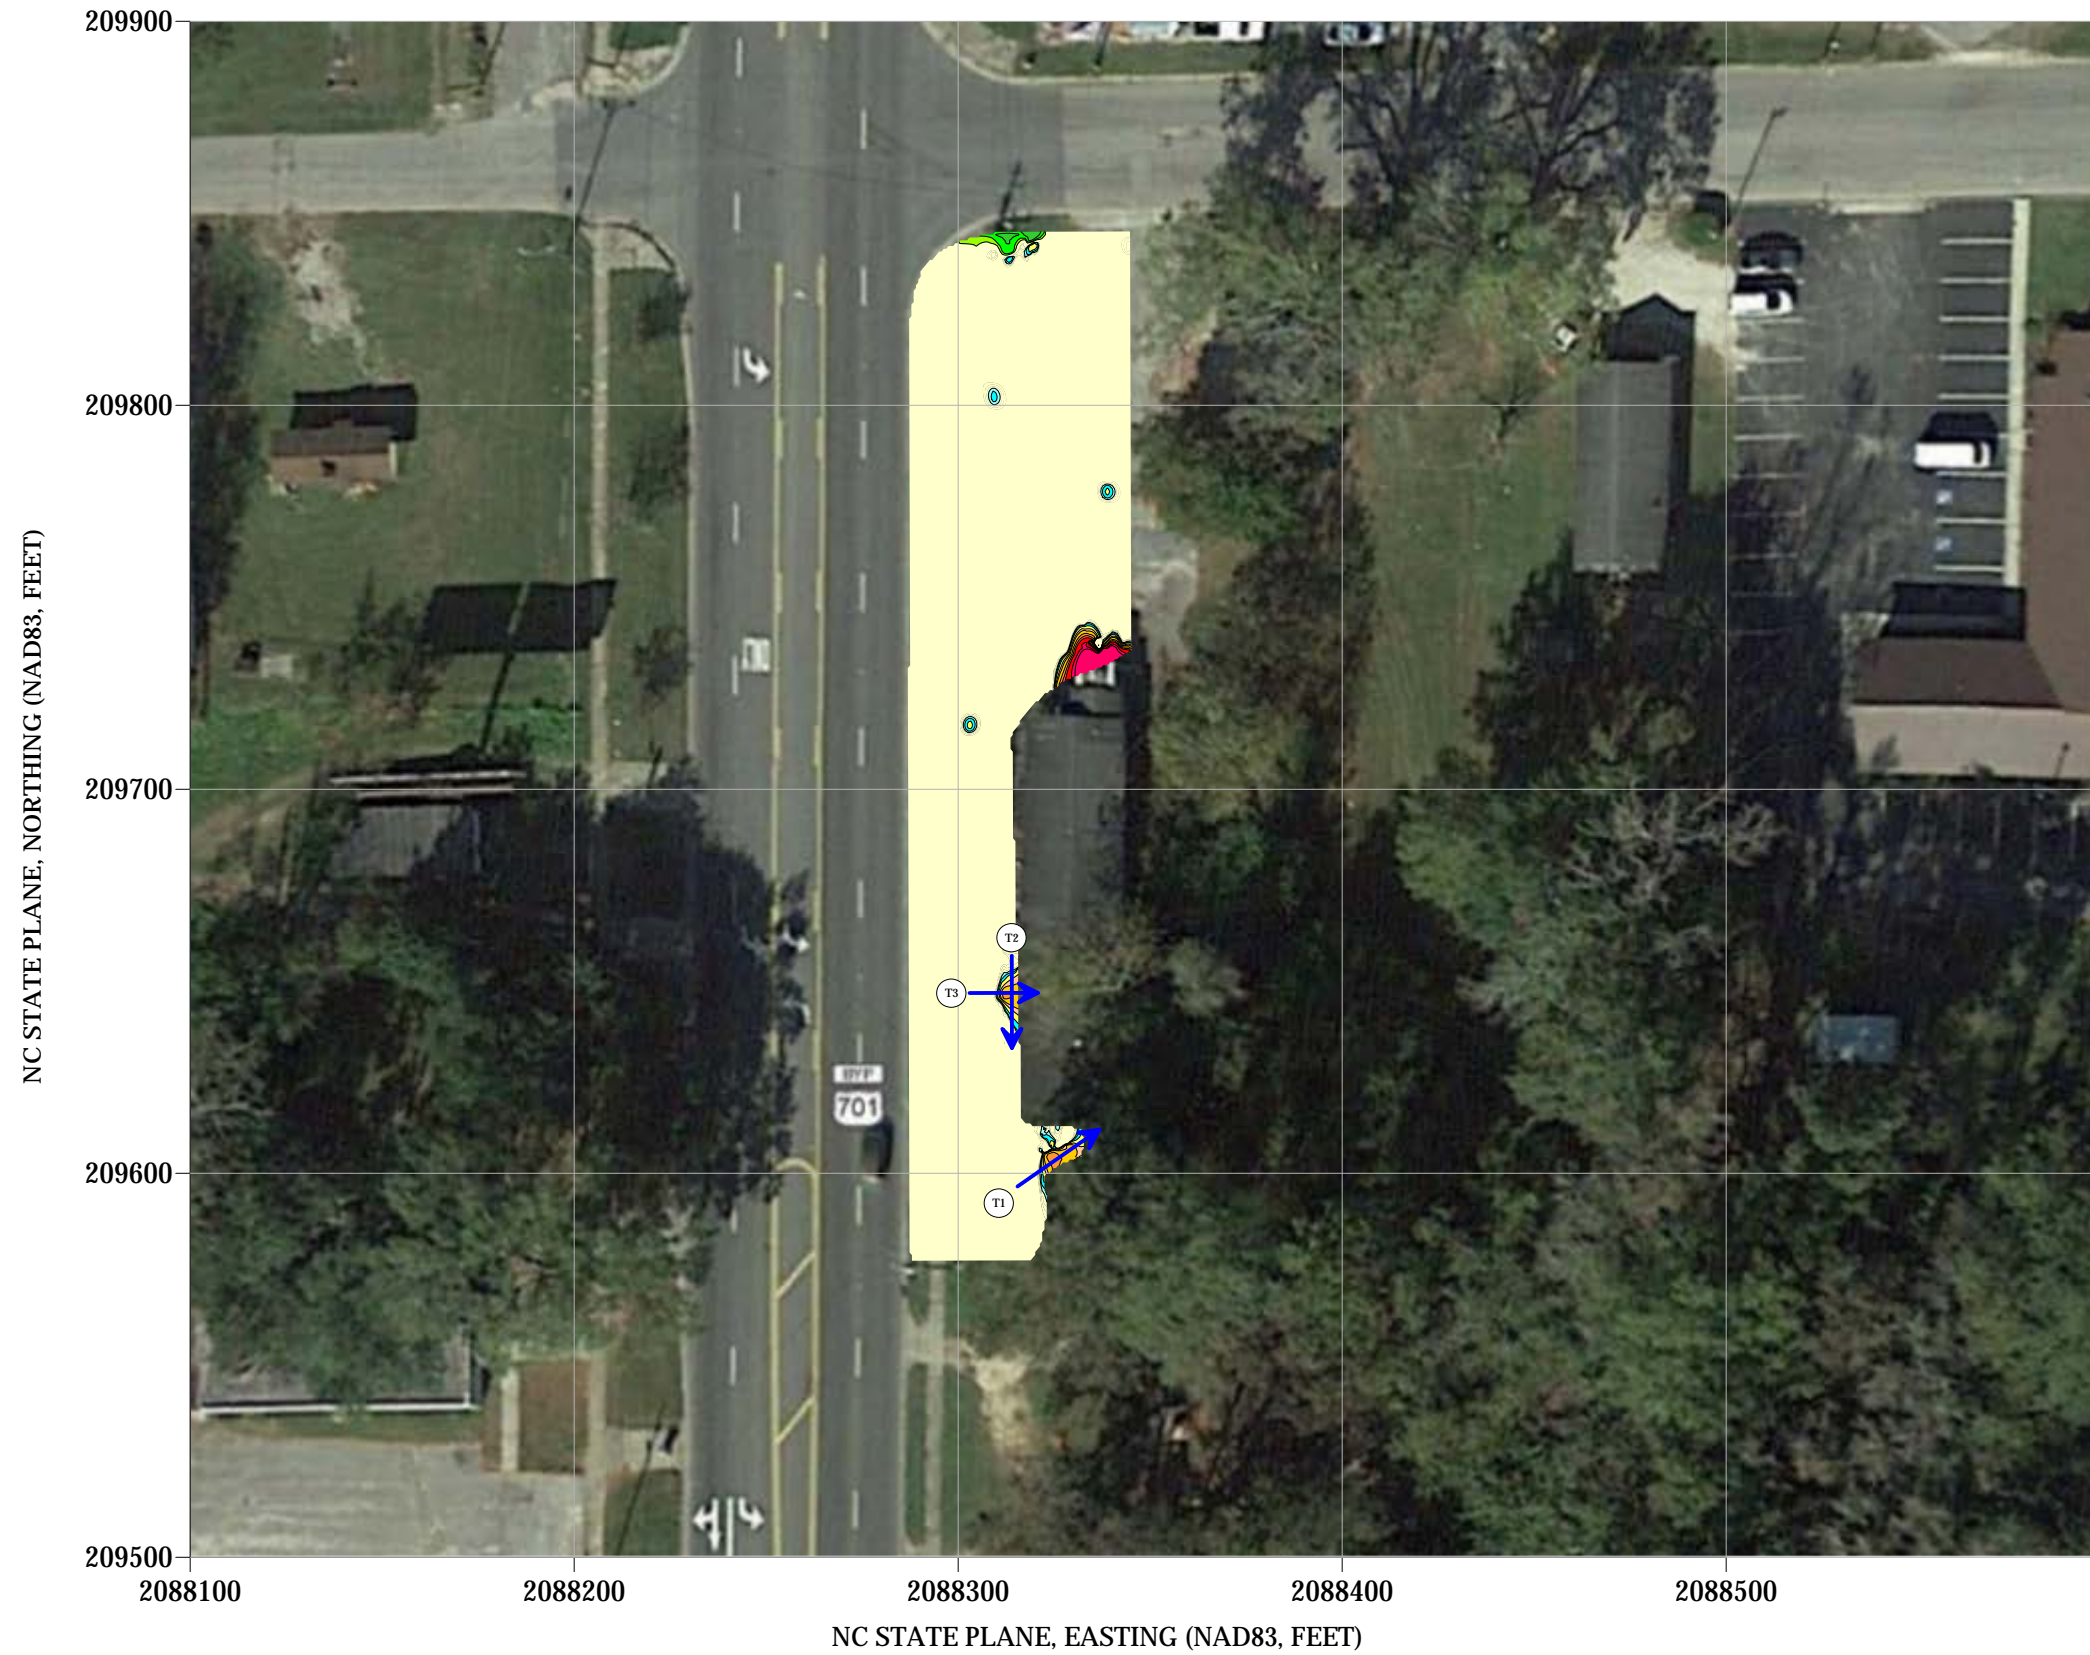
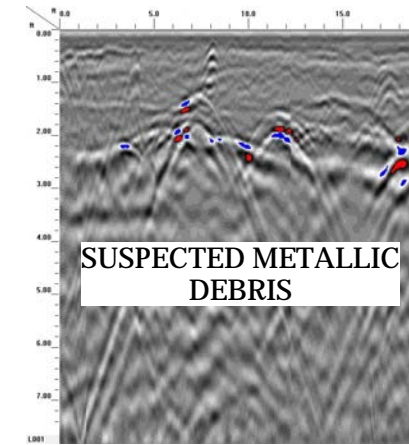
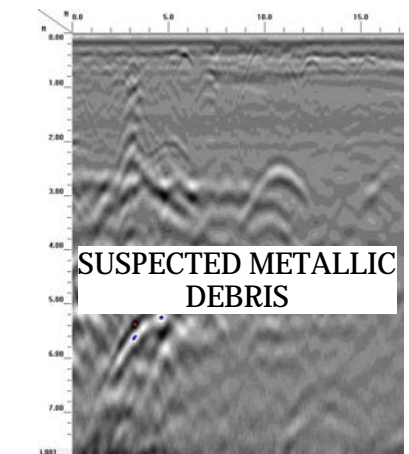
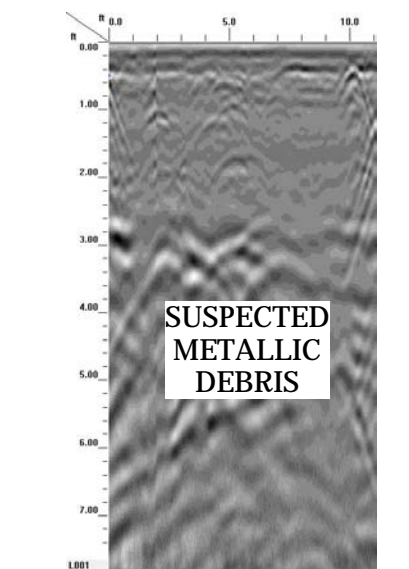
CLIENT  
Apex Companies, LLC  
**FIGURE 3**

**Figure 3** presents the locations of the formal GPR transects performed at the property, as well as the transect images. A total of three GPR transects were performed at the site. GPR Transects 1 – 3 were performed across EM Anomalies 3 and 4. These transects recorded evidence of isolated, small hyperbolic reflectors that were suggestive of buried metallic debris. No evidence of a larger structure such as a UST was observed in this area.

GPR TRANSECT 1 (T1)

GPR TRANSECT 2 (T2)

GPR TRANSECT 3 (T3)
