Preliminary Site Assessment Report

Waccamaw Development Corporation Property

Parcel # 21

US 701 Bypass (Madison St-Powell Blvd) from SR 1437 (Virgil Ave) to US 74/76

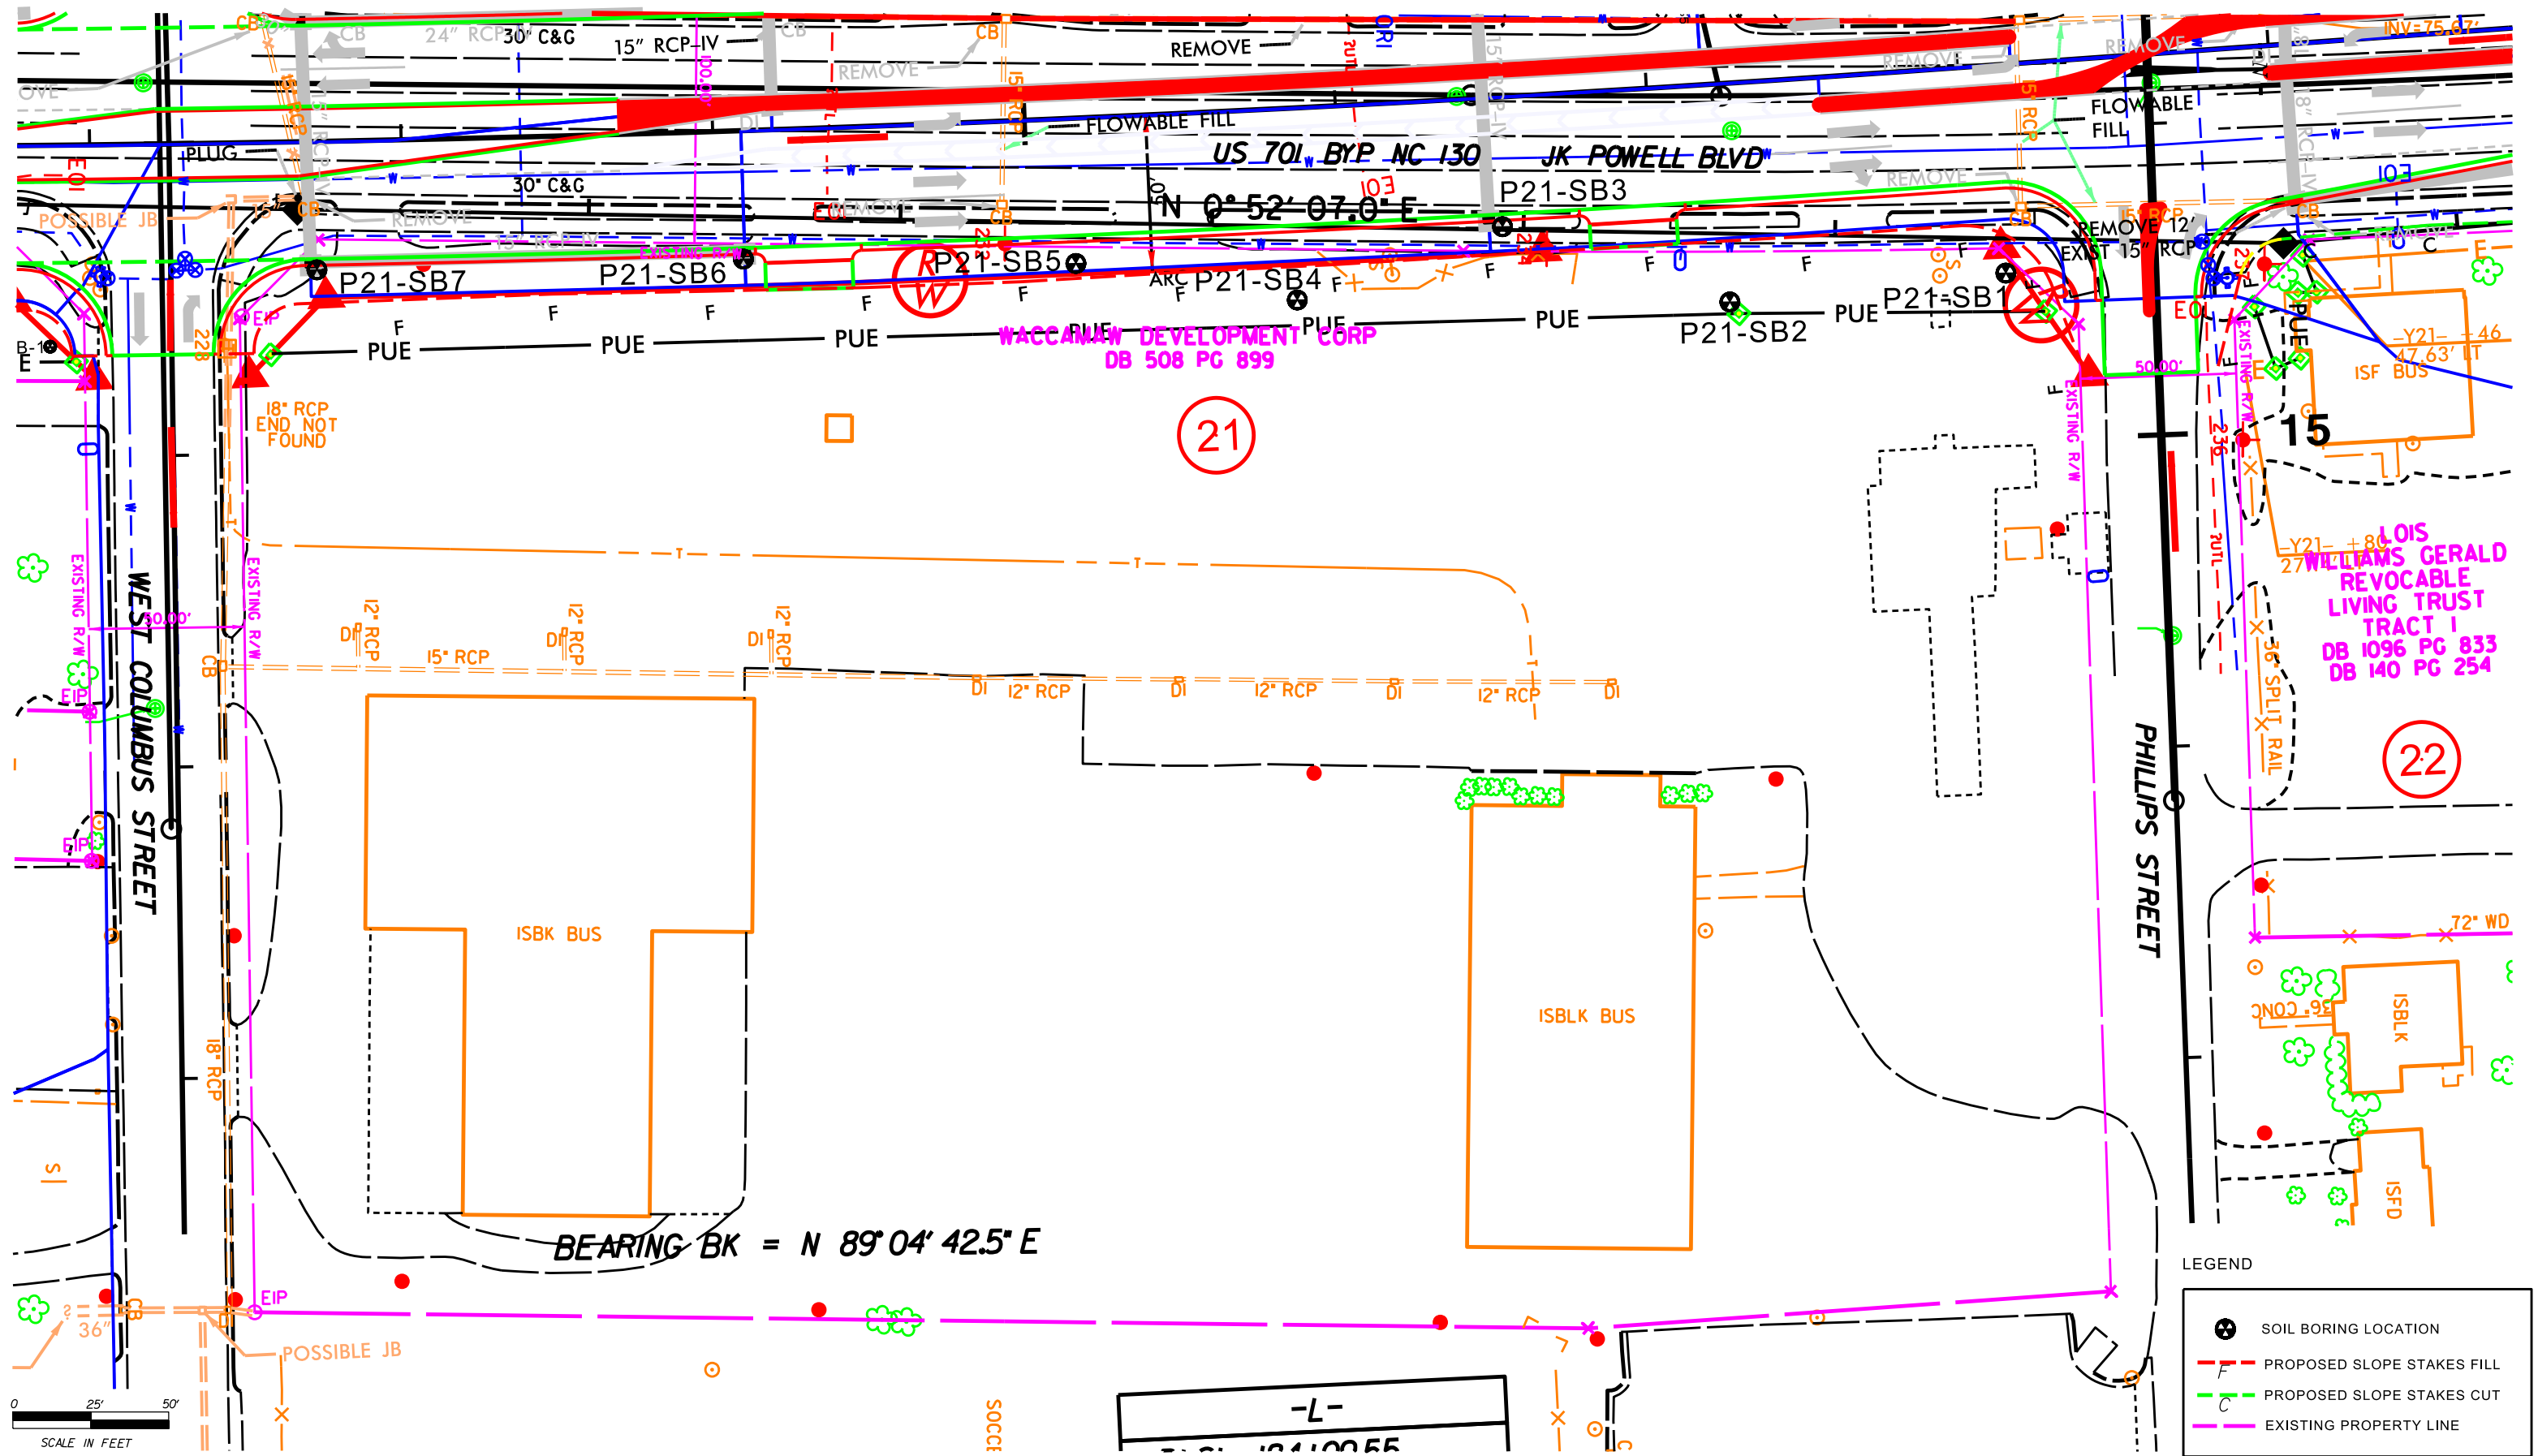
FIGURE 2
PARCEL 021
315-215 S. JK. POWELL BLVD.
SITE MAP WITH SOIL BORING
LOCATIONS

Site geology was observed through the drilling and sampling of seven direct push technology (DPT) soil borings (P21-SB1 through P21-SB7) onsite. **Figure 2** presents the boring locations and site layout. Borings did not exceed a total depth of ten feet below ground surface (bgs) since that depth was the maximum excavation depth for proposed drainage features. Soil

Apex conducted drilling activities at the site on June 6, 2018. The purpose of soil sampling was to determine if a release of petroleum or other volatile organic chemicals had occurred within the investigation area, and if so, to estimate the volume of impacted soil that might require special handling during construction activities. Apex drilling subcontractor, CSI, advanced seven DPT soil borings within the proposed investigation area. These seven borings were placed in a linear pattern along the western parcel boundary that maximized the likelihood of intercepting potential soil contamination that might exist in the area of future construction activities. **Figure 2** presents the Site Map with boring locations and site structures.

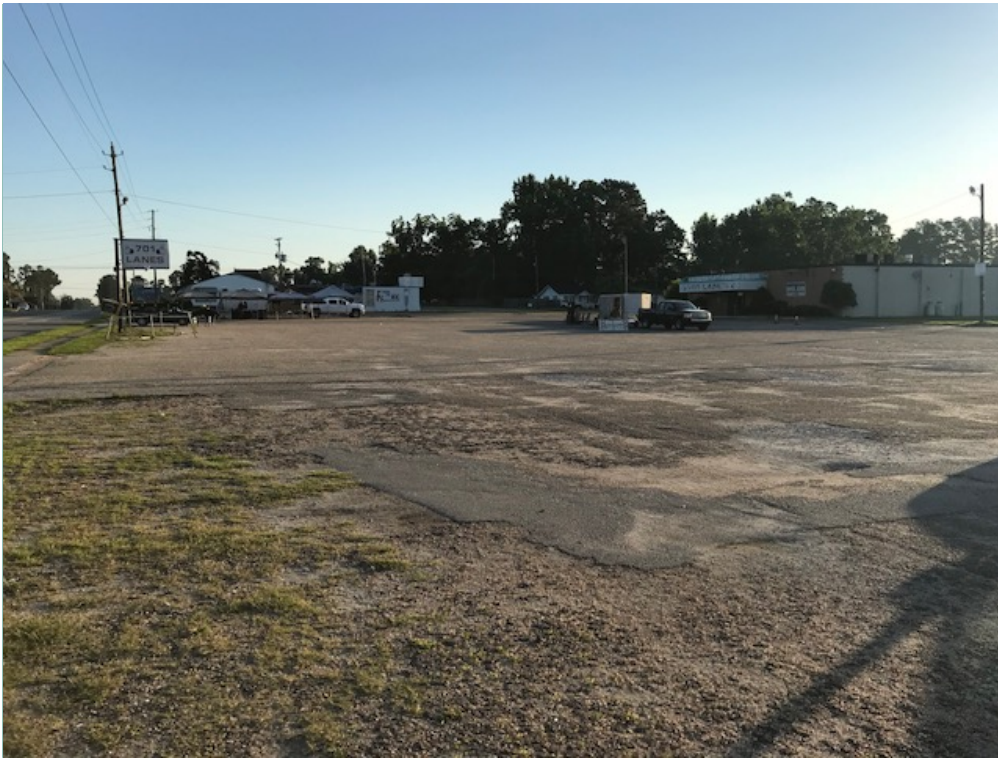
Photo 1

Overview of the site, looking north, prior to preliminary site assessment activities.

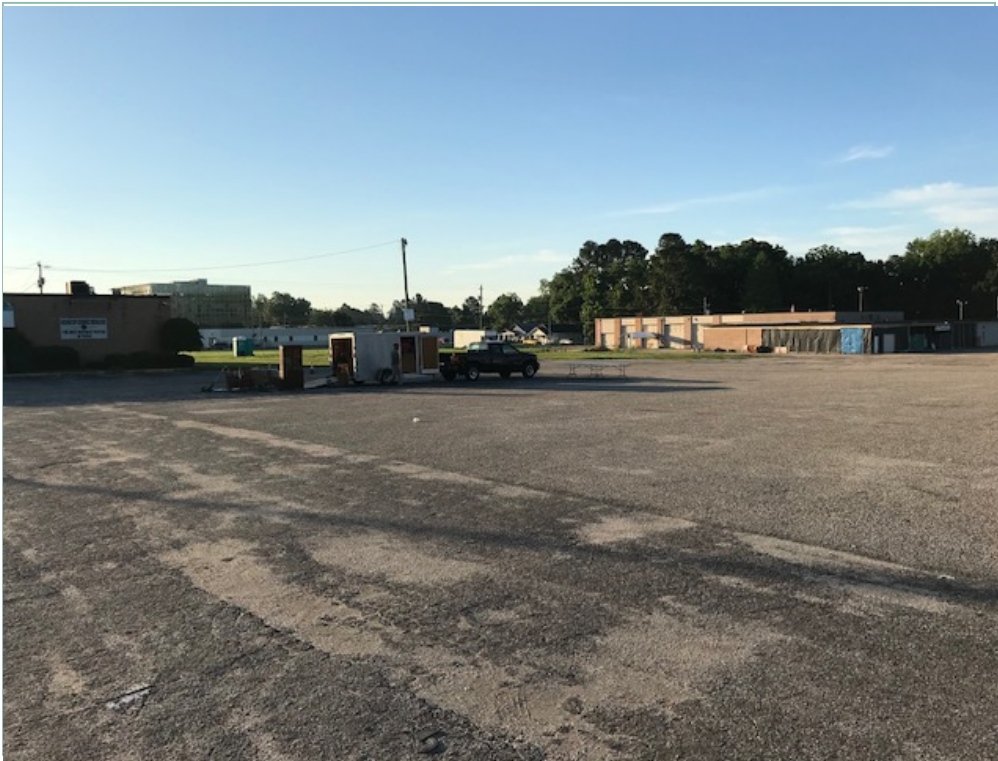
Photo 2

Overview of the site, looking southeast, prior to preliminary site assessment activities.

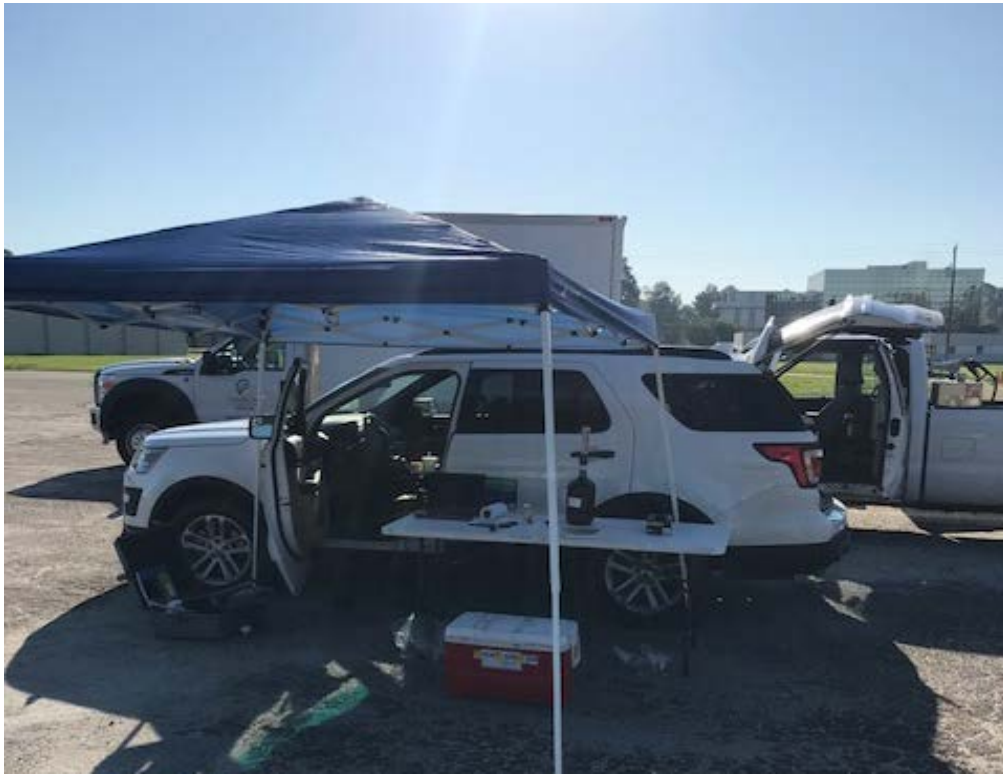
Photo 5

Photo of mobile lab set up prior to running UVF samples.

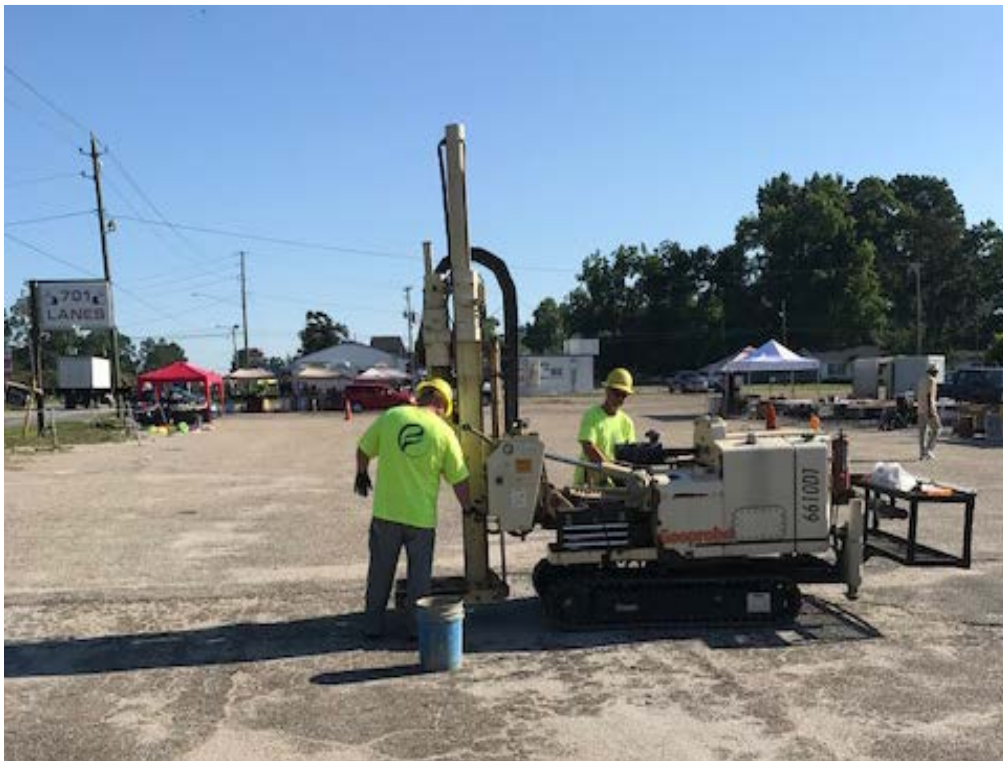
Photo 6

Photo shows CSI operating direct push drill rig.

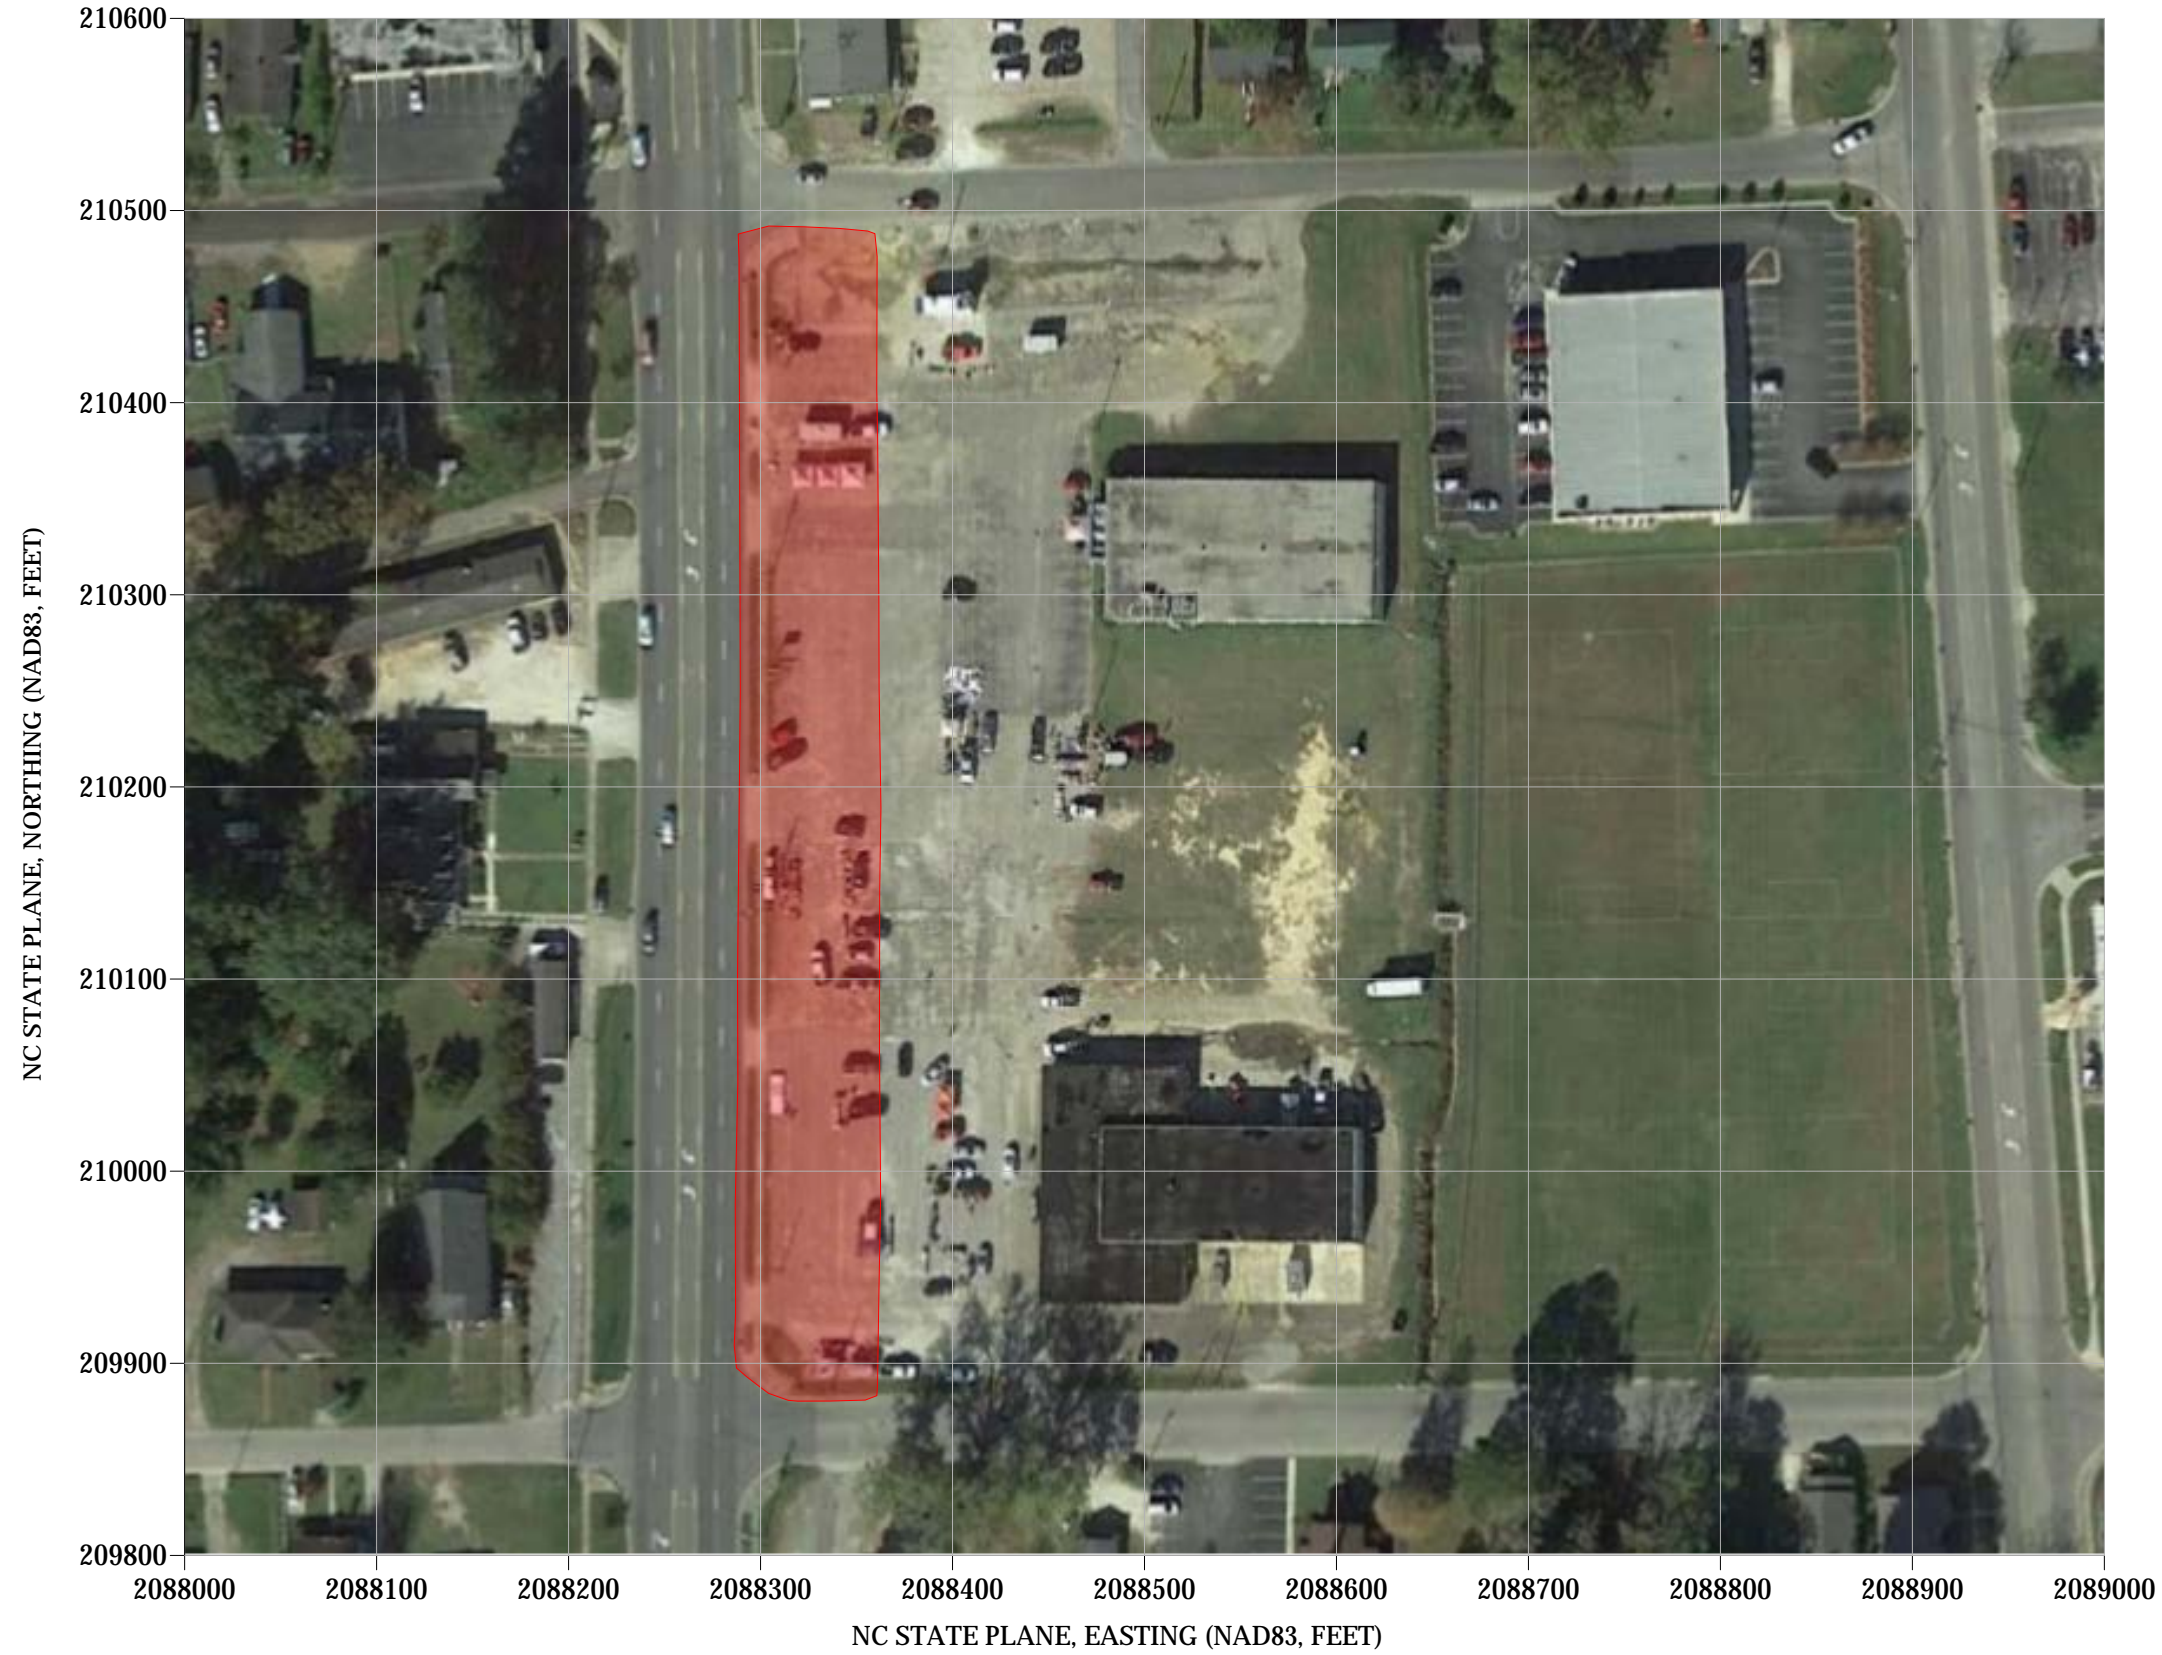
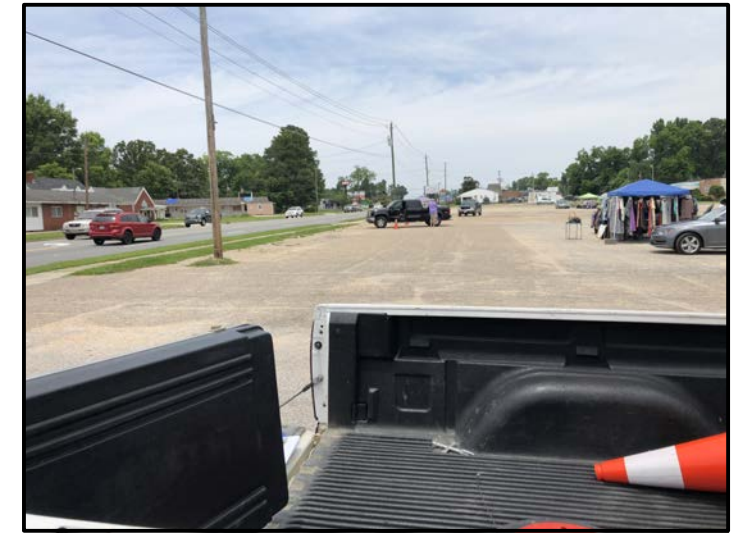
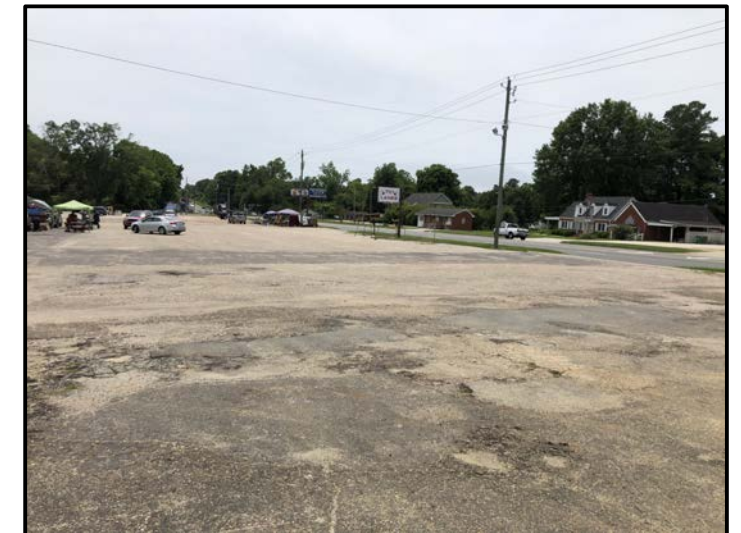
FIGURE 1

APPROXIMATE BOUNDARIES OF GEOPHYSICAL SURVEY AREA

View of Survey Area
(Facing Approximately North)

View of Survey Area
(Facing Approximately South)

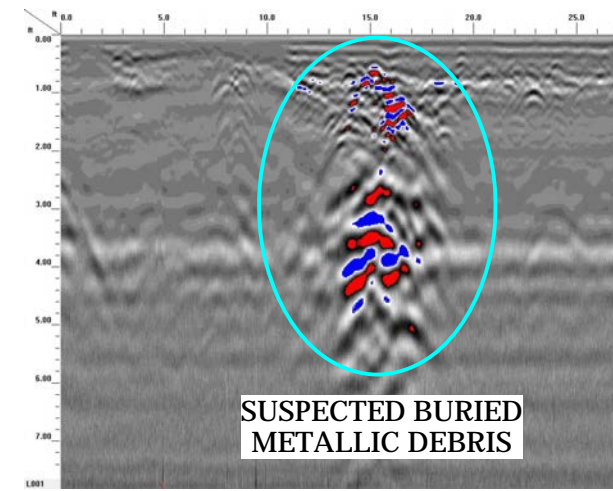
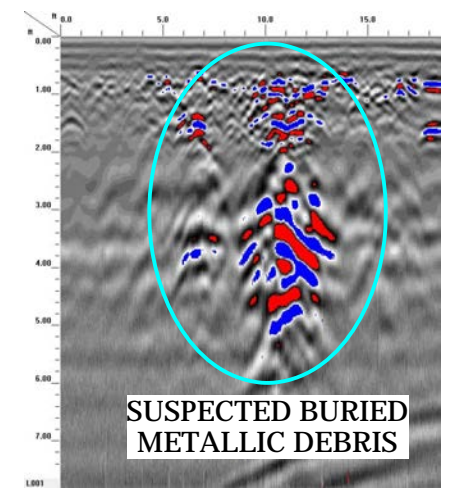
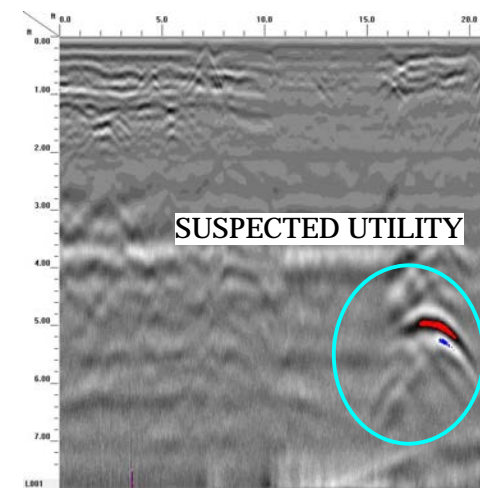
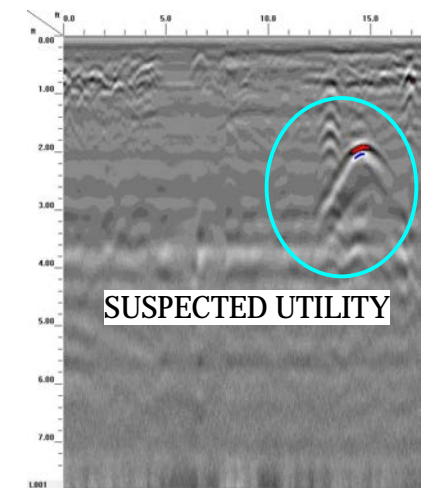
CLIENT
Apex Companies, LLC
FIGURE 3

Figure 3 presents the locations of the formal GPR transects performed at the property, as well as the transect images. A total of four GPR transects were performed at the site. GPR Transects 1 and 2 were performed across EM Anomaly 4. These transects recorded evidence of isolated high-amplitude reflectors and an increase in signal penetration that were suggestive of buried metallic debris. No evidence of a larger structure such as a UST was observed in this area.

GPR Transects 3 and 4 were performed across Anomaly 9. These transects verified the presence of suspected utilities, but no evidence of larger structures such as USTs was observed.

LOCATIONS OF GPR TRANSECTS

GPR TRANSECT 1 (T1)

GPR TRANSECT 2 (T2)

GPR TRANSECT 3 (T3)

GPR TRANSECT 4 (T4)
