Reference: **Preliminary Site Assessment Report**
NCDOT Project I-5878, WBS Element 53078.1.1
Parcel 49-Former Welcome Mart
601 Spring Branch Road
Dunn, Harnett County, North Carolina
S&ME Project 4305-19-161

Preliminary Site Assessment Report
 NCDOT Project I-5878, WBS Element 53078.1.1
 Parcel 49-Former Welcome Mart
 Dunn, Harnett County, North Carolina
 S&ME Project No. 4305-19-161

Preliminary Site Assessment Report
NCDOT Project I-5878, WBS Element 53078.1.1
Parcel 49B-Allen Walker Former Texaco
Dunn, Harnett County, North Carolina
S&ME Project No. 4305-19-161

Preliminary Site Assessment Report
 NCDOT Project I-5878, WBS Element 53078.1.1
 Parcel 50-Former Double T Restaurant
 Dunn, Harnett County, North Carolina
 S&ME Project No. 4305-19-161

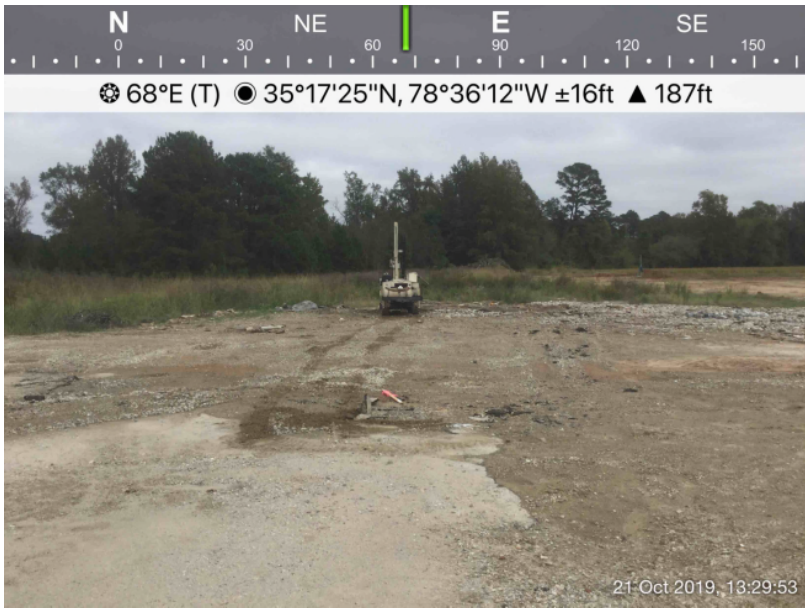
Date: 10/21/2019
Photographer: JTH			
1	Location / Orientation	View of site looking east.	
	Remarks	View is of former gasoline convenience store area.

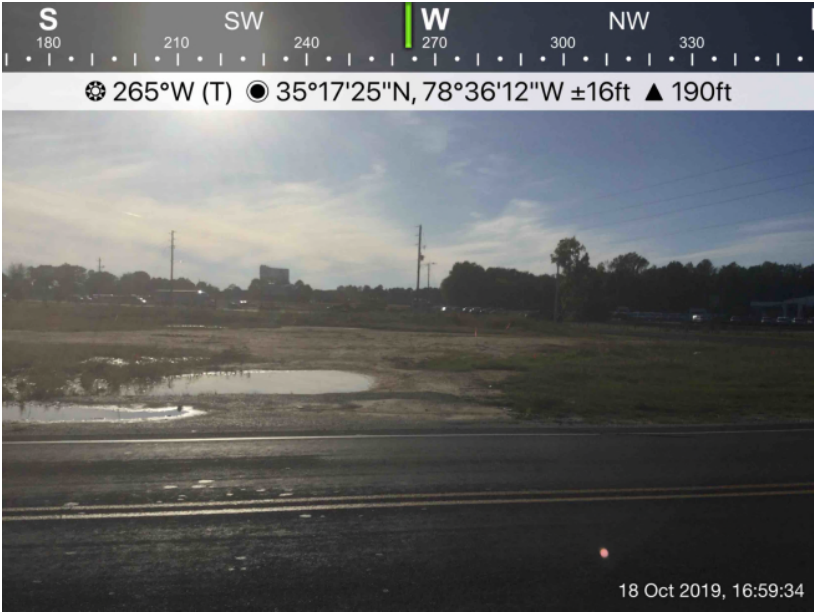
Date: 10/18/2019
			Photographer: JTH
1	Location / Orientation	View of site looking west from Spring Branch Road.	
	Remarks	View is of former gasoline/service station area.

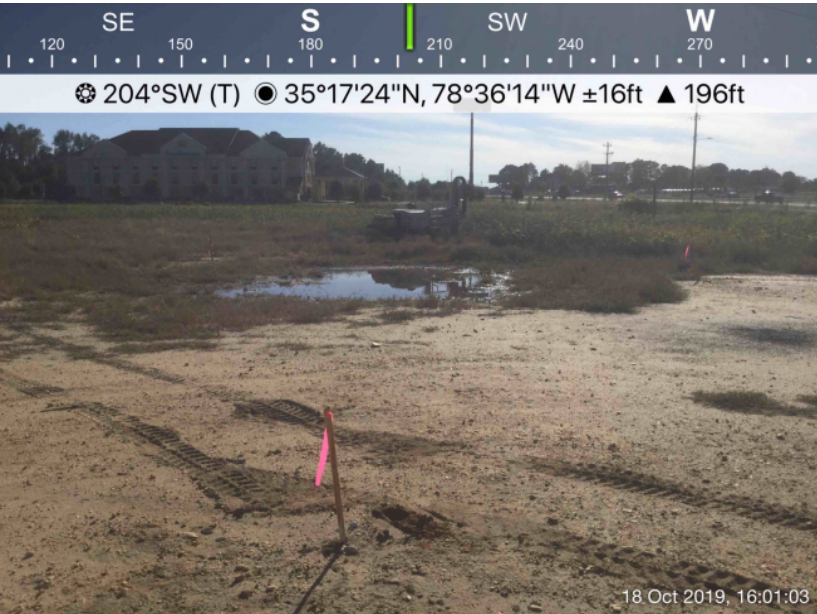
Date: 10/18/2019
			Photographer: JTH
2	Location / Orientation	View looking south. Standing water is within former UST basin area.	
	Remarks	None

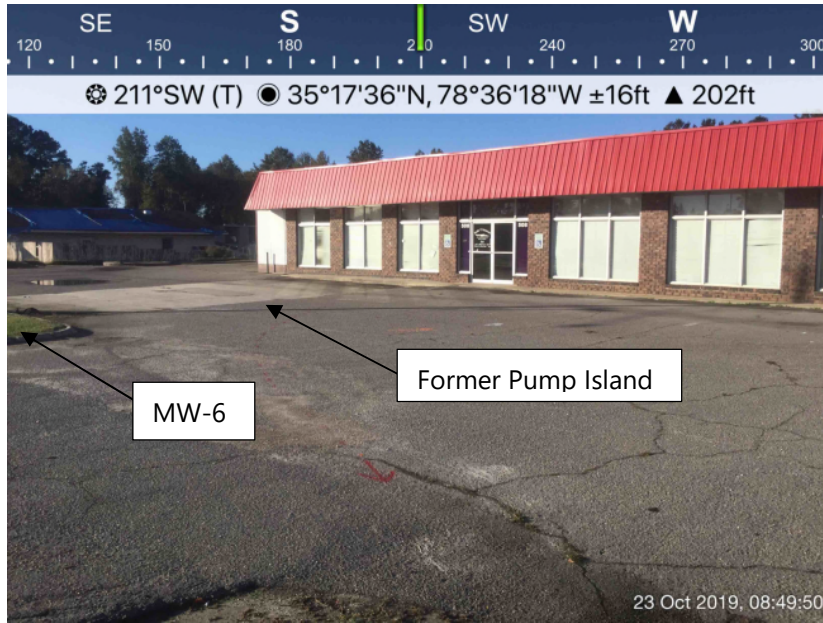
1	Location / Orientation	View of site looking south-southwest.
	Remarks	Concrete area is a former pump island. MW-6 is located within grassy area.

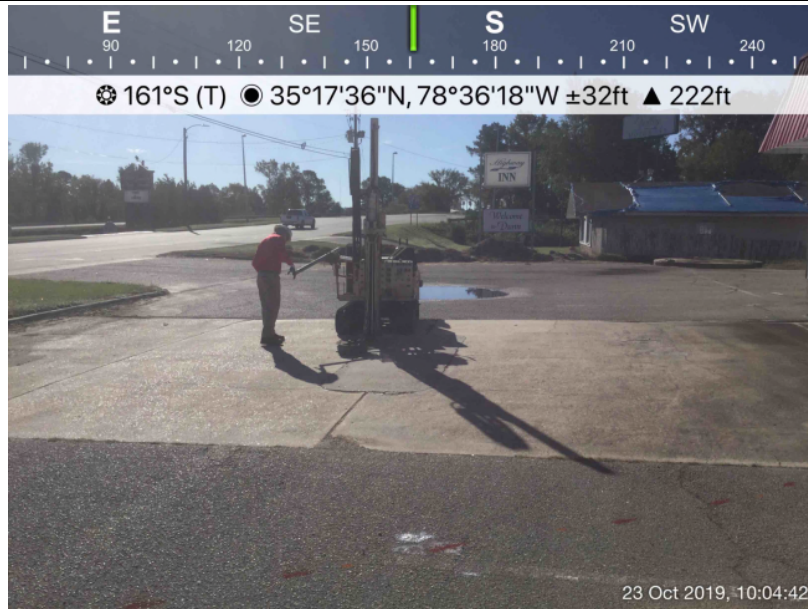
2	Location / Orientation	View looking south-southeast at former pump island.
	Remarks	Probing of boring B-9/TW-1.
