Reference: **Preliminary Site Assessment Report**
NCDOT Project I-5878, WBS Element 53078.1.1
Parcel 84-Building and Earth
610 Spring Branch Road
Dunn, Harnett County, North Carolina
S&ME Project 4305-19-161

Preliminary Site Assessment Report
NCDOT Project I-5878, WBS Element 53078.1.1
Parcel 84-Building and Earth
Dunn, Harnett County, North Carolina
S&ME Project No. 4305-19-161

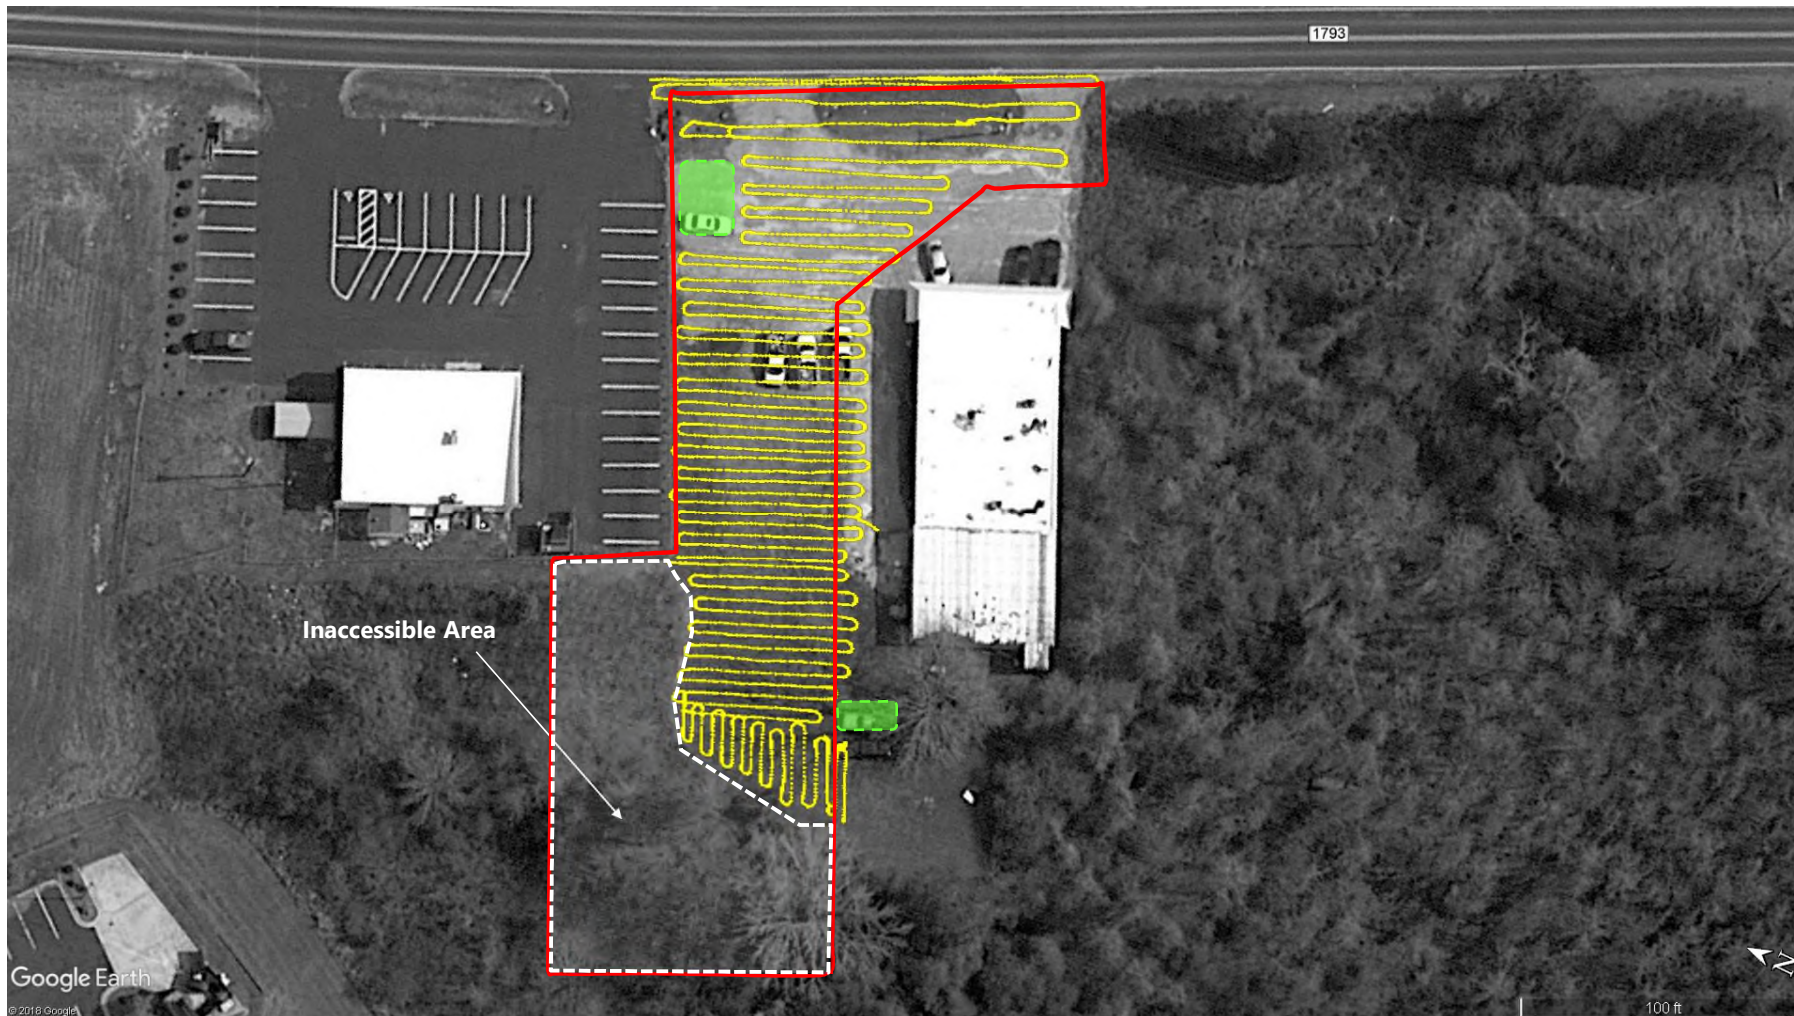
Figure 4: TDEM Path Location Plan

On July 25, 2019, S&ME completed Time Domain Electromagnetic (TDEM) and Ground Penetrating Radar (GPR) surveys within accessible areas of the proposed ROW/easement at Parcel 84. Brief descriptions of these complementary geophysical techniques are presented in the following paragraphs.

We used a Geonics Limited EM-61 MK2 TDEM system in general accordance with ASTM D6820 "*Standard Guide for Use of the Time Domain Electromagnetic Method for Subsurface Investigation*." Data was collected along lines spaced at approximately five feet using a Juniper® Systems Geode™ sub-meter GPS as positioning support. The presence of vehicles and thick vegetation within the survey area, prevented TDEM data collection in several locations. The approximate TDEM data collection paths are presented in **Figure 4**. Golden Software's Surfer® program was used to grid and plot the data (**Figures 5 and 6**). The TDEM data has been presented as Plots A and B in order to provide both opaque and semi-transparent views, respectively.

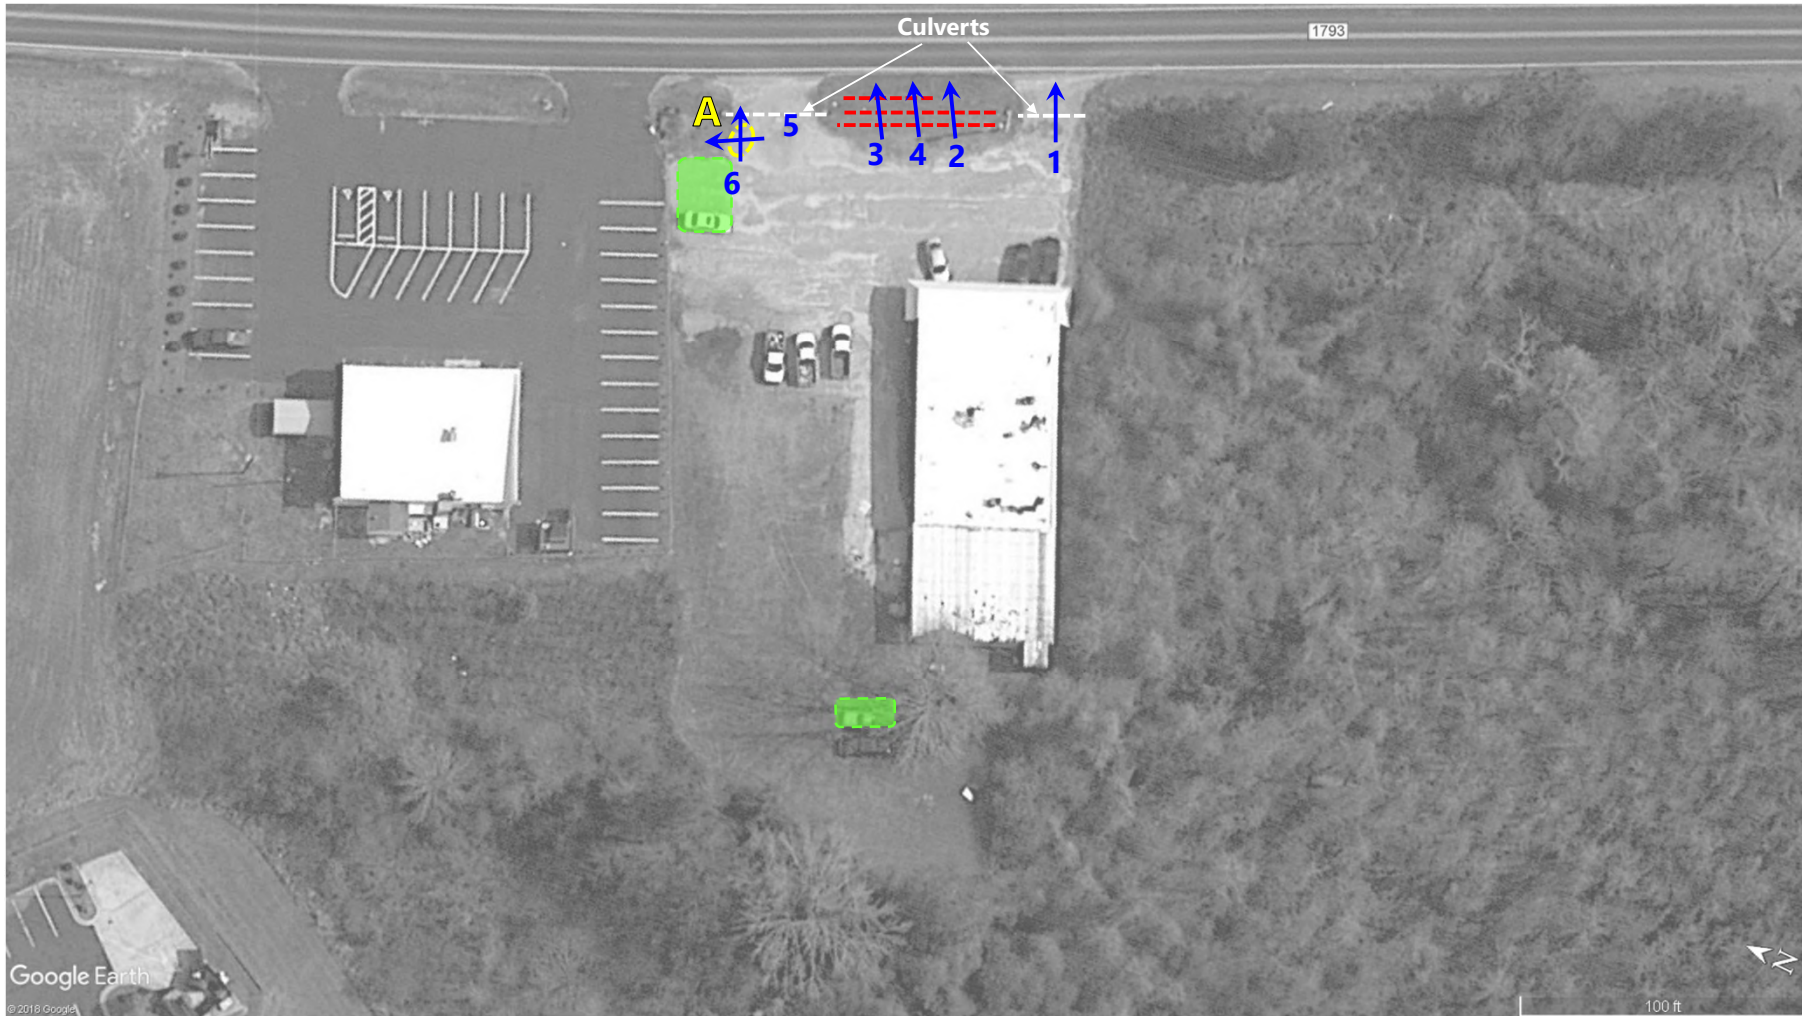
A total of six GPR profiles (Lines 1 through 6) were collected for documentation (**Figure 7**). The data was post-processed using the GSSI Radan® 7 GPR software program for additional analysis.

Responses indicative of a potential UST were not identified in the geophysical data sets collected at the site. One anomalous feature unrelated to known surficial targets was identified in the geophysical data sets (Anomaly A; **Figures 6 and 7**). Anomaly A is characterized by high amplitude GPR responses located less than about one foot below ground surface (bgs) and may be related to a relatively small isolated buried metallic object. The anomaly was marked in the field using white spray paint. Example GPR profiles are presented in **Figure 8**.

The geophysical survey identified one anomaly (Anomaly A) which may be related to a relatively small isolated buried metallic object. Responses indicative of a potential UST were not identified in the geophysical data sets collected at the site.
