Reference: **Preliminary Site Assessment Report**
NCDOT Project I-5986B, WBS Element 47532.1.3
Parcel 214-Lucky's Truck and Trailer Sales
1185 Sadler Drive
Dunn, Harnett County, North Carolina
S&ME Project 4305-18-175A

**Preliminary Site Assessment Report
NCDOT Project I-5986B, WBS Element 47532.1.3
Parcel 214-Lucky's Truck and Trailer Sales
Dunn, Harnett County, North Carolina
S&ME Project No. 4305-18-175A**

NCDOT I-5986B
PARCEL NO. 214 (LUCKY'S TRUCK AND TRAILER SALES)
1185 SADLER DRIVE, DUNN, HARNETT COUNTY, NORTH CAROLINA

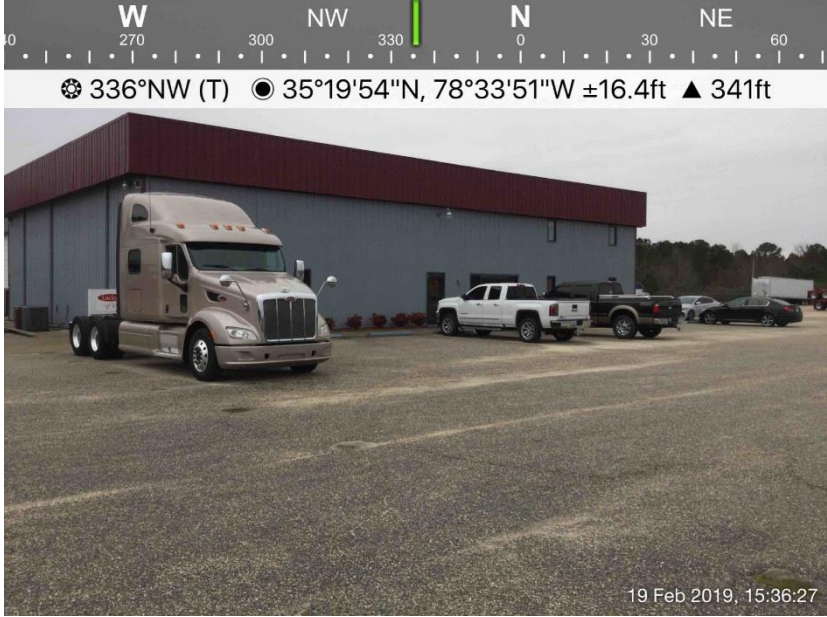
<p>W NW N NE 270 300 330 0 30 60 336°NW (T) 35°19'54"N, 78°33'51"W ±16.4ft ▲ 341ft 19 Feb 2019, 15:36:27</p>			Date: 2/19/2019
			Photographer: JTH
1	Location / Orientation	Front view of site looking northwest.	
	Remarks	None

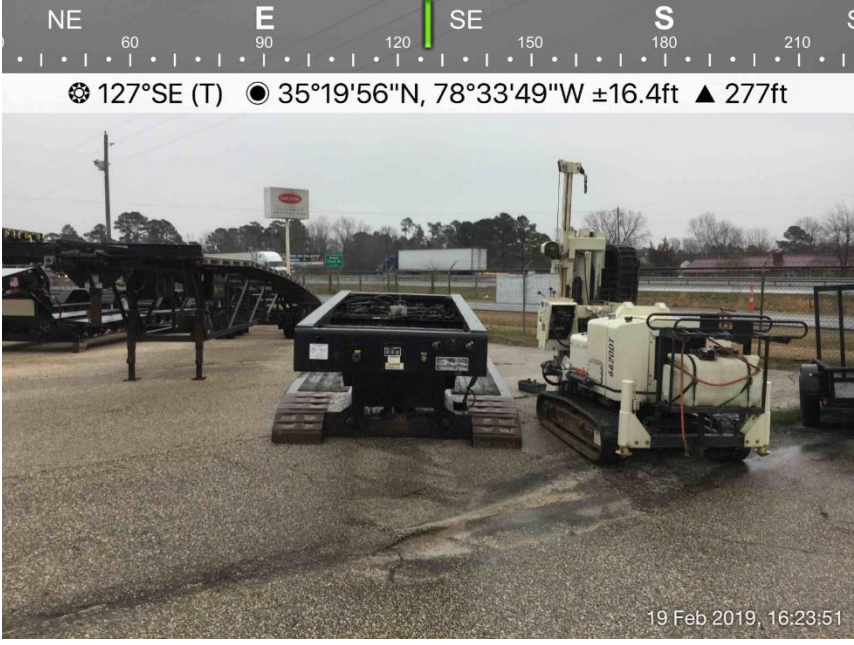
</div>			Date: 2/19/2019
			Photographer: JTH
3	Location / Orientation	Front view of site looking southeast.	
	Remarks	Note soil boring B-3

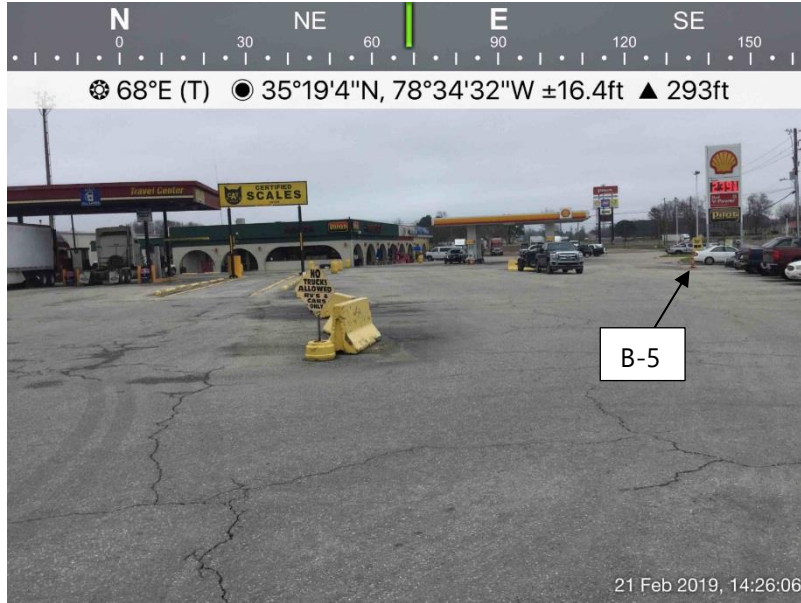
2	Location / Orientation	Groundwater sampling at B-5/TW-1.
	Remarks	None

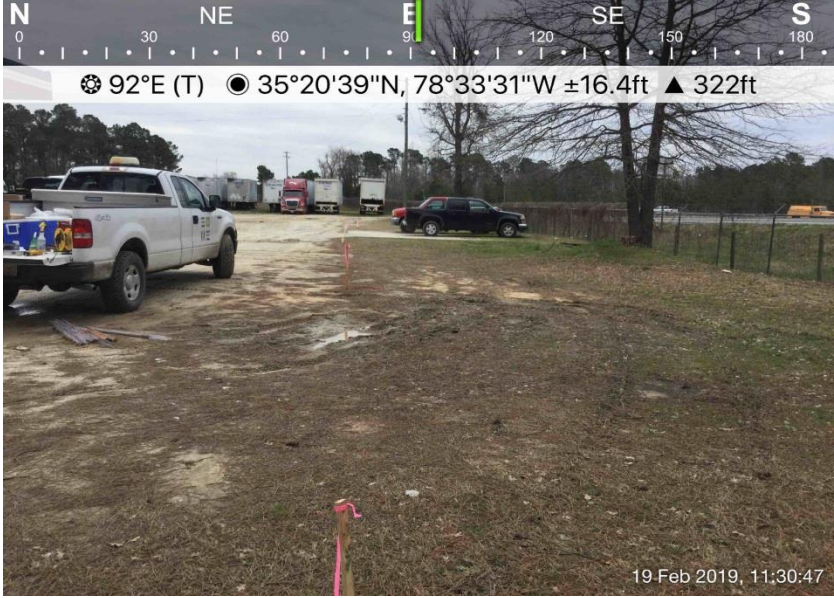
Date: 2/19/2019
			Photographer: JTH
3	Location / Orientation	View looking east at soil boring locations.	
	Remarks	None

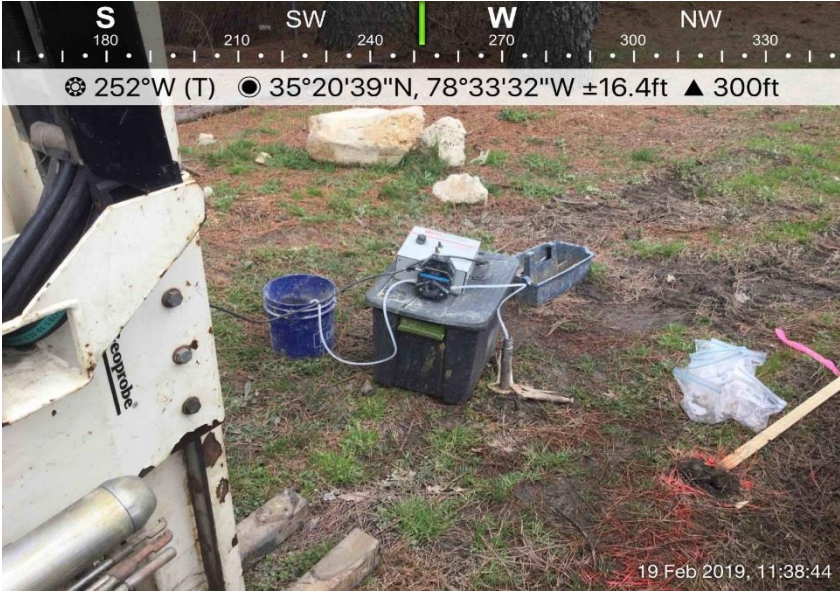
Date: 2/19/2019
			Photographer: JTH
4	Location / Orientation	View of groundwater sampling at B-2/TW-1.	
	Remarks	Sampling from Geoprobe screen.
