PRELIMINARY SITE ASSESSMENT
FOR
PARCEL 117
MICHAEL & CAROLE RICHARDS PROPERTY
(MIDWAY TRADING POST)
3296 SOUTHPORT SUPPLY ROAD
BOLIVIA, BRUNSWICK COUNTY, NORTH CAROLINA

NC 211 FROM SR 1500 (MIDWAY ROAD) TO NC 87

WBS ELEMENT: 41582.1.1
STATE PROJECT: R-5021

**PRELIMINARY SITE ASSESSMENT
FOR
PARCEL 117
MICHAEL & CAROLE RICHARDS PROPERTY
(MIDWAY TRADING POST)
3296 SOUTHPORT SUPPLY ROAD
BOLIVIA, BRUNSWICK COUNTY, NORTH CAROLINA
NC 211 FROM SR 1500 (MIDWAY ROAD) TO NC 87**

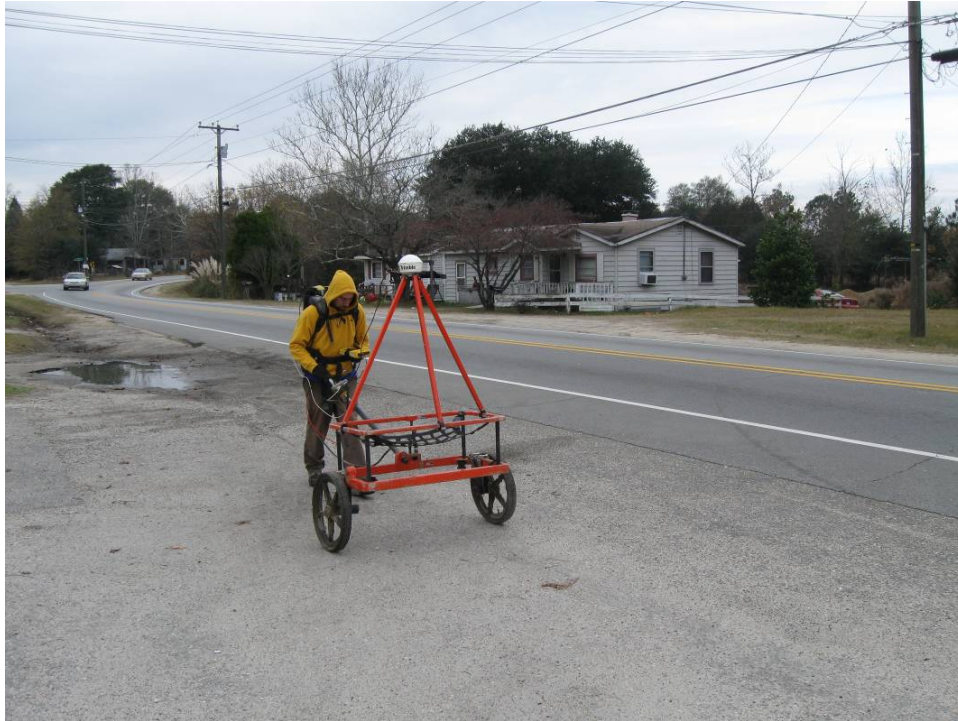
Geonics EM61-MK2 Metal Detector with Trimble DGPS Unit

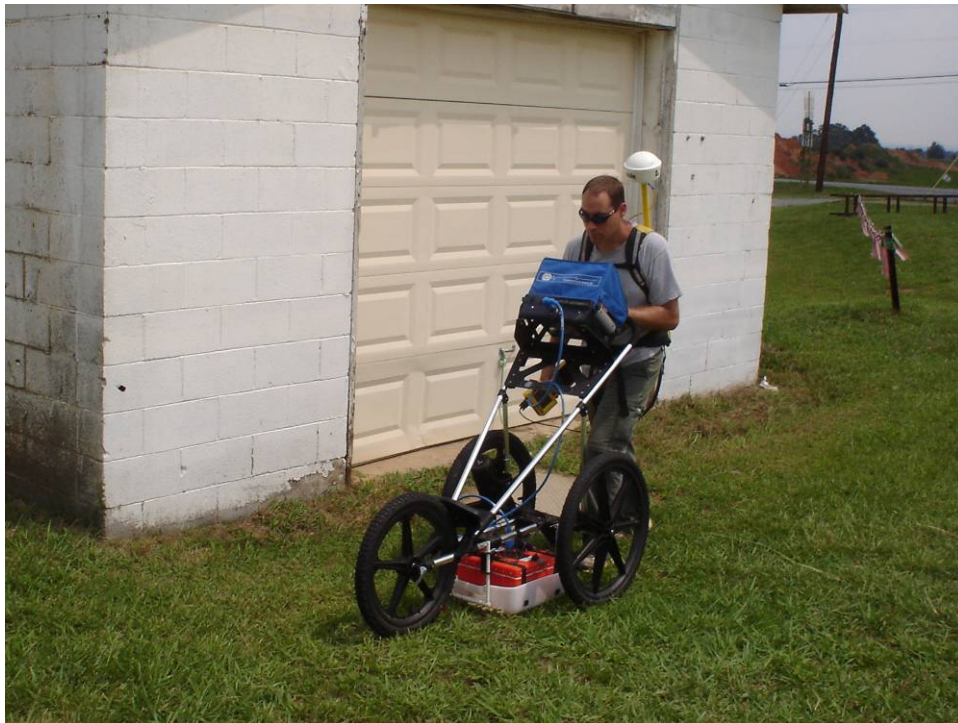
GSSI SIR-3000 Ground-Penetrating Radar with 400 MHz Antenna

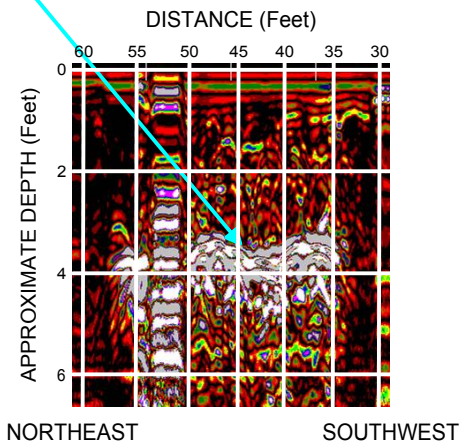
EXAMPLE GPR
RESPONSE FROM
THE LONG AXIS
OF KNOWN
UST NO. 1
