Preliminary Site Assessment

**US 221 South of US 74 Business (Charlotte Road) to North of
SR 1366 (Roper Loop Road)
Parcel 115 – Darrill Burnett
365 East Mountain Street, North Carolina**

State Project No. R-2233BB

Terracon Project No. 71177323

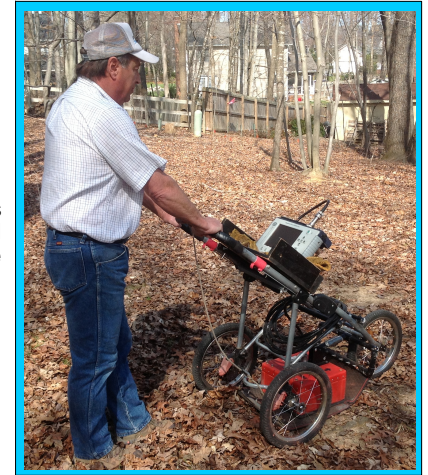
GROUND PENETRATING RADAR UNIT

The photograph shows the Geophysical Survey Systems SIR-3000 ground penetrating radar (GPR) unit equipped with a 400 MHz antenna that were used to conduct the GPR scanning across selected portions of the site.

GPR scans were performed along northerly-southerly and easterly-westerly directions spaced primarily 3 to 5 feet apart across selected EM61 differential anomalies and areas containing steel reinforced concrete using the Geophysical Survey Systems SIR-3000 unit equipped with a 400 MHz antenna. GPR data were viewed in real time in a continuous mode using a vertical scan of 512 samples, at a sampling rate of 48 scans per second. A 70 MHz high pass filter and an 800 MHz low pass filter were used during data acquisition with the 400 MHz antenna. GPR data were viewed to a maximum investigating depth of approximately 7.0 feet based on an estimated two-way travel time of 8.0 nanoseconds per foot.

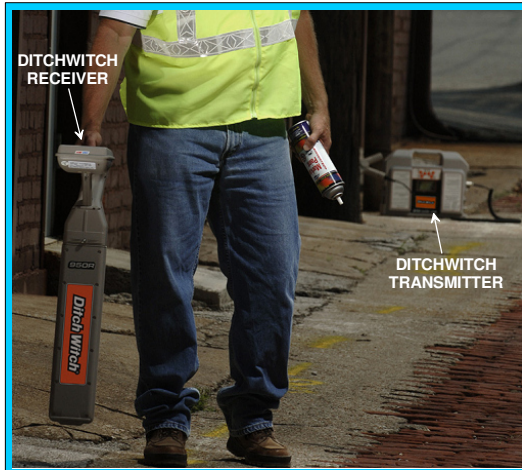
DITCHWITCH UTILITY LOCATOR

The photograph shows the DitchWitch 910 utility locator which was used to detect buried lines across the proposed boring locations.

Following the UST investigation, areas around the proposed Terracon soil borings were scanned with the GPR unit and a DitchWitch 910 utility locator for buried utility line clearance and no further discussion regarding the utility clearance work will be made in this report. Photographs of the geophysical equipment used for the investigation and of the site are presented in Figure 1.

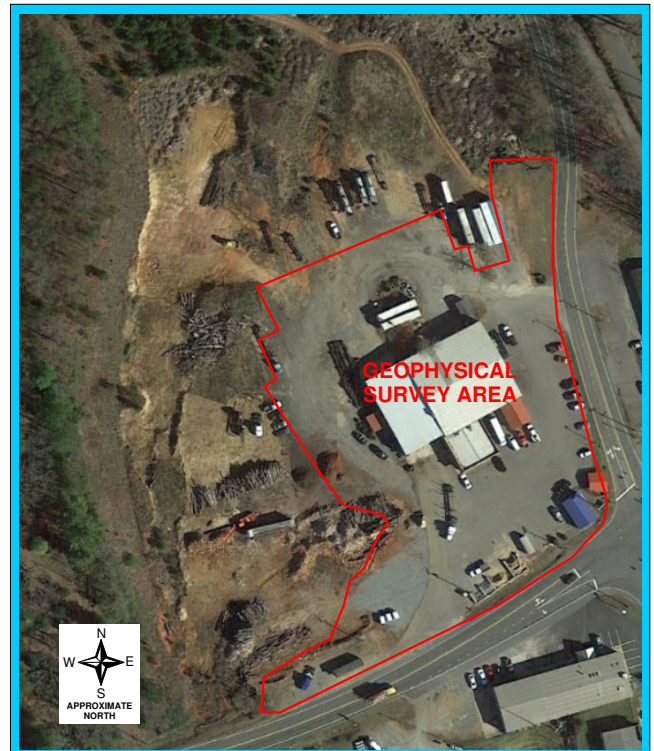
GEOPHYSICAL SURVEY AREA

The red polygon in the aerial photograph represents the approximate perimeter of the geophysical survey area at the Darrill Burnett property (Parcel 115) located at the intersection of East Mountain Street and Rock Road, near Rutherfordton, North Carolina. The geophysical investigation was conducted on July 29 and August 3, 2017.

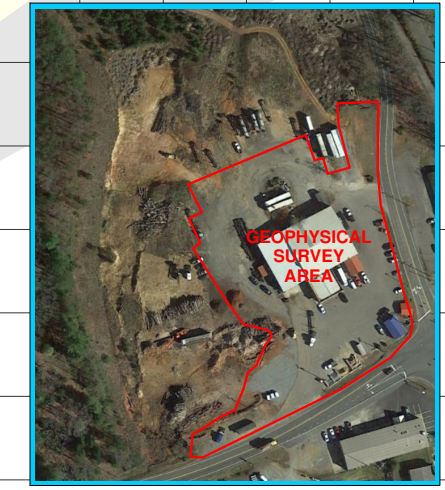
11/27/17 FIGURE 3

EM61-MK2A METAL DETECTION
(DIFFERENTIAL RESULTS)

The red polygon in the aerial photograph represents the approximate perimeter of the geophysical survey area.
