# Preliminary Site Assessment

**US 221 South of US 74 Business (Charlotte Road) to North of  
SR 1366 (Roper Loop Road)  
Parcel 243 – Heath and Erin McSwain  
174 US Highway 64, Rutherfordton, North Carolina**

State Project No. R-2233BB

Terracon Project No. 71177323

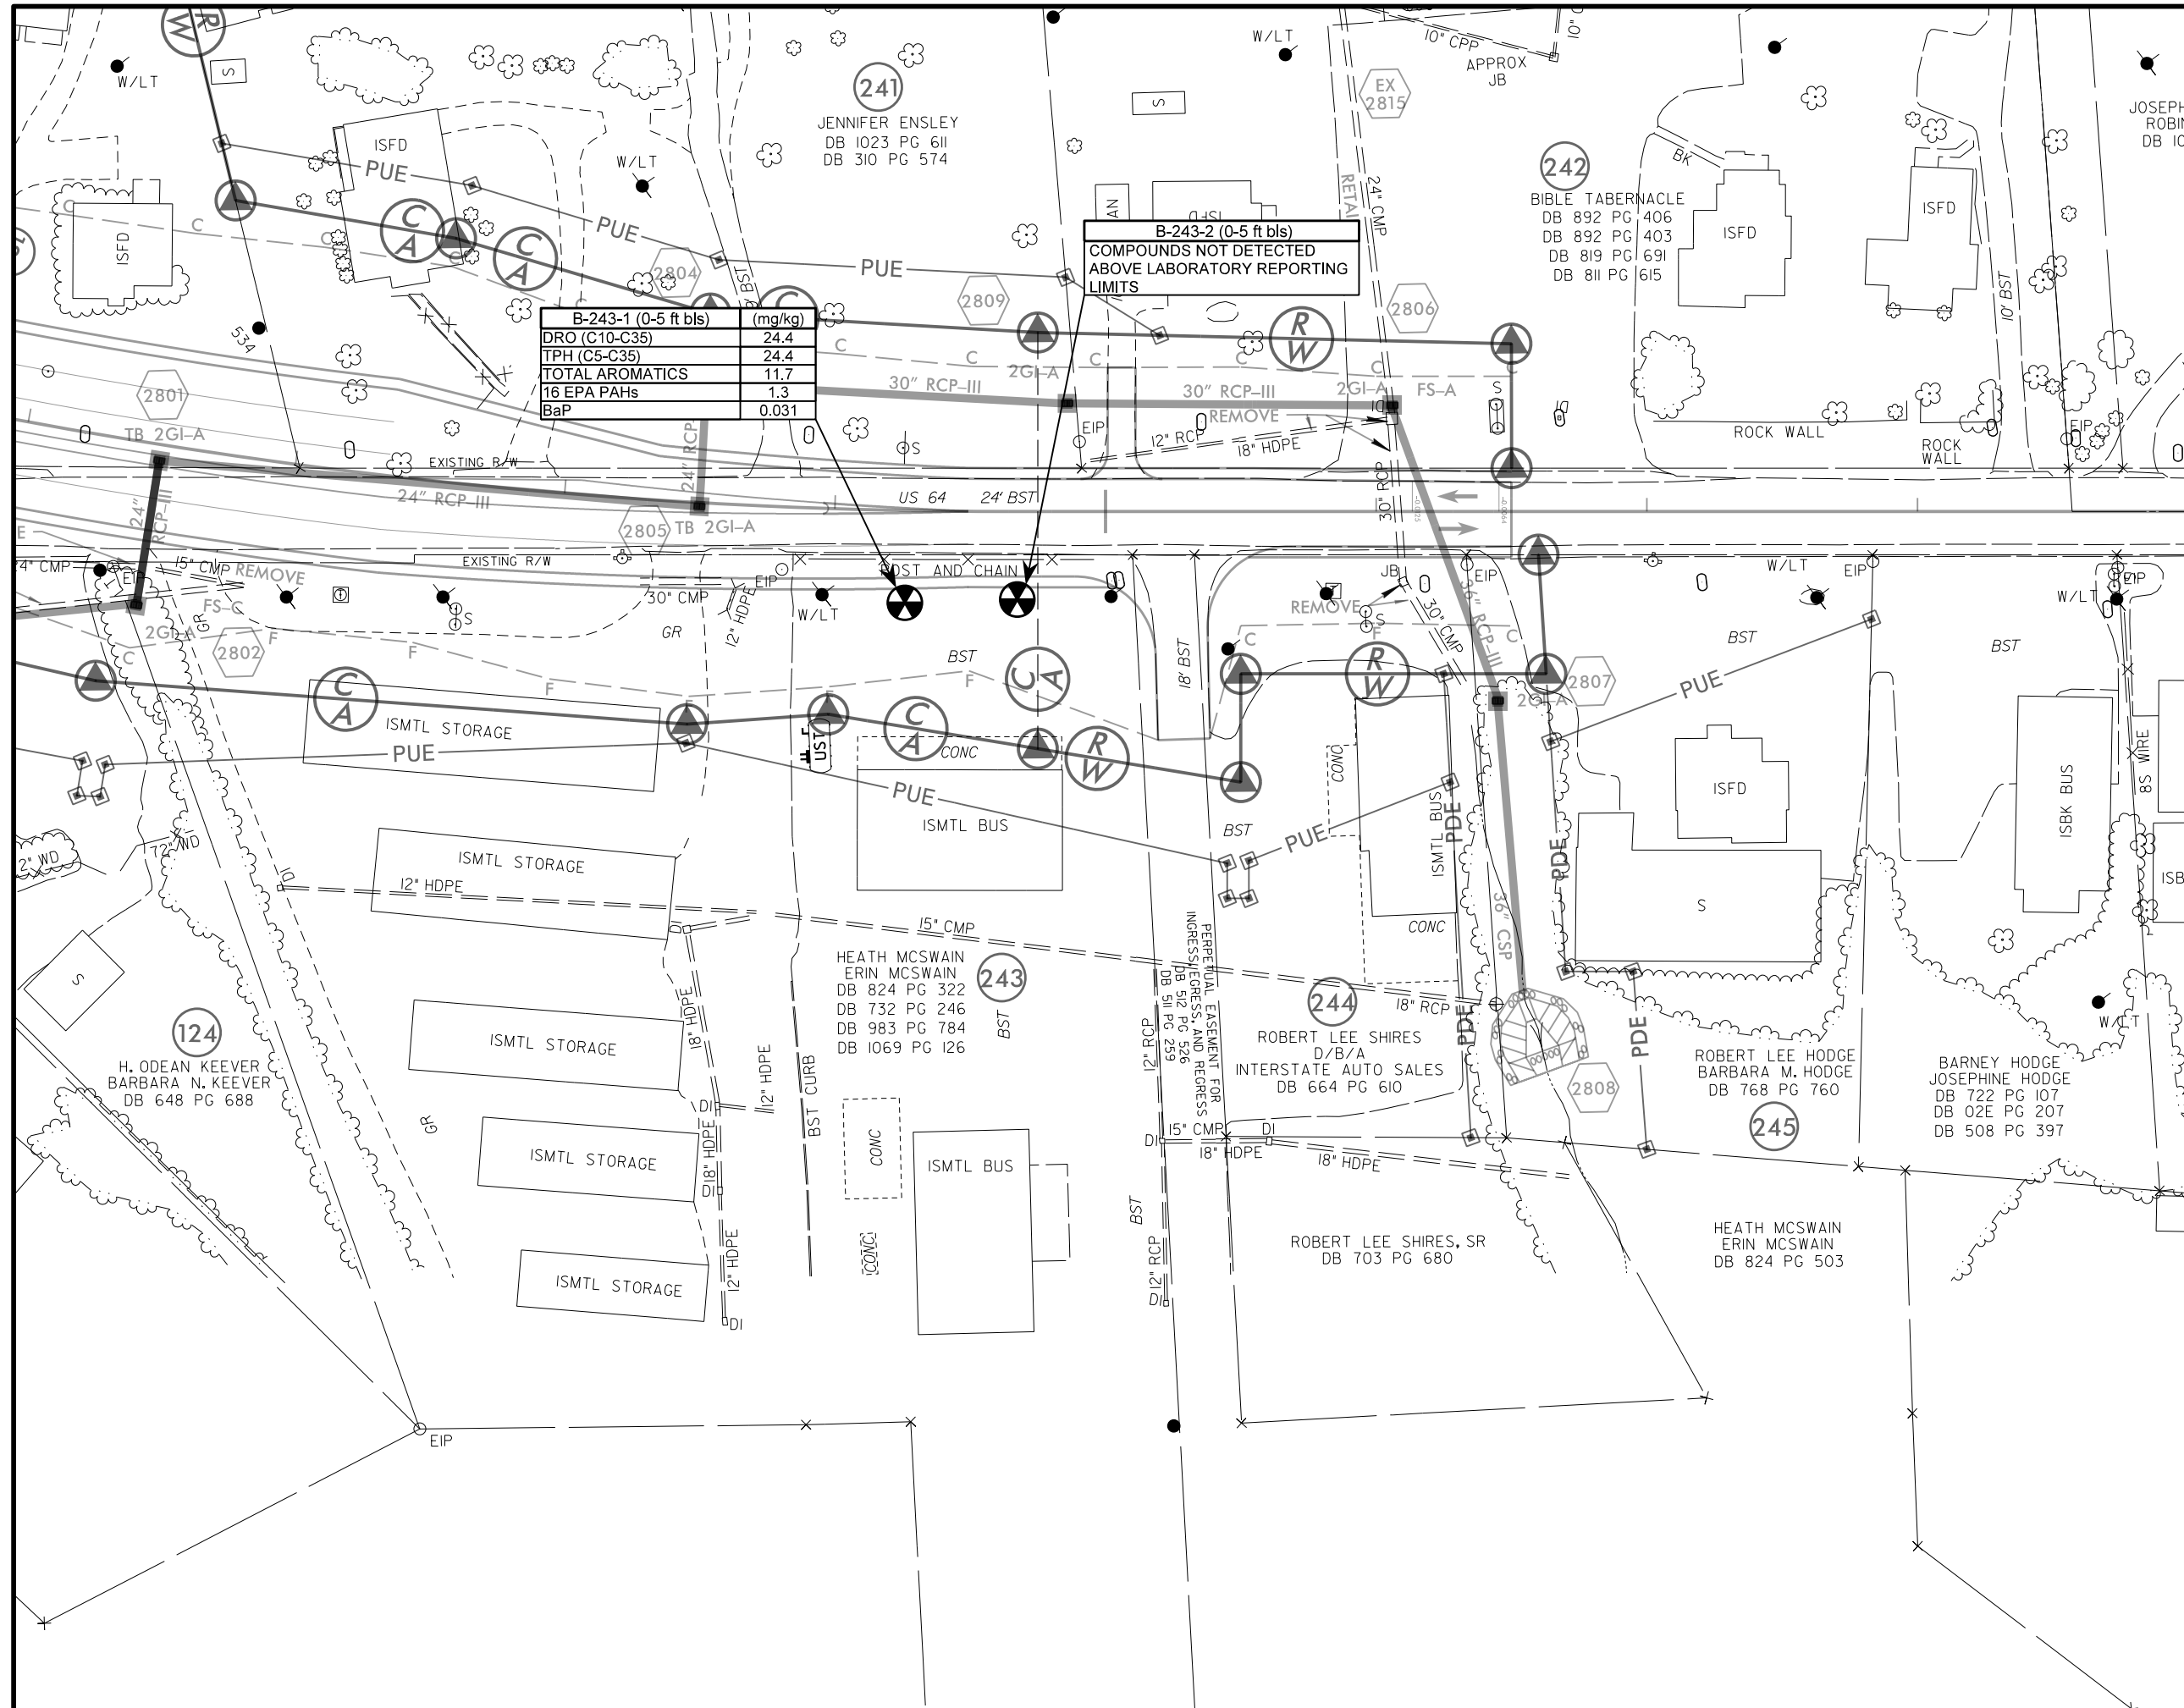
**EXHIBIT 2B – SITE DIAGRAM WITH SOIL BORING LOCATIONS  
AND ANALYTICAL DATA**

The identified constituents were detected at concentrations below their respective NCDEQ regulatory action levels (50 mg/kg for GRO and 100 mg/kg for DRO). **Table 1** summarizes the results of the UVF analyses of the soil samples.

LABORATORY ANALYTICAL RESULTS DID NOT REPORT CONTAMINANTS OF CONCERN AT CONCENTRATIONS IN EXCESS OF THE NORTH CAROLINA DEPARTMENT OF ENVIRONMENTAL QUALITY (NCDEQ) ACTION LEVELS AND / OR CLEAN-UP STANDARDS.

- n Based on the analytical results, Terracon does not recommend additional assessment of the ROW at Parcel 243 at this time. The detection of petroleum constituents (below regulatory standards) in the two borings is an indication that future roadway construction activities at the site could encounter petroleum impacted soils within other areas of the ROW.

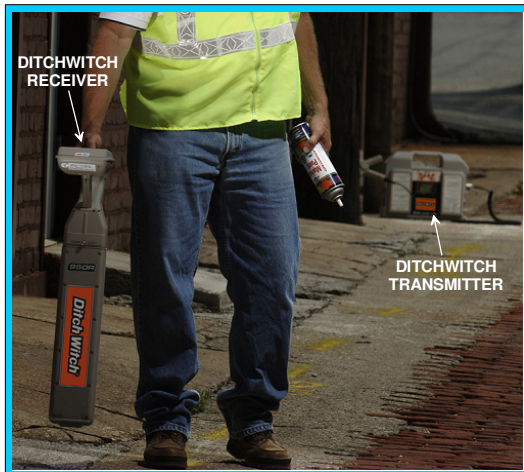
**DITCHWITCH UTILITY LOCATOR**

The photograph shows the DitchWitch 910 utility locator which was used to detect buried lines across the proposed boring locations.

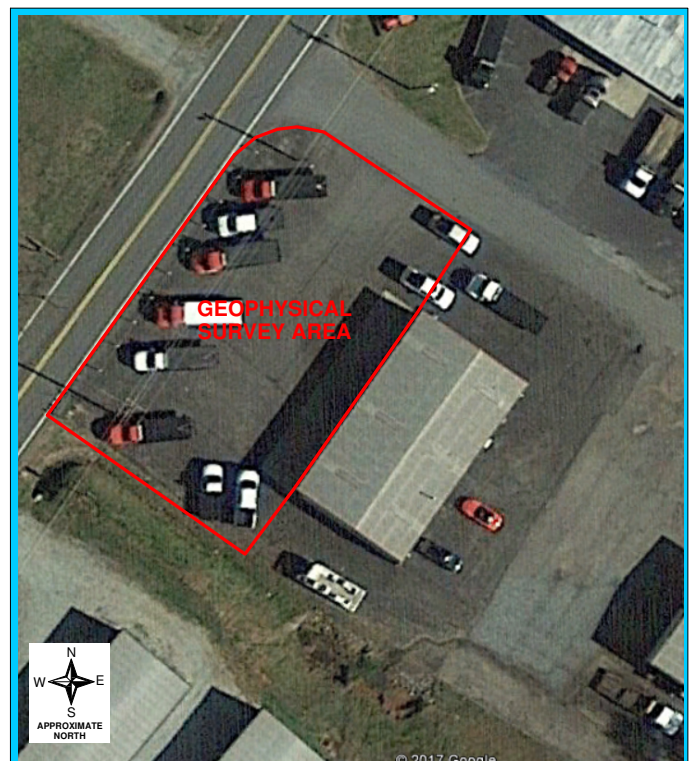
**GEOPHYSICAL SURVEY AREA**

The red polygon in the aerial photograph represents the approximate perimeter of the geophysical survey area at the Heath & Erin McSwain property (Parcel 243). The geophysical investigation was conducted on July 28 and August 2, 2017.

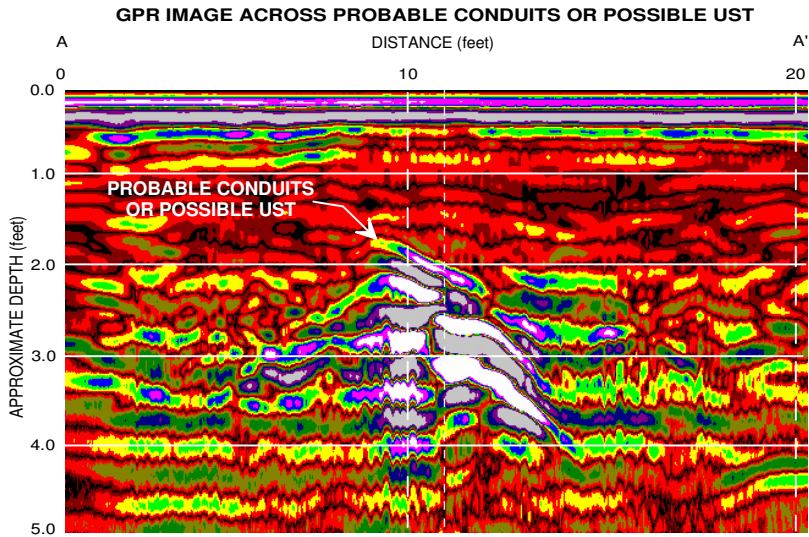
The high amplitude, hyperbolic reflections in the GPR image (above) are probably in response to two short metallic conduits or a possible UST buried approximately 2.0 feet below present grade. The purple line labeled AA' in the photograph shown below represents the approximate location of the GPR image.

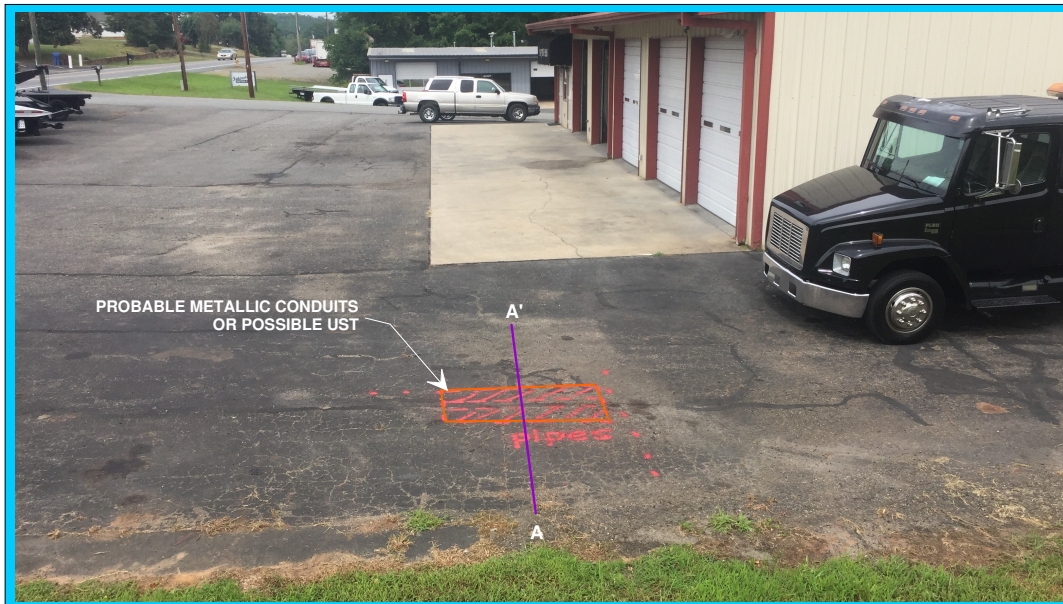
The orange rectangle in the photograph represents the approximate foot print of probable two short pieces of metallic conduits or a possible (low confidence) UST that were/was detected by the geophysical investigation. Based on the GPR data, the buried object(s) is approximately 5.0 feet long, 2.5 feet wide and buried 2.0 feet below present grade. The solid purple line labeled AA' in the photograph represents the approximate location of GPR image AA' shown above. The photograph is viewed in a northeasterly direction.
