Preliminary Site Assessment

US 221 South of US 74 Business (Charlotte Road) to North of
SR 1366 (Roper Loop Road)
Parcel 118 – S&D Investments
877 and 881 Railroad Avenue, Rutherfordton, North Carolina

State Project No. R-2233BB

Terracon Project No. 71177323

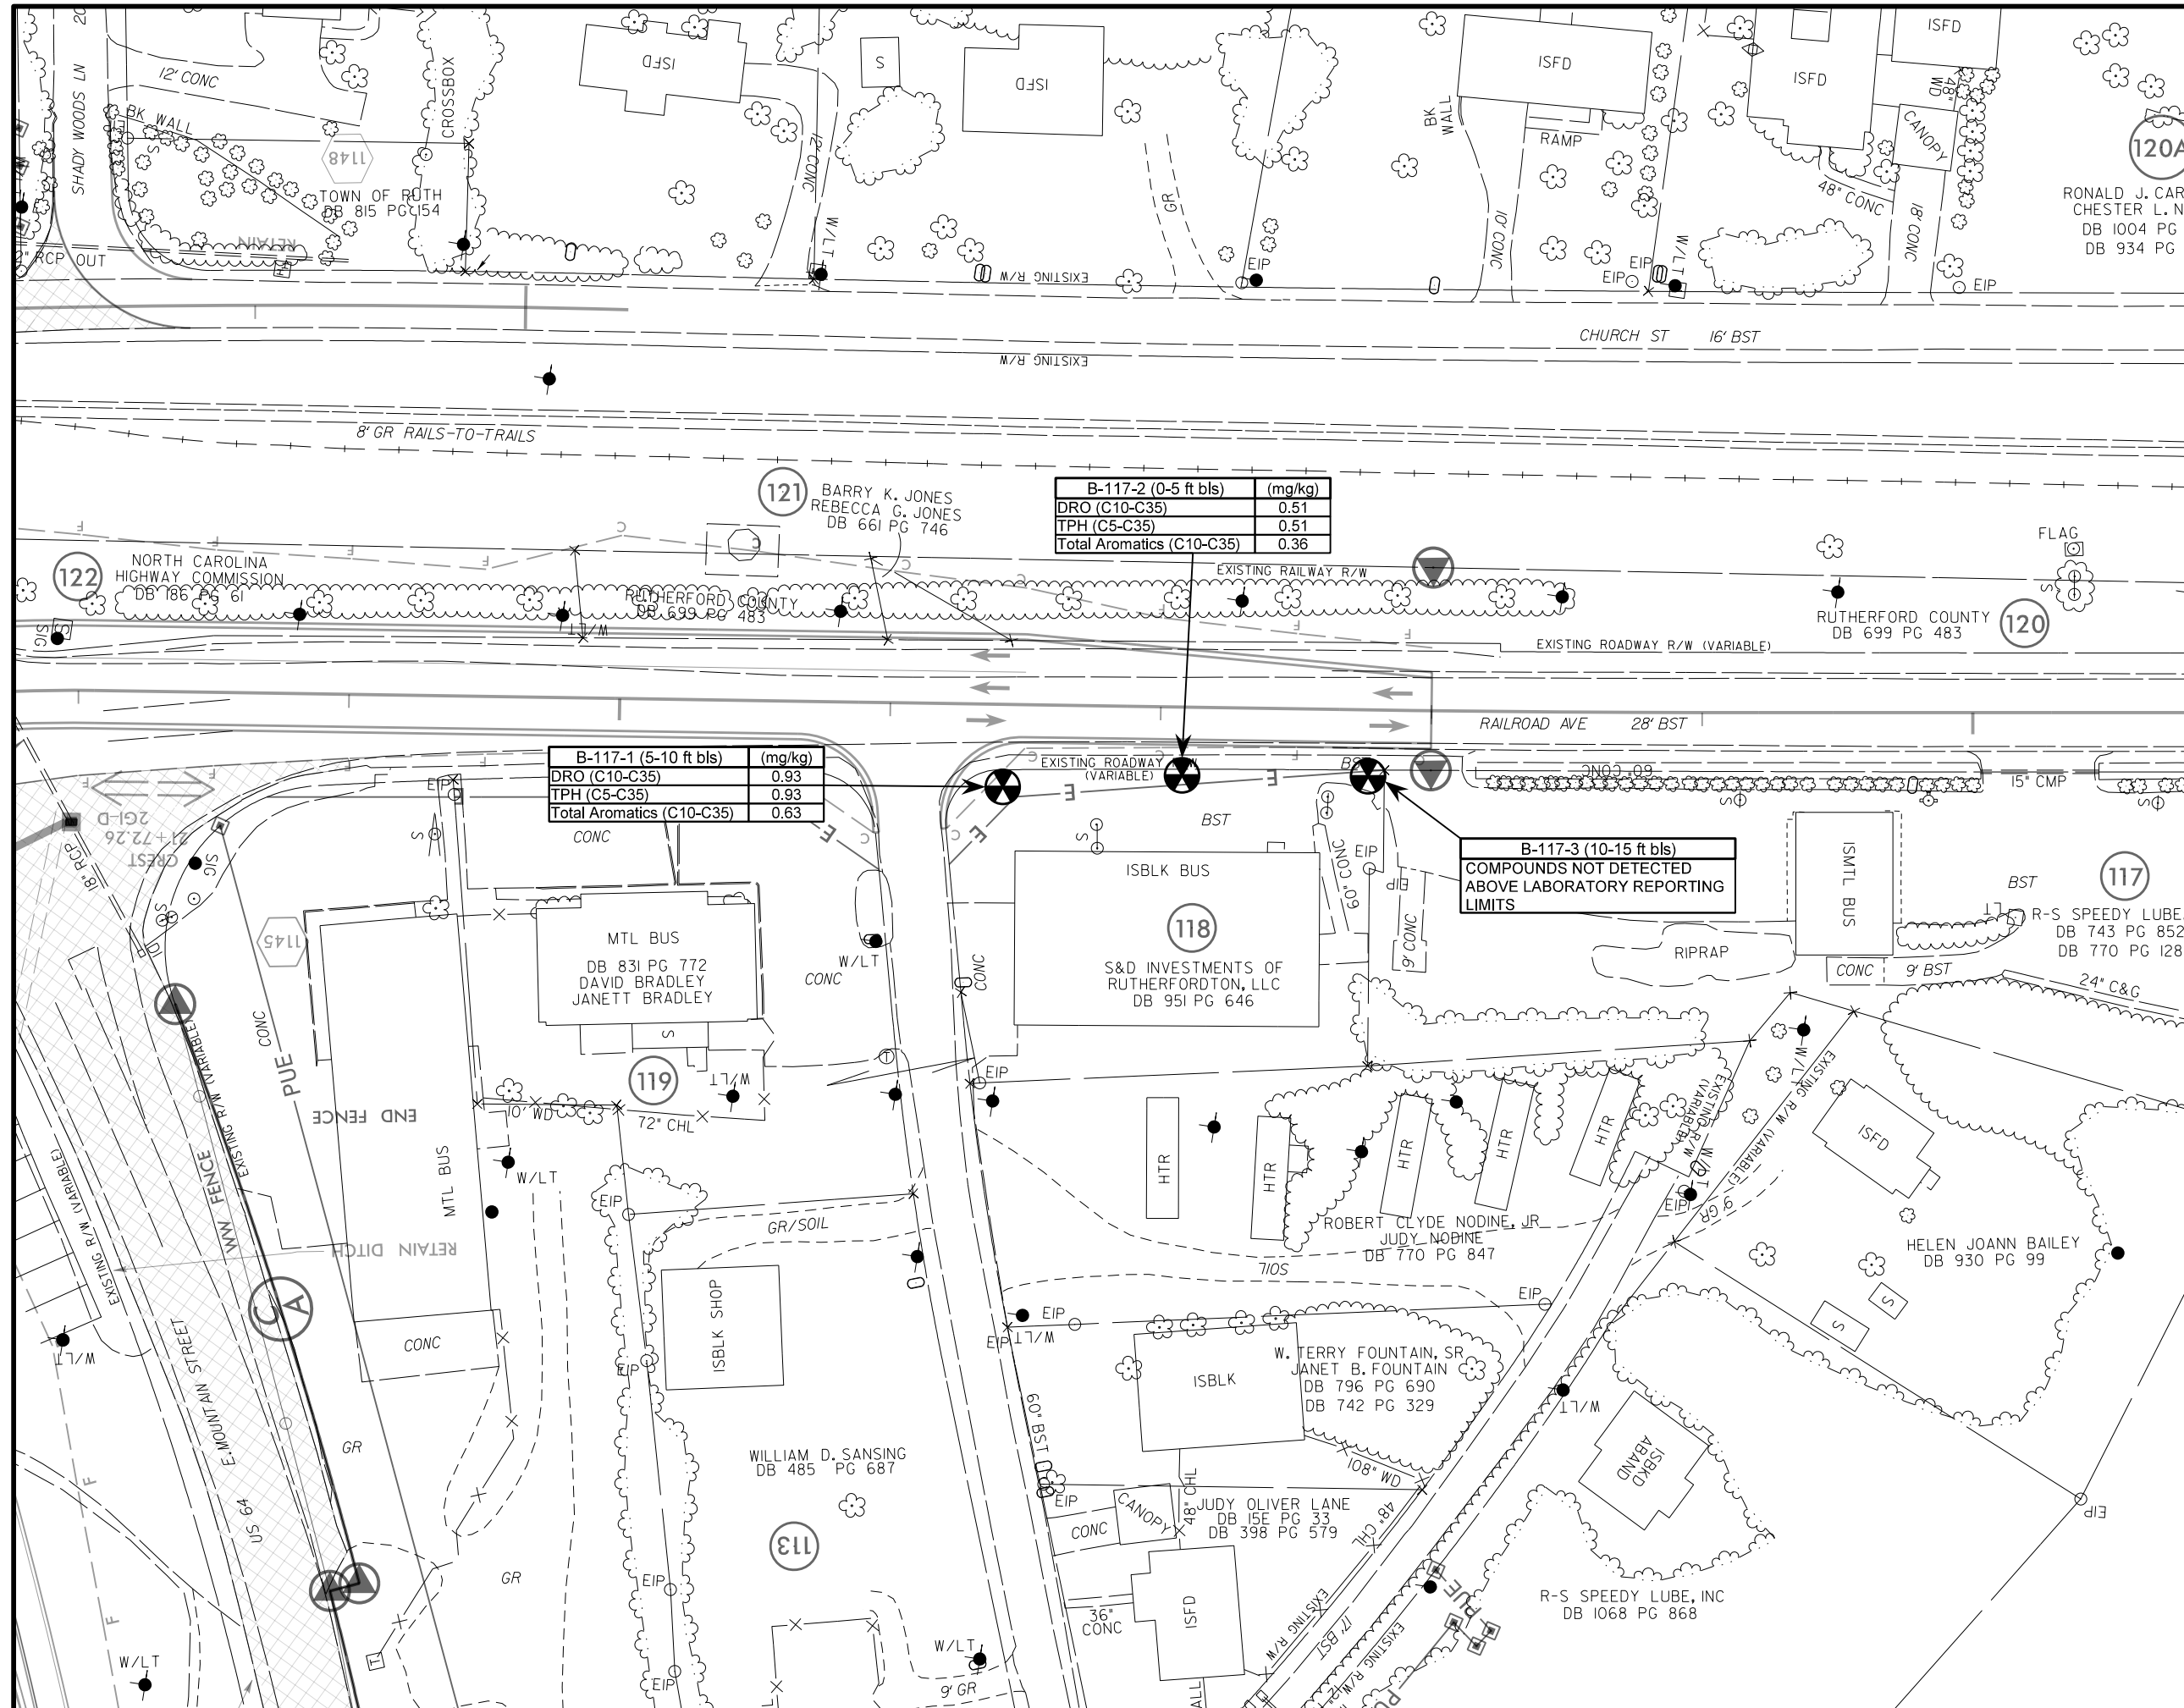
SITE DIAGRAM WITH BORING LOCATIONS

PARCEL 118 - S&D INVESTMENTS OF RUTHERFORDTON, LLC. PROPERTY
 877 - 881 RAILROAD AVENUE
 RUTHERFORDTON, RUTHERFORD COUNTY

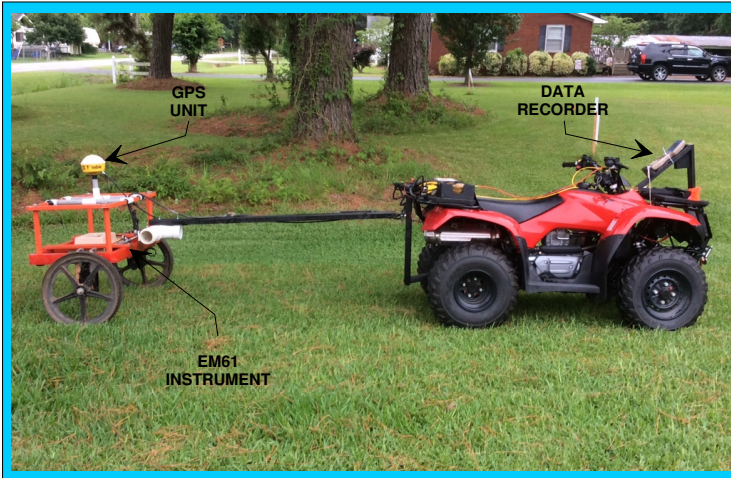
EM61 METAL DETECTOR

The photograph shows the Geonics EM61-MK2A metal detector, a Hemisphere A101 GPS unit, a Juniper data recorder, and a Honda Recon ATV which were used to conduct the metal detection survey across the S&D Investments of Rutherforddon LLC property.

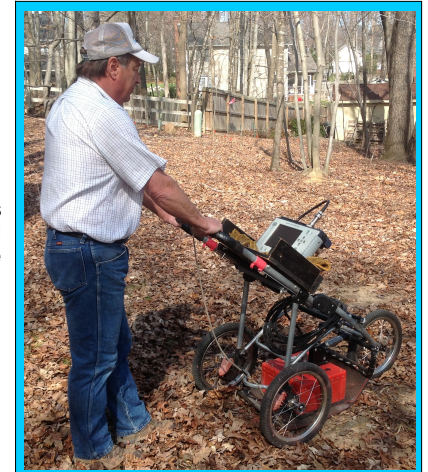
GROUND PENETRATING RADAR UNIT

The photograph shows the Geophysical Survey Systems SIR-3000 ground penetrating radar (GPR) unit equipped with a 400 MHz antenna that were used to conduct the GPR scanning across selected portions of the site.

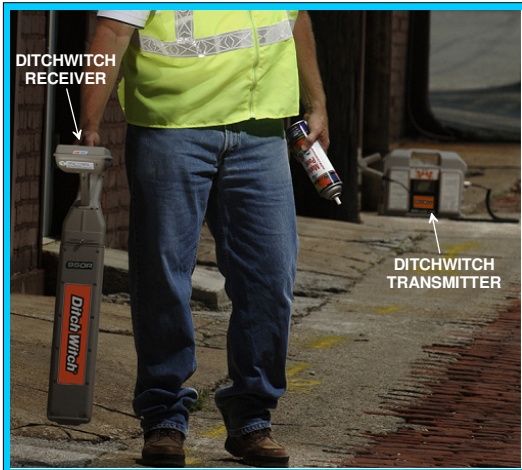
DITCHWITCH UTILITY LOCATOR

The photograph shows the Ditch Witch 910 utility locator which was used to detect buried lines across the proposed boring locations.

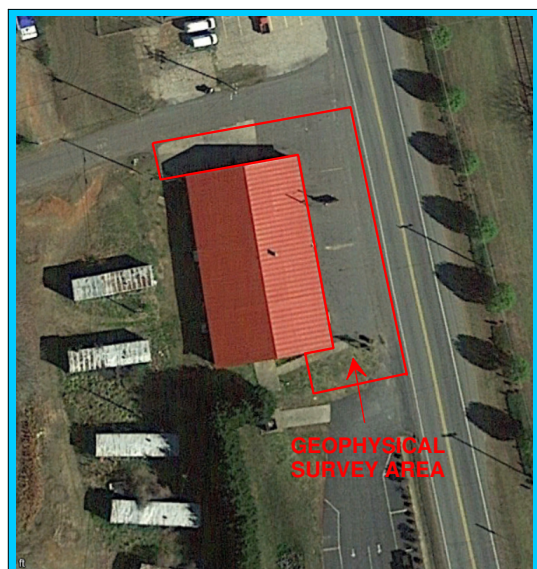
GEOPHYSICAL SURVEY AREA

The red polygon in the aerial photograph represents the approximate perimeter of the geophysical survey area at the S&D Investments of Rutherforddon LLC property (Parcel 118). The geophysical investigation was conducted on July 28 and August 2, 2017.

The red polygon in the aerial photograph represents the approximate perimeter of the geophysical survey area at Parcel 118.

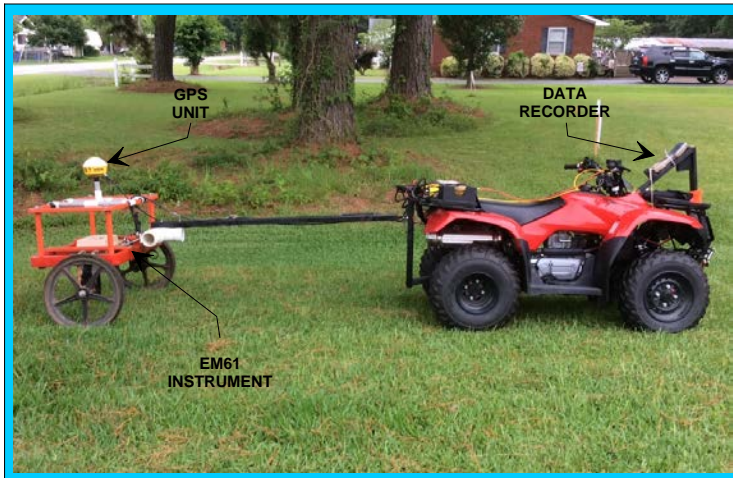
EM61 METAL DETECTOR

The photograph shows the Geonics EM61-MK2A metal detector, a Hemisphere A101 GPS unit, a Juniper data recorder, and a Honda Recon ATV which were used to conduct the metal detection survey across the Timothy & Lois Mace property.

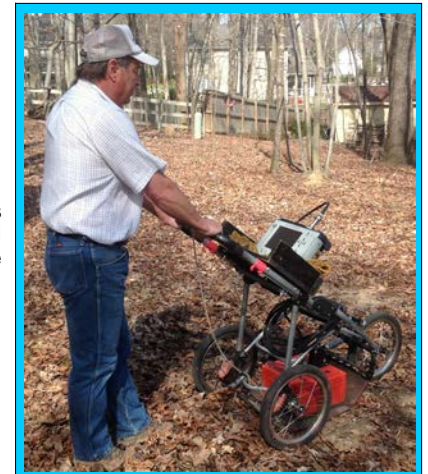
GROUND PENETRATING RADAR UNIT

The photograph shows the Geophysical Survey Systems SIR-3000 ground penetrating radar (GPR) unit equipped with a 400 MHz antenna that were used to conduct the GPR scanning across selected portions of the site.

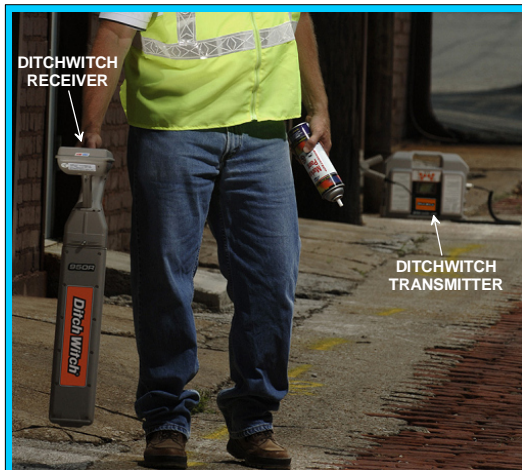
DITCHWITCH UTILITY LOCATOR

The photograph shows the DitchWitch 910 utility locator which was used to detect buried lines across the proposed boring locations.

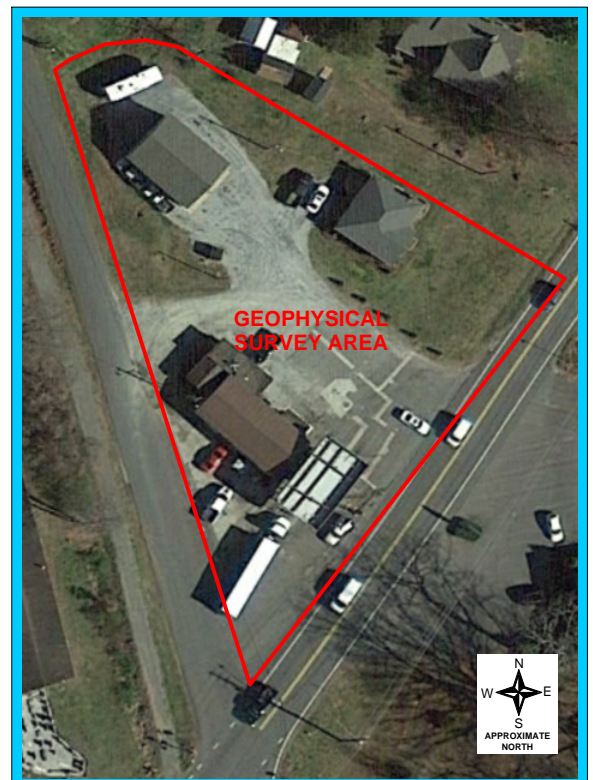
GEOPHYSICAL SURVEY AREA

The red polygon in the aerial photograph represents the approximate perimeter of the geophysical survey area at the Timothy & Lois Mace property (Parcel 125). The geophysical investigation was conducted on July 28 and August 2-3, 2017.

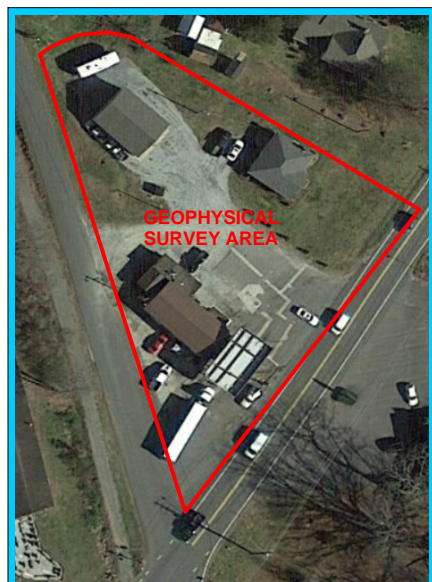
The red polygon in the aerial photograph represents the approximate perimeter of the geophysical survey area at Parcel 125

The contour plot shows the early time gate (most sensitive) response of the Geonics EM61-MK2A metal detection instrument in millivolts (mV). The early time gate response shows buried, metallic objects, lines and conduits regardless of size. GPR scans were conducted across selected EM61 anomalies and steel reinforced concrete using a Geophysical Survey Systems SIR 3000 instrument with a 400 MHz antenna. The geophysical investigation was conducted on July 28 and August 2 - 3, 2017.

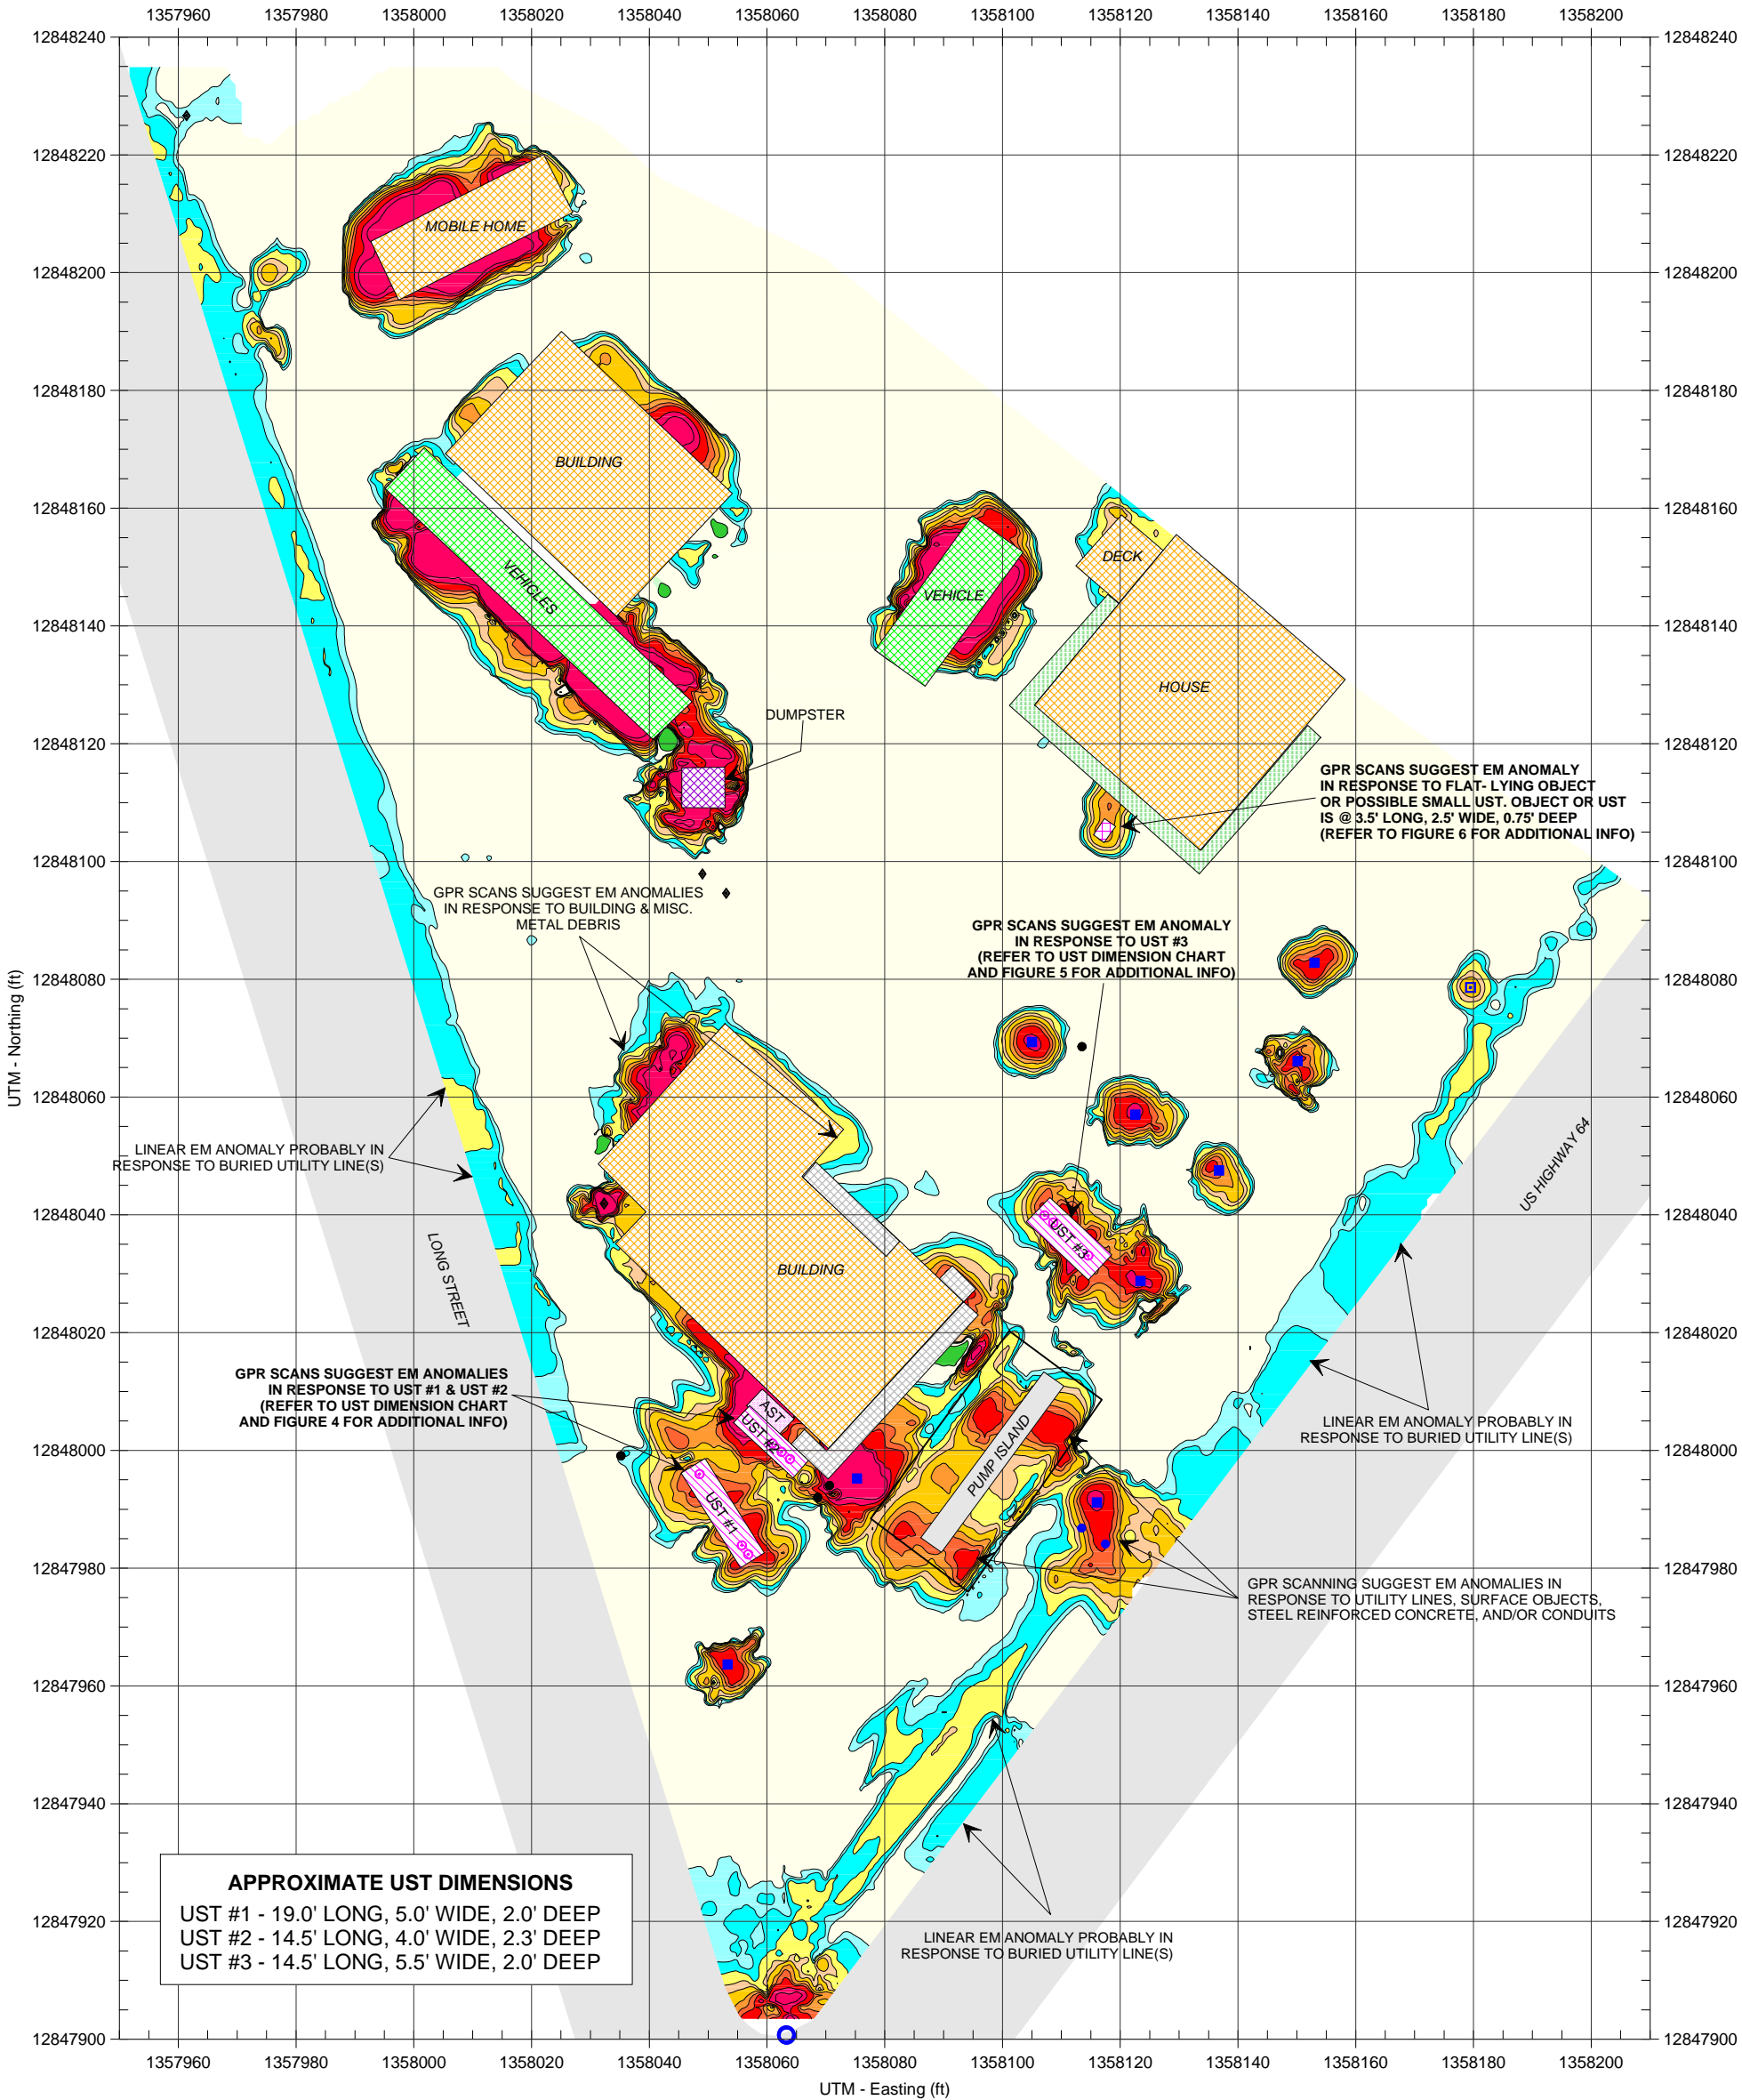
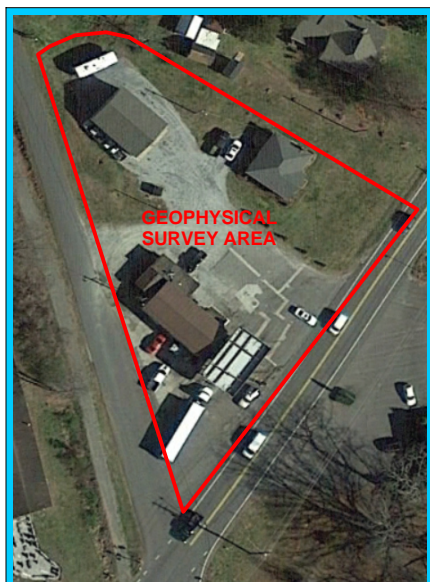
EM61-MK2A METAL DETECTION
(DIFFERENTIAL RESULTS)

The red polygon in the aerial photograph represents the approximate perimeter of the geophysical survey area at Parcel 125

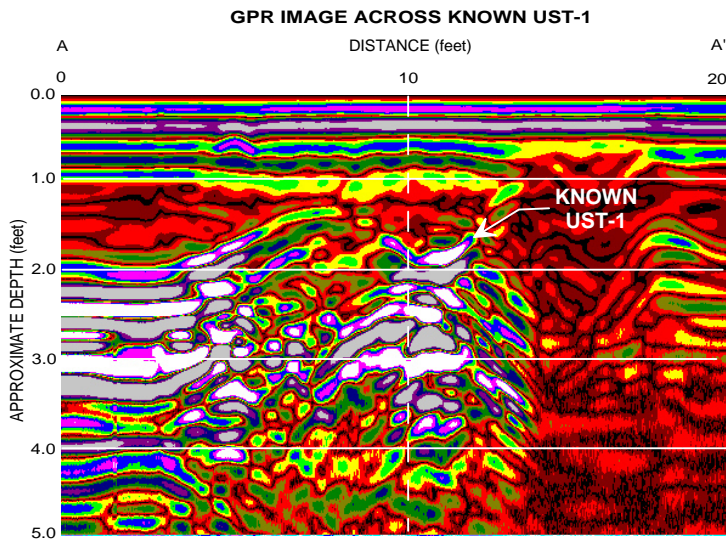
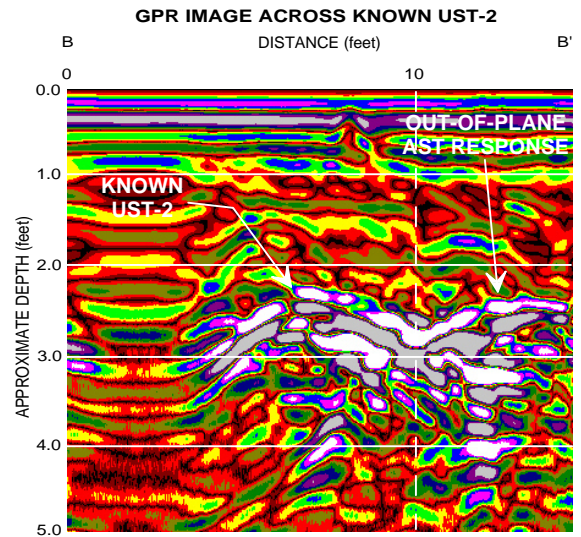
The high amplitude, hyperbolic reflections in the GPR image (left) are probably in response to known (active) UST-1 buried approximately 2.0 feet below present grade. The purple line labeled AA' in the photograph shown below represents the approximate location of the GPR image.

The high amplitude, hyperbolic reflections in the GPR image (right) are probably in response to known (active) UST-2 buried approximately 2.3 feet below present grade. The purple line labeled BB' in the photograph shown below represents the approximate location of the GPR image.

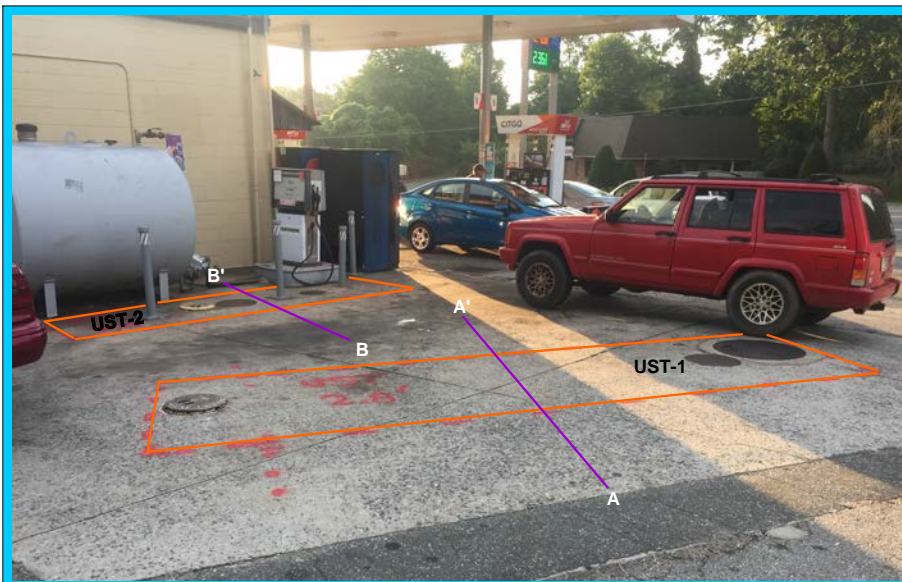
The orange rectangles in the photograph represent the approximate foot prints of known USTs-1 and 2 that were detected by the geophysical investigation. Based on the GPR data, active UST-1 is approximately 19.0 feet long, 5.0 feet wide and buried 2.0 feet below present grade. Active UST-2 is approximately 14.5 feet long, 4.0 feet wide and buried 2.3 feet below present grade.

The solid purple lines labeled AA' and BB' in the photograph represent the approximate location of GPR images AA' and BB' shown above. The photograph is viewed in an easterly direction.

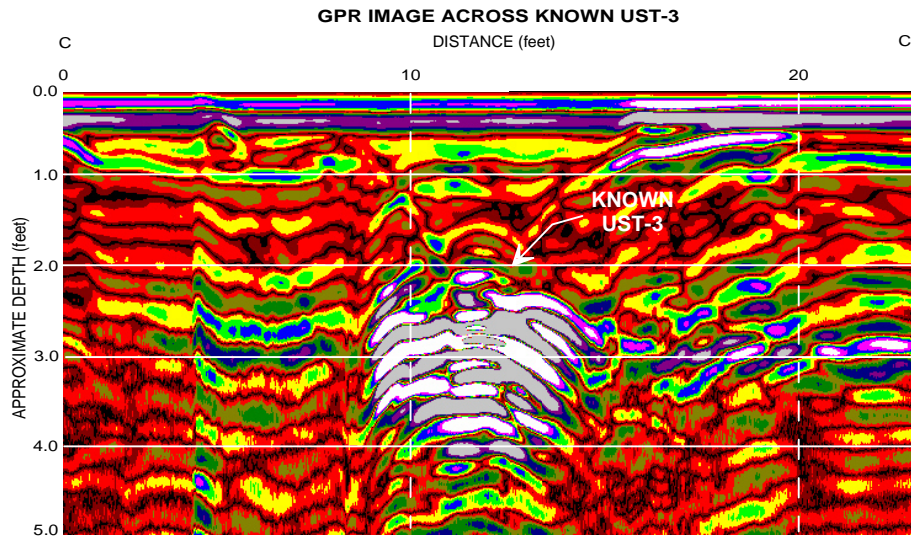
The high amplitude, hyperbolic reflections in the GPR image (above) are probably in response to known (active) UST-3 buried approximately 2.0 feet below present grade. The purple line labeled CC' in the photograph shown below represents the approximate location of the GPR image.

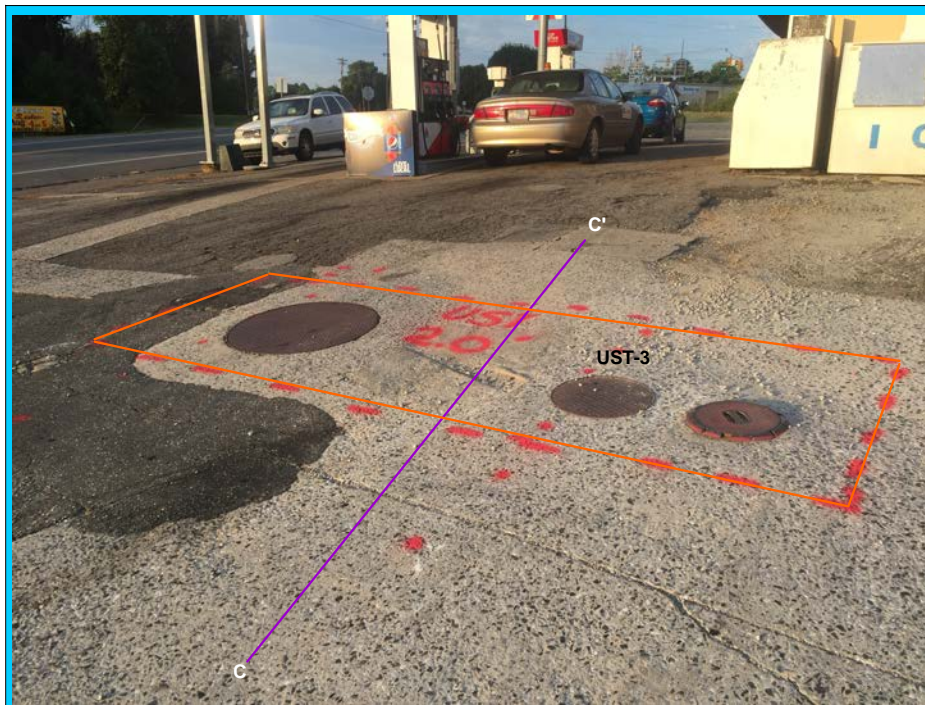
The orange rectangle in the photograph represents the approximate foot print of known UST-3 that was detected by the geophysical investigation. Based on the GPR data, the active UST is approximately 14.5 feet long, 5.5 feet wide and buried 2.0 feet below present grade. The solid purple line labeled CC' in the photograph represents the approximate location of GPR image CC' shown above. The photograph is viewed in a southwesterly direction.

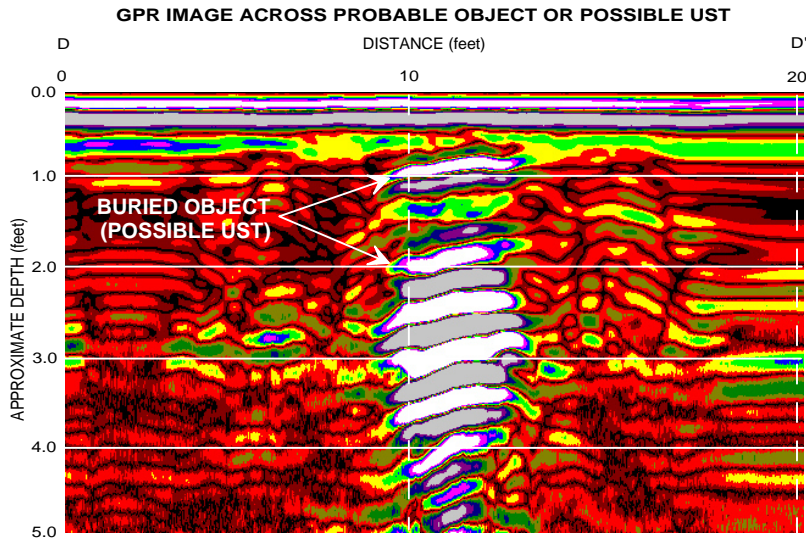
The high amplitude, flat-lying reflections in the GPR image (above) are probably in response to a miscellaneous, metal object or a possible (low confidence) UST buried approximately 0.75 feet below present grade. The purple line labeled DD' in the photograph shown below represents the approximate location of the GPR image.

- GPR scanning suggests that the EM61 differential anomaly centered near UTM coordinates 1358117-E 12848105-N is probably in response to a flat-lying, miscellaneous, metallic object or to a possible (low confidence) small UST. An intrusive investigation is recommended to determine the identity of the buried object or possible UST.
- Excluding the aforementioned active three USTs and the possible, small UST located adjacent to the home, the EM61 and GPR investigation suggests the remaining portion of the geophysical survey area (proposed ROW/PUE area) at Parcel 125 does not contain metallic USTs.

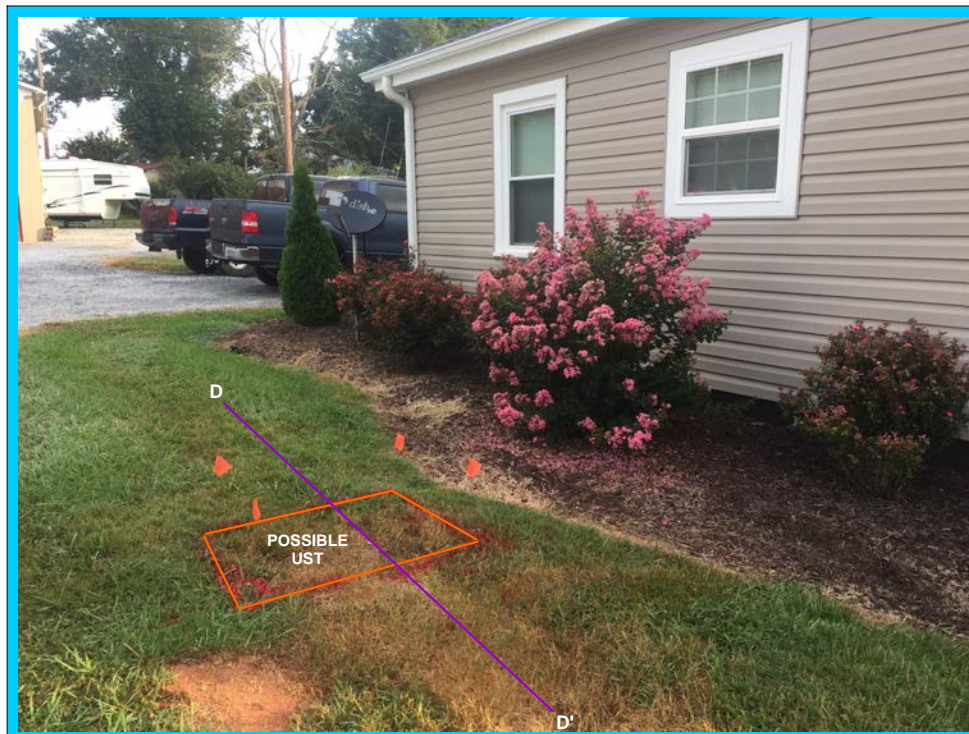
The orange rectangle in the photograph represents the approximate foot print of a probable, miscellaneous, buried, metallic object or a possible (low confidence) UST that was detected by the geophysical investigation. Based on the GPR data, the probable object/possible UST is approximately 3.5 feet long, 2.5 feet wide and buried 0.75 feet below present grade. The solid purple line labeled DD' in the photograph represents the approximate location of GPR image DD' shown above. The photograph is viewed in a northerly direction.

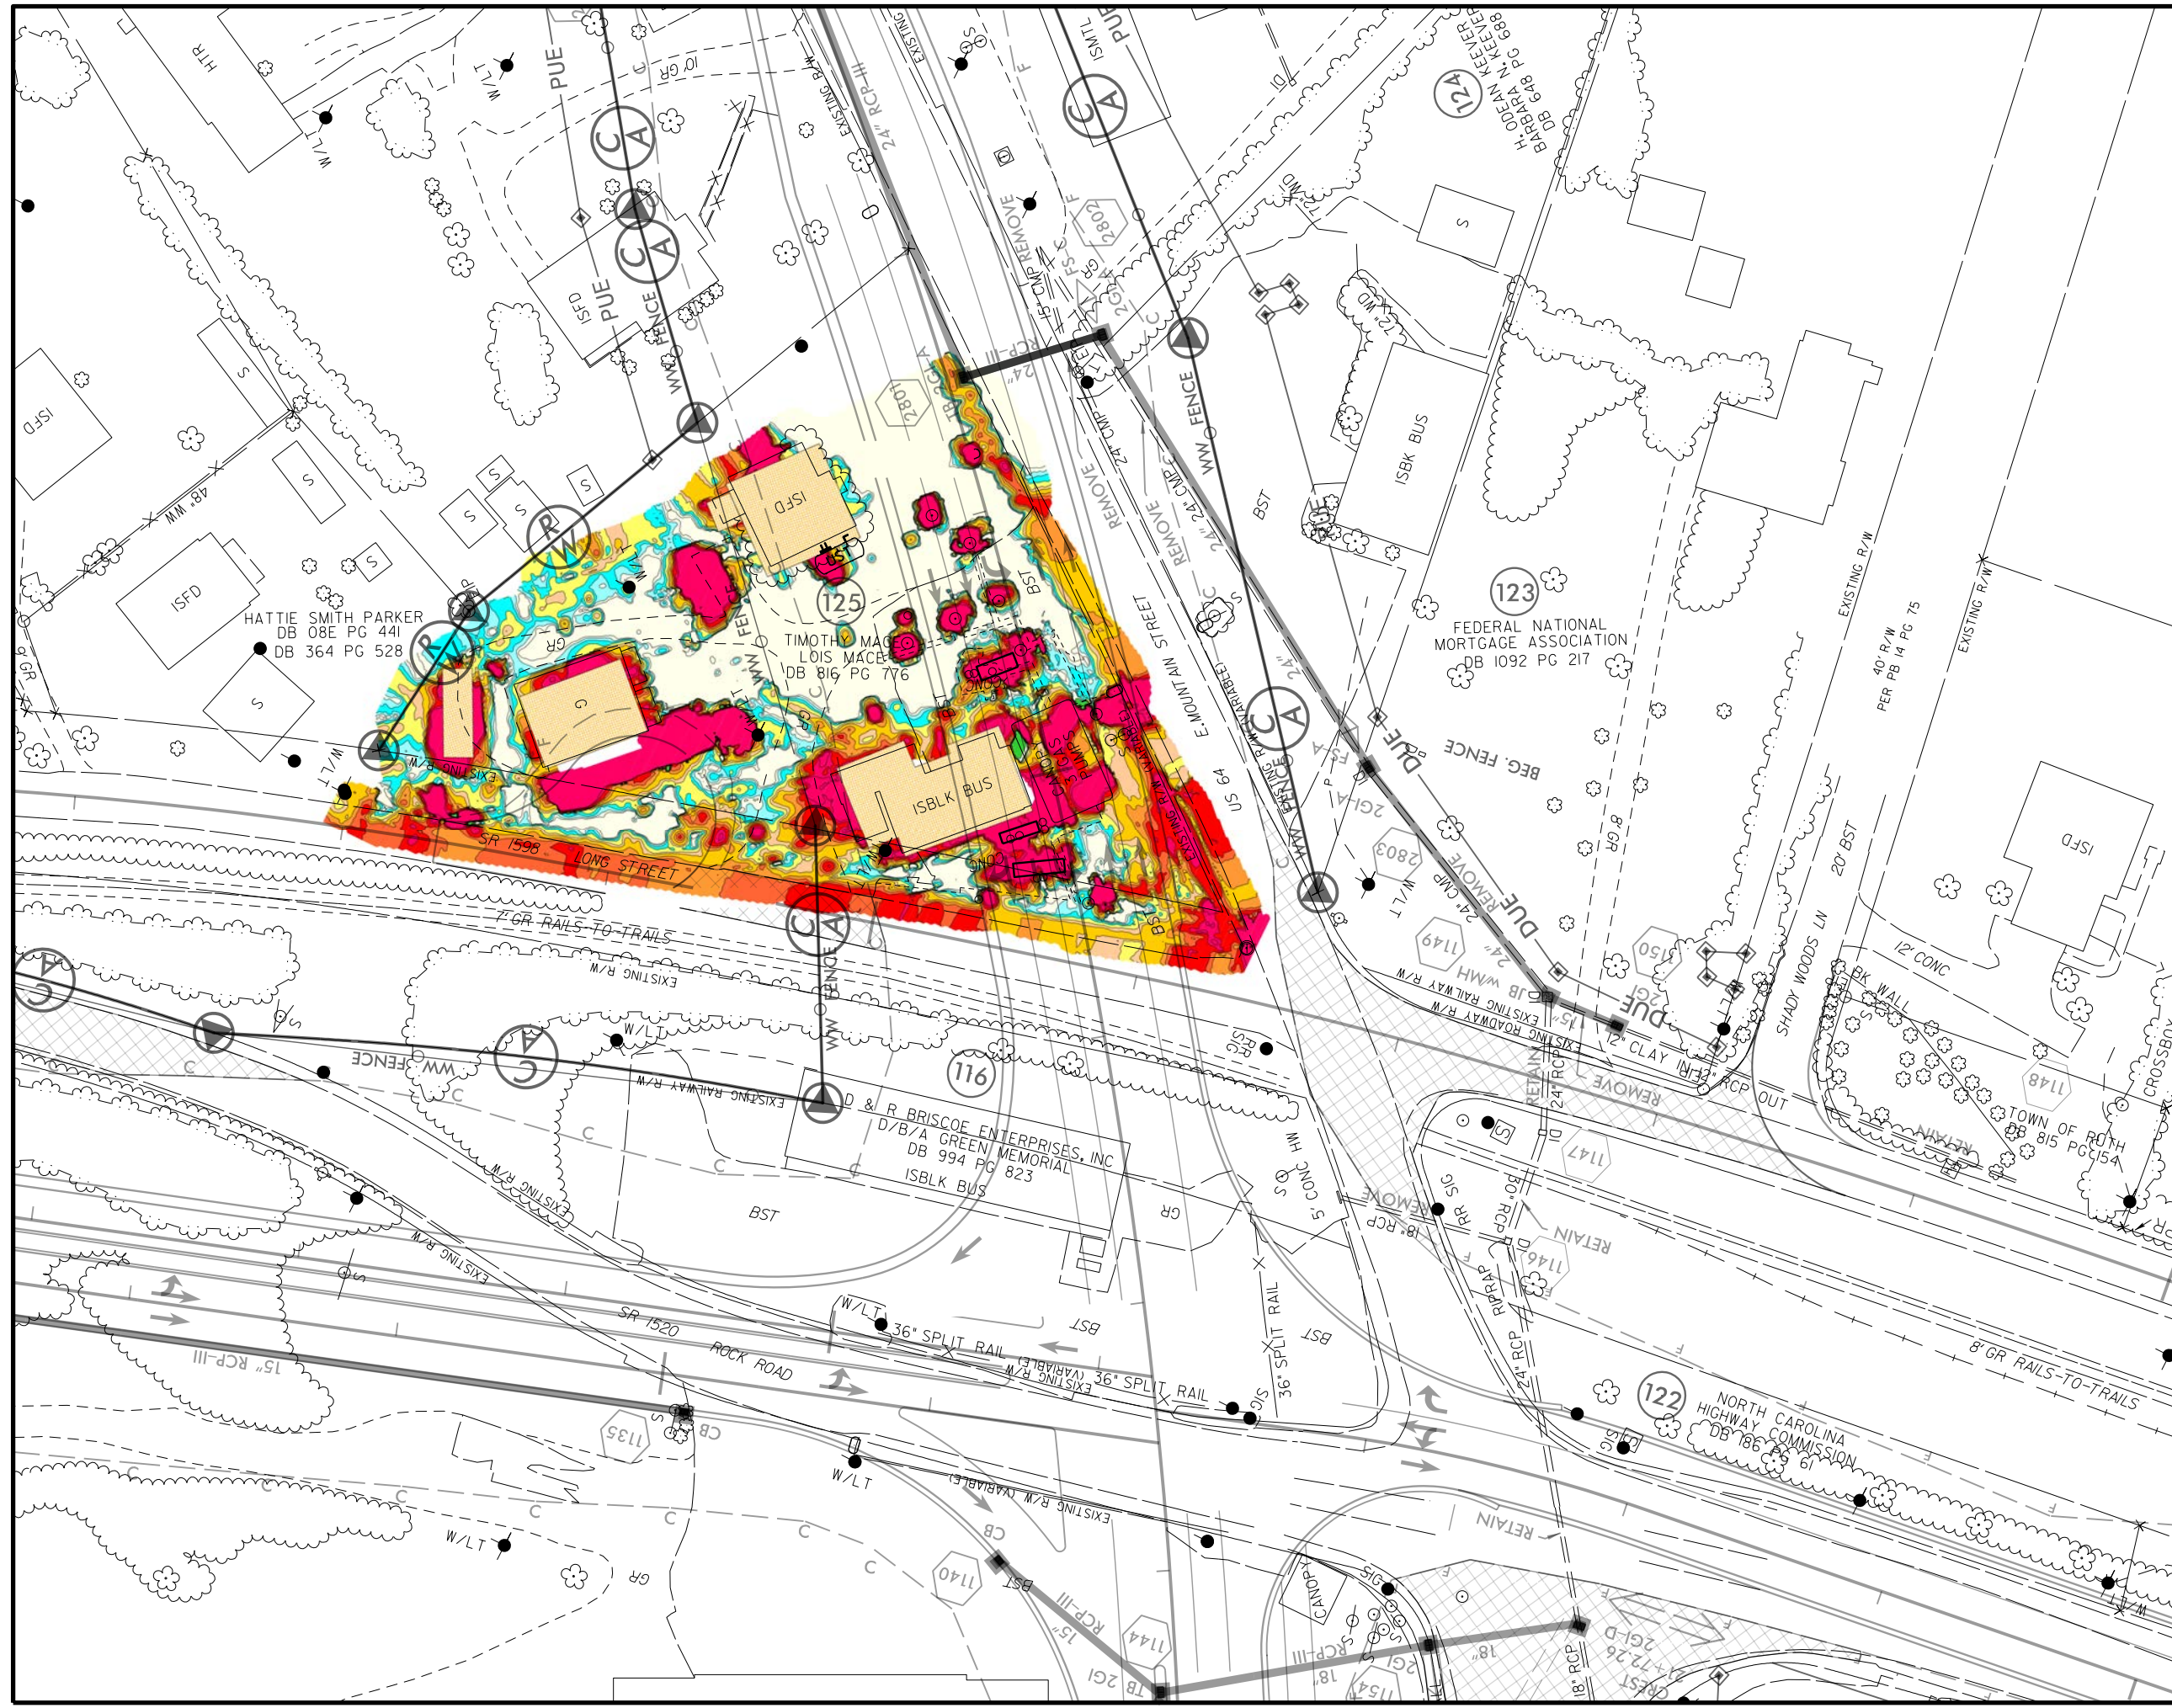
- LEGEND**
- PROPERTY LINE
 - EXISTING RIGHT OF WAY LINE
 - ⊕ ⊖ PROPOSED CONTROL OF ACCESS LINE WITH CONCRETE MARKER
 - ⊕ ⊖ PROPOSED RIGHT OF WAY WITH MARKER
 - EXISTING EDGE OF PAVEMENT
 - PROPOSED EDGE OF TRAVEL
 - F C PROPOSED CUT / FILL LINE
 - PROPOSED CATCH BASIN
 - PROPOSED DRAINAGE PIPING
 - PUE PROPOSED PERMANENT UTILITY EASEMENT
 - DUE PROPOSED PERMANENT DRAINAGE / UTILITY EASEMENT
 - ⊗ BORING LOCATION
 - OUTLINE OF KNOWN UST LOCATION
 - ▬ UST POSSIBLE UST LOCATION

- n The geophysical investigation confirmed the presence of three USTs associated with the operations of the gasoline station as well as a potential fourth UST located near the on-site residence. The metal detection and GPR scans also identified underground utility lines within the depth interval of zero to eight feet bls.
- n Terracon recommends the NCDOT obtain permission from the property owner prior to conducting the planned soil sampling activities at Parcel 125.
