Preliminary Site Assessment

**US 221 South of US 74 Business (Charlotte Road) to North of
SR 1366 (Roper Loop Road)
Parcel 243 – Heath and Erin McSwain
174 US Highway 64, Rutherfordton, North Carolina**

State Project No. R-2233BB

Terracon Project No. 71177323

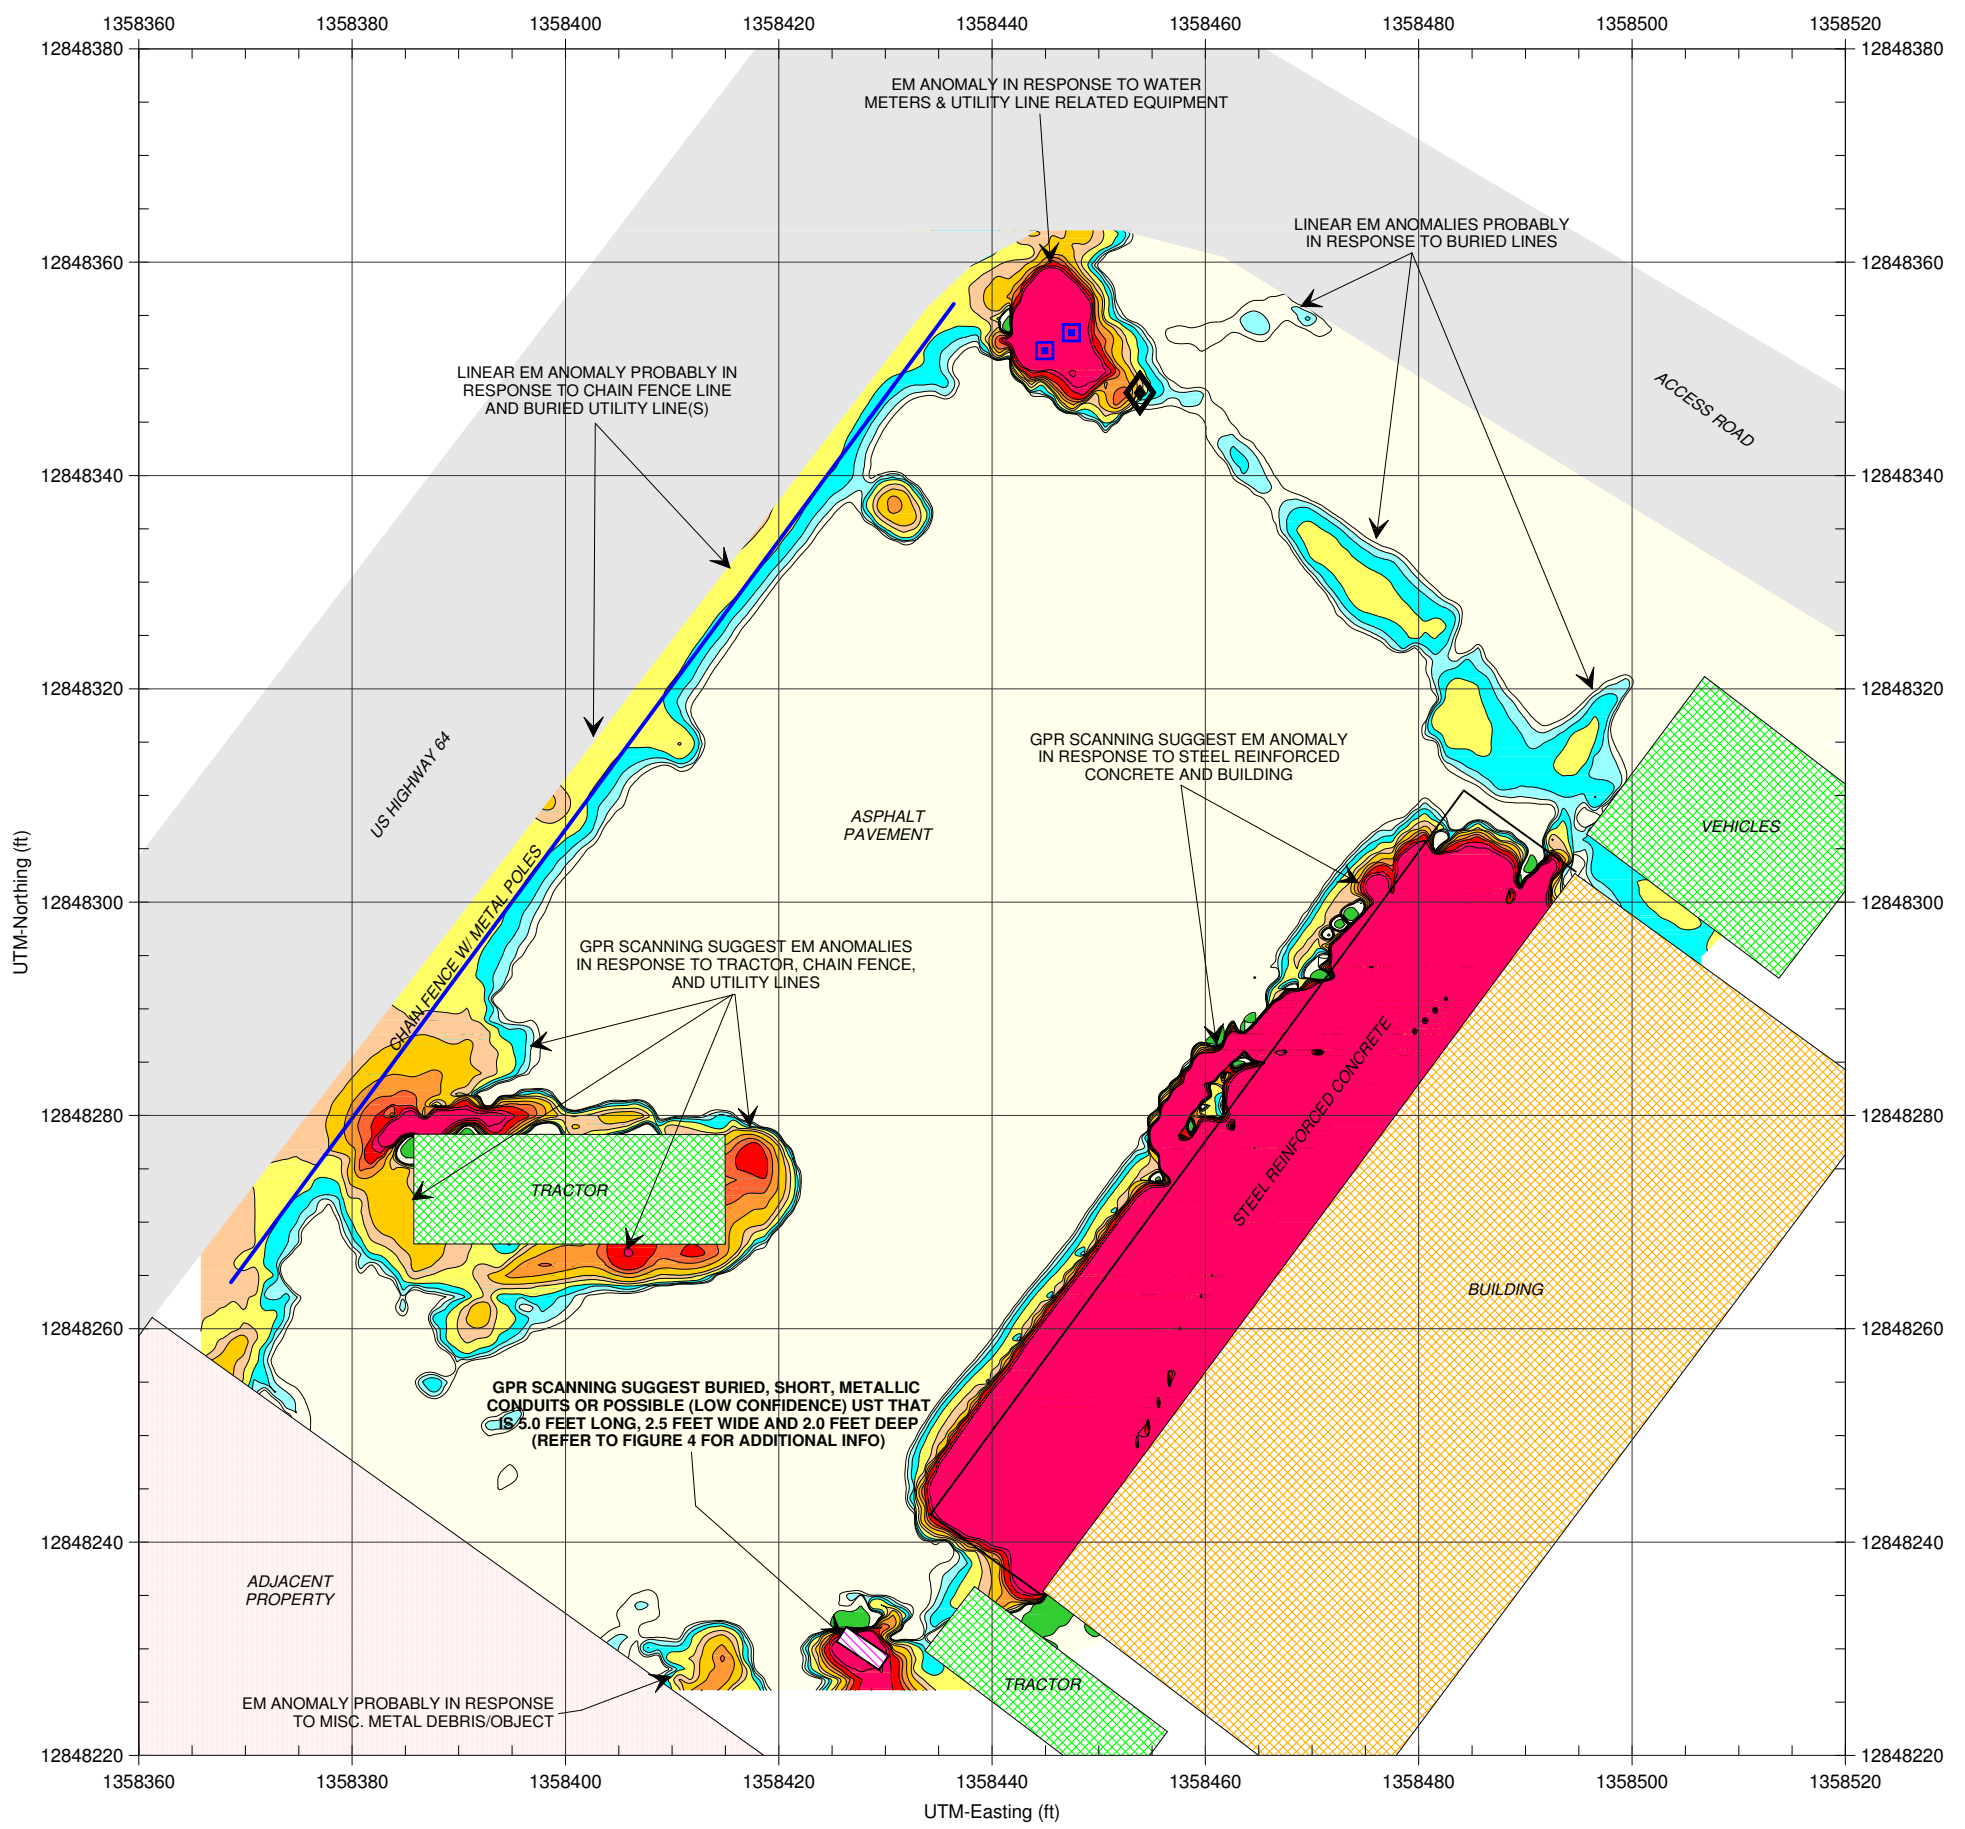
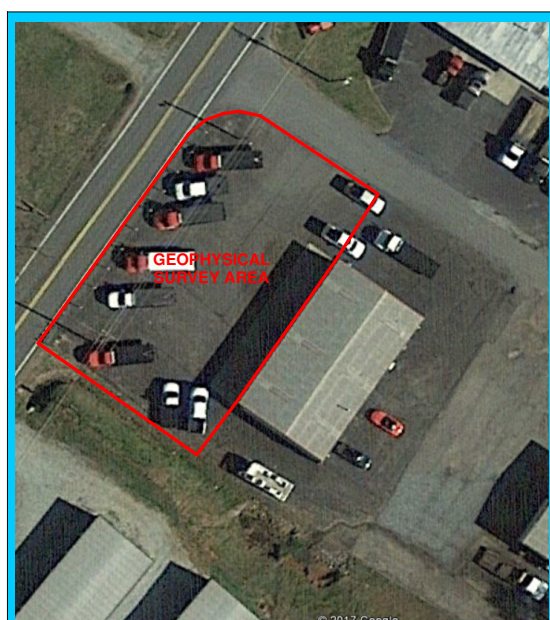
**EM61-MK2A METAL DETECTION
(EARLY TIME GATE RESULTS)**

The linear, EM61 early time gate anomalies intersecting UTM coordinates 1358411-E 12848323-N and 1358473-E 12848330-N are probably in response to buried utility lines. The early time gate anomalies at 1358431-E 12848337-N and 1358413-E 12848228-N are probably in response to buried, miscellaneous metal debris or objects.

GPR scanning suggests that the large, high-amplitude, EM61 anomaly centered near UTM coordinates 1358463-E 12848272-N is in response to steel reinforced concrete pavement that runs along the edge of the building. GPR data suggest the EM61 differential anomalies centered near coordinates 1358399-E 12848272-N are in response to the tractor that was present during data acquisition.

The red polygon in the aerial photograph represents the approximate perimeter of the geophysical survey area at Parcel 243.

The contour plot shows the early time gate (most sensitive) response of the Geonics EM61-MK2A metal detection instrument in millivolts (mV). The early time gate response shows buried, metallic objects, lines and conduits regardless of size. GPR scans were conducted across selected EM61 anomalies and steel reinforced concrete using a Geophysical Survey Systems SIR 3000 instrument with a 400 MHz antenna. The geophysical investigation was conducted on July 28 and August 2, 2017.

Contour plots of the EM61 early time gate results and the EM61 differential results are presented in **Figures 2 and 3**, respectively. The early time gate results represent the most sensitive component of the EM61 instrument and detect metal objects regardless of size. The early time gate response can be used to delineate metallic conduits or utility lines, small, isolated, metal objects and areas containing insignificant metal debris. The differential results are obtained from the difference between the early time gate channel and late time gate channel of the EM61 instrument. The differential results focus on the larger metal objects such as drums and UST-size objects and ignore the smaller, insignificant, metal objects or debris.

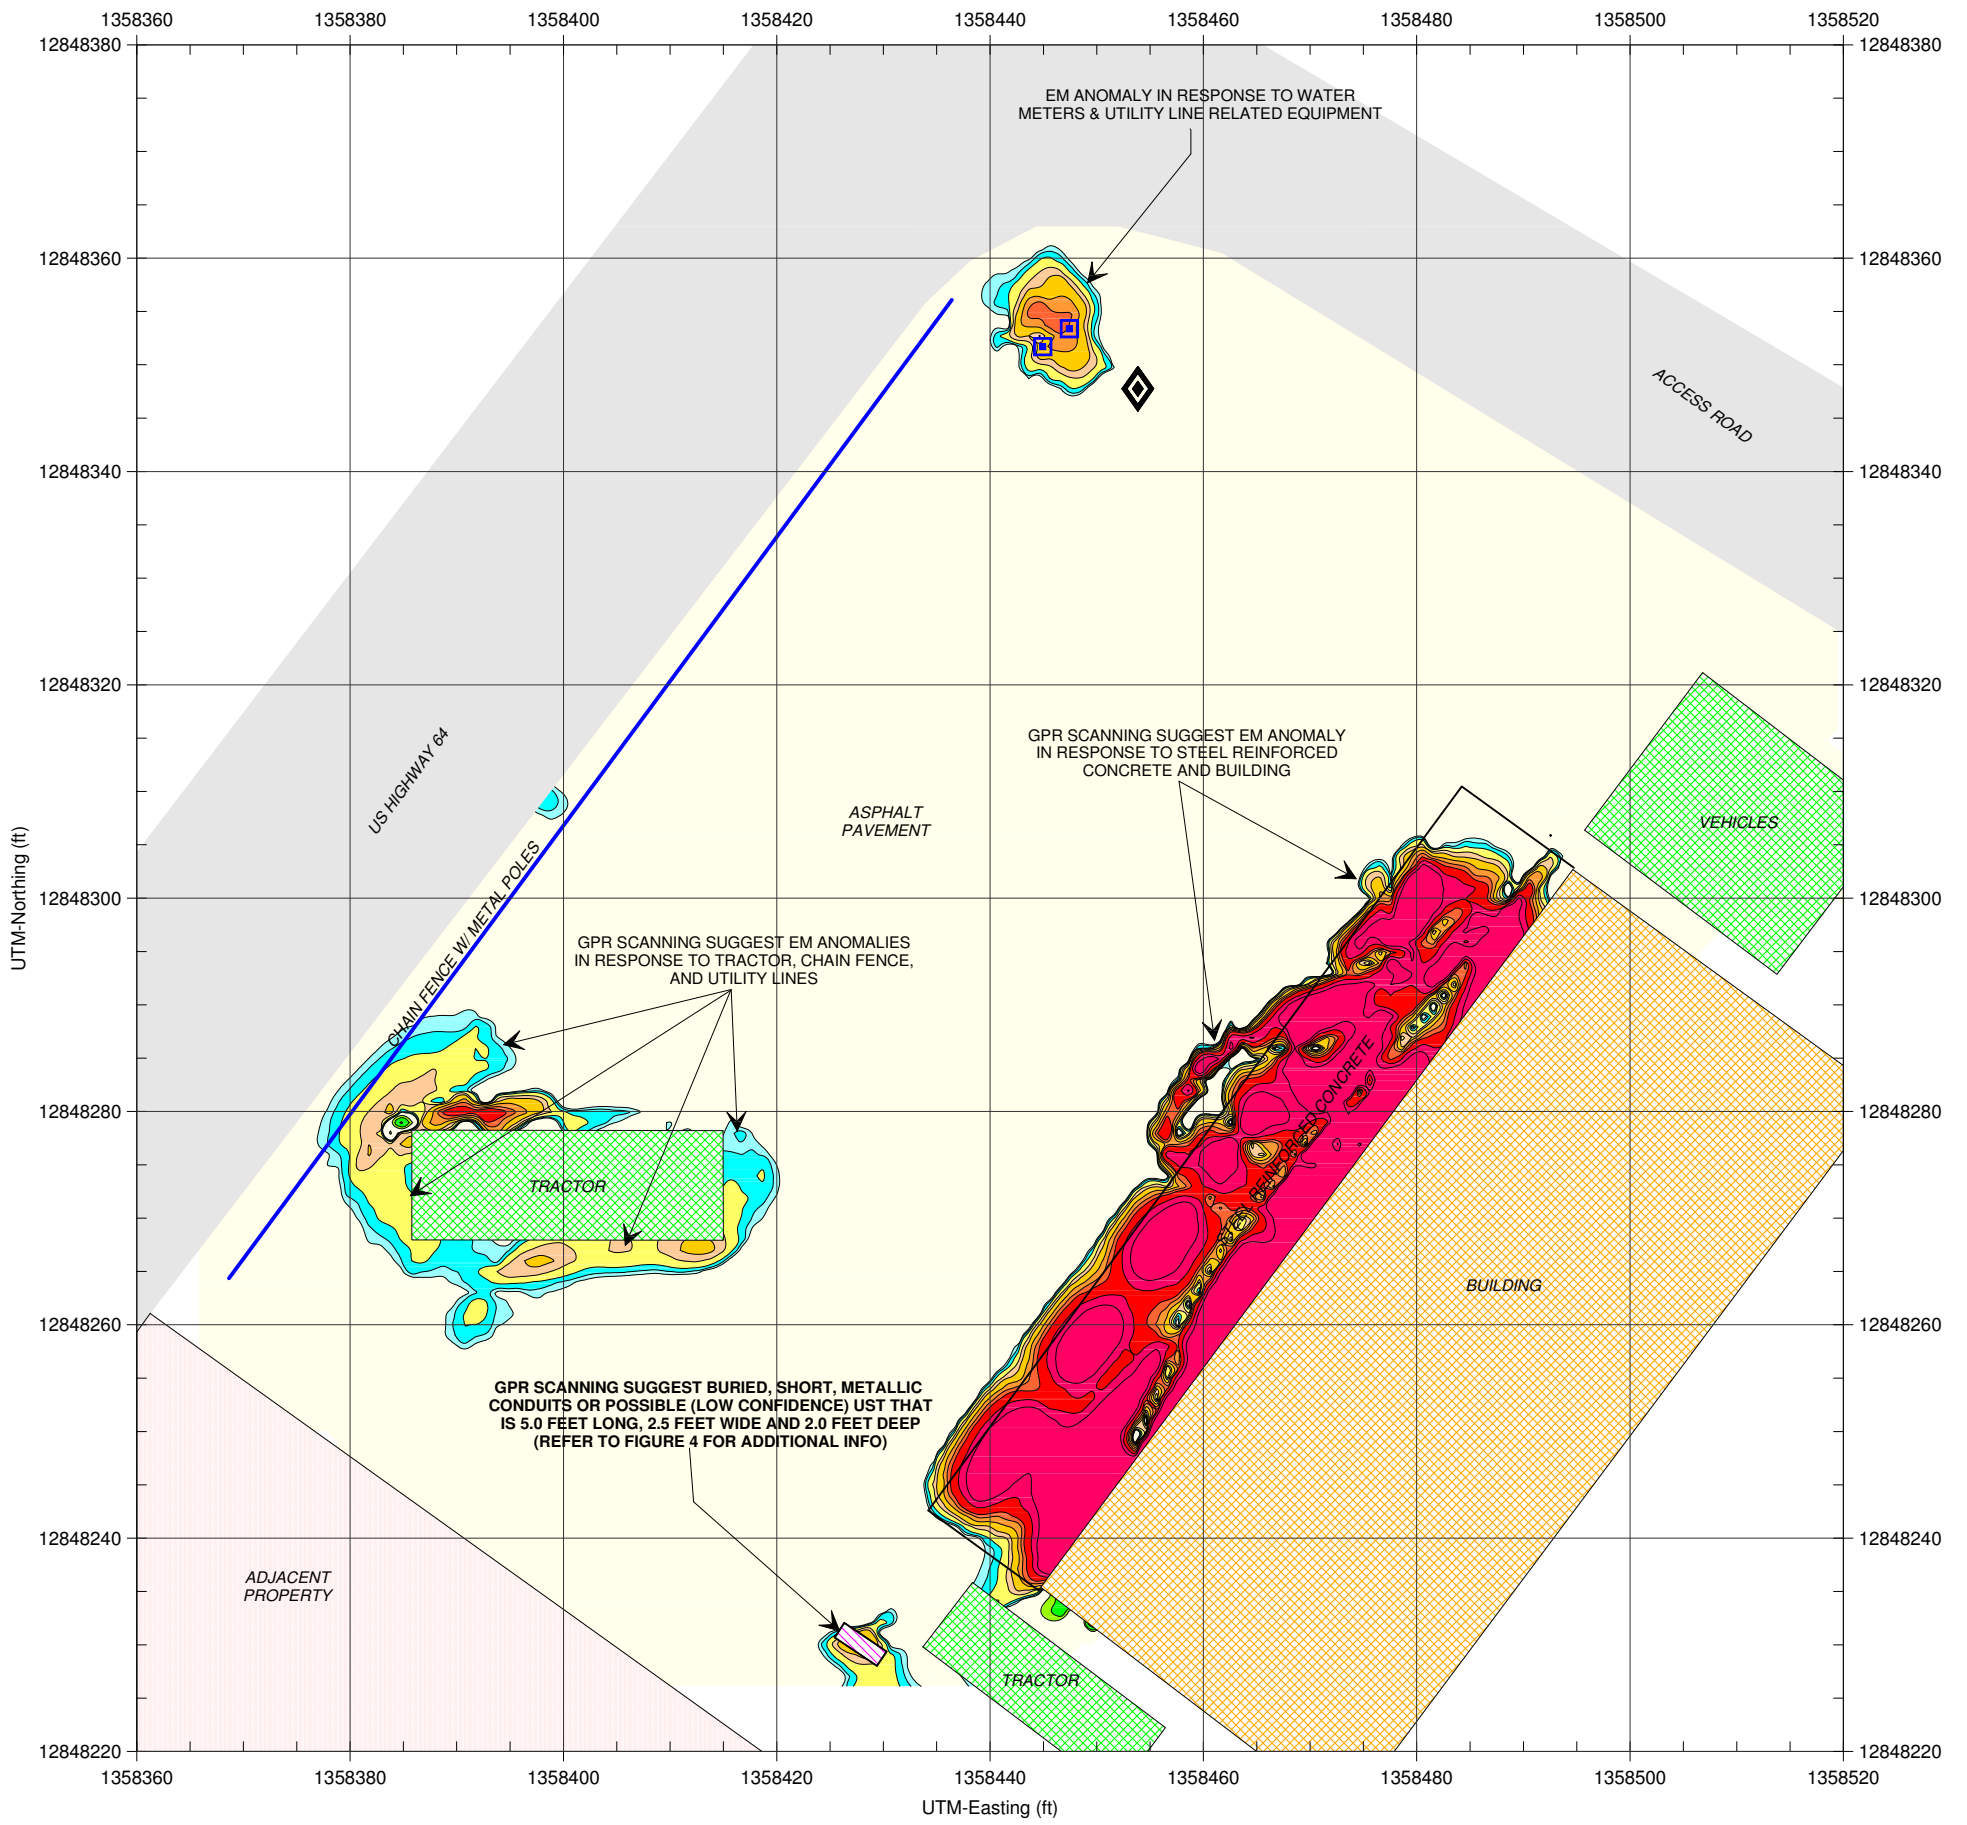
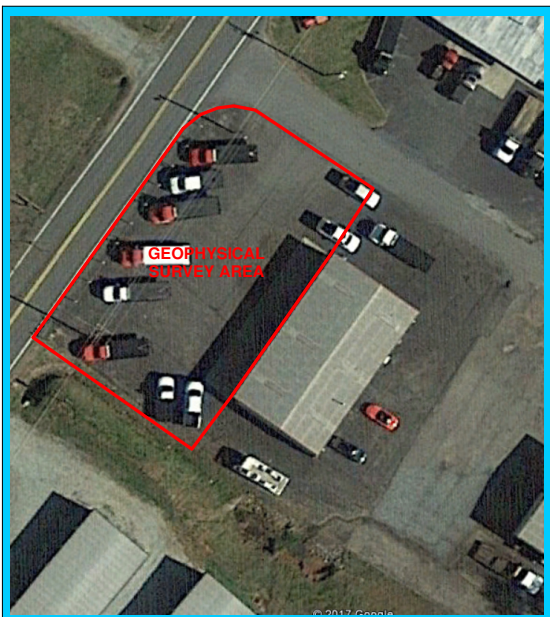
EM61-MK2A METAL DETECTION (DIFFERENTIAL RESULTS)

GPR scanning suggests that the EM61 differential anomaly centered near UTM coordinates 1358427-E 12848230-N is probably in response to two short segments of metallic conduits or a possible (low confidence) UST oriented in a northwest-southeast direction. Based on the GPR data, the probable conduits or possible UST is approximately 5.0 feet long, 2.5 feet wide and buried 2.0 feet below present grade. A GPR image across the buried object and a photograph showing the location of the buried object are presented in **Figure 4**. An intrusive investigation is recommended to determine the identity of the buried object.

The red polygon in the aerial photograph represents the approximate perimeter of the geophysical survey area at Parcel 243.

Note: The contour plot shows the differential response between the early time gate and the late time gate channels of the Geonics EM61-MK2A metal detection instrument in millivolts (mV). The differential response focuses on larger, buried, metallic objects such as drums and USTs and ignores smaller miscellaneous, metal debris. Ground penetrating radar (GPR) scans were conducted across selected EM61 anomalies and areas containing reinforced concrete using a Geophysical Survey Systems SIR 3000 unit with a 400 MHz antenna. The geophysical investigation was conducted on July 28 and August 2, 2017.

- GPR scanning suggests that the EM61 differential anomaly centered near UTM coordinates 1358427-E 12848230-N is probably in response to two short segments of metallic conduits or a possible (low confidence) UST oriented in a northwest-southeast direction. An intrusive investigation is recommended to determine the identity of the buried object.

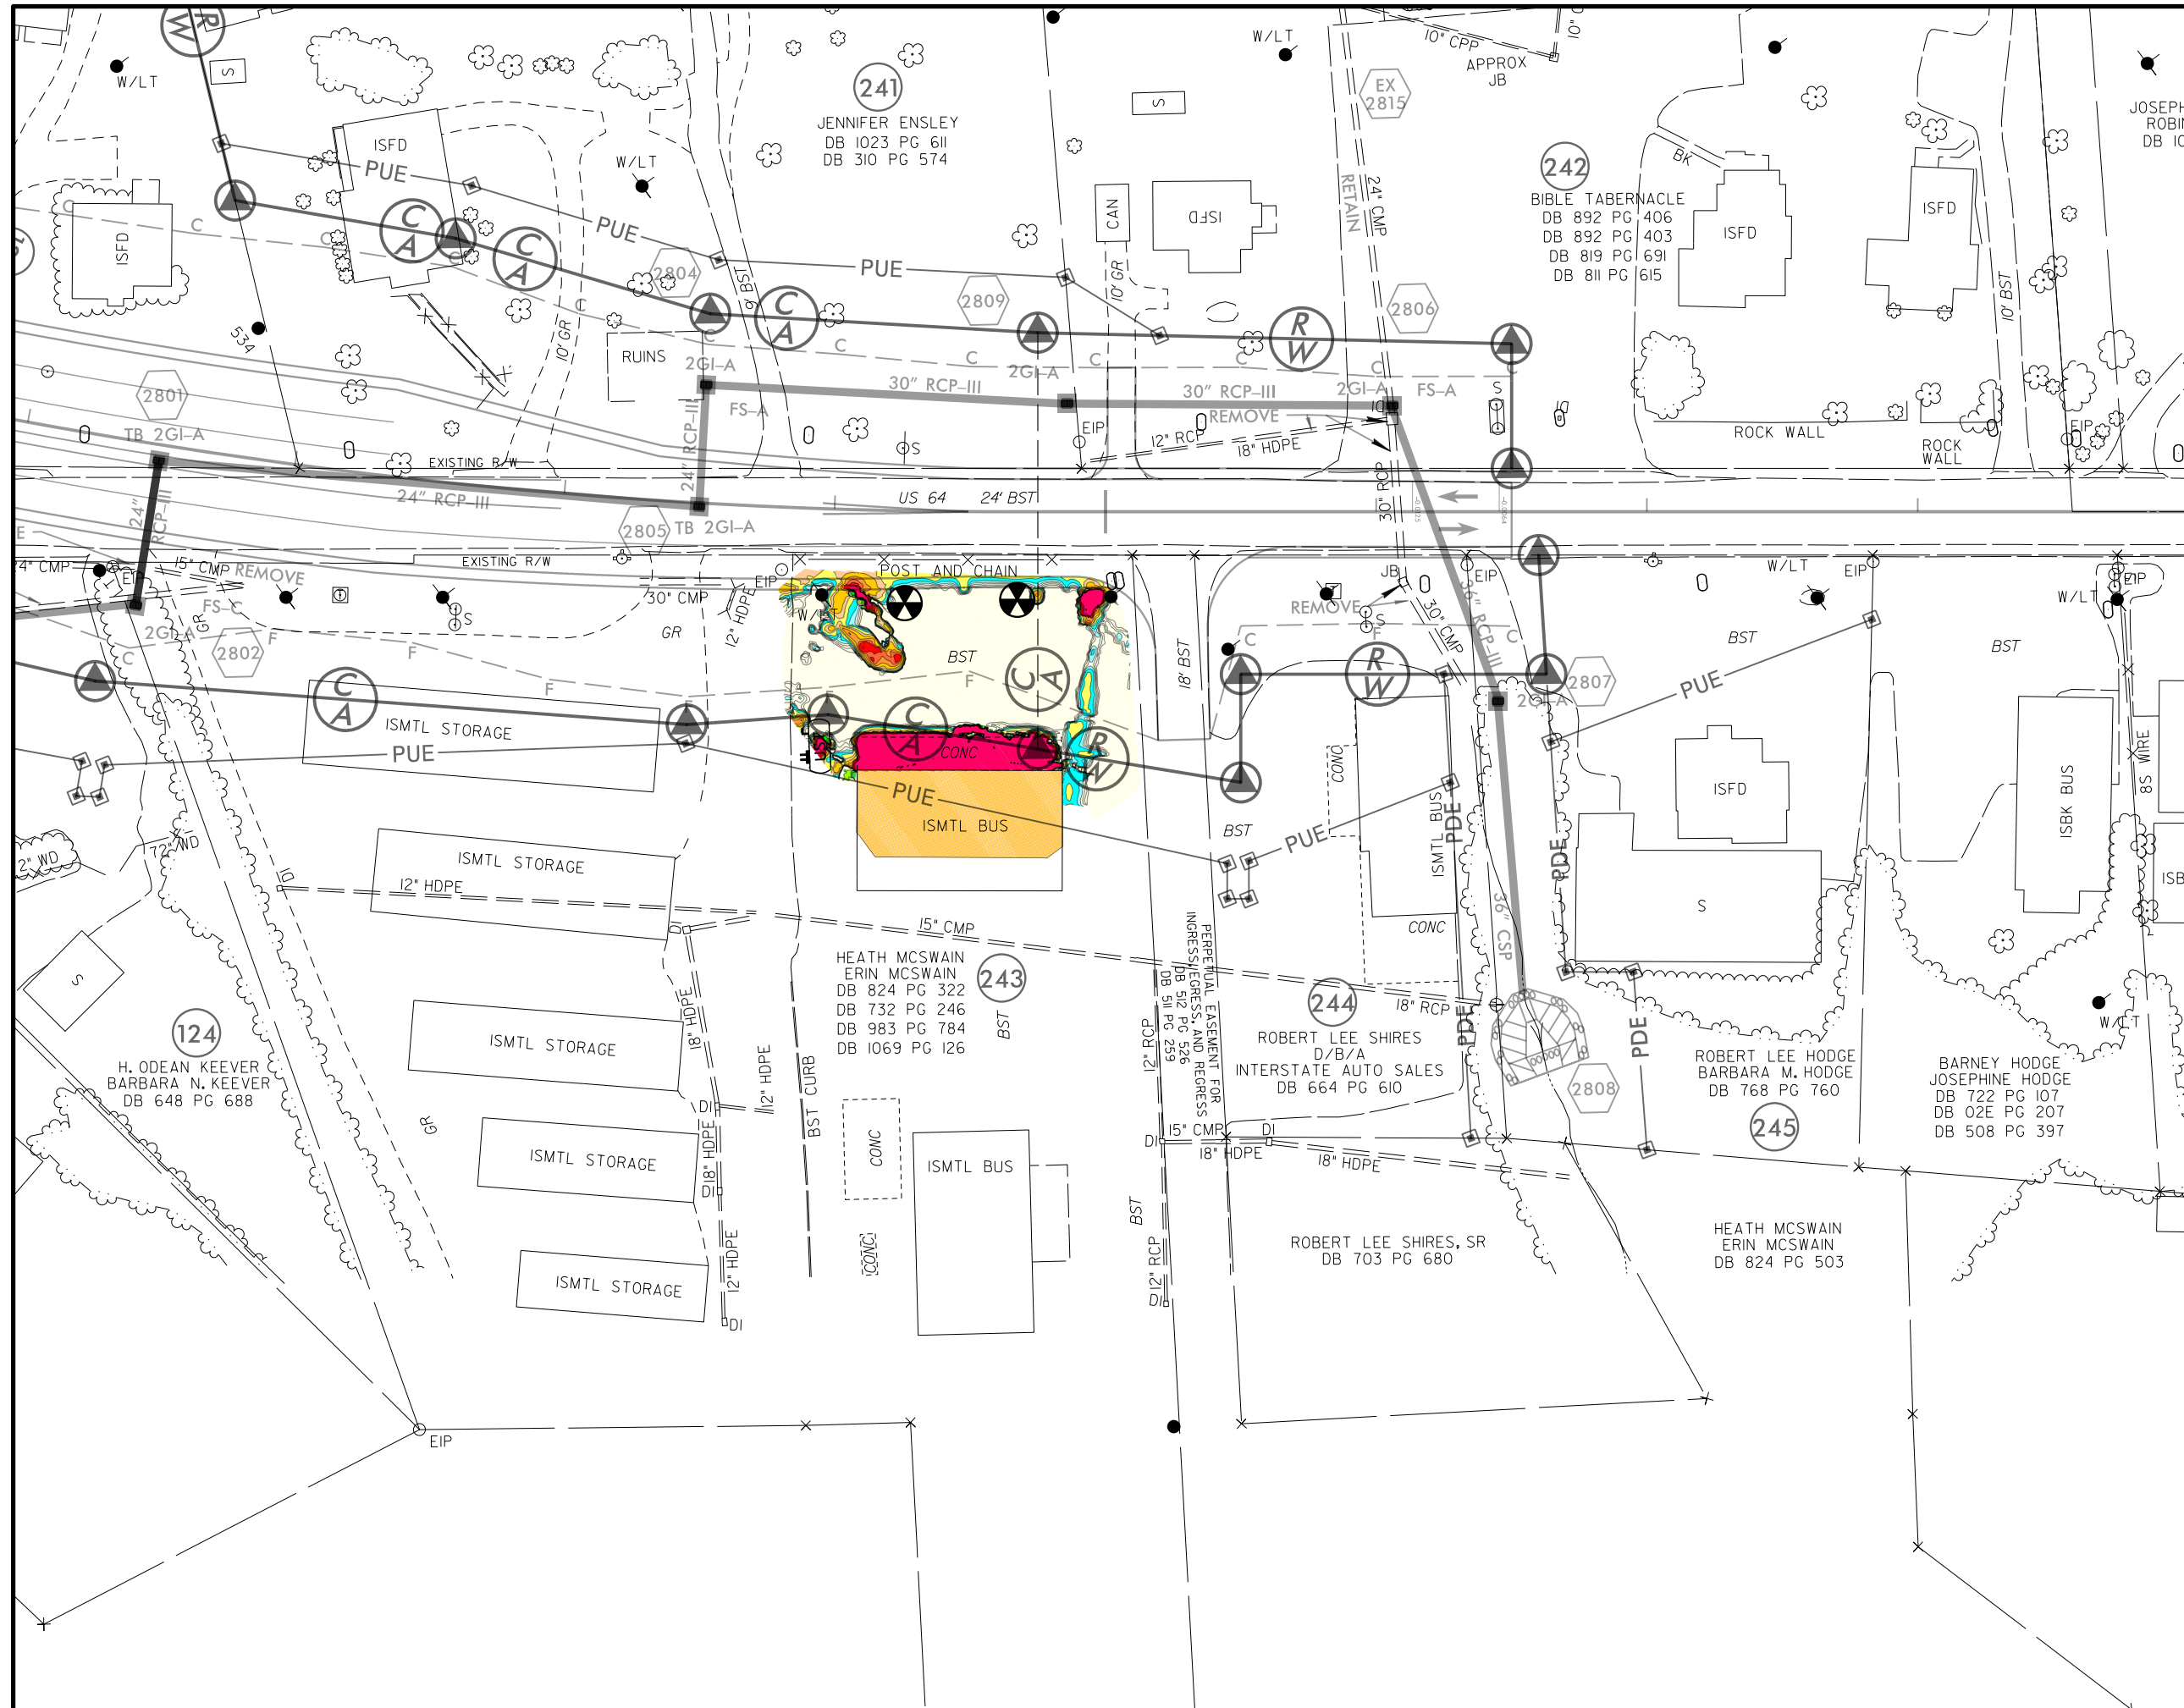
Excluding the aforementioned probable buried conduits or possible UST, the EM61 and GPR investigation suggests the remaining portion of the geophysical survey area (proposed ROW/PUE area) at Parcel 243 does not contain metallic USTs. Please refer to Figures 2 through 4 for additional (detailed) information regarding the geophysical findings at this site. The EM61 results are also shown on NCDOT base maps in **Figures 5 and 6**.
