Preliminary Site Assessment

**US 221 South of US 74 Business (Charlotte Road) to North of
SR 1366 (Roper Loop Road)
Parcel 244 – Robert L. Shires
196 US Highway 64, Rutherfordton, North Carolina**

State Project No. R-2233BB

Terracon Project No. 71177323

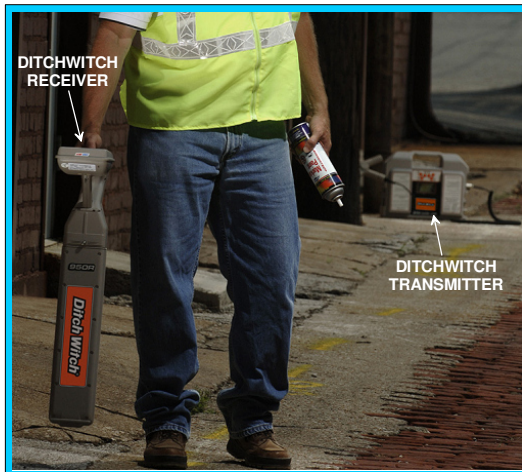
DITCHWITCH UTILITY LOCATOR

The photograph shows the Ditch Witch 910 utility locator which was used to detect buried lines across the proposed boring locations.

Following the UST investigation, areas around the proposed Terracon soil borings were scanned with the GPR unit and a DitchWitch 910 utility locator for buried utility line clearance and no further discussion regarding the utility clearance work will be made in this report. Photographs of the geophysical equipment used for the investigation and of the site are presented in Figure 1.
