Re: Preliminary Site Assessment (PSA)
Norfolk Southern Mainline Grade Crossing Separation at Rogers Road Crossing in
Kannapolis
Parcel 53 – Chester & Patricia Cook Property
1309 S. Ridge Avenue, Kannapolis, North Carolina
TIP No. Y-4810K
WBS Element: 40325.1.46

Preliminary Site Assessment

Norfolk Southern Mainline Grade Crossing Separation at Rogers Road in Kannapolis

**Parcel 53 – Chester & Patricia Cook Property
1309 S. Ridge Avenue, Kannapolis, North Carolina**

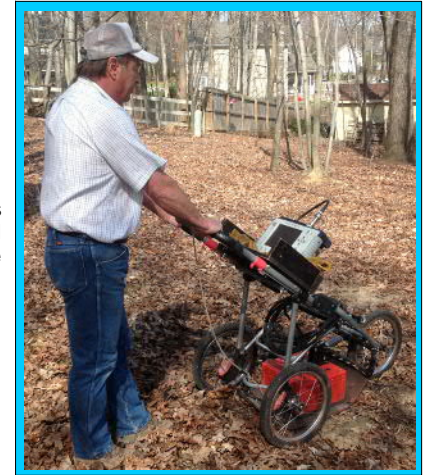
GROUND PENETRATING RADAR UNIT

The photograph shows the Geophysical Survey Systems SIR-3000 ground penetrating radar (GPR) unit equipped with a 400 MHz antenna that were used to conduct the GPR scanning across selected areas.

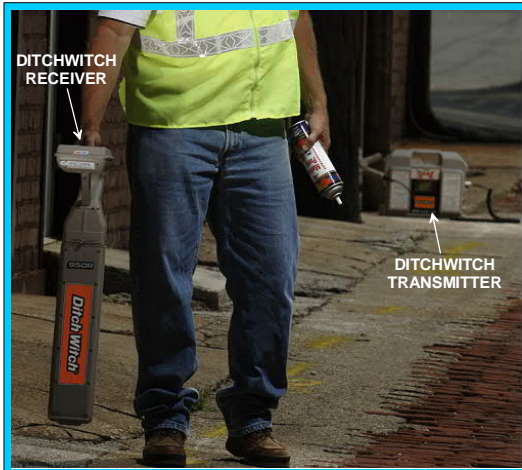
DITCHWITCH UTILITY LOCATOR

The photograph shows the DitchWitch 910 utility locator which was used to detect buried lines across the proposed boring locations.

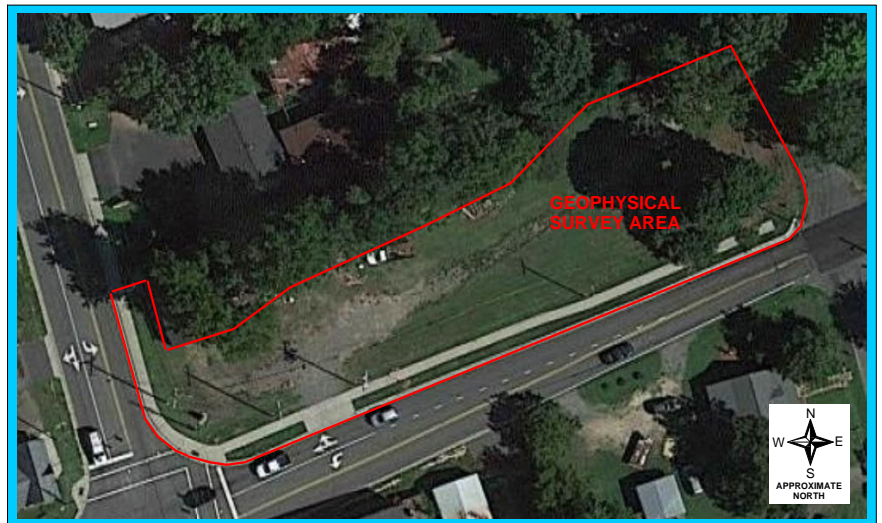
GEOPHYSICAL SURVEY AREA

The red polygon in the aerial photograph represents the approximate perimeter of the geophysical survey area at Parcel 53. The geophysical investigation was conducted on June 19-21, 2018.

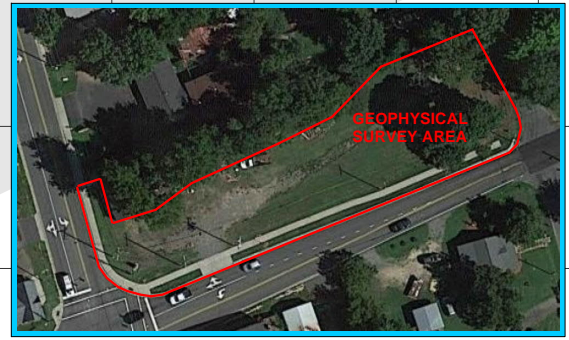
EM61-MK2A METAL DETECTION (EARLY TIME GATE RESULTS)

The contour plot shows the early time gate (most sensitive) response of the Geonics EM61-MK2A metal detection instrument in millivolts (mV). The early time gate response shows buried, metallic objects, lines and conduits regardless of size. GPR scans were conducted across selected EM61 anomalies and steel reinforced concrete using a Geophysical Survey Systems SIR 3000 instrument with a 400 MHz antenna. The geophysical investigation was conducted on June 19-21, 2018.

The red polygon in the aerial photograph represents the approximate perimeter of the geophysical survey area at Parcel 53.
