Preliminary Site Assessment Report
Alex Economy Property
Parcel No. 17

Alex Economy Property
3114 Central Heights Road
Goldsboro, North Carolina 27534
Wayne County PIN 3529040190.00

US 13 (Berkeley Blvd) – Realignment of SR 1709
(Central Heights Road) at Berkeley Blvd.
TIP No.: U-5724
WBS Element: 54016.1.2

Report Date: October 30, 2018
MAA Job #: 000R3203.00

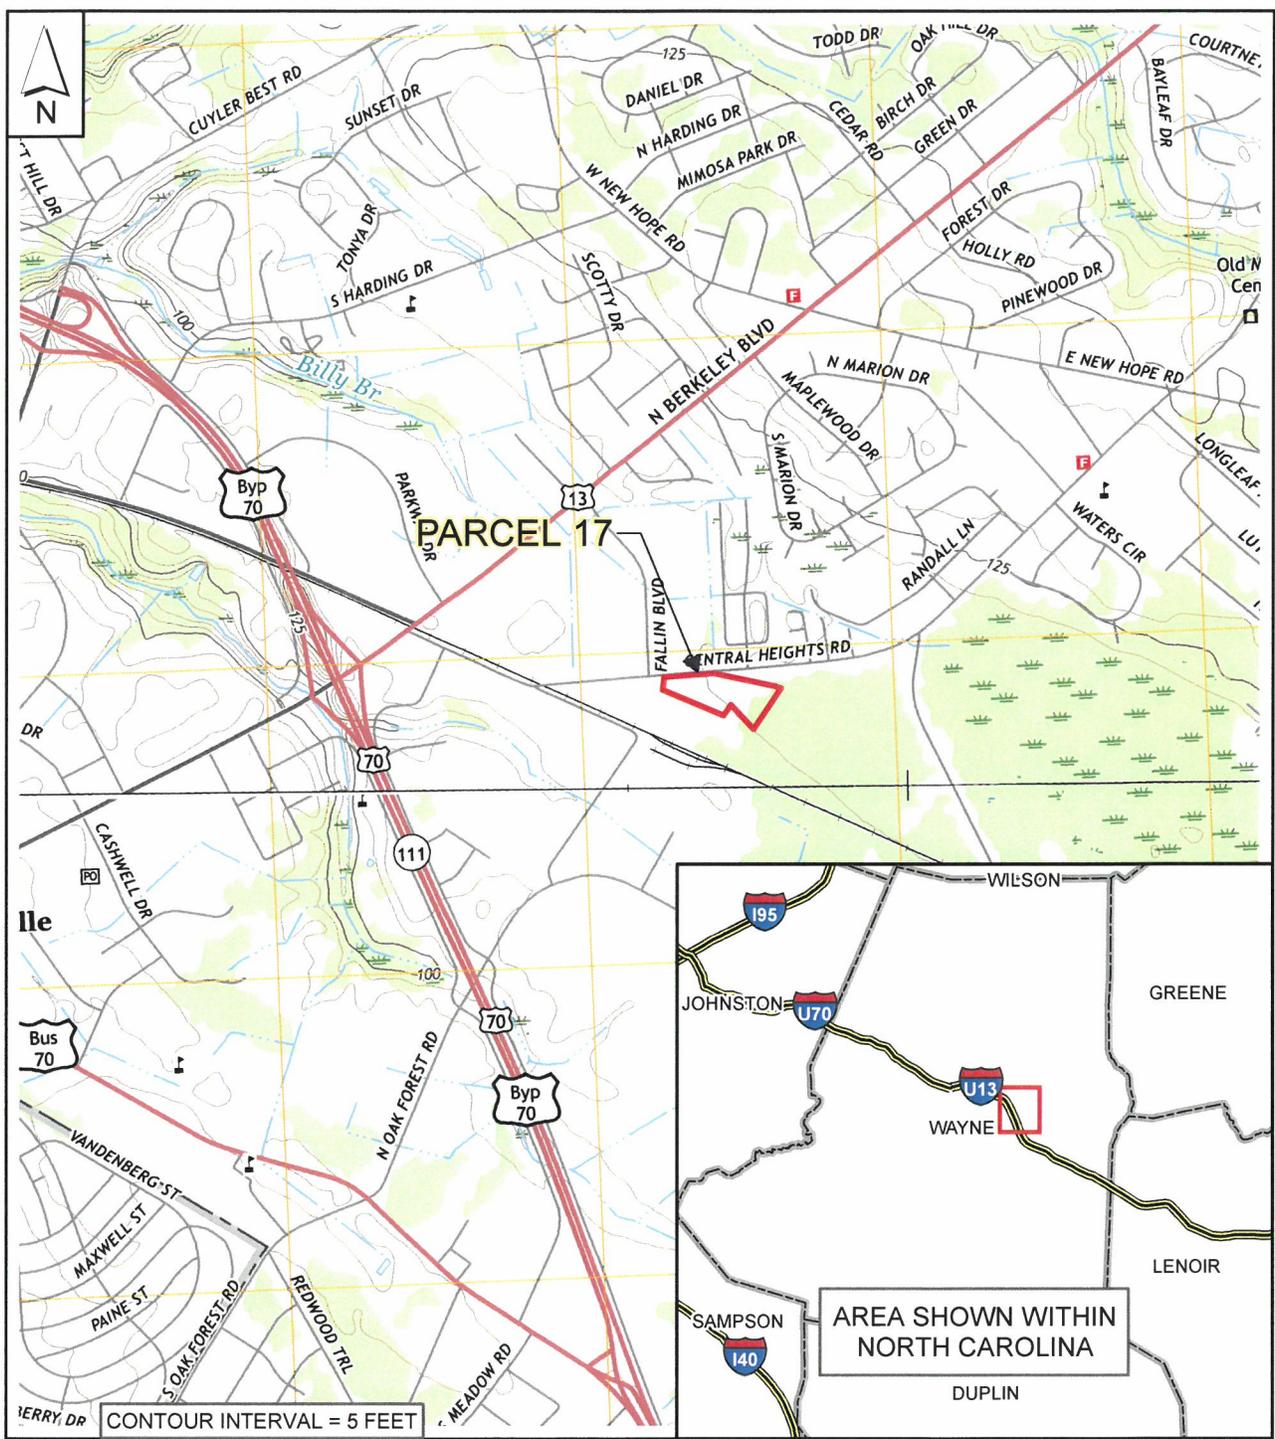
TOPOGRAPHIC SITE MAP
 PARCEL 17
 ALEX ECONOMY PROPERTY
 3114 CENTRAL HEIGHTS ROAD
 GOLDSBORO, NORTH CAROLINA

The Subject Site is located in a mostly residential area of Goldsboro, although commercial properties are located nearby to the south and west of the site. It is currently developed with a mobile home park. A concrete block building, which was reportedly used for retail purposes in the past, is located on the northern portion of the property. The site is bounded to the north (across Central Heights Road) and east by agricultural fields, to the south (across Central Heights Road; note: the road forks) by commercial/industrial enterprises, and to the west by residential properties and additional agricultural land. Please refer to **Drawing 1.1** for the site location and site topography.

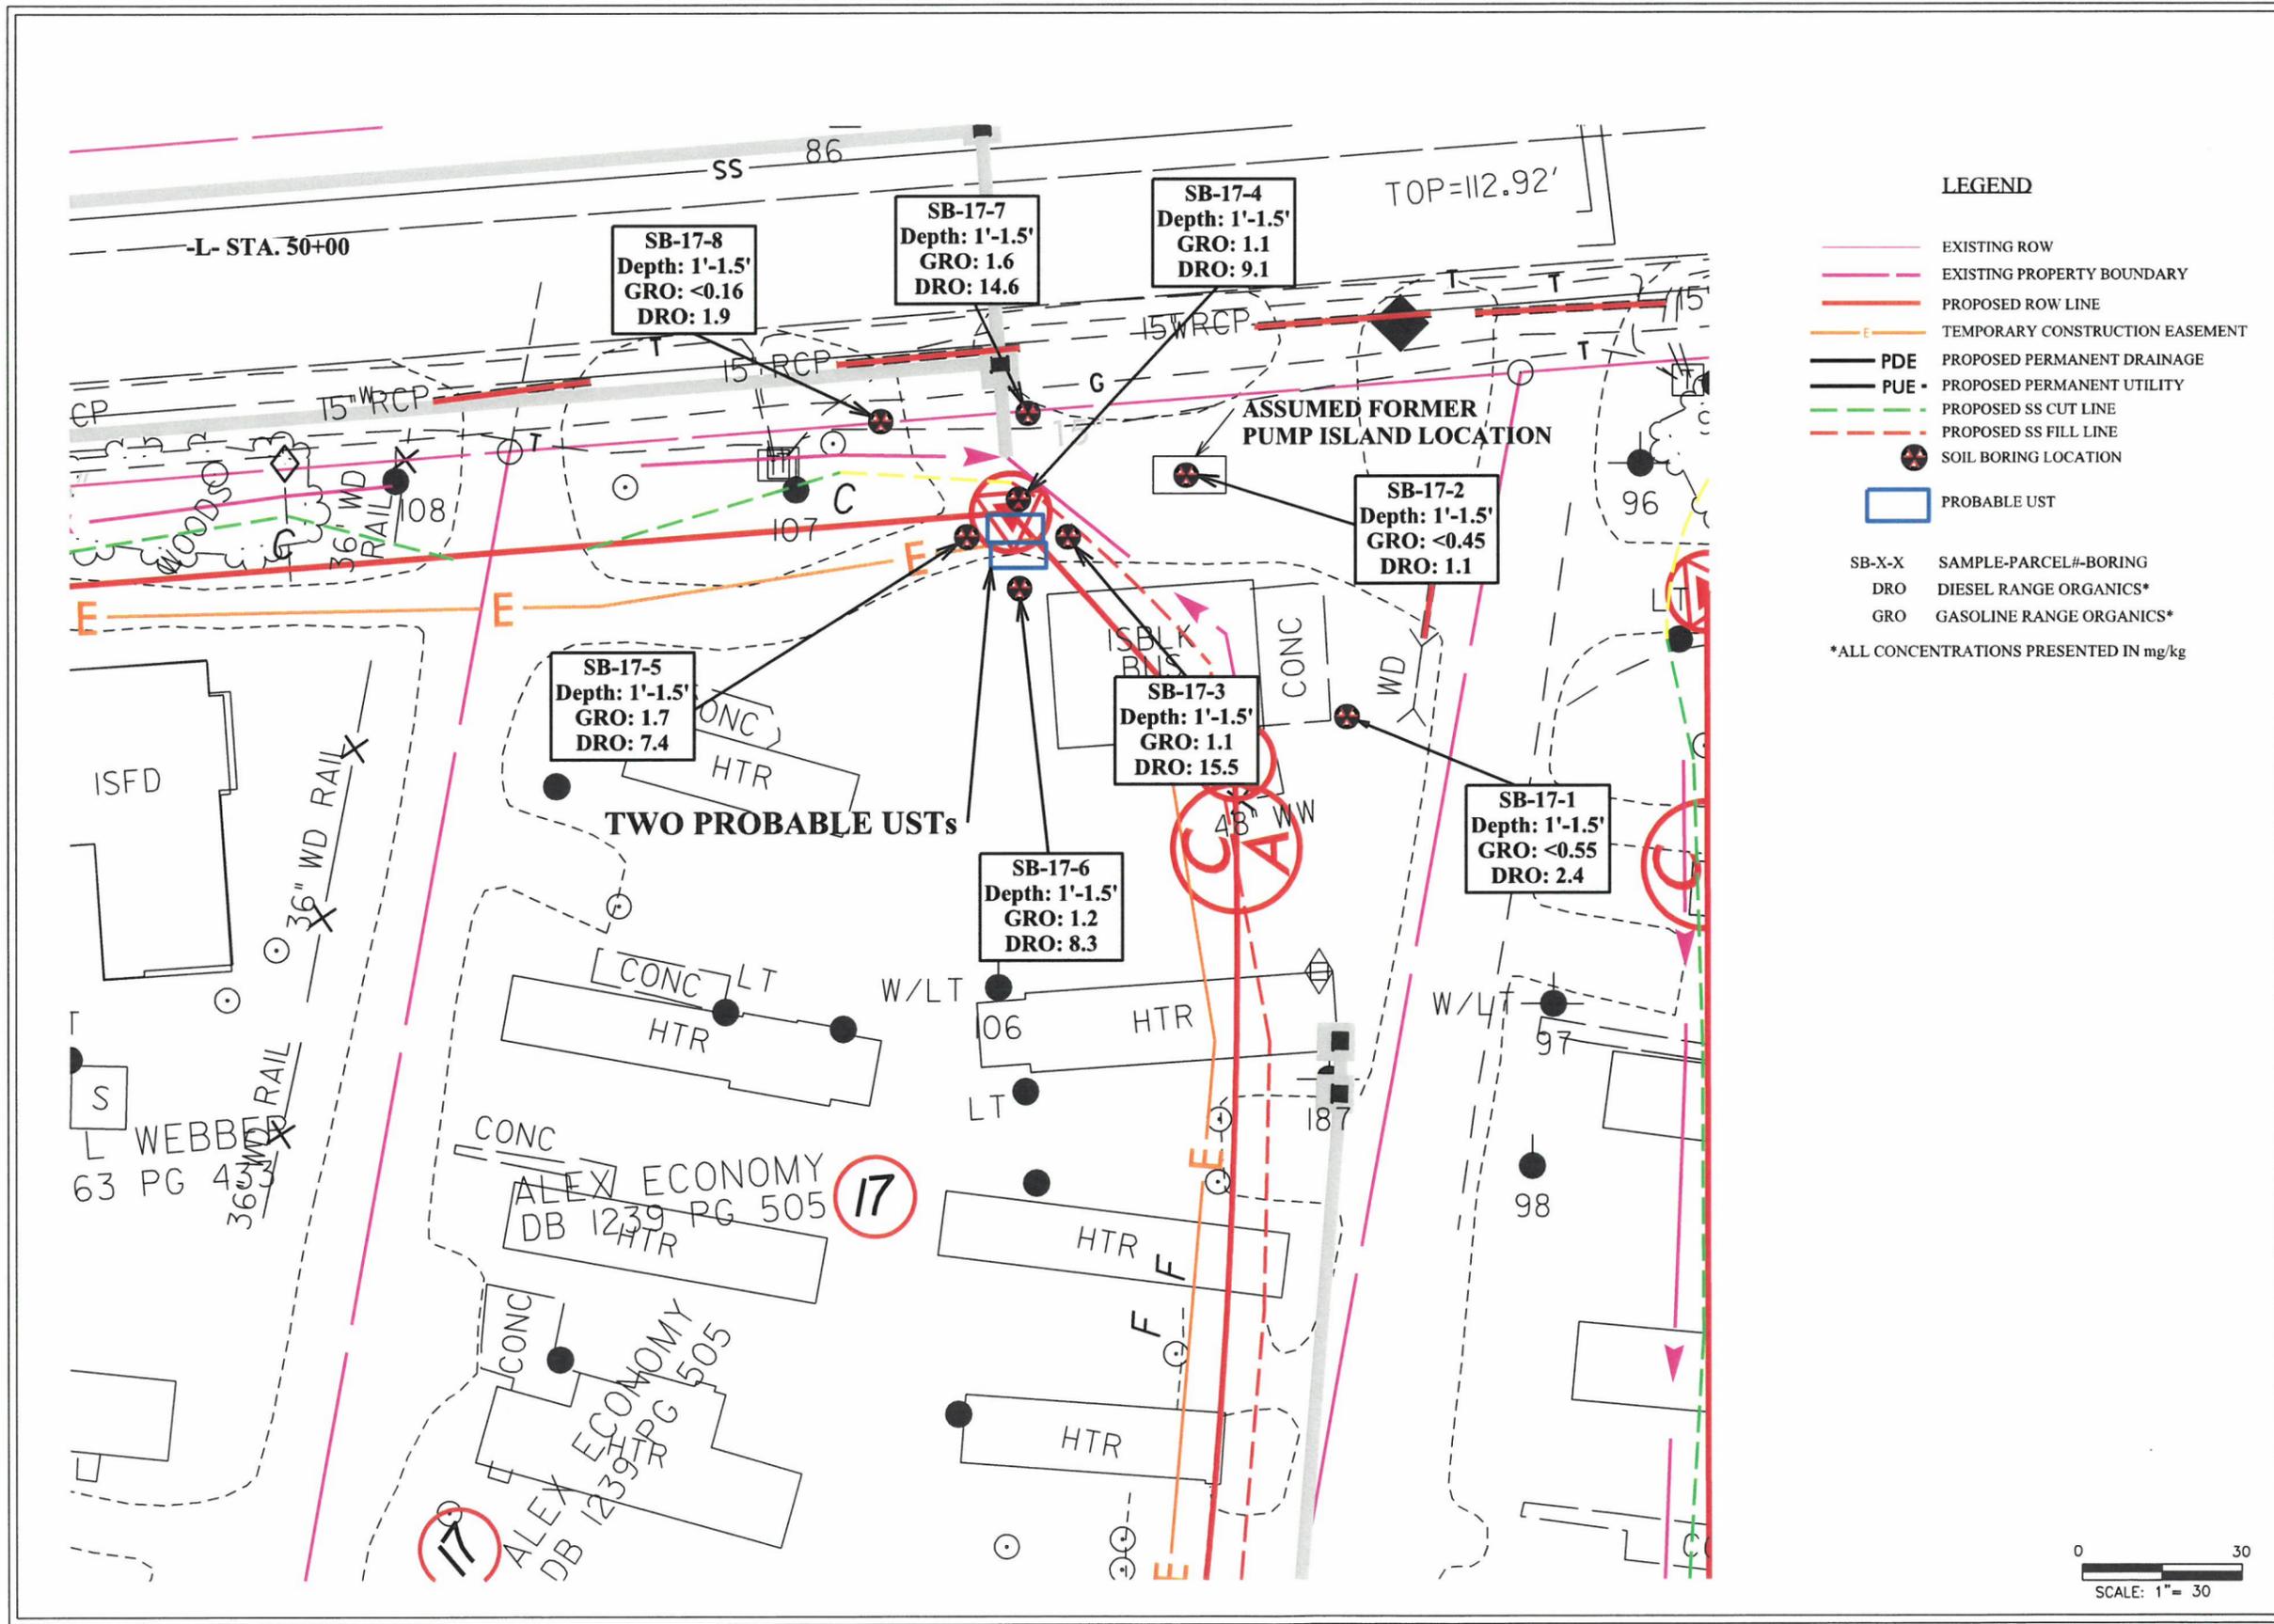
As documented in RED Lab's report located in **Appendix E** and summarized (along with PID readings) in **Table 5.1**, TPH GRO were detected in five of the eight samples at concentrations exceeding the UVF analyzer's detection limit. However, none of the samples exhibited concentrations exceeding the NCDEQ Action Level of 50 mg/kg. TPH DRO were detected in all eight samples at concentrations exceeding the UVF analyzer's detection limit. However, none of the samples exhibited concentrations exceeding the NCDEQ Action Level of 100 mg/kg. The laboratory analytical report and graphs for the soil samples collected at the site are provided in **Appendix E**. Detected chemical constituents in soil samples are shown on **Drawing 4.1**.

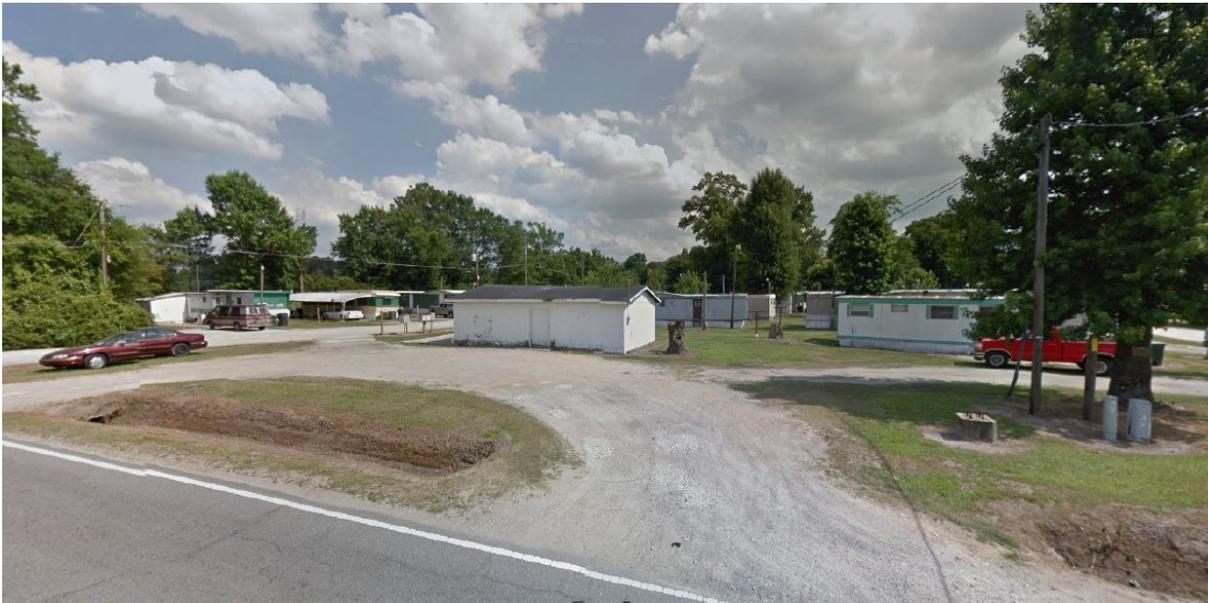
Photo 1 – A general view of site. Concrete block building at center.
(photo courtesy of Google Earth)

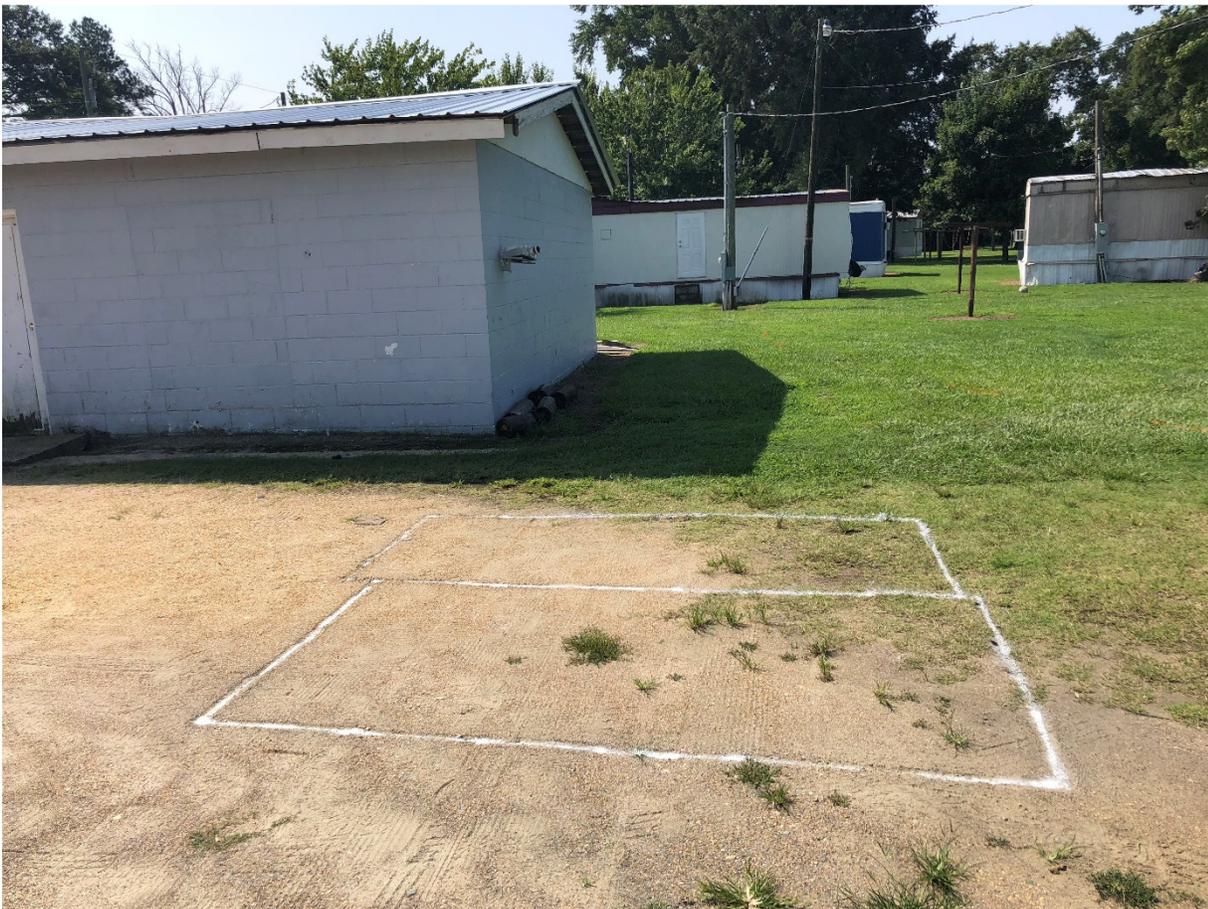
Photo 2 – A view of the probable UST locations (in white paint), looking south.

- Removal of the USTs, piping, and former dispenser island, as applicable; and
- If impacted soils or groundwater are encountered during removal of the USTs and generated as waste, they should be properly managed and disposed at a permitted facility.

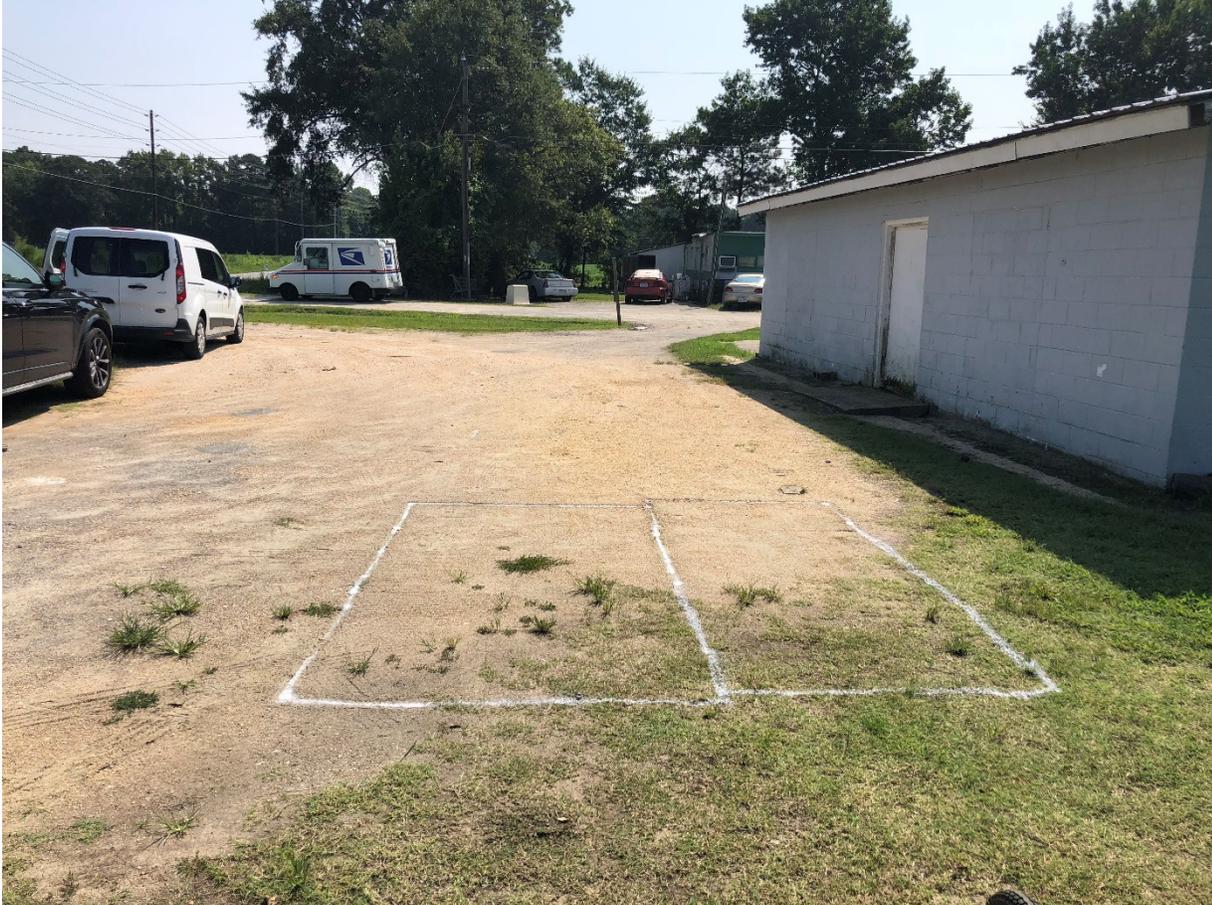
Photo 3 – A view of the probable UST locations (in white paint), looking east.

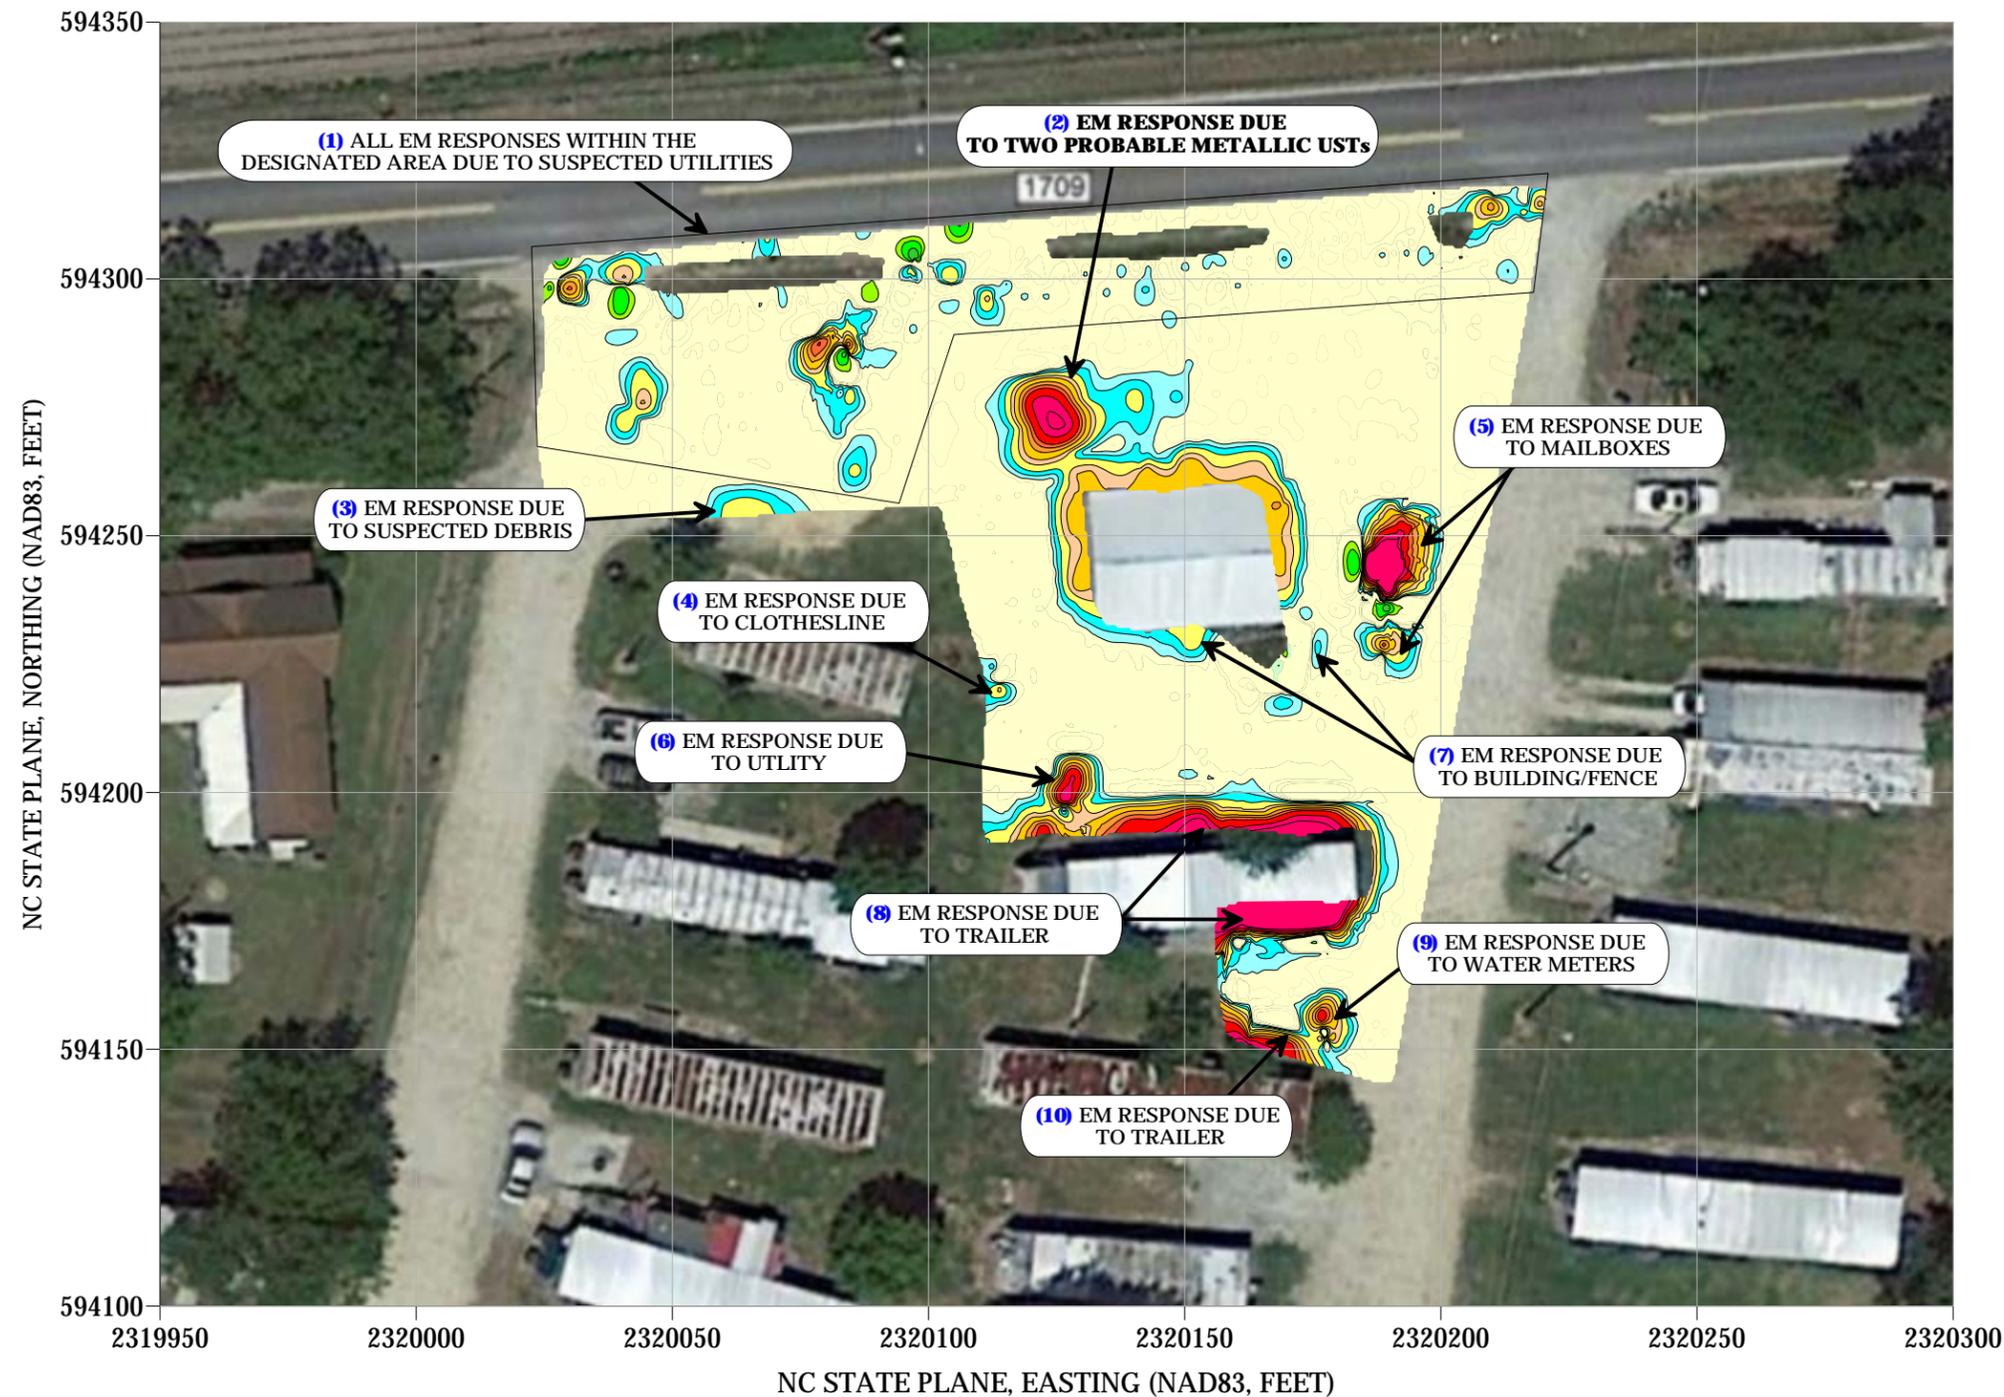
EVIDENCE OF TWO PROBABLE METALLIC USTs OBSERVED.

The contour plot shows the differential results of the EM61 instrument in millivolts (mV). The differential results focus on larger metallic objects such as USTs and drums. The EM61 data were collected on August 22, 2018, using a Geonics EM61 instrument. Verification GPR data were collected using a GSSI UtilityScan DF instrument with a dual frequency 300/800 MHz antenna on August 23, 2018.

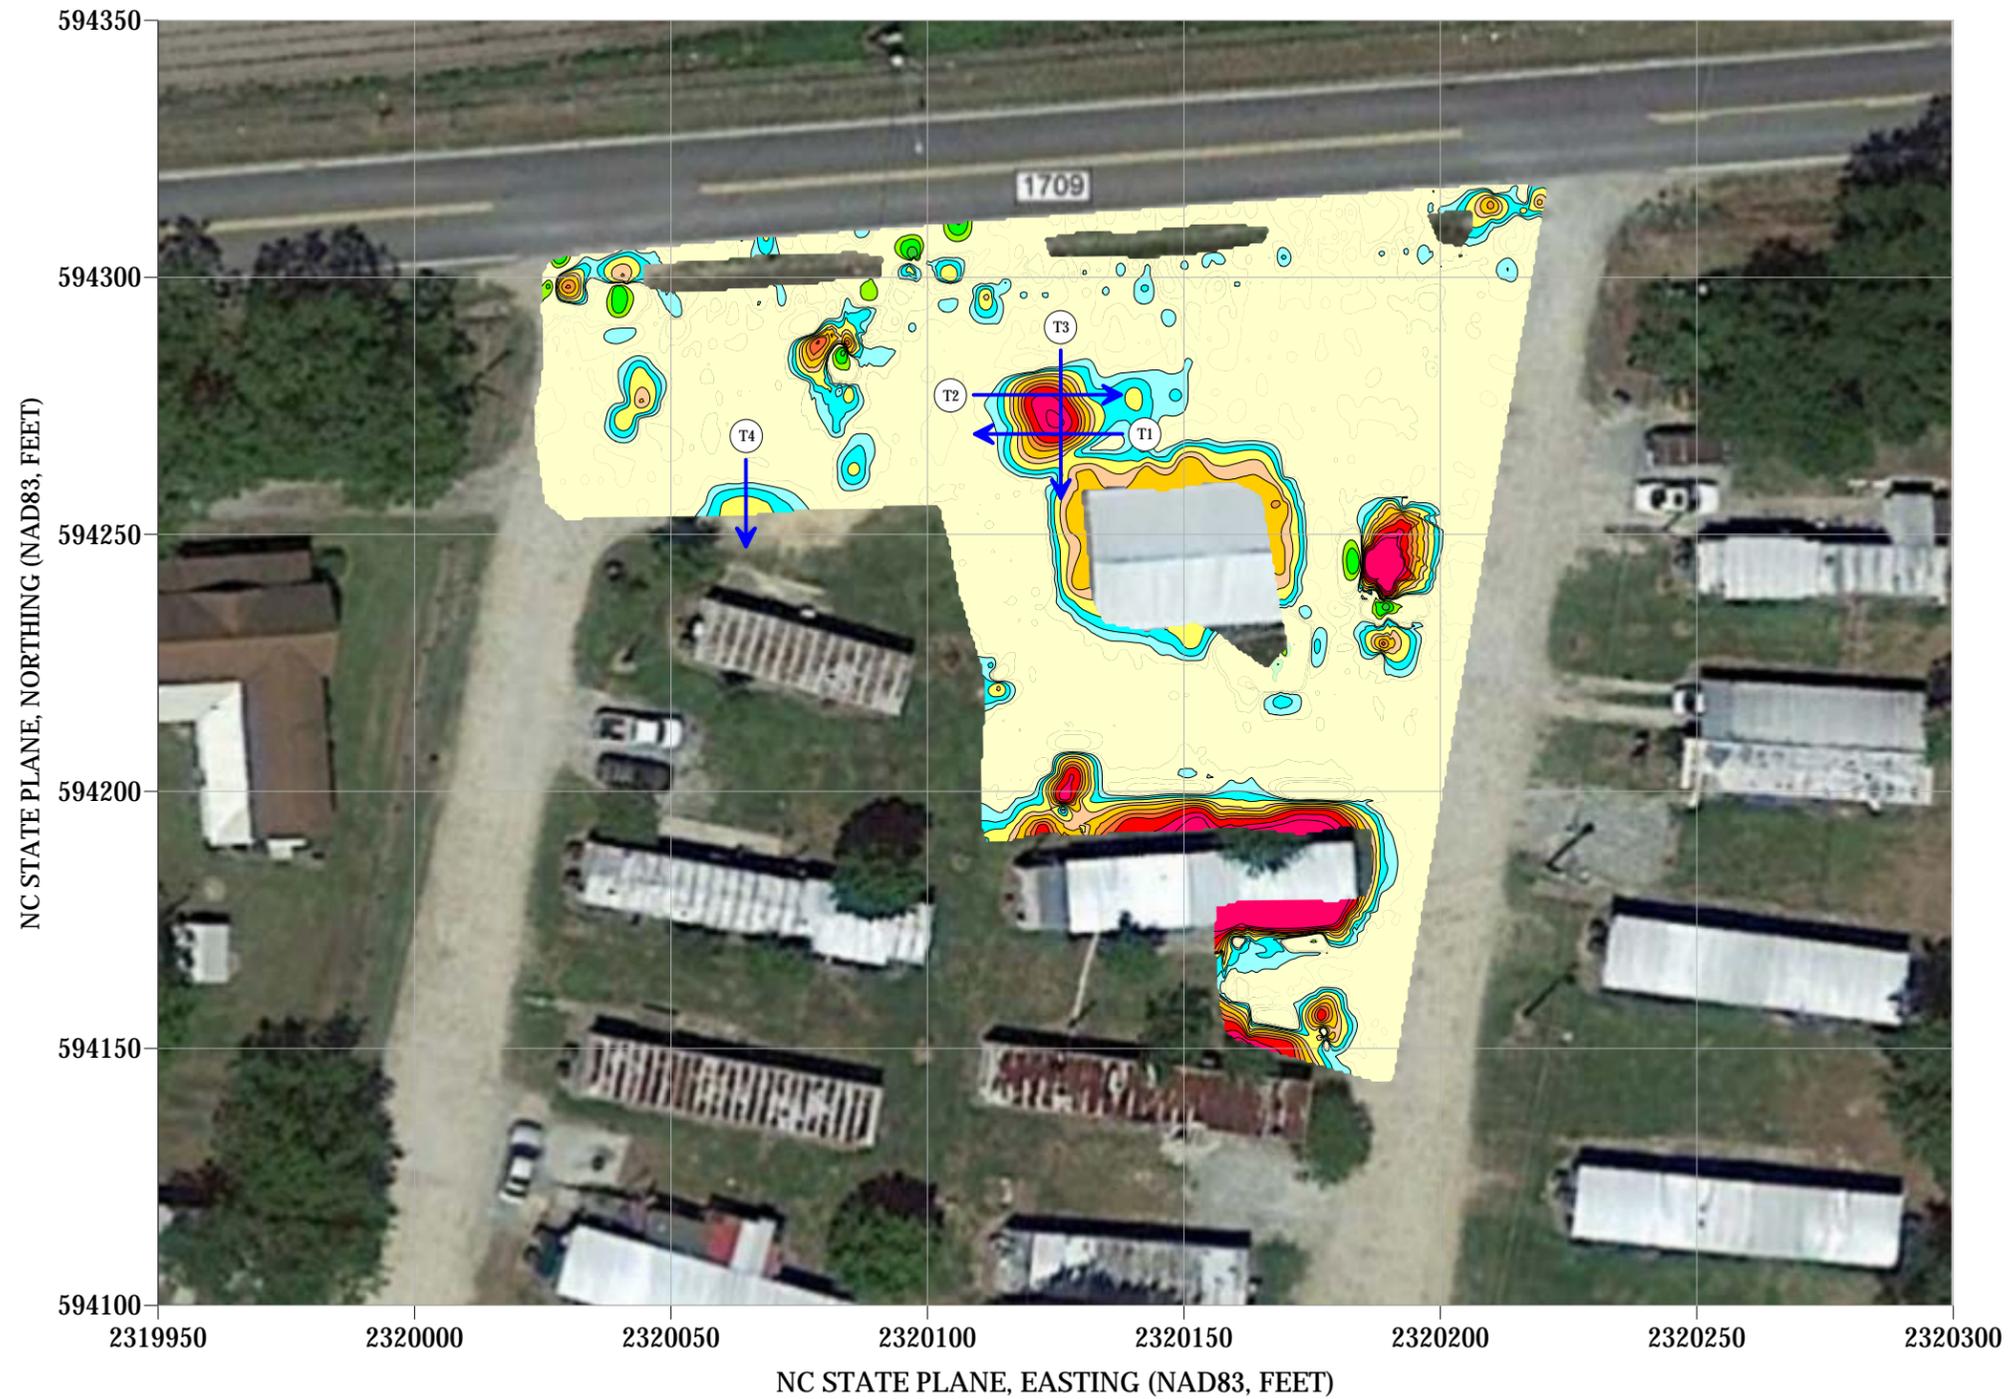
LOCATIONS OF GPR TRANSECTS

*EXTENSIVE GPR SCANS WERE CONDUCTED OVER THE ENTIRE SITE. TRANSECT LINES ON THE MAP ABOVE INDICATE LOCATIONS WHERE DATA WERE SAVED. THESE LOCATIONS WERE CHOSEN TO HIGHLIGHT STRUCTURES IDENTIFIED IN THE SUBSURFACE OR TRANSECTS THAT ARE REPRESENTATIVE OF GENERAL SUBSURFACE CONDITIONS.

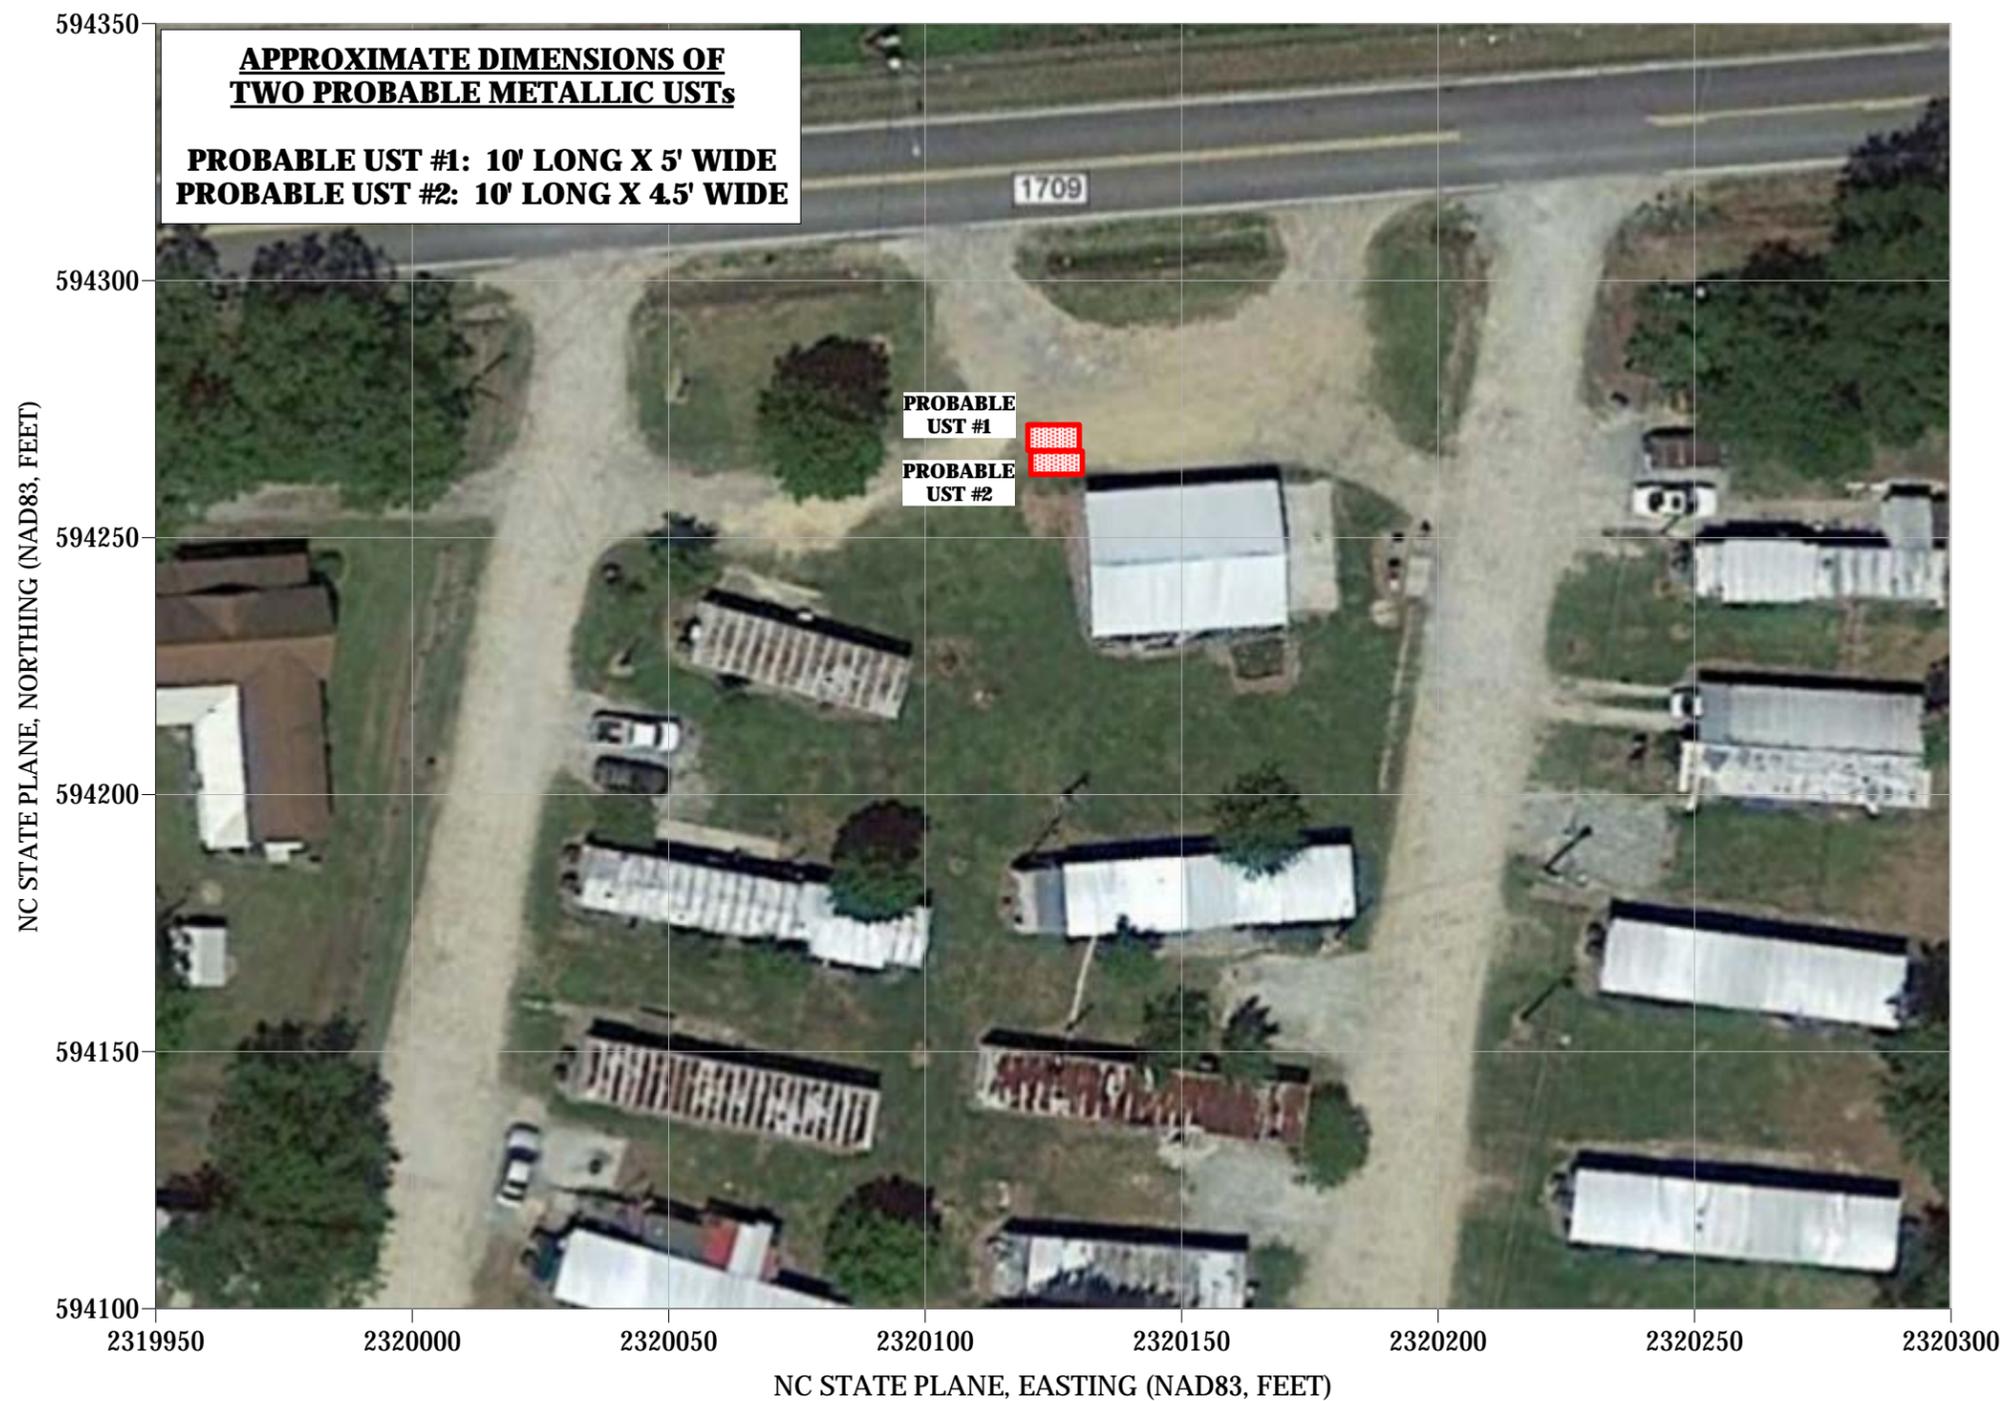
LOCATIONS OF TWO PROBABLE METALLIC USTs

The geophysical survey conducted by Pyramid found two probable USTs directly off the northwest corner of the concrete block building, as shown in their report provided in **Appendix B**. Based on the GPR results, the USTs appear to be laying side-by-side in an east-west trending direction and are approximately 10 feet in length by 5 feet in diameter. These dimensions appear to be consistent with USTs that are approximately 1,500 or 2,000 gallons in capacity.

- The geophysical survey indicated the presence of two probable metallic USTs located on the northern portion of the site near the concrete block building. The USTs appear to be in the 1,500 to 2,000 gallon capacity range.

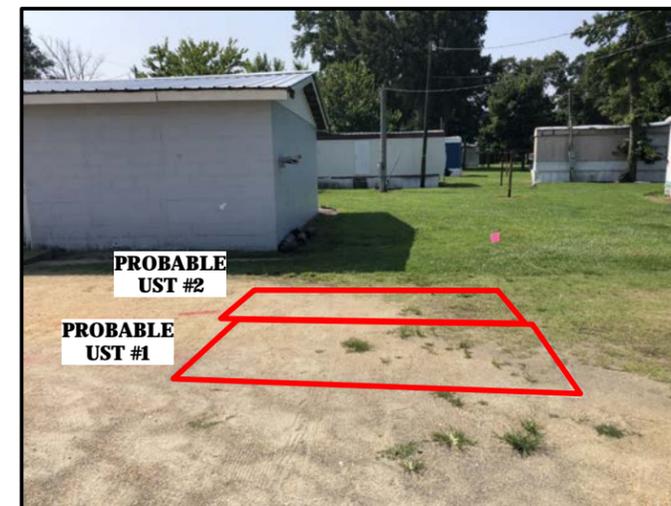
View of Two Probable USTs Facing Approximately South

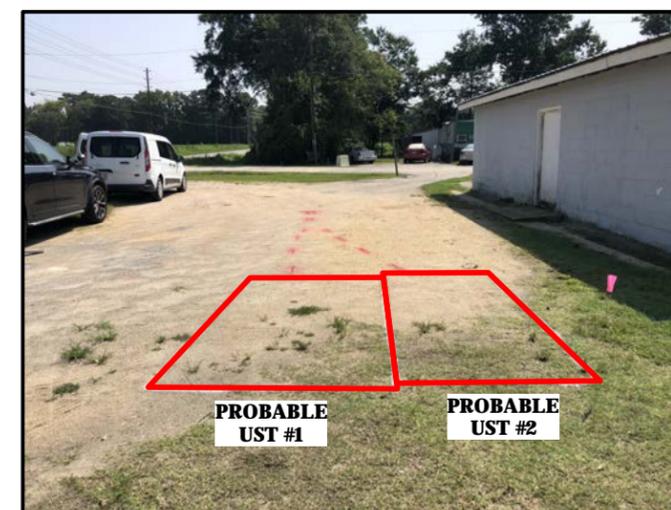
View of Two Probable USTs Facing Approximately West
