# **Preliminary Site Assessment Report**

## **Richard S. Smith Revocable 1990 Trust Property**

### **Parcel No. 5**

US 13 (Berkeley Blvd) – Realignment of SR 1709  
(Central Heights Road) at Berkeley Blvd.  
TIP No.: U-5724  
WBS Element: 54016.1.2

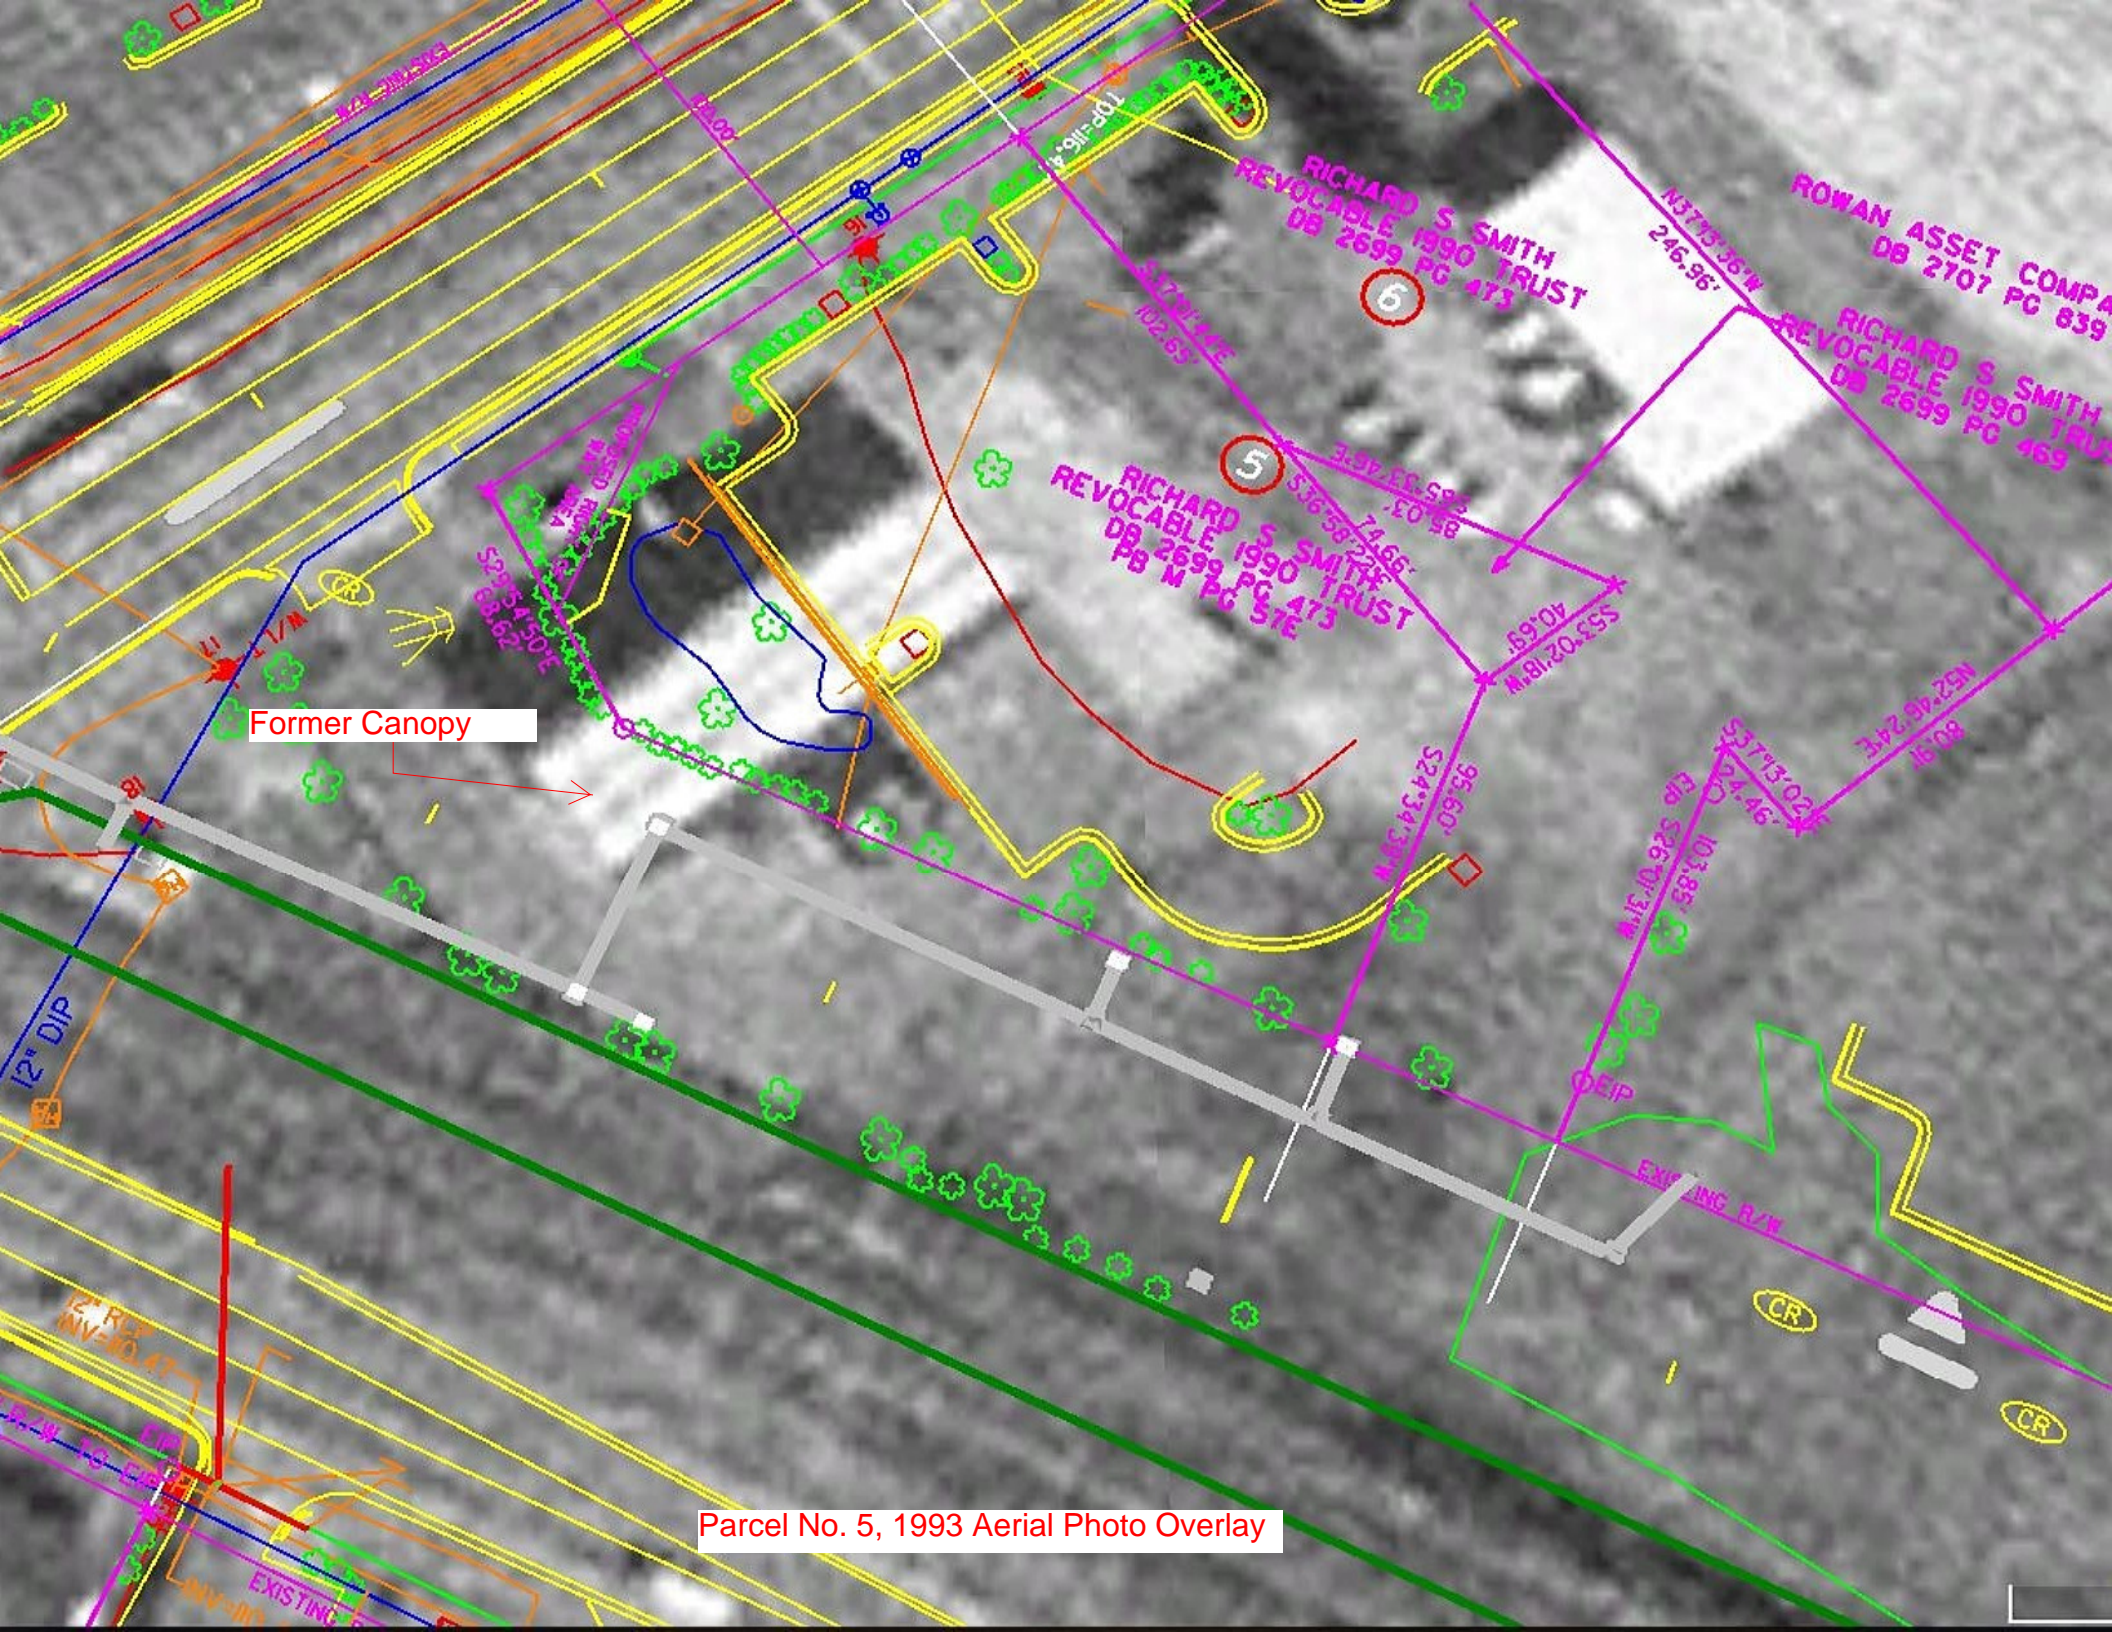
Parcel No. 5, 1993 Aerial Photo Overlay

Former Canopy

- Historical data indicates that the site was used as a gasoline filling station from approximately 1974 to 2005, and two different sets of USTs were utilized during that period. Aerial photographs indicate that the canopy (and thus the dispensers/piping) extended into the current easement, as well as into the railroad's ROW. Although petroleum-impacted vadose zone soil was not found in this area during this assessment, it is possible that it could be present; and
- A historical release of petroleum has impacted the groundwater beneath the site. Based on the depth to groundwater (approximately 5 to 6 feet BLS, with potential for natural fluctuations), it is possible that impacted groundwater will be encountered during drainage utility and/or other construction activities.

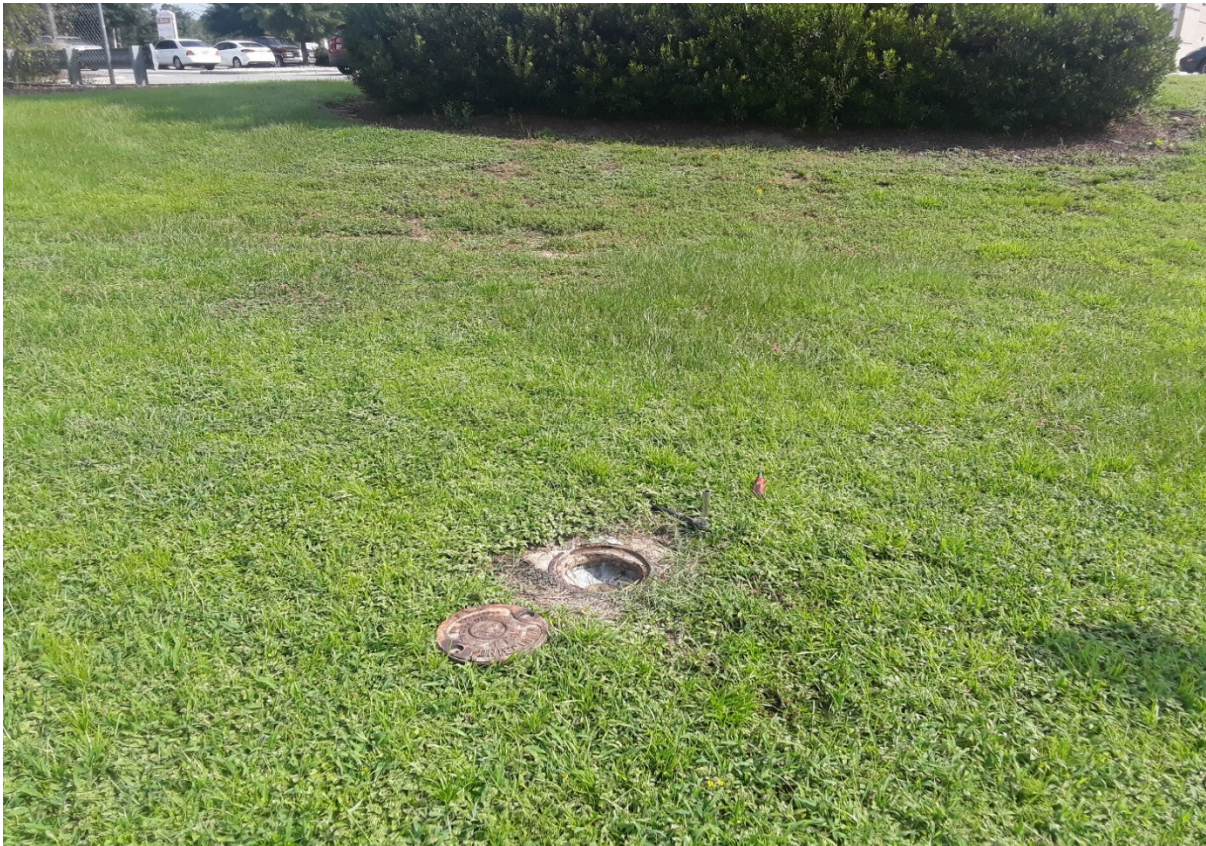
Photo 2 – A view of the four-inch diameter monitoring well (abandoned)  
in the railroad right of way.

Mid-Atlantic observed two former groundwater monitoring wells on the Subject Site (note: these wells are located in the current railroad right of way). The locations are shown on **Drawing 3.1**. Mid-Atlantic's technician opened the well covers and discovered that both wells were PVC and one was 4 inches in diameter and one was 2 inches in diameter. The wells appeared to have been abandoned (casings were filled with grout), although the manholes and pads were still intact.

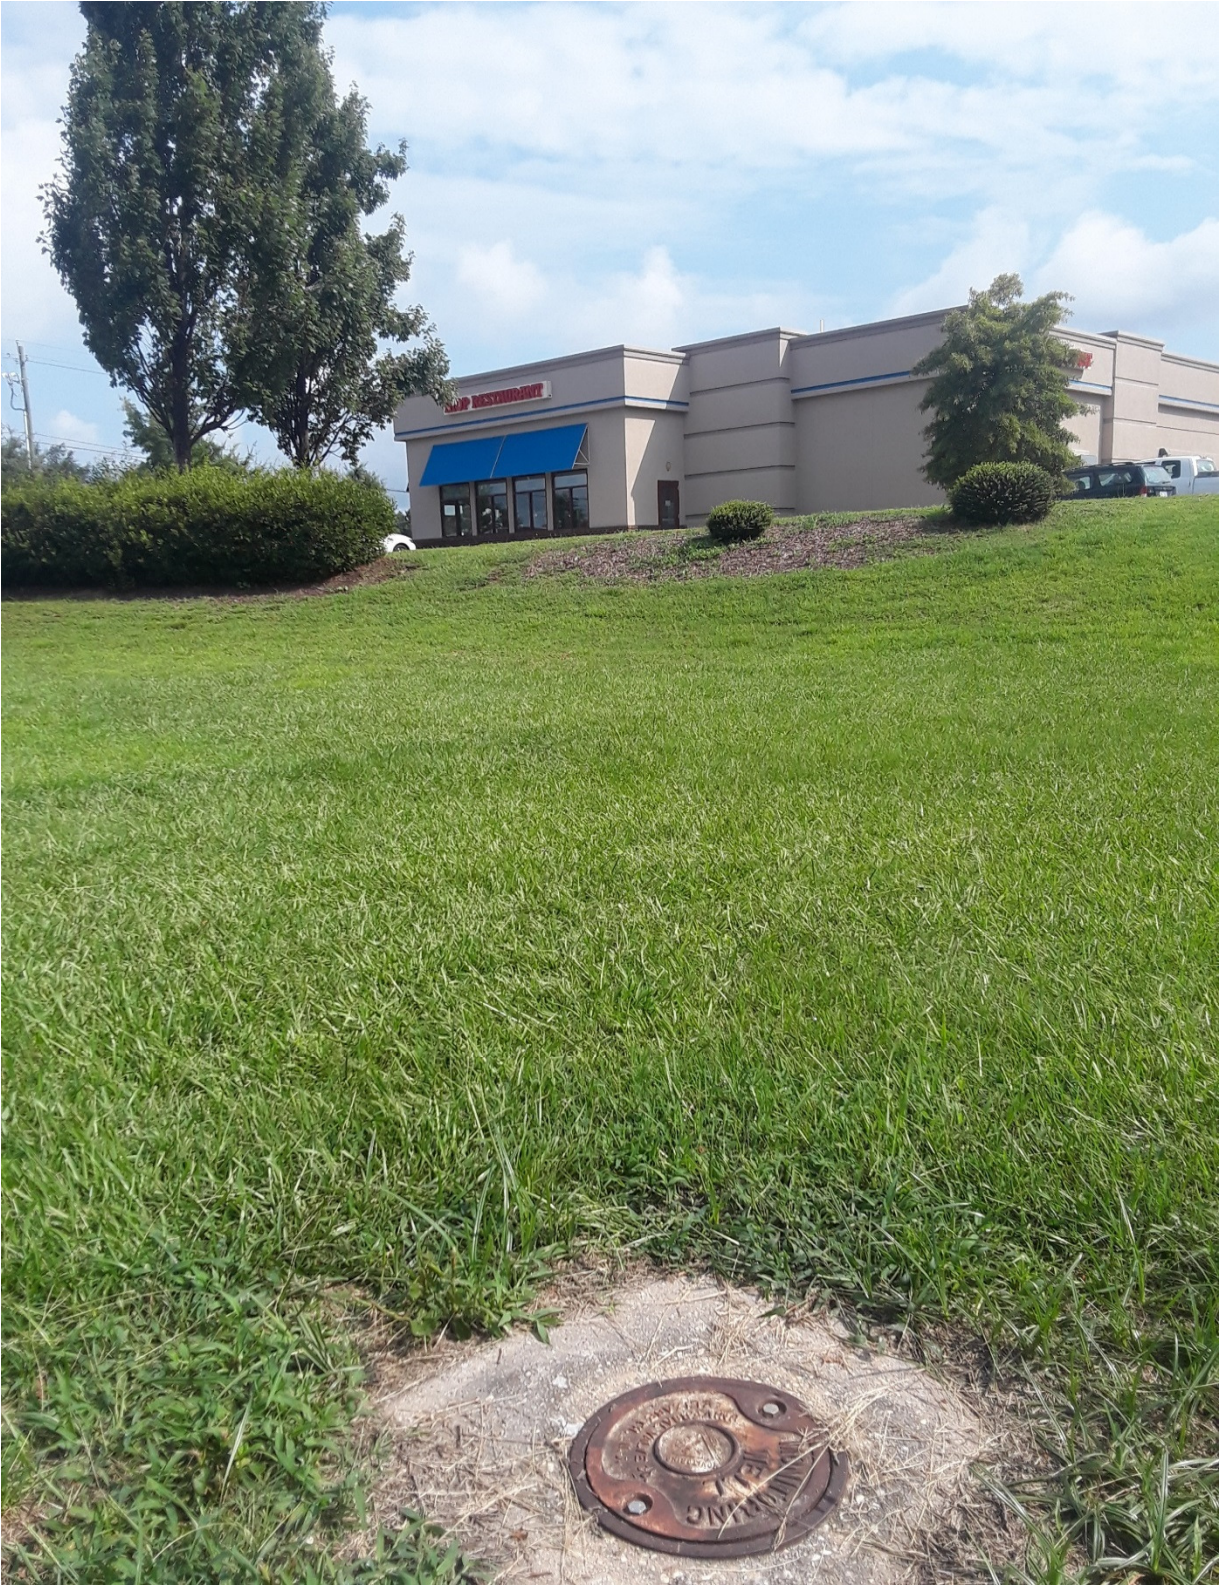
Photo 3 – A view of the two-inch diameter monitoring well (abandoned) in the railroad right of way.

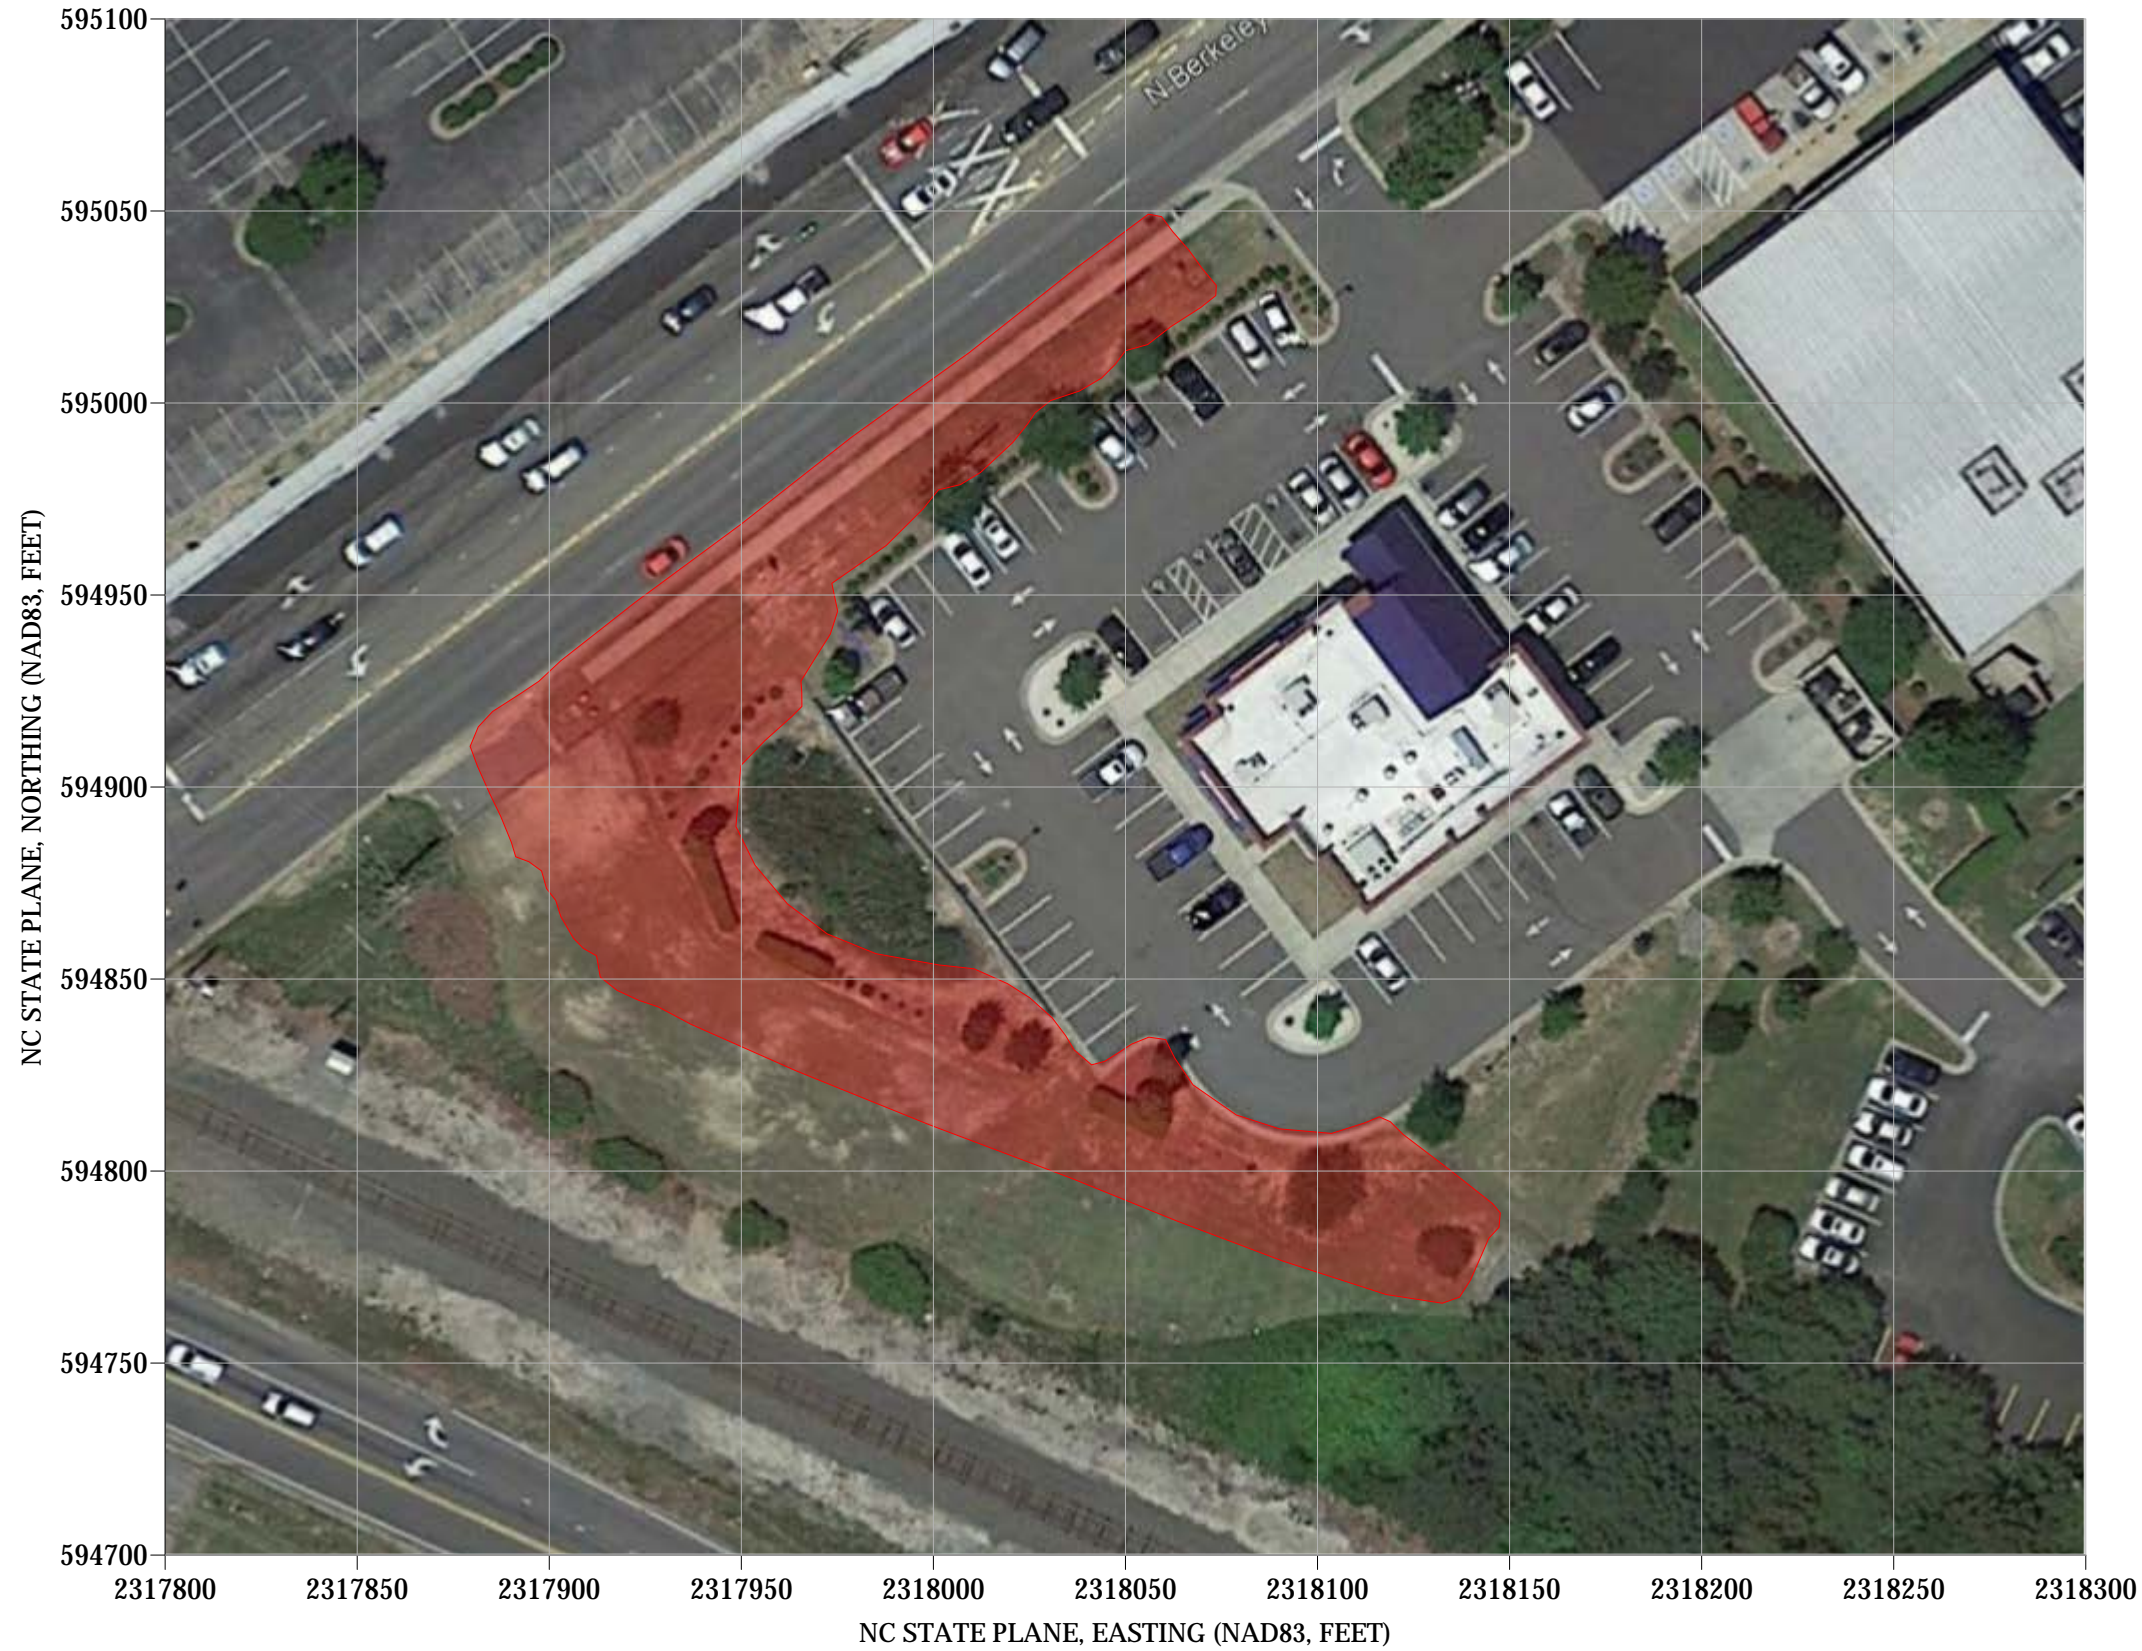
# APPROXIMATE BOUNDARIES OF GEOPHYSICAL SURVEY AREA

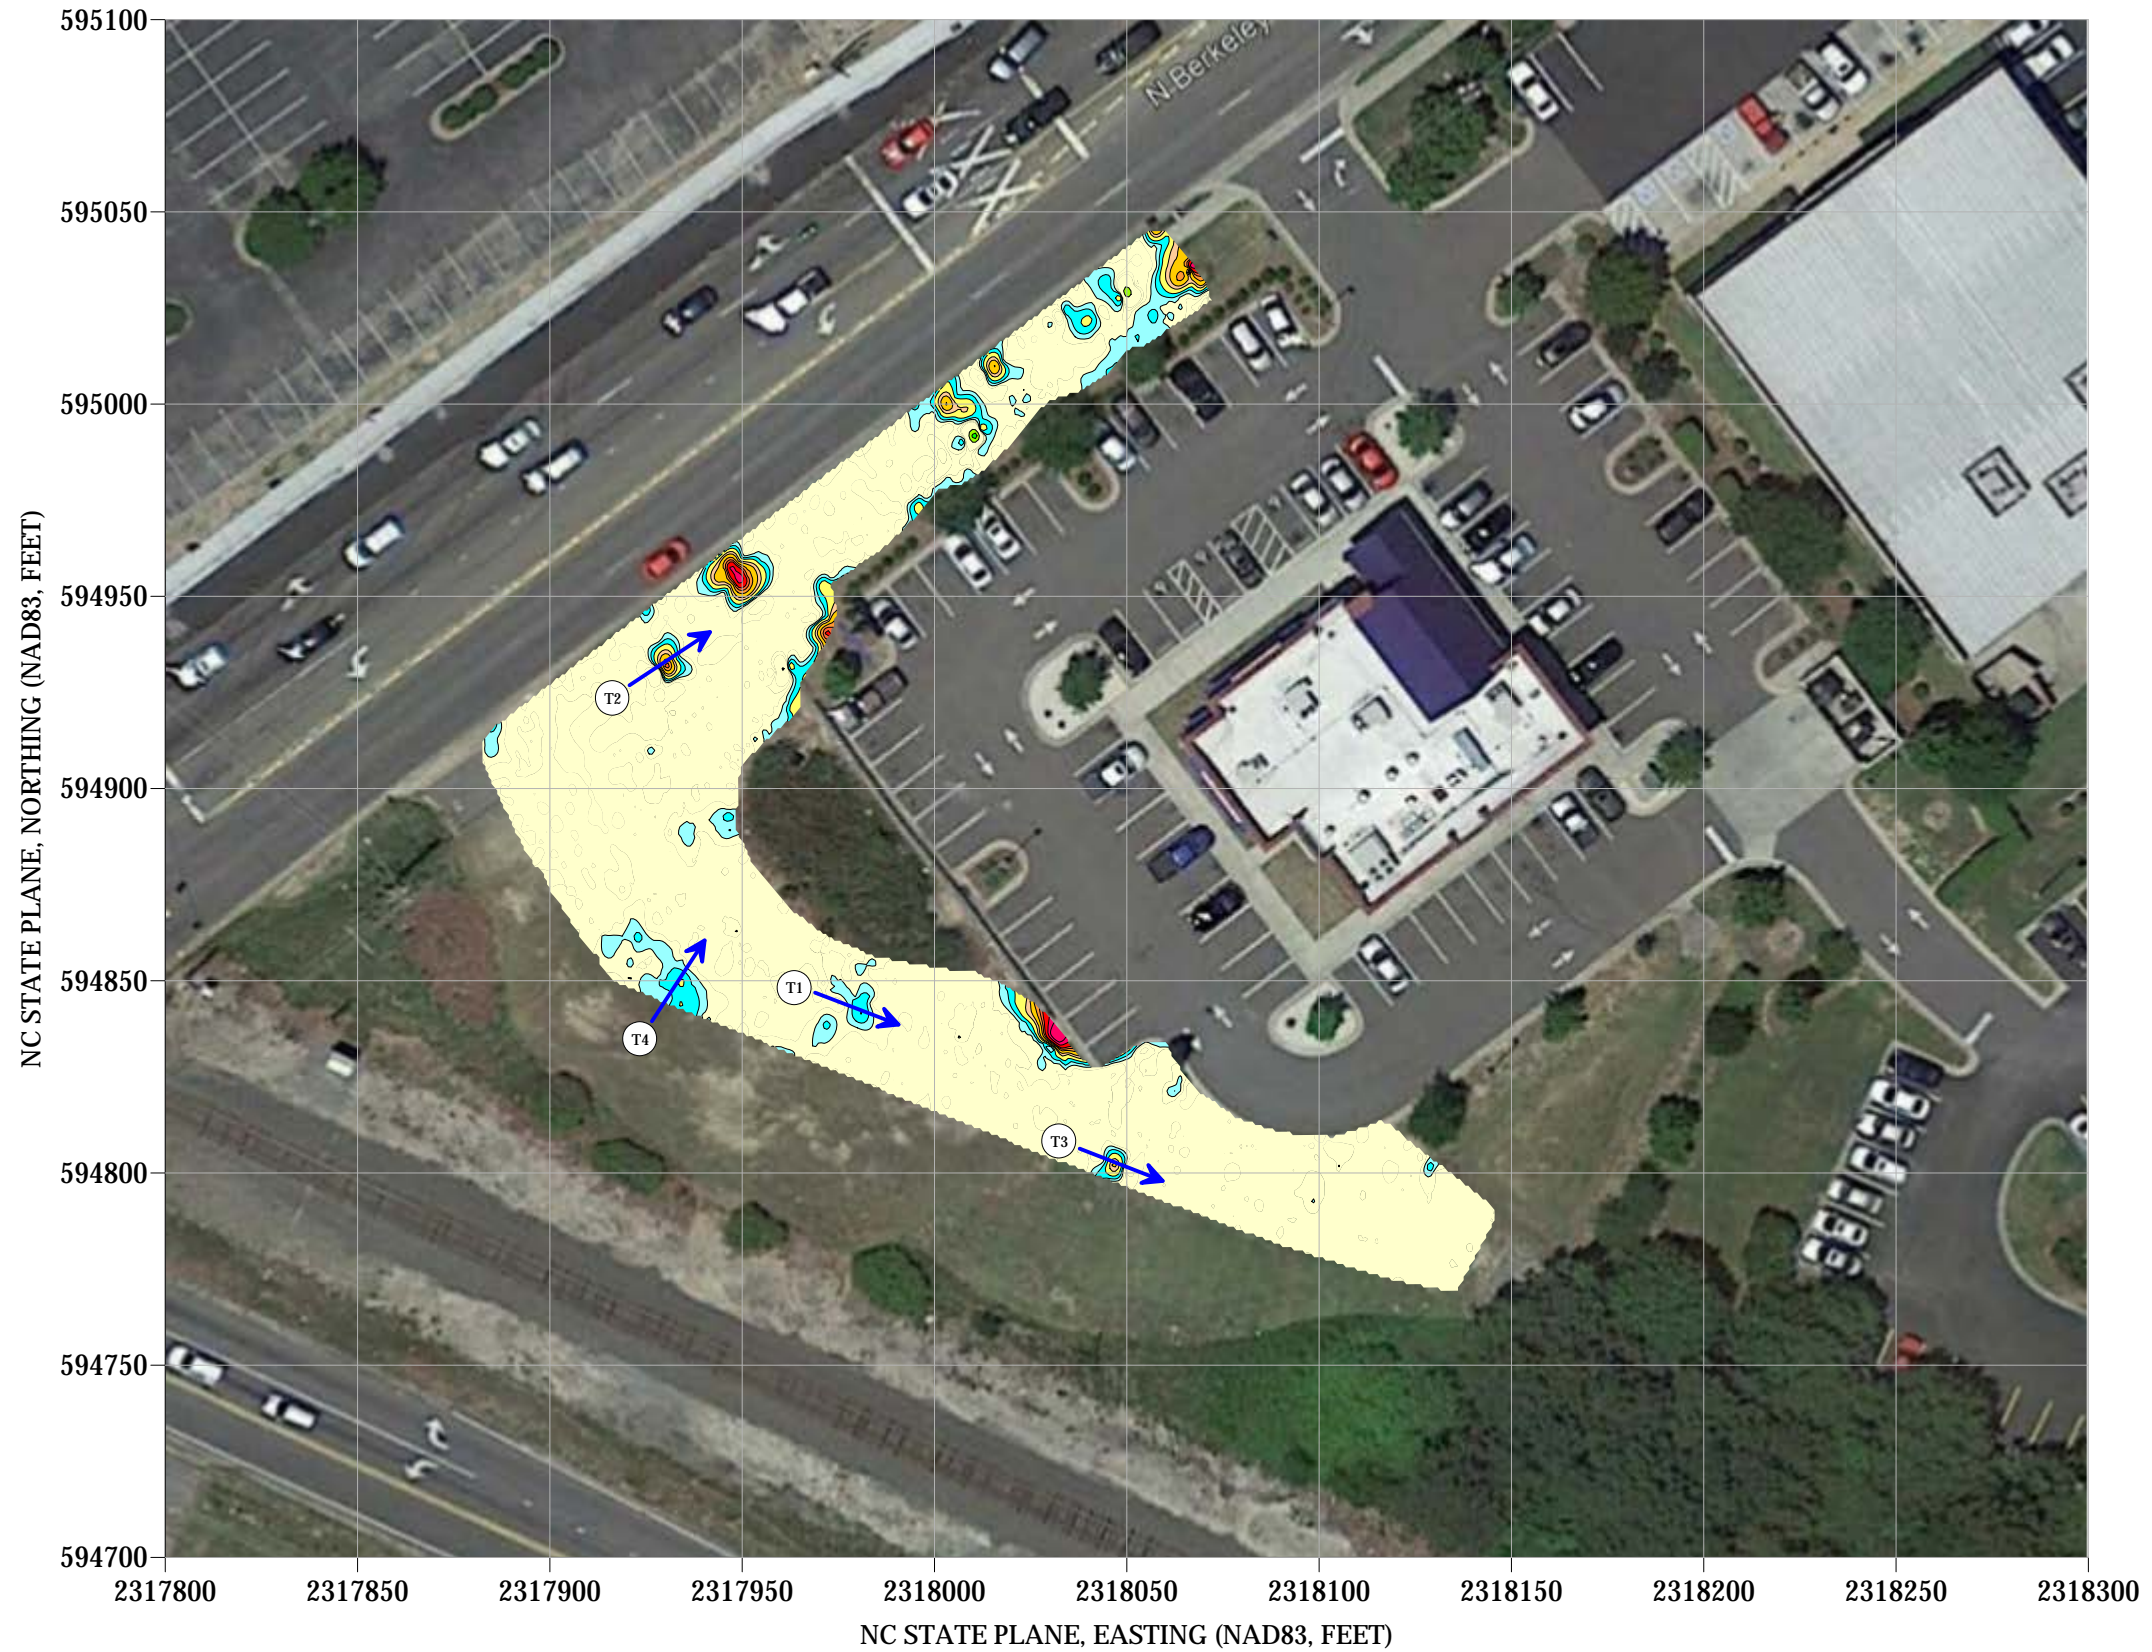
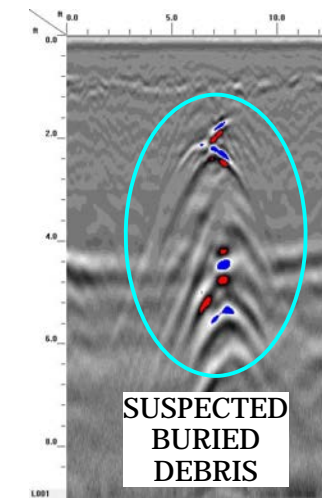
# LOCATIONS OF GPR TRANSECTS

\*EXTENSIVE GPR SCANS WERE CONDUCTED OVER THE ENTIRE SITE. TRANSECT LINES ON THE MAP ABOVE INDICATE LOCATIONS WHERE DATA WERE SAVED. THESE LOCATIONS WERE CHOSEN TO HIGHLIGHT STRUCTURES IDENTIFIED IN THE SUBSURFACE OR TRANSECTS THAT ARE REPRESENTATIVE OF GENERAL SUBSURFACE CONDITIONS.

anomalies are located in the vicinity of the former gas station and may be related to remnant debris/infrastructure. Extensive reconnaissance GPR scans were conducted across this area to further investigate for significant structures. No evidence of larger structures such as USTs was observed.

- Multiple anomalies were associated with suspected buried metallic debris and/or utilities and were further investigated with GPR.
- GPR performed across EM anomalies within the footprint of the former gas station recorded evidence of buried debris and isolated structures that may be related to remnant debris/infrastructure. Extensive reconnaissance GPR scans were conducted across this area to further investigate for significant structures. No evidence of larger structures such as USTs was observed.
