TIP NO: B-5808  
WBS: 45762.1.1  
COUNTY: Cabarrus  
DIVISION: 10  
DESCRIPTION: Replace Bridge No. 57 & 59 on US 29 & US 601 over Irish Buffalo Creek

SUBJECT: **GeoEnvironmental Report for Planning**

## **Hazardous Materials Report**

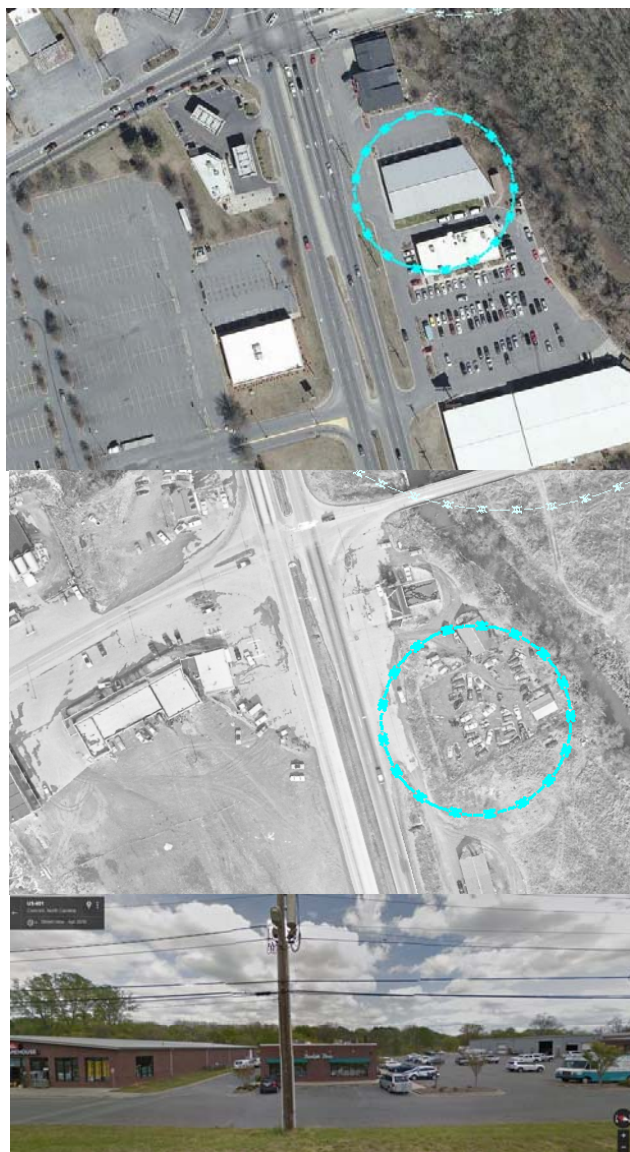
1)	<b>Property Name</b> Historical Automotive Service and/or Automotive Recycling 570 – 530 Concord Pkwy N Concord, NC	<b>Property Owner</b> Whitaker Investments LLC A NC LLC 530 Concord Pkwy N Concord, NC
	<b>Facility ID #:</b> NA	<b>UST Owner:</b> NA
	<b>Incident #:</b> NA

First Image c. 2015; second image NCDOT Historical Aerial 2/1/1961 Mission 129, exposure 13 (top of page is northward); Third Image Google Streetview c. 2016 (view northeastward)

This parcel is located south of the intersection of US 29 & US 601 and Poplar Tent Rd. This single parcel contains Dan'elle Clothing Warehouse, Punchy's Diner, and Punchy Whitaker's Wheel and Tire Pros. This parcel does not appear on the UST Section Registry nor are any NCDEQ incidents associated. There is no evidence of USTs or UST removals. Hydraulic lifts were not observed at the modern Punchy Whitakers Wheel and Tire Pros. In a NCDOT Historical Aerial, several cars and pre-existing buildings were observed that suggest that auto service and/or auto recycling was performed, thus hydraulic lifts or spills from auto recycling may be present. **This site is anticipated to present low geoenvironmental impacts to the project.**

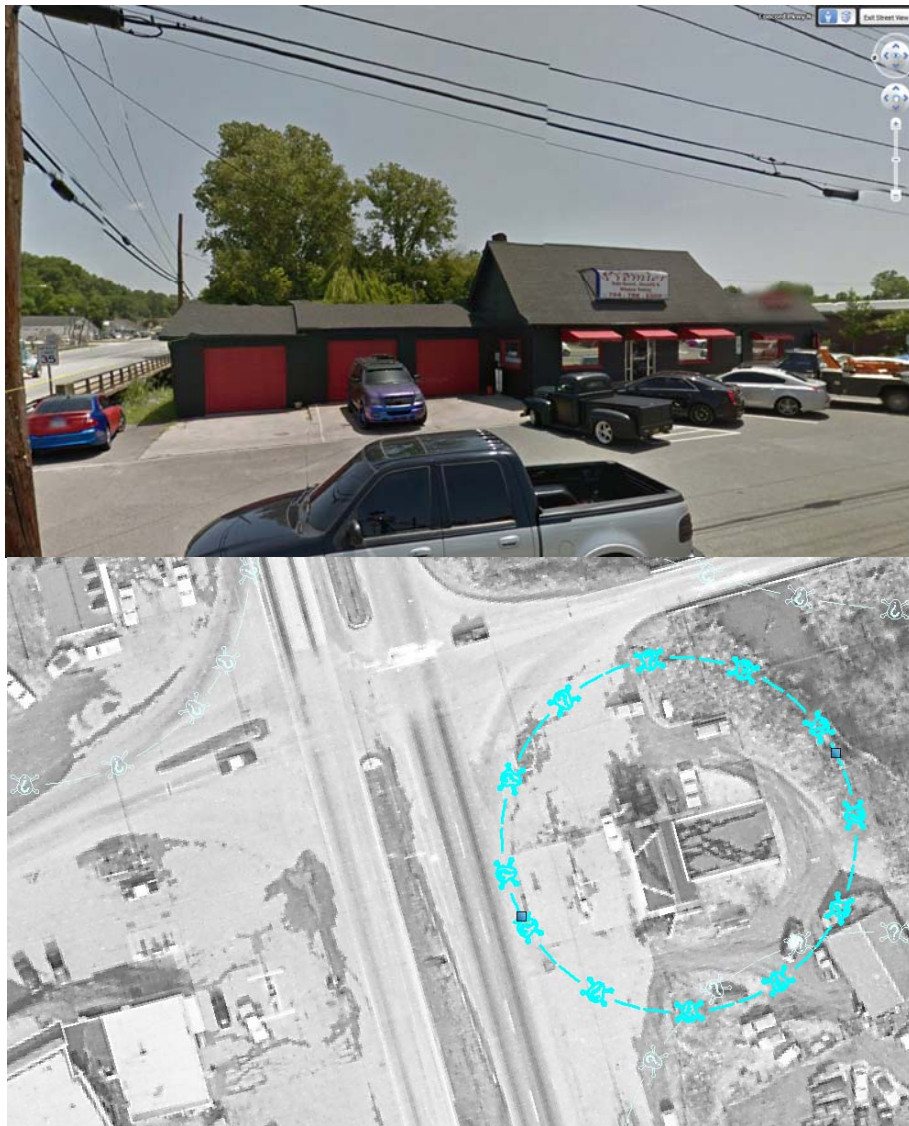
2)	<b>Property Name</b> Premier Auto Sound Security Concord Ink Tattoo/Piercing 590 Concord Pkwy N Concord, NC	<b>Property Owner</b> Whitaker Donald E 3661 Richwood Cir. Kannapolis, NC
----	---	--

First Image Streetview c. 2015 view eastward Image c. 2015; Second image NCDOT Historical Aerial 2/1/1961 Mission 129, exposure 13 (top of page is northward)

This apparent former gas station is located on southeastern quadrant of the intersection of US 29 & US 601 and Poplar Tent Rd. The architectural style, age, location and NCDOT Historical Aerial suggest that it operated as a gas station c. 1961. **This site is anticipated to present low goenvironmental impacts to the project.**

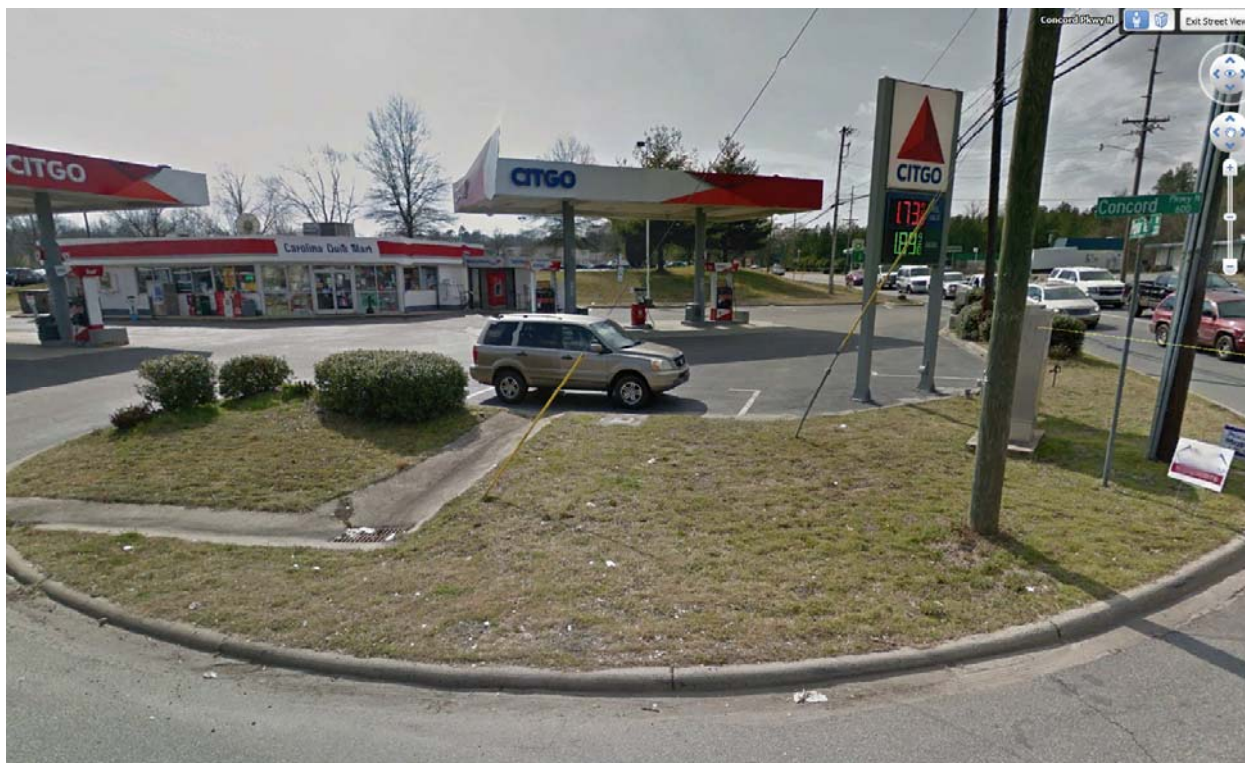
3)	<b>Property Name</b> Citgo AKA Carolina Quick Lube 589 Concord Pkwy N Concord, NC	<b>Property Owner</b> United Oil of the Carolinas PO Box 68 Gastonia, NC
	<b>Facility ID #:</b> 0-034794 <b>Incident #:</b> NA	<b>UST Owner:</b> United Oil of the Carolinas PO Box 68 2758 E Ozark Ave. Gastonia, NC

View southeastward (Google Streetview c. 2015)

This active gas station is located on south-southwestern quadrant of the intersection of US 29 & US 601 and Poplar Tent Rd. A groundwater monitoring well was observed near the store building. **This site is anticipated to present low geoenvironmental impacts to the project.**

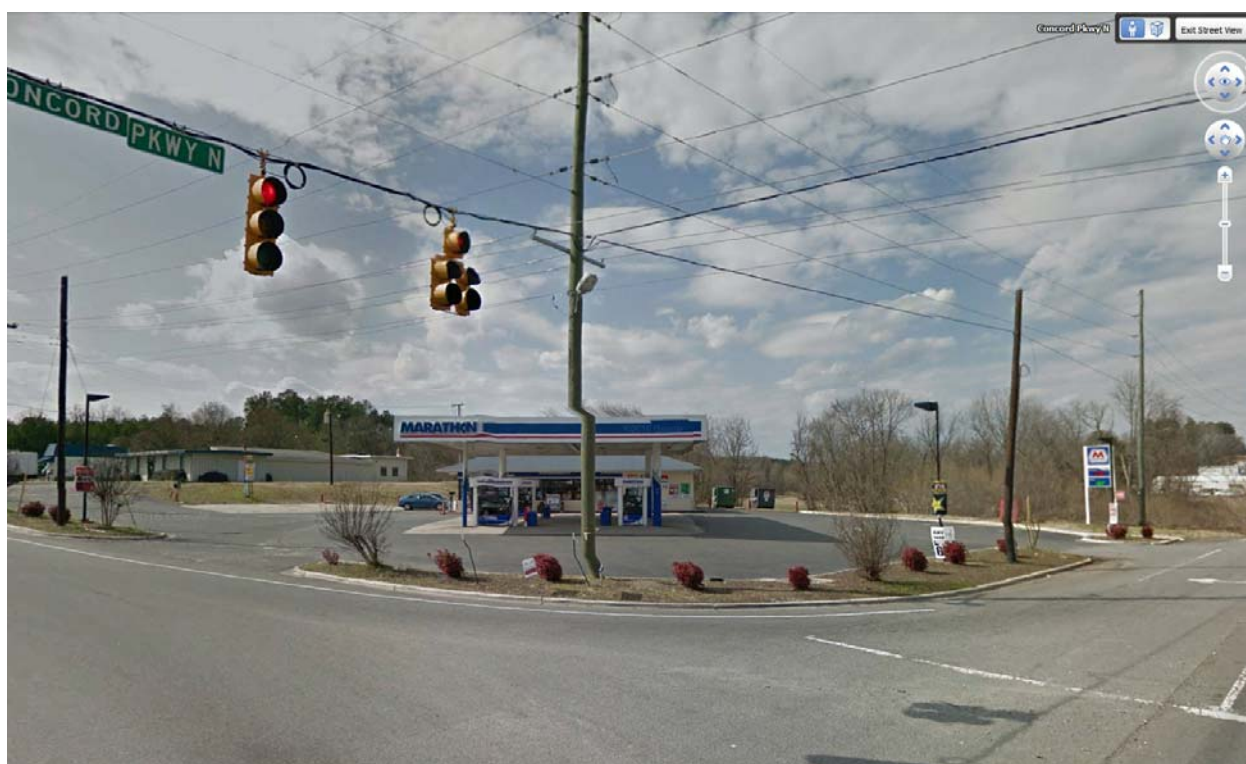
View northwestward (Google Streetview c. 2015)

This active gas station is located on the western quadrant of the intersection of US 29 & US 601 and Poplar Tent Rd. An Incident was assigned by NCDEQ. **This site is anticipated to present low geoenvironmental impacts to the project.**

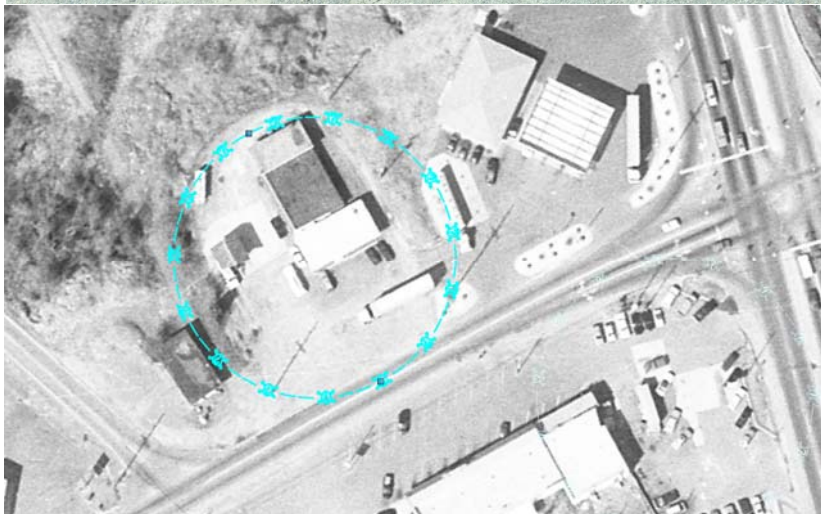
First image view northwestward; Second Image NCDOT Historical Aerial 3/10/1993 Mission 3092, exposure 60 (top of page is northward);

This former gas station and/or oil company facility is located approximately 300 feet west of the intersection of US 29 & US 601 and Poplar Tent Rd. According to the UST Section Registry USTs were registered and an Incident recorded. Four USTs are evident west of the building. **This site is anticipated to present low geoenvironmental impacts to the project.**

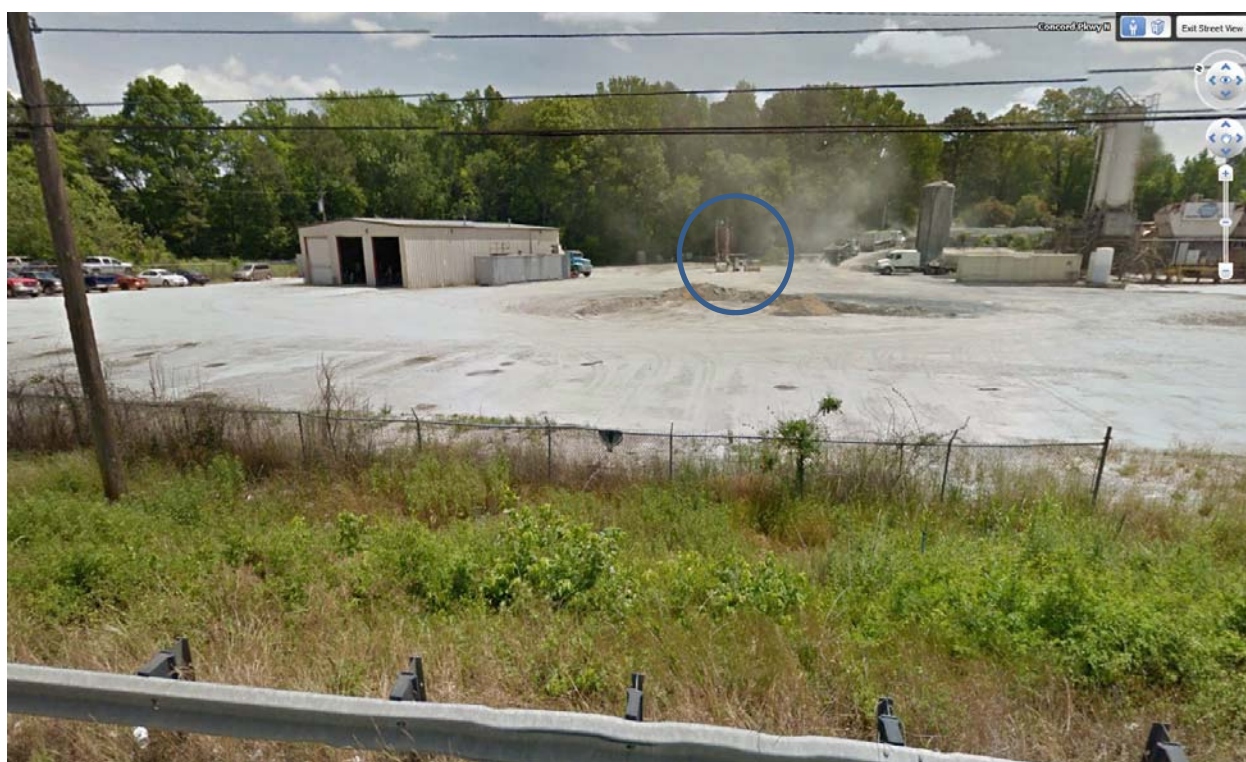
View northward (Google Streetview c. 2015)

This cement plant is located on northeastern quadrant of the intersection of US 29 & US 601 and Poplar Tent Rd. According to the UST Section Registry two USTs were reportedly filled in situ with inert material. An above ground storage tank (AST) is currently on site currently (blue circle). **This site is anticipated to present low geoenvironmental impacts to the project.**

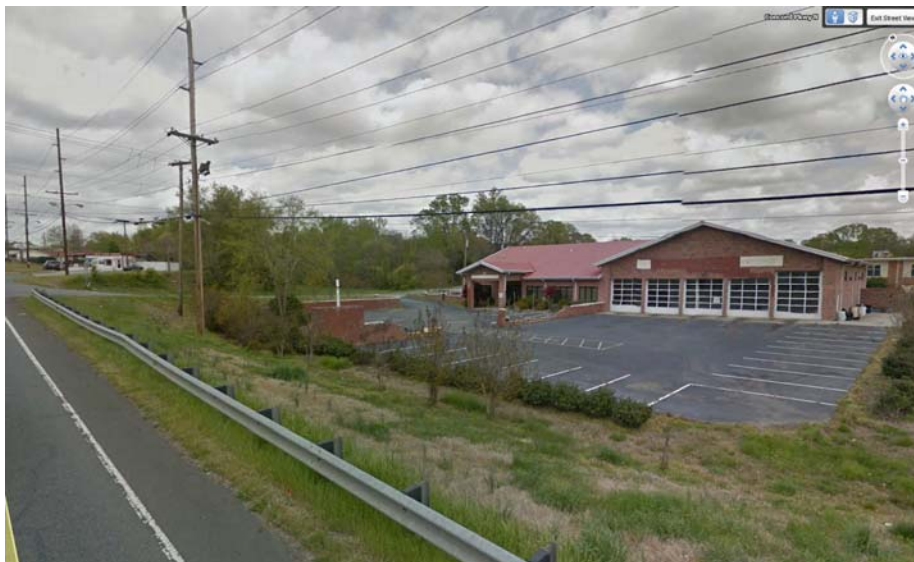
7) **Property Name**  
Webster Radiator and A/C  
650 Concord Pkwy N.  
Concord, NC

View north-northeastward (Google Streetview c. 2015)

This former location of Webster Radiator and A/C is located 1000 feet north of the intersection of US 29 & US 601 and Poplar Tent Rd. Hydraulic lifts may be present behind the bay five bay doors. **This site is anticipated to present low geoenvironmental impacts to the project.**

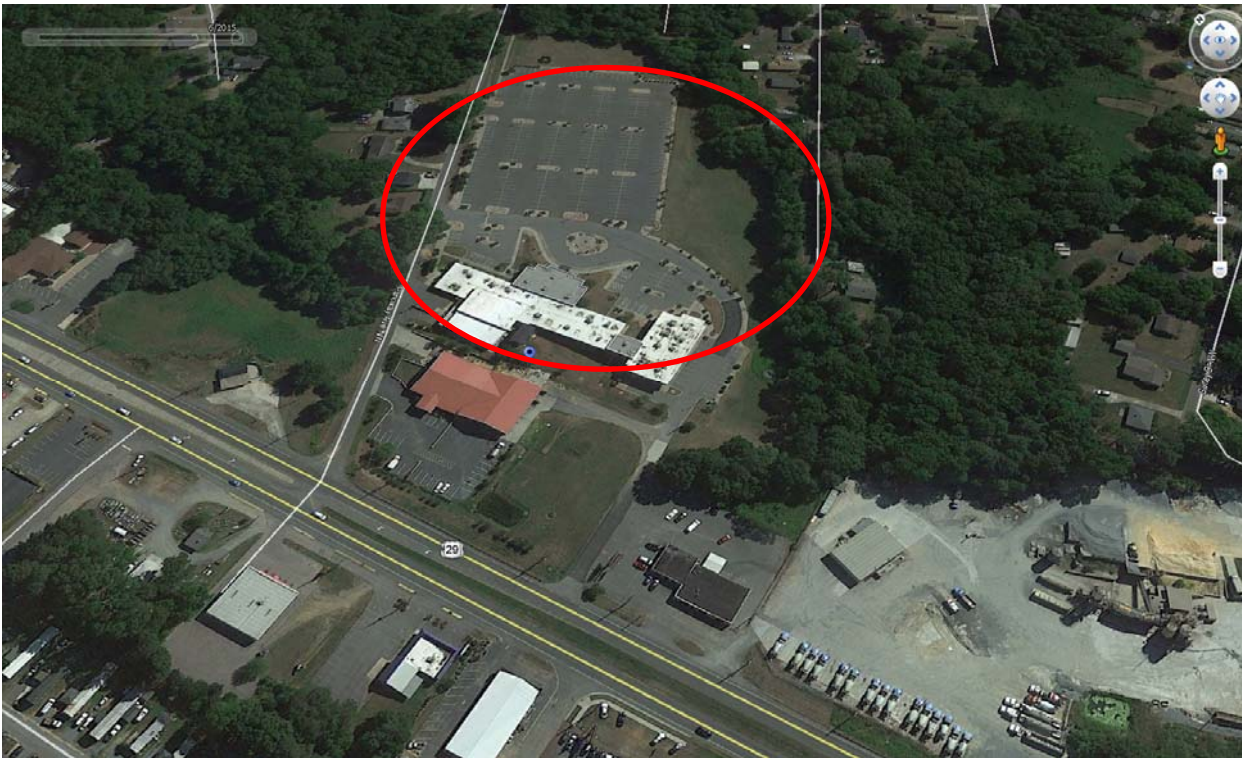
View north-northeastward (Google Streetview c. 2015)

This school maintenance facility is located 1000 feet north of the intersection of US 29 & US 601 and Poplar Tent Rd. behind the site of Webster Radiator and A/C. According to the UST Section Registry a UST registered and an Incident recorded, and a No Further Action status was reportedly granted c. 2001. **This site is anticipated to present low geoenvironmental impacts to the project.**

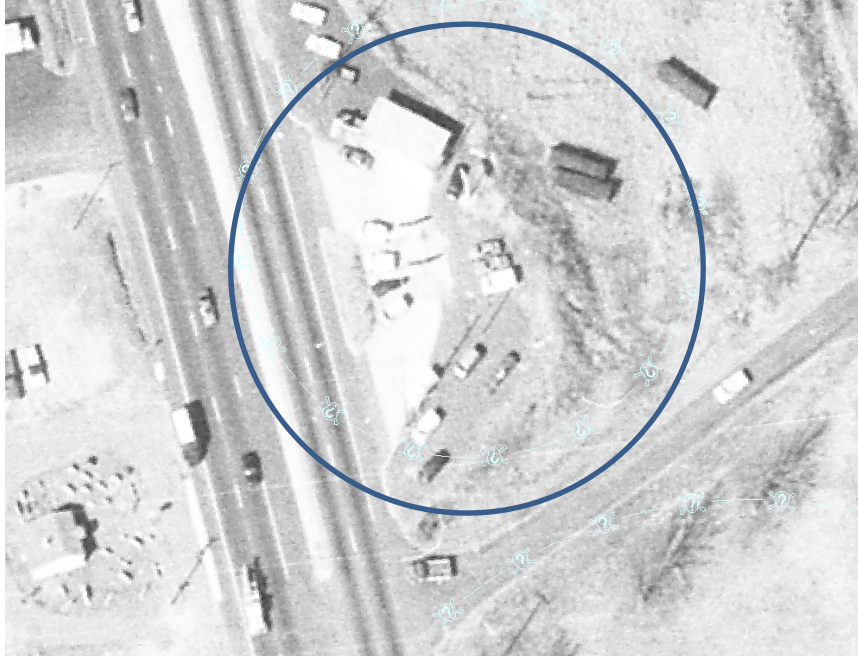
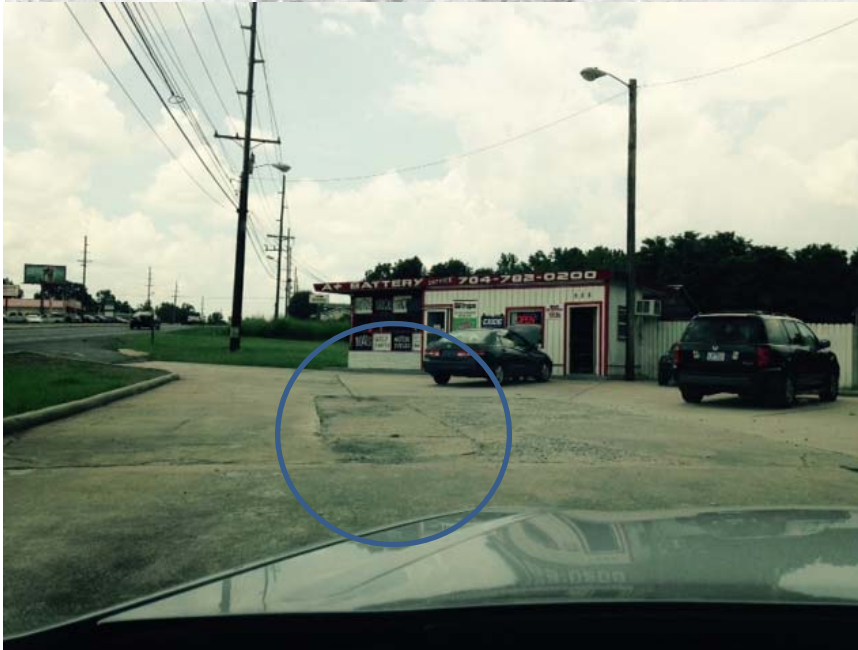
9)	<b>Property Name</b> Car Battery Sales 688 Concord Pkwy N Concord, NC	<b>Property Owner</b> Frances Medlin Fam. Farms I LLC PO Box 703 Concord, NC
	<b>Facility ID #:</b> NA <b>Incident #:</b> NA	<b>UST Owner:</b> NA

First Image NCDOT Historical Aerial 3/10/1993 Mission 3092, exposure 60 (top of page is northward); Second Image view northward

This car battery sales facility and apparent former gas station is located 1000 feet north of the intersection of US 29 & US 601 and Poplar Tent Rd. A NCDOT Historical Aerial suggests it was a gas station (first image, blue circle), and an apparent former pump island is evident in the concrete (second image, blue circle). **This site is anticipated to present low geoenvironmental impacts to the project.**
