## **GEOENVIRONMENTAL PHASE II INVESTIGATION REPORT PARCEL #10, 20671 CATAWBA AVENUE, CORNELIUS, NC**

**Description:** Intersection of US 21 and SR 2697 (Catawba Avenue), Cornelius, Mecklenburg County, NC

**Parcel No (PIN):** Parcel #10; Fast Express 504  
PIN #00319201

**Address:** 20671 Catawba Avenue, Cornelius, NC 28031

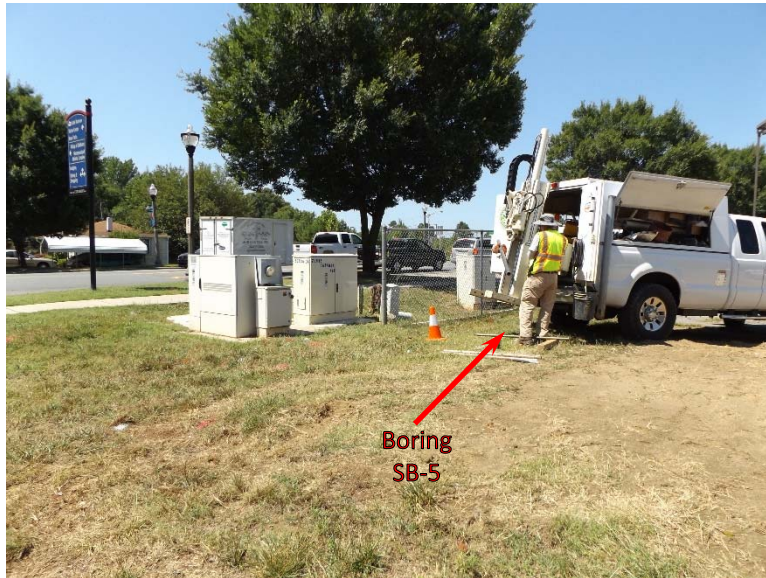
The field PID screening measurements listed in Appendix B indicate the presence of organic vapors only in one boring, SB-5, which is the boring closest to the kerosene UST excavation and corrective action area (see Section 2.0). The horizon with the highest PID measurement, 186 parts per million (ppm), was 2 to 3 feet bgs. Therefore, a sample of the soil collected from 2 to 3 feet bgs was submitted to RED Lab for indicator-parameter UVF Spectrometry analysis to evaluate for the presence petroleum contaminated soil. None of the other soil borings showed significant PID readings or discernable differences between soil horizons, and so the sample collected from all other borings from 1 to 2 feet bgs was selected for laboratory analysis, as discussed in Section 4.2. A summary of the soil sampling details is tabulated below, along with a listing of the northing and easting coordinates for the boring locations.

Petroleum hydrocarbons were identified in soil boring SB-5. The reported TPH concentration (C5-C35) of 166.2 mg/Kg exceeds the NCDEQ screening level of 10 mg/Kg. The proximity of this boring to the location of the kerosene UST removal and corrective action area infers that the identified contamination is associated with the prior kerosene release. Although RED Lab’s computer algorithm did not result in a hydrocarbon fingerprint match (see Table 1 and Appendix C), the 2:1 hydrocarbon concentration ratio between diesel range organics (DRO, C10-C35) to gasoline range organics (GRO, C5-C10) is somewhat consistent with weathered kerosene.

Photograph 7. GeoEnvironmental soil boring location SB-5.

No additional environmental investigation of the soil at the site is recommended at this time. However, it is recommended that soil excavated in the vicinity of soil borings SB-5 as part of NCDOT's planned construction activities be handled appropriately as petroleum contaminated soil and further characterized for petroleum constituents, as warranted.
