REFERENCE: B-6046

PROJECT: 48409

STRUCTURE
SUBSURFACE INVESTIGATION

COUNTY STANLY
PROJECT DESCRIPTION REPLACE BRIDGE NO. 102 ON
SR 1917 (BETHLEHEM CHURCH ROAD) OVER
LONG CREEK

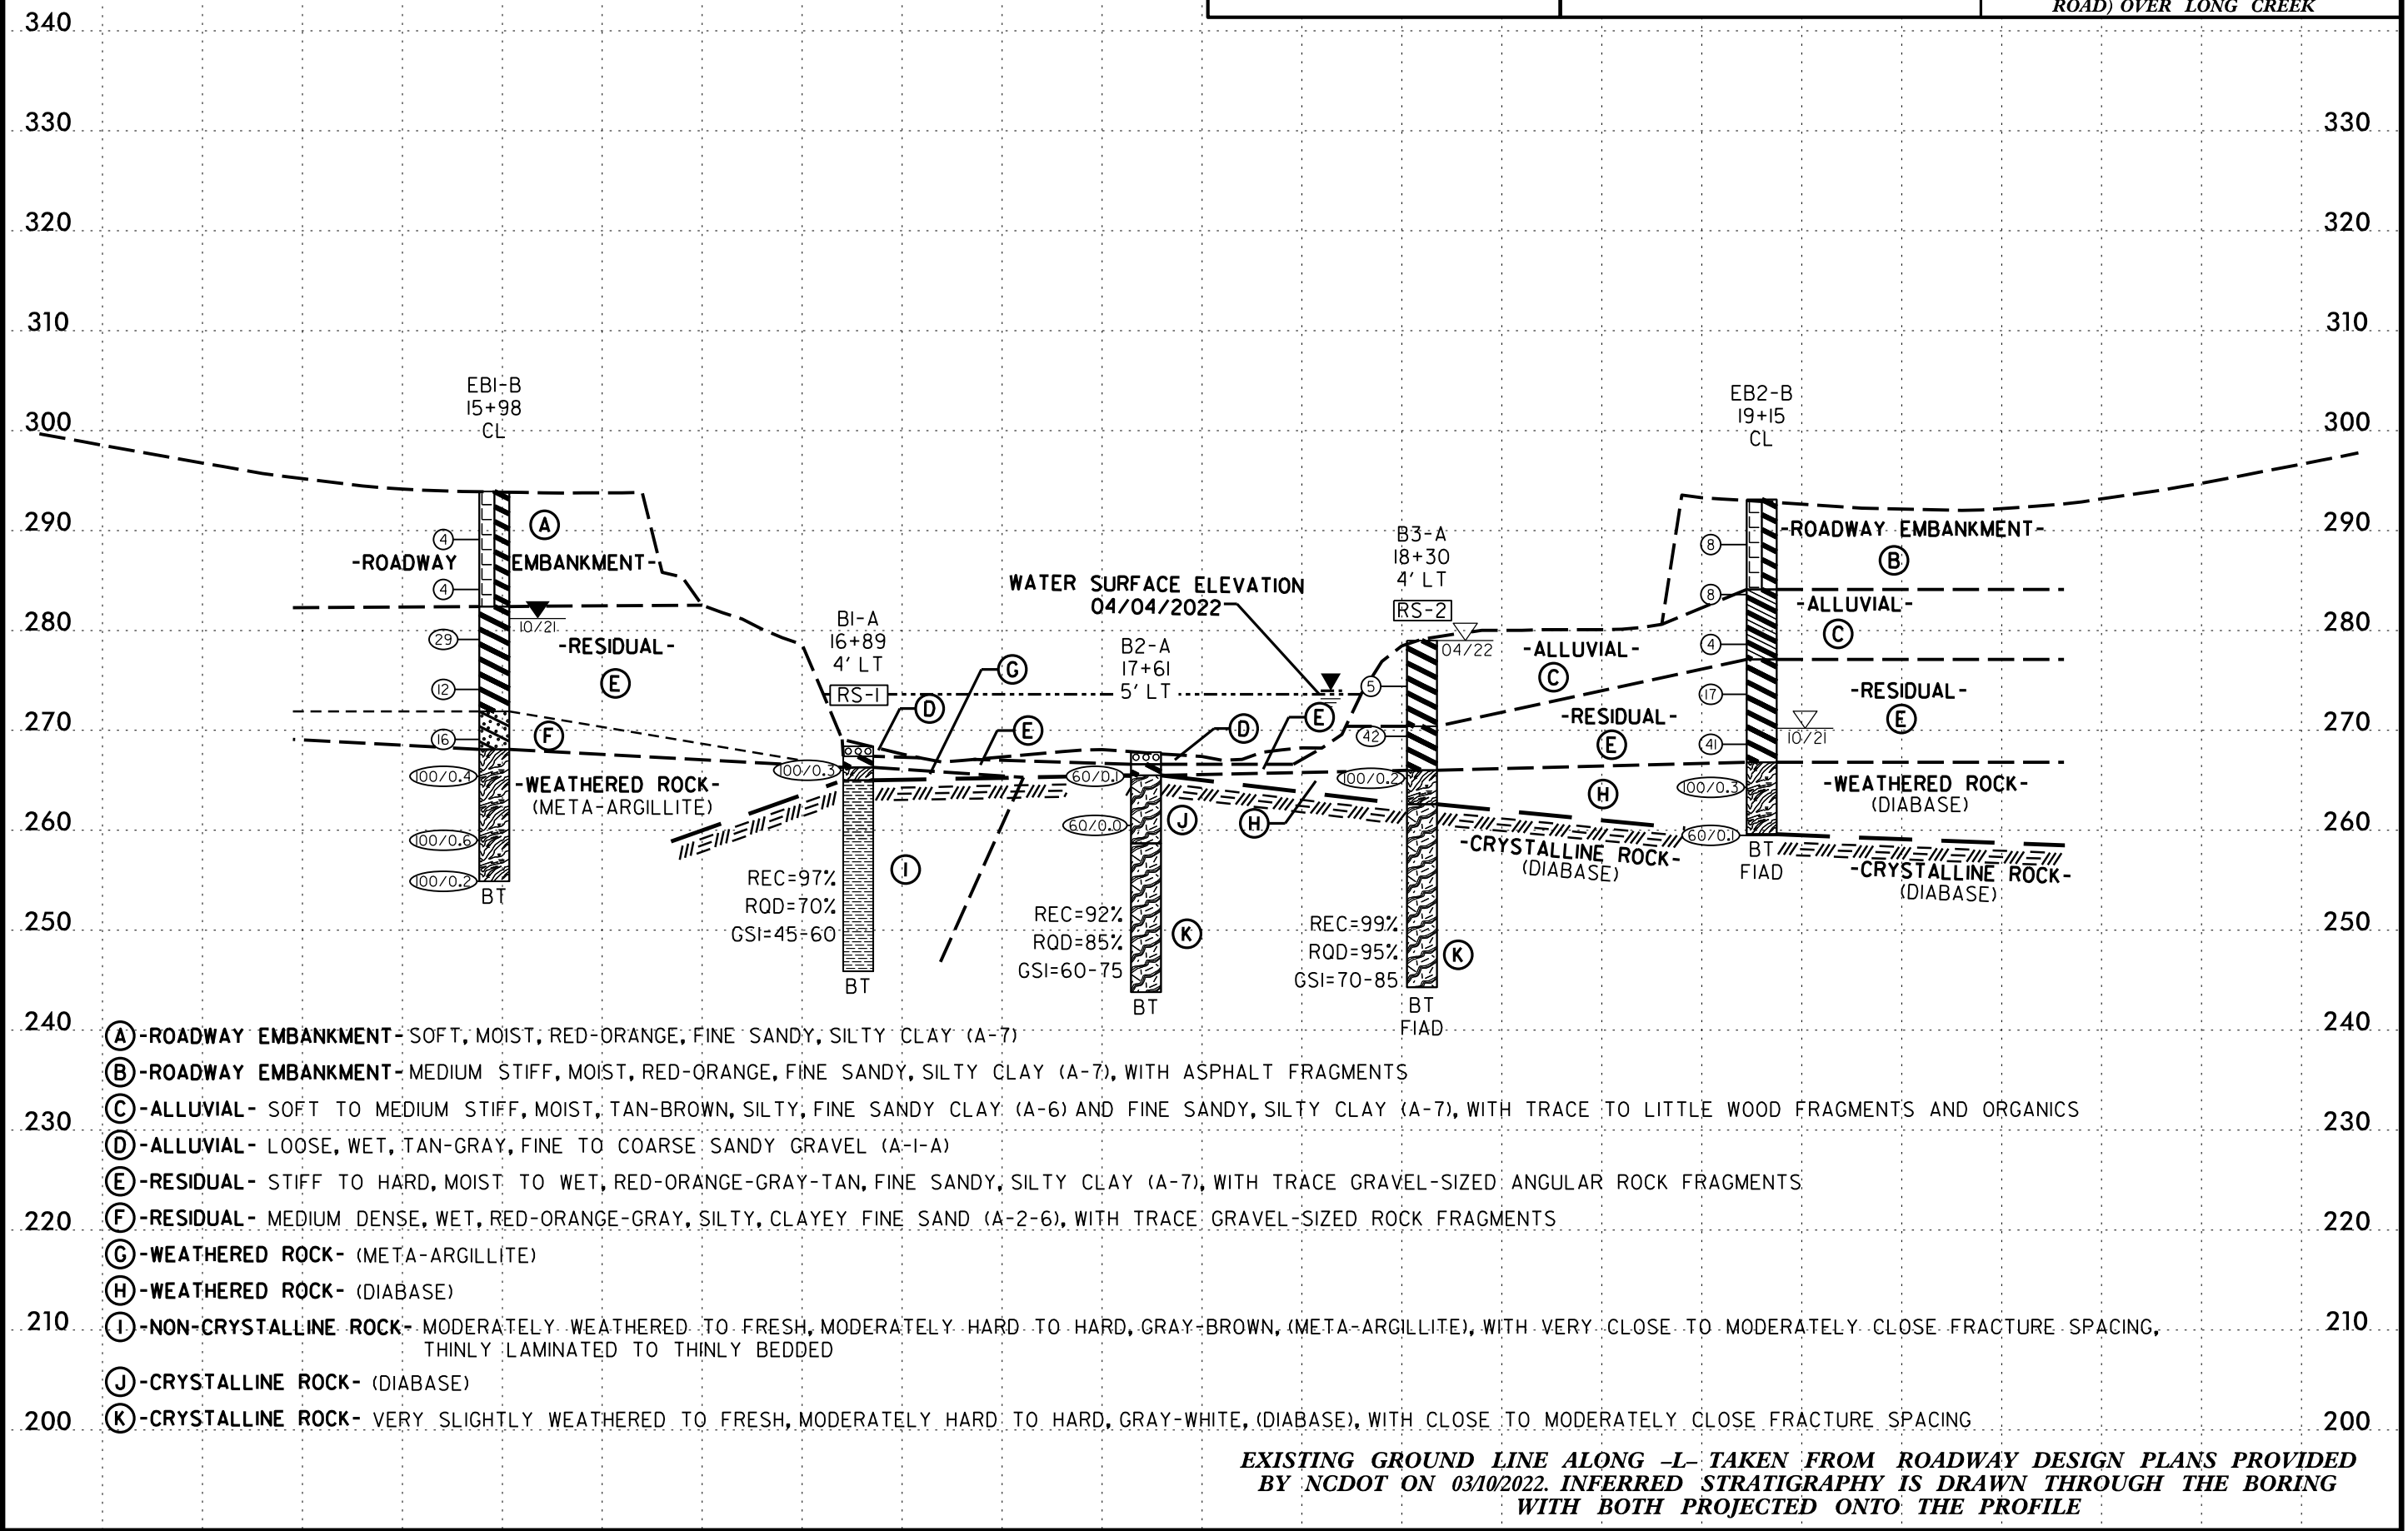
- 240 (A) -ROADWAY EMBANKMENT- SOFT, MOIST, RED-ORANGE, FINE SANDY, SILTY CLAY (A-7)
- 230 (B) -ROADWAY EMBANKMENT- MEDIUM STIFF, MOIST, RED-ORANGE, FINE SANDY, SILTY CLAY (A-7), WITH ASPHALT FRAGMENTS

- 230 (C) -ALLUVIAL- SOFT TO MEDIUM STIFF, MOIST, TAN-BROWN, SILTY, FINE SANDY CLAY (A-6) AND FINE SANDY, SILTY CLAY (A-7), WITH TRACE TO LITTLE WOOD FRAGMENTS AND ORGANICS

- 230 (D) -ALLUVIAL- LOOSE, WET, TAN-GRAY, FINE TO COARSE SANDY GRAVEL (A-1-A)
- 220 (E) -RESIDUAL- STIFF TO HARD, MOIST TO WET, RED-ORANGE-GRAY-TAN, FINE SANDY, SILTY CLAY (A-7), WITH TRACE GRAVEL-SIZED ANGULAR ROCK FRAGMENTS

- 220 (F) -RESIDUAL- MEDIUM DENSE, WET, RED-ORANGE-GRAY, SILTY, CLAYEY FINE SAND (A-2-6), WITH TRACE GRAVEL-SIZED ROCK FRAGMENTS
- 210 (G) -WEATHERED ROCK- (META-ARGILLITE)

- 210 (H) -WEATHERED ROCK- (DIABASE)
- 210 (I) -NON-CRYSTALLINE ROCK- MODERATELY WEATHERED TO FRESH, MODERATELY HARD TO HARD, GRAY-BROWN, (META-ARGILLITE), WITH VERY CLOSE TO MODERATELY CLOSE FRACTURE SPACING, THINLY LAMINATED TO THINLY BEDDED

- 210 (J) -CRYSTALLINE ROCK- (DIABASE)
- 200 (K) -CRYSTALLINE ROCK- VERY SLIGHTLY WEATHERED TO FRESH, MODERATELY HARD TO HARD, GRAY-WHITE, (DIABASE), WITH CLOSE TO MODERATELY CLOSE FRACTURE SPACING

EXISTING GROUND LINE ALONG -L- TAKEN FROM ROADWAY DESIGN PLANS PROVIDED BY NCDOT ON 03/10/2022. INFERRED STRATIGRAPHY IS DRAWN THROUGH THE BORING WITH BOTH PROJECTED ONTO THE PROFILE

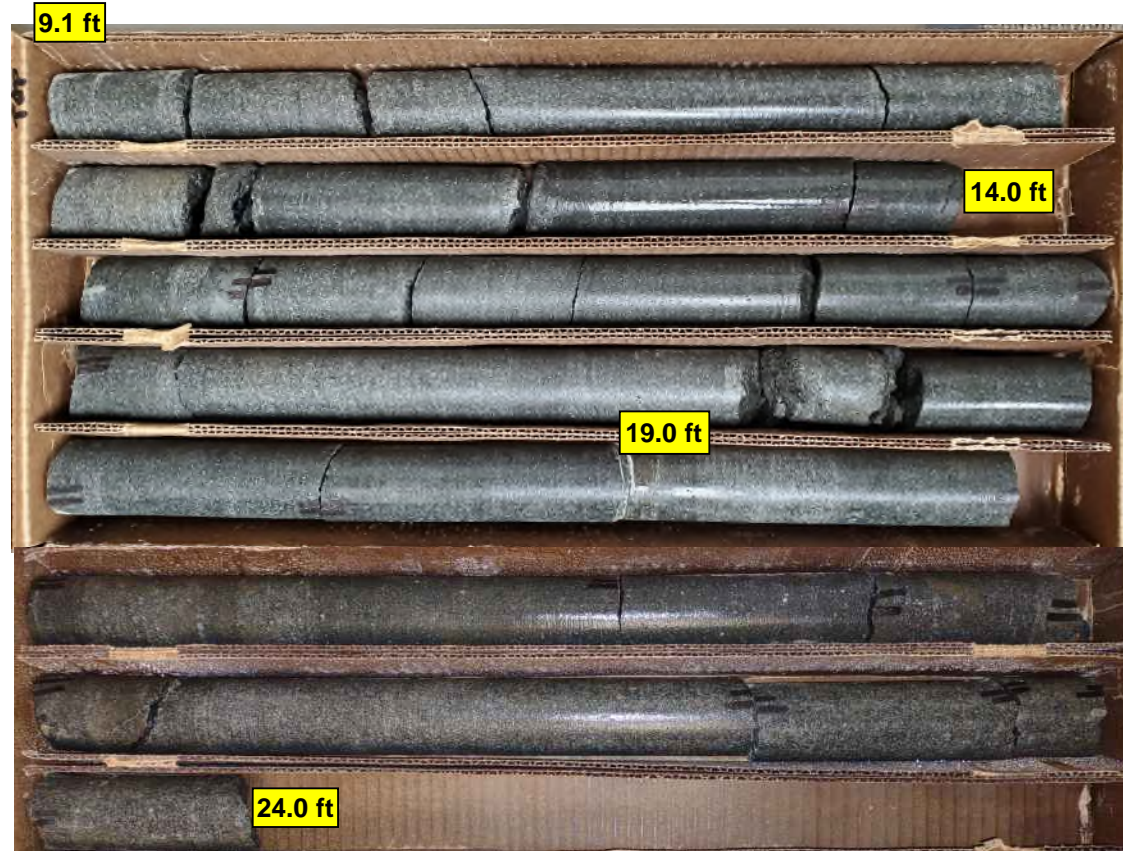
Bridge No. 102 on SR 1917 (Bethlehem Church Road) over
Long Creek
Rock Core Photographs
Boring: B2-A
9.1 to 24.0 Feet

258.67	258.7	9.1	4.9		(3.7) 76%	(2.8) 57%		(13.7) 92%	(12.6) 85%		Begin Coring @ 9.1 ft	
255	253.8	14.0	5.0		(5.0) 100%	(4.8) 96%					Very Slightly Weathered to Fresh, Moderately Hard to Hard, Gray-White (DIABASE), with Close to Moderately Close Fracture Spacing	9.1
250	248.8	19.0	5.0		(5.0) 100%	(5.0) 100%						
245	243.8	24.0									Boring Terminated at Elevation 243.8 ft In Crystalline Rock (DIABASE)	24.0

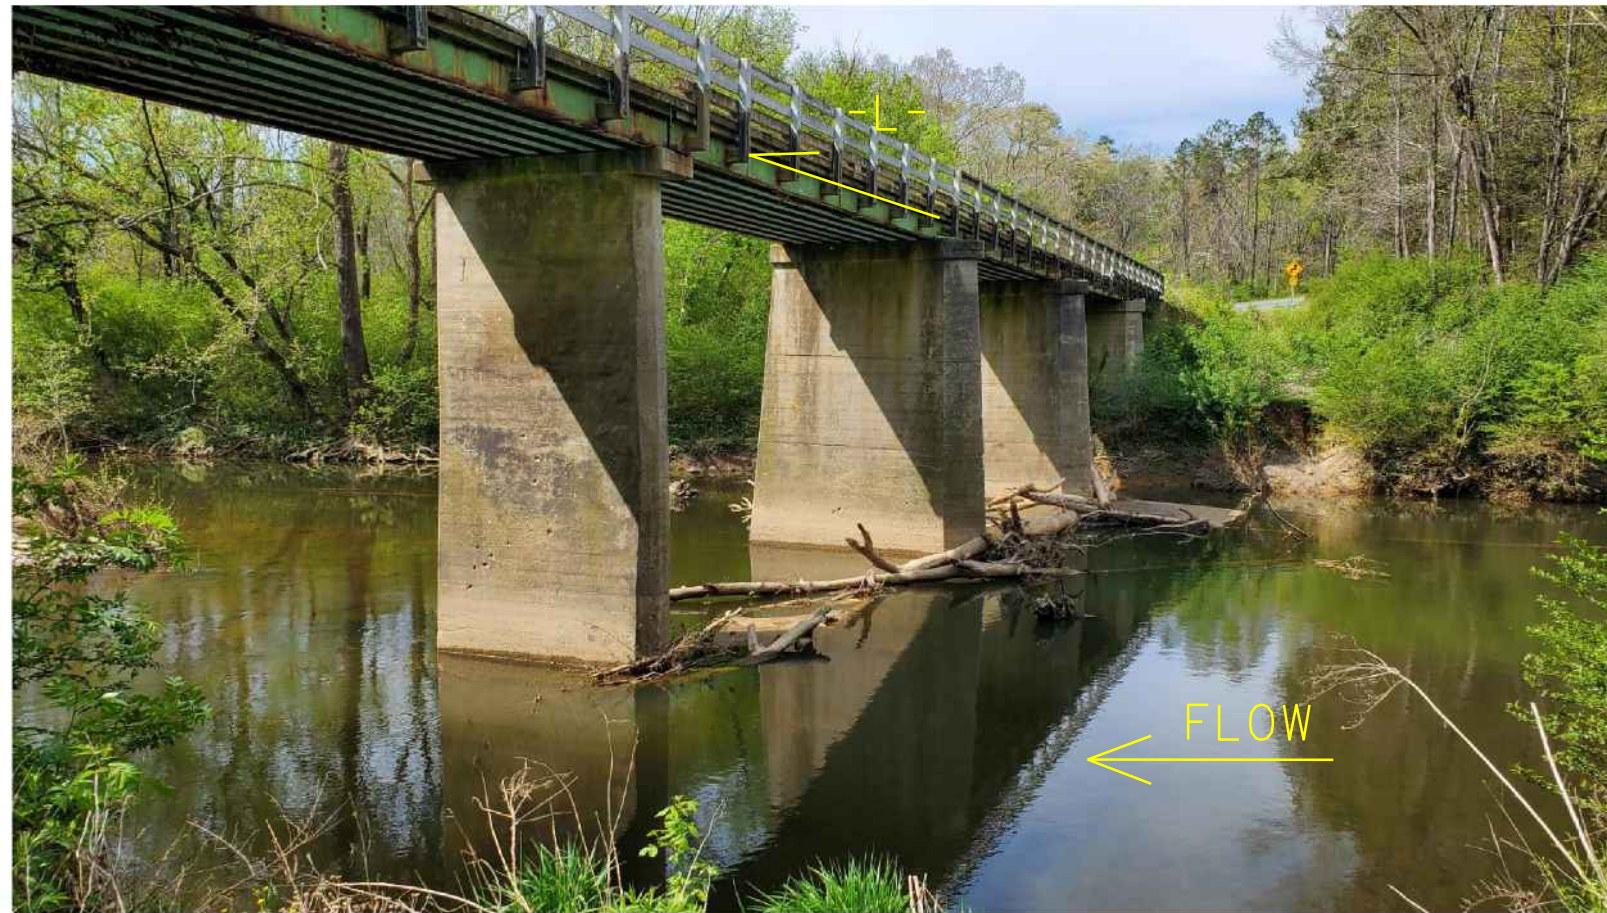
Photo #1: North side of existing bridge looking south/southwest (downstation)

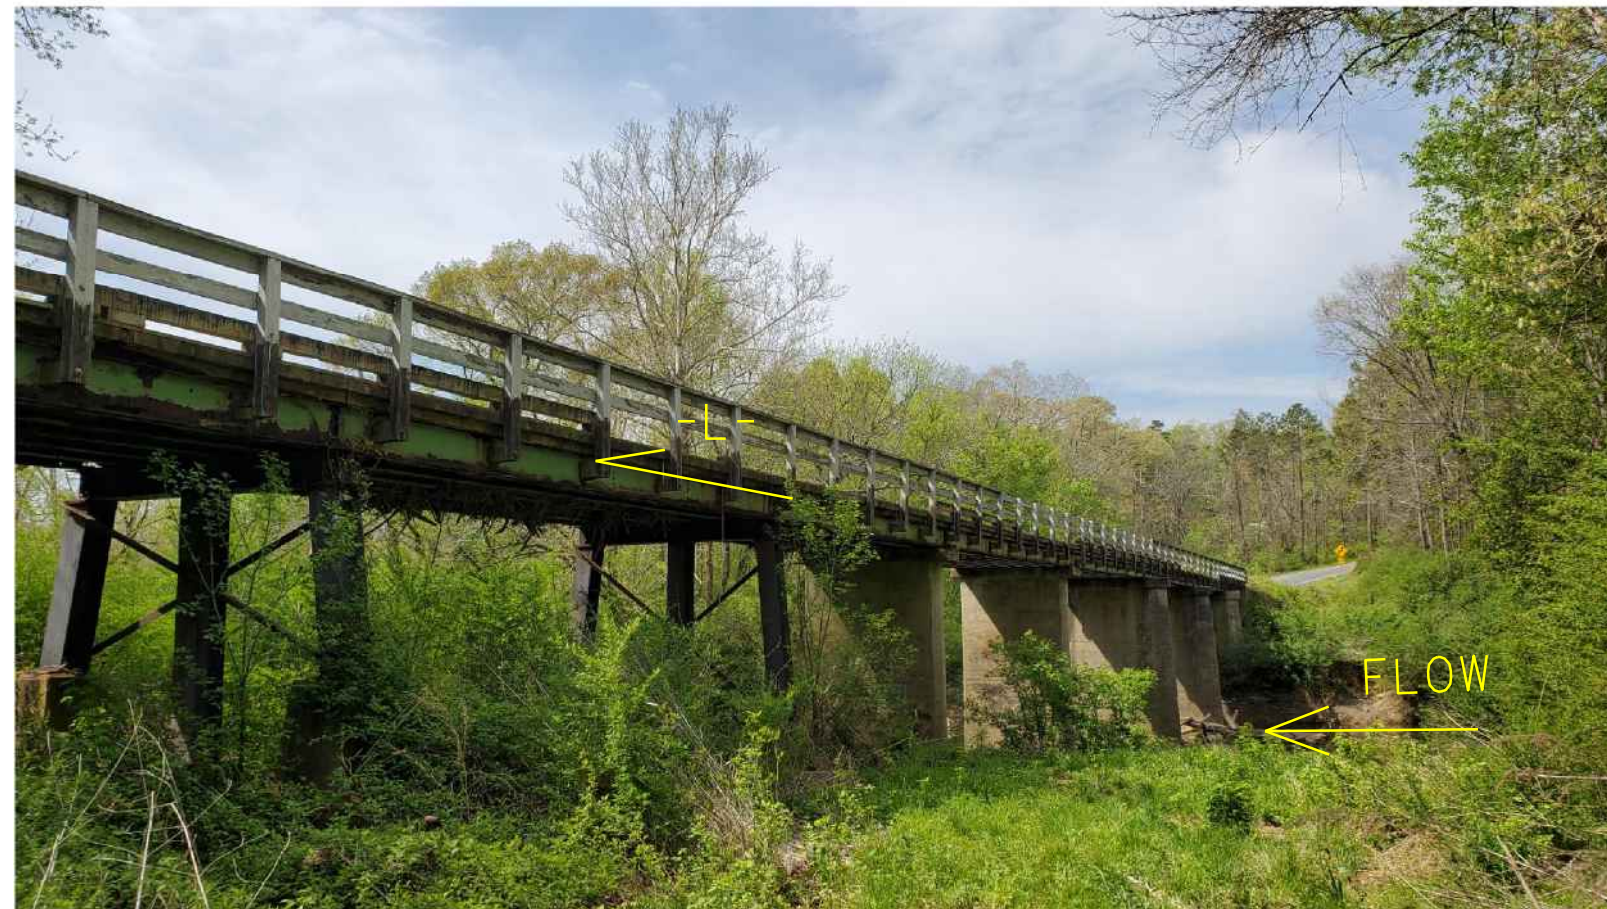
Photo #2: North side of existing bridge looking south/southwest (downstation)

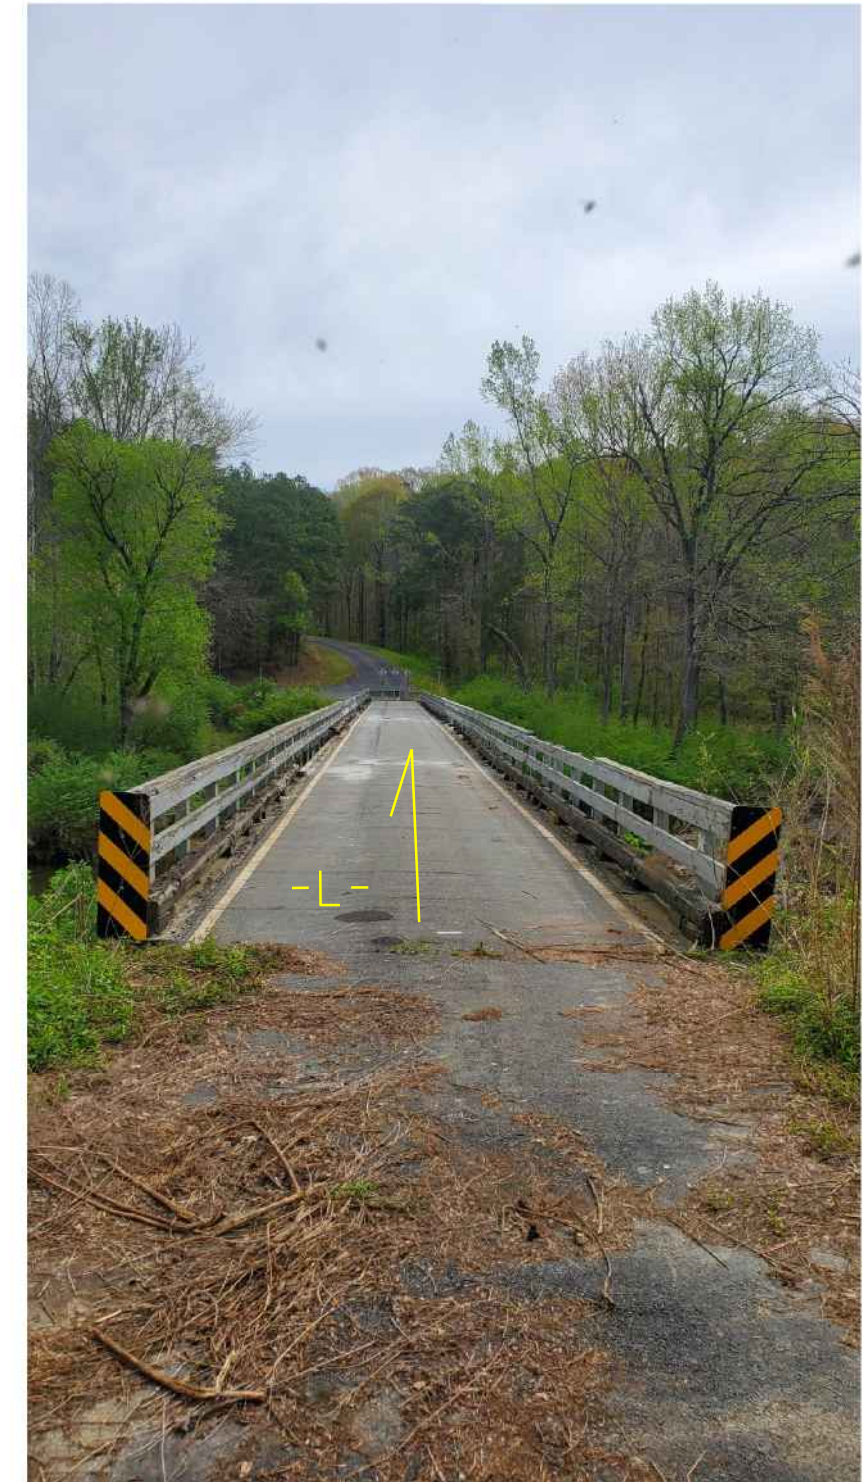
Photo #3: End Bent 1 looking north/northeast (upstation)
