RE: **GEOENVIRONMENTAL PHASE II INVESTIGATION OF PARCEL 6** Valero Gas Station, FAW JC 801 S. State St., Yadkinville, North Carolina ESP Project No. GR22.309

TIP Number:	U-5809
WBS Number:	44382.1.1
County:	YADKIN
Description:	Construct median along US 601 (State Street) from US 421 to SR 1146
	(Lee Avenue) and add roundabouts at both ends of project

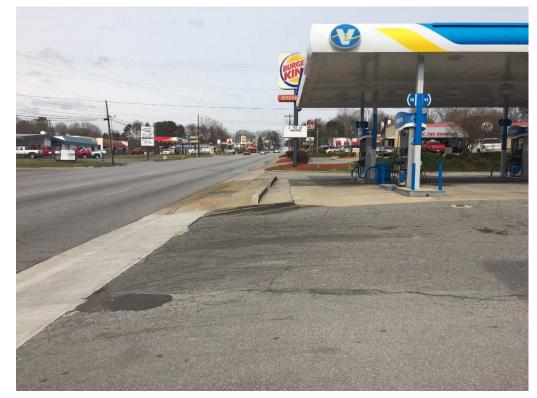
D. Photo of proposed easement area, looking north.

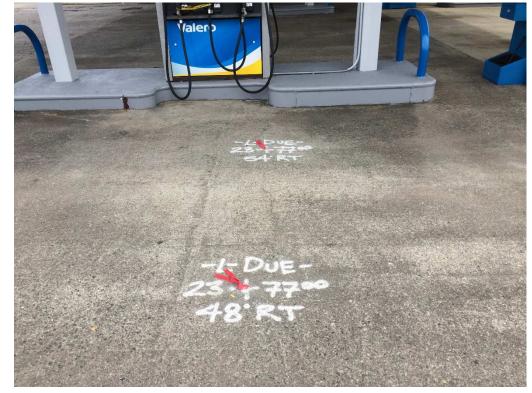
D. Photo of NCDOT easement markings on west side of western pump island.

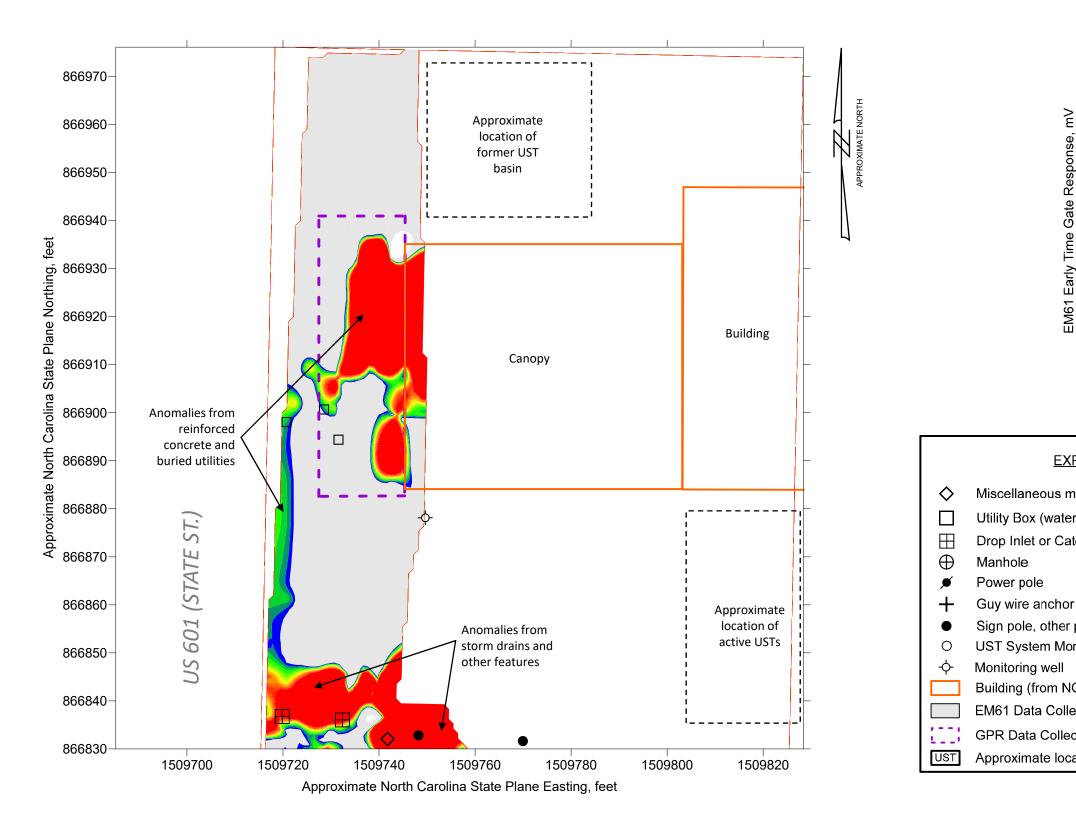
FIGURE 3 - PARCEL EM61 EARLY TIME GA	
YADKIN COUNTY, NORTI

ESP performed a metal detector study over the accessible areas of the study area using a Geonics EM61 MK2 with a line spacing of about three feet (Figures 3 and 4). Location control was provided

The EM61 early time gate data show the response from both shallow and deeper metallic objects (Figure 3). The differential response reduces the effect of shallow anomalies and emphasizes anomalies from larger and more deeply buried metallic objects, such as USTs (Figure 4). The EM61 differential responses corresponded to known site features, such as storm drains, buried utilities, and reinforced concrete. GPR data were collected over selected EM61 anomalies. The GPR data did not indicate the presence of unknown USTs within the study area.

The geophysical data did not indicate the presence of abandoned USTs in the study area.

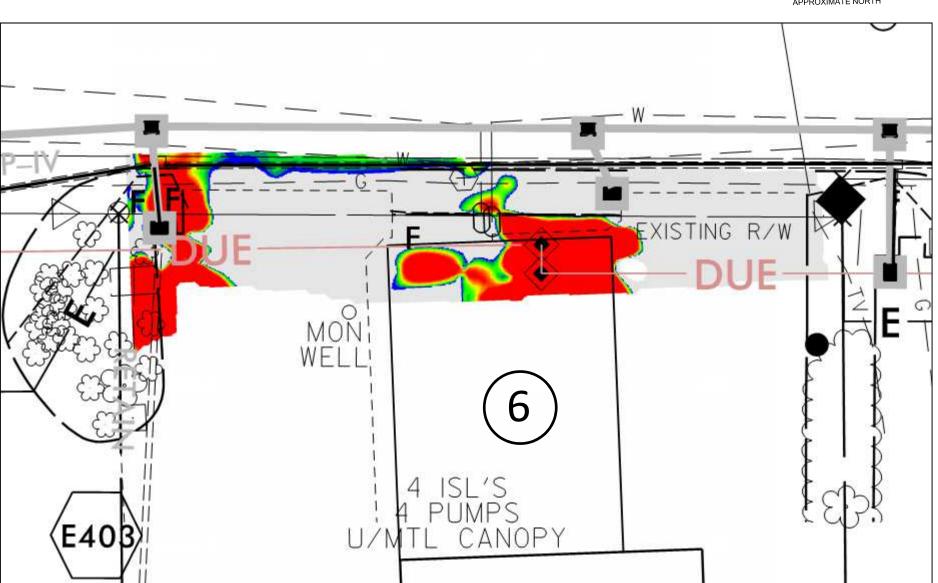
PROJECT NO. GR22.309	FIGURE 5 – PARCEL
^{scale} 1" = 20'	EM61 EARLY TIME GATE RESPO
^{DATE} 4/11/19	U-5809, CONSTRUCT MEDIAN ALONG U US 421 TO SR 1146 (LEE AVENUE) A
EDB	YADKIN COUNTY, NORT

The EM61 early time gate response and differential response are shown on the plan sheet on Figures 5 and 6, respectively.

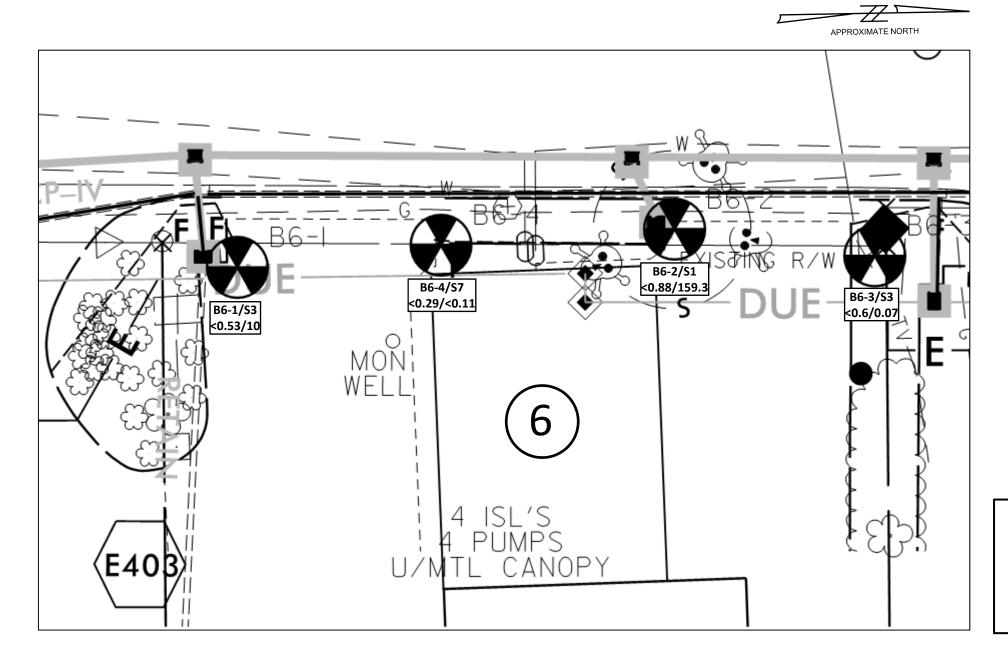
PROJECT NO. GR22.309	FIGURE 8 – PARCEL
^{scale} 1" = 50'	SOIL ANALYTICAL RESULT
^{date} 4/11/19	U-5809, CONSTRUCT MEDIAN ALONG L US 421 TO SR 1146 (LEE AVENUE) A
EDB	YADKIN COUNTY, NOR

The results of the laboratory testing indicated that BTEX and GRO were below the laboratory detection limits for the 6 samples tested. DRO were detected above the NCDEQ action level of 100 ppm with a concentration of 159.3 ppm in sample B6-2 S1 and above laboratory detection limits in 4 of the 5 other samples. PAHs were detected in 5 out of 6 soil samples tested with values ranging from 0.002 to 2.0 ppm. BaP was below the NCDEQ Maximum Soil Contamination Concentration (MSCC) for soil-to-water of 0.096 ppm.

The results of the laboratory UVF hydrocarbon analyses indicate the presence of contaminated soil below the NCDEQ action levels for DRO of 100 ppm, except in one sample from Boring B6-2 (Figure 8). Petroleum hydrocarbon soil contamination was detected above the NCDEQ action level for DRO of 100 ppm in Boring B6-2, Sample S1 from a depth of 1.0 to 1.5 feet below ground surface within the proposed easement.

Maximum Analytical Results per Boring Boring No./Sample No. GRO/DRO (mg/kg, ppm)

ESP recommends that the soil removed from the site as part of NCDOT construction activities in the upper 3.0 feet in the vicinity of Boring B6-2 be screened for petroleum hydrocarbon contamination, properly handled, segregated, and disposed of in accordance with NCDEQ regulations.
