RE: GEOENVIRONMENTAL PHASE II INVESTIGATION OF PARCEL 7

Foothills Firearms and Ammo, Crystal Cleaners and Laundry Inc.

724 S. State St., Yadkinville, North Carolina

TIP Number: U-5809 WBS Number: 44382.1.1 County: YADKIN

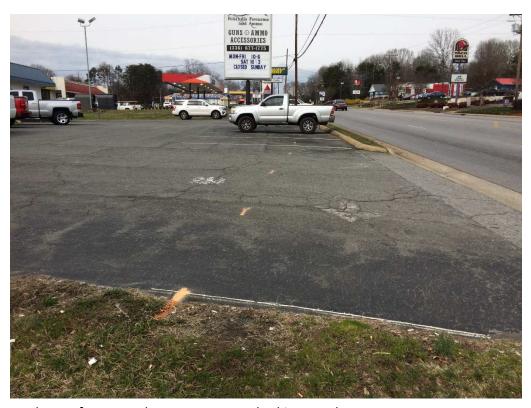
During our February and March 2019 field work, the site was occupied by the Foothills Firearms and Ammo store (Figure 2). The ground in the study area was covered by asphalt pavement and grass. A possible former petroleum dispenser island patch was observed in the asphalt pavement outside of the proposed easement (Figure 2, Photo C).

A. Photo of proposed easement area, looking north.

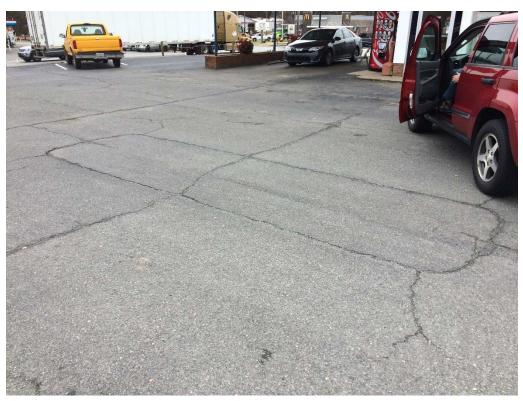
C. Photo of possible former pump island location, center of site.

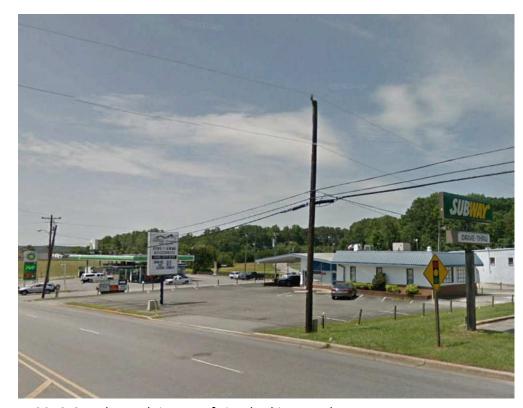
B. 2018 Google Earth image of site, looking southwest.

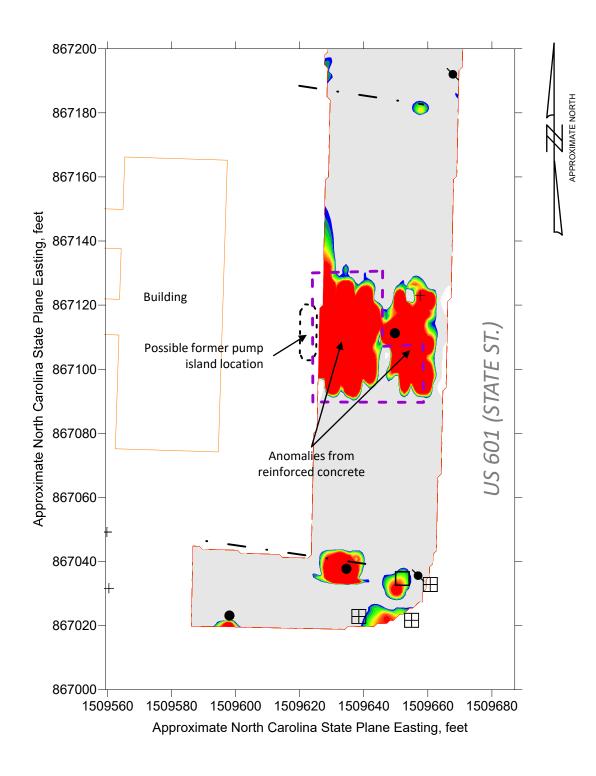
PROJECT NO. GR22.309	FIGURE 3 - PARCEL 7, CRYSTAL CLEANERS & LAUNDRY	
AS SHOWN	EM61 EARLY TIME GATE RESPONSE	
5/7/19	U-5809, CONSTRUCT MEDIAN ALONG US 601 (STATE STREET) FROM US 421 TO SR 1146 (LEE AVENUE) AND ADD ROUNDABOUTS	
EDB	YADKIN COUNTY, NORTH CAROLINA

ESP performed a metal detector study over the accessible areas of the site using a Geonics EM61 MK2 with a line spacing of about three feet (Figures 3 and 4). Location control was provided in real-time using a differential global positioning system (DGPS). We collected ground-penetrating radar (GPR) data over selected EM61 anomalies using our Sensors and Software Noggin 250 GPR system. The GPR data were collected using a line spacing of one to two feet.

The EM61 early time gate data show the response from both shallow and deeper metallic objects (Figure 3). The differential response reduces the effect of shallow anomalies and emphasizes anomalies from larger and more deeply buried metallic objects, such as USTs (Figure 4). The EM61 differential responses corresponded to known site features, such as buried utilities and reinforced concrete. GPR data were collected over selected EM61 anomalies. The GPR data did not indicate the presence of unknown USTs within the study area.

The geophysical data did not indicate the presence of abandoned USTs in the study area.

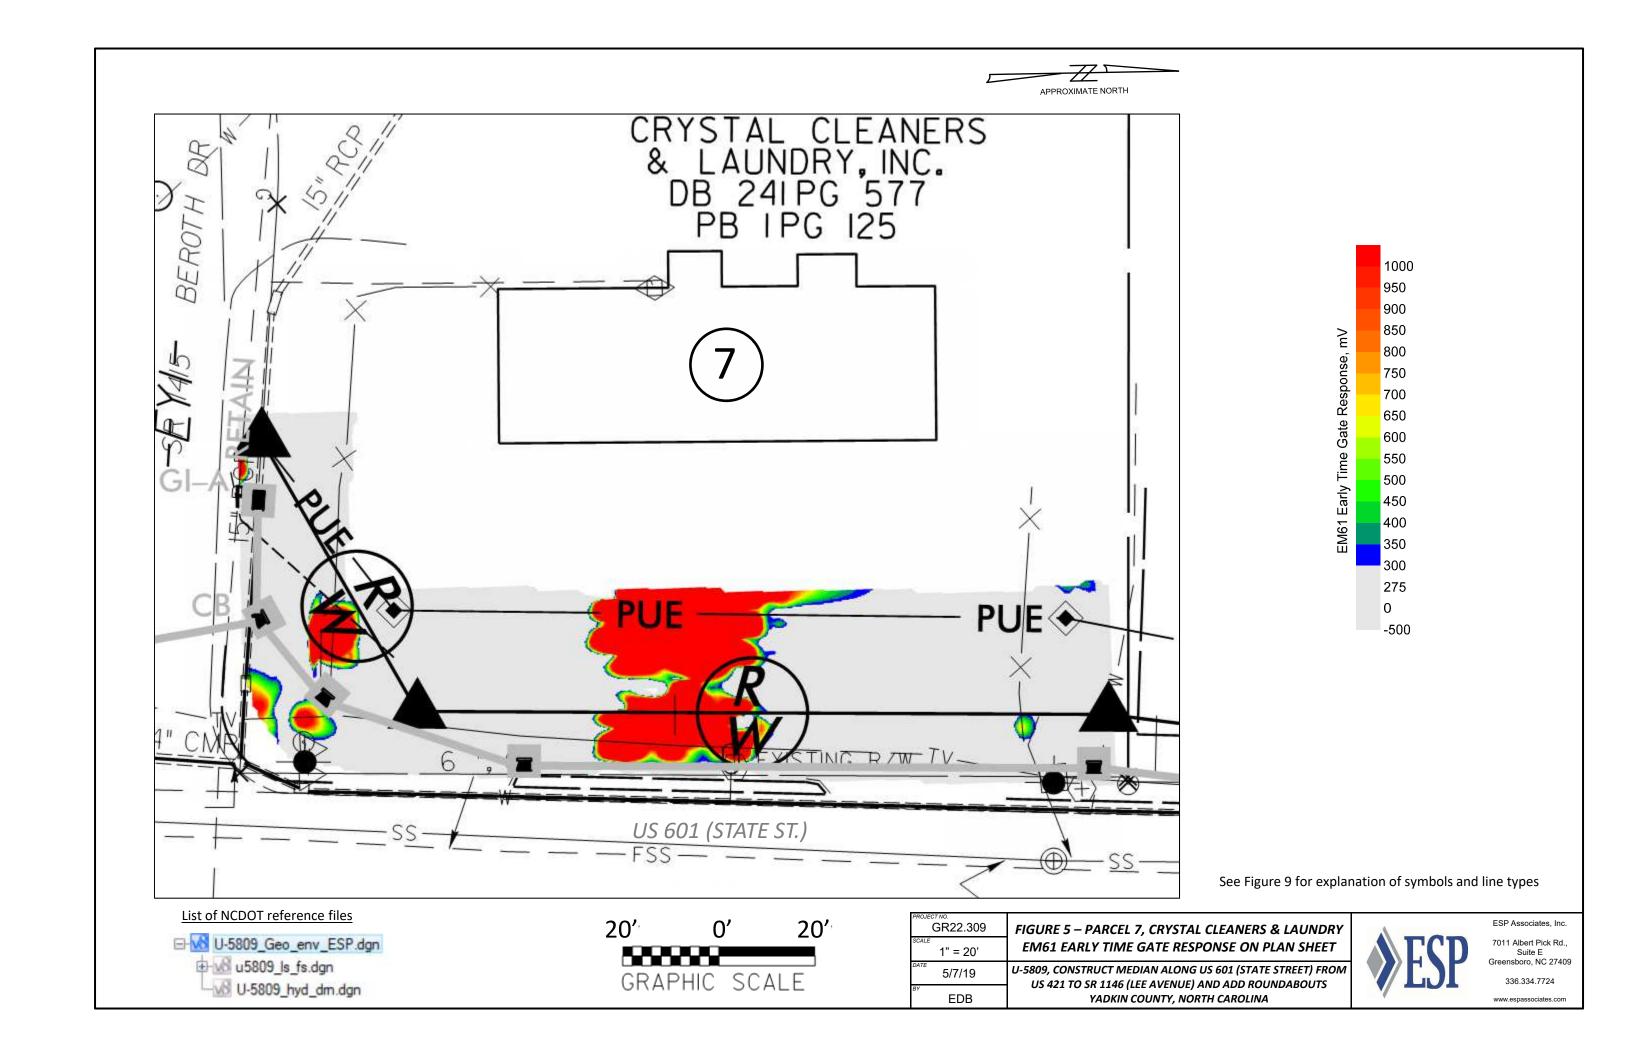
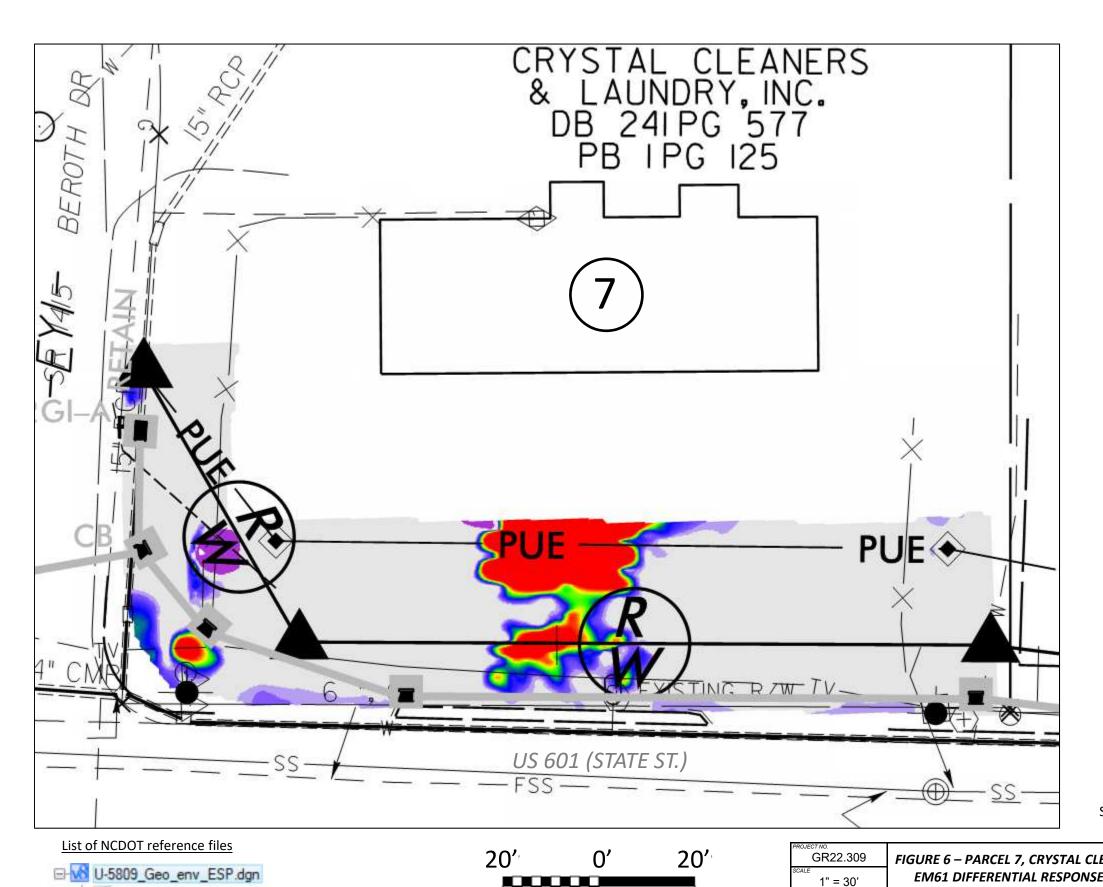
GR22.309	FIGURE 6 – PARCEL 7, CRYSTAL CLEANERS & LAUNDRY
1" = 30'	EM61 DIFFERENTIAL RESPONSE ON PLAN SHEET
5/7/19	U-5809, CONSTRUCT MEDIAN ALONG US 601 (STATE STREET) FROM

The EM61 early time gate response and differential response are shown on the plan sheet on Figures 5 and 6, respectively.

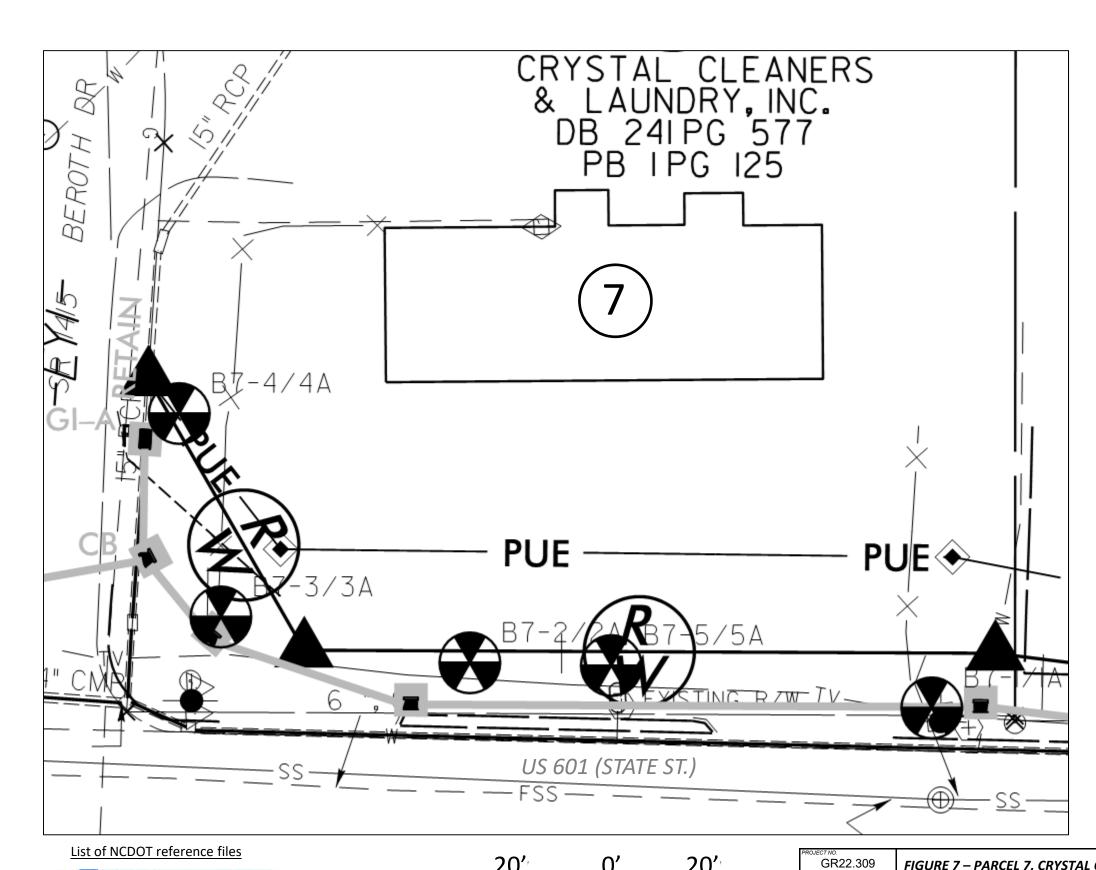
FIGURE 7 – PARCEL 7, CRYSTAL CLEANERS & LAUNDRY

ESP performed direct-push drilling activities within the proposed ROW/easement of Parcel 7 using a subcontractor, SAEDACCO of Fort Mill, South Carolina. Five borings were drilled, designated B7-1 through B2-5 (Figure 7). The soil borings were advanced using a GeoProbe 7822DT drill rig. Soil samples were obtained to a depth of approximately 10 feet using two 5-foot long Macro-Core® tubes. The borings were redrilled with an approximate 0.5 to 1.0-foot offset on April 25, 2019 using a Geoprobe 54DT with the boreholes designated B7-1A through B7-5A. Soil samples were obtained to a depth of approximately 10 feet using three 4-foot long Macro-Core® tubes. Soil cores varied in recovery from 1.9 to 5 feet. The sampling equipment was decontaminated prior to drilling and between borings by the driller using a Liquinox® detergent solution.

BORING LOCATIONS ON PLAN SHEET

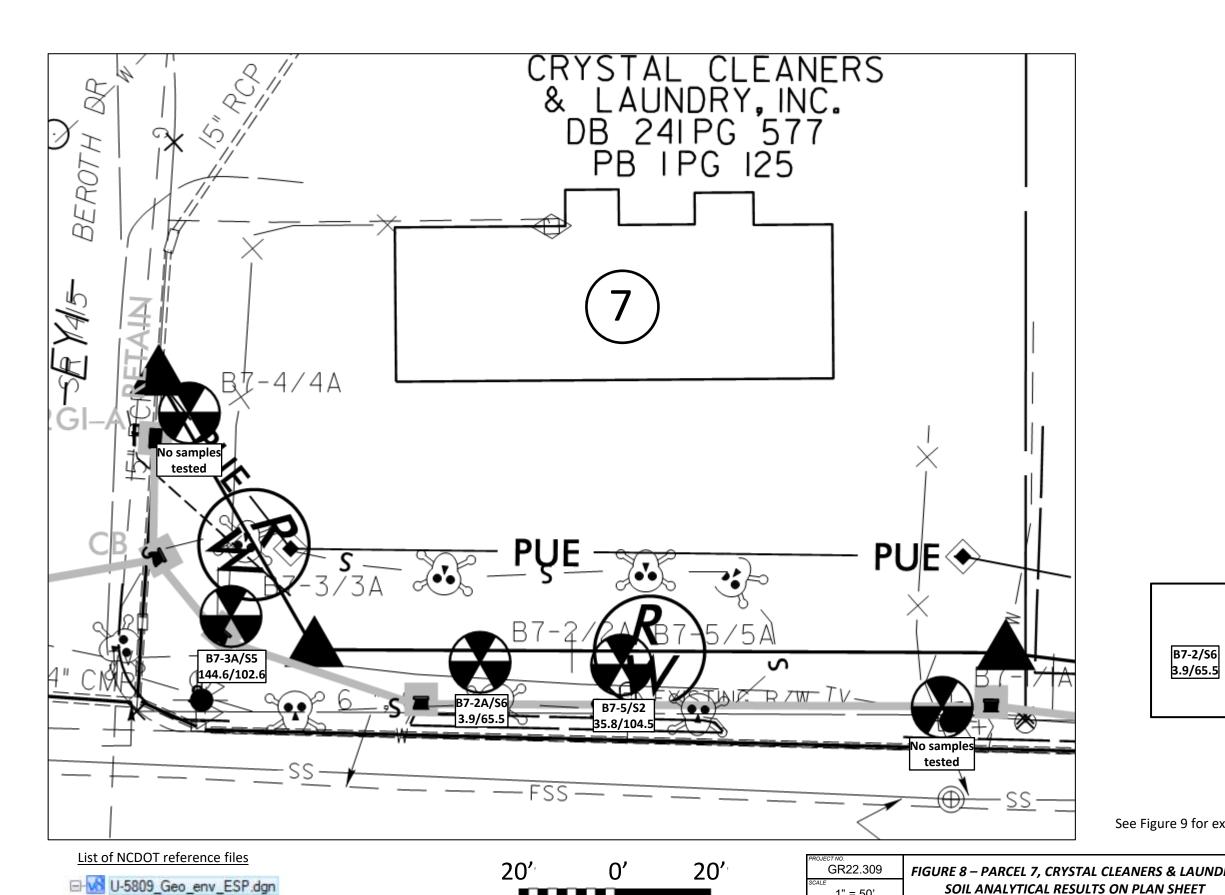
GR22.309	FIGURE 8 – PARCEL 7, CRYSTAL CLEANERS & LAUNDRY
1" = 50'	SOIL ANALYTICAL RESULTS ON PLAN SHEET
5/7/19	U-5809, CONSTRUCT MEDIAN ALONG US 601 (STATE STREET) FROM

The results of the laboratory UVF hydrocarbon analyses indicate the presence of contaminated soil above the NCDEQ action level for DRO in one sample (B7-5, S2) and above the NCDEQ action level for GRO and DRO in another sample (B7-3A, S5) (Figure 8). Based on the PID readings and the UFV results, the hydrocarbon soil contamination appears to extend from Boring B7-3/3A to Boring B7-5/5A and from a depth of approximately 2.0 feet to 10.0 feet. Chlorinated solvents were not detected.

Maximum Analytical Results per Boring Boring No./Sample No. GRO/DRO (mg/kg, ppm)

ESP recommends that soil removed from the site as part of NCDOT construction activities be screened for petroleum hydrocarbon contamination, properly handled, segregated, and disposed of in accordance with NCDEQ regulations. A strong odor was observed in a few samples but not in all of the contaminated samples.
