**SUBJECT: Preliminary Site Assessment Report
Parcel 13, DSF of NC, Inc.
WBS Element No. 54035.1.1, TIP No. U-5757
NC 8 (Winston Road) from 9th Street to SR 1408 (Biesecker Rd) in
Lexington. Widen to multi lanes
Kleinfelder Project No. 20201105.001A**

**PRELIMINARY SITE ASSESSMENT REPORT
PARCEL 13 DSF OF NC, INC.
PARCEL 1101200000036
1009 OLD US HIGHWAY 52
LEXINGTON, DAVIDSON COUNTY, NORTH CAROLINA**

**NCDOT WBS ELEMENT 54035.1.1
STATE PROJECT U-5757
NC 8 (WINSTON RD) FROM 9TH STREET TO SR 1408
(BIESECKER RD) IN LEXINGTON. WIDEN TO MULTI LANES**

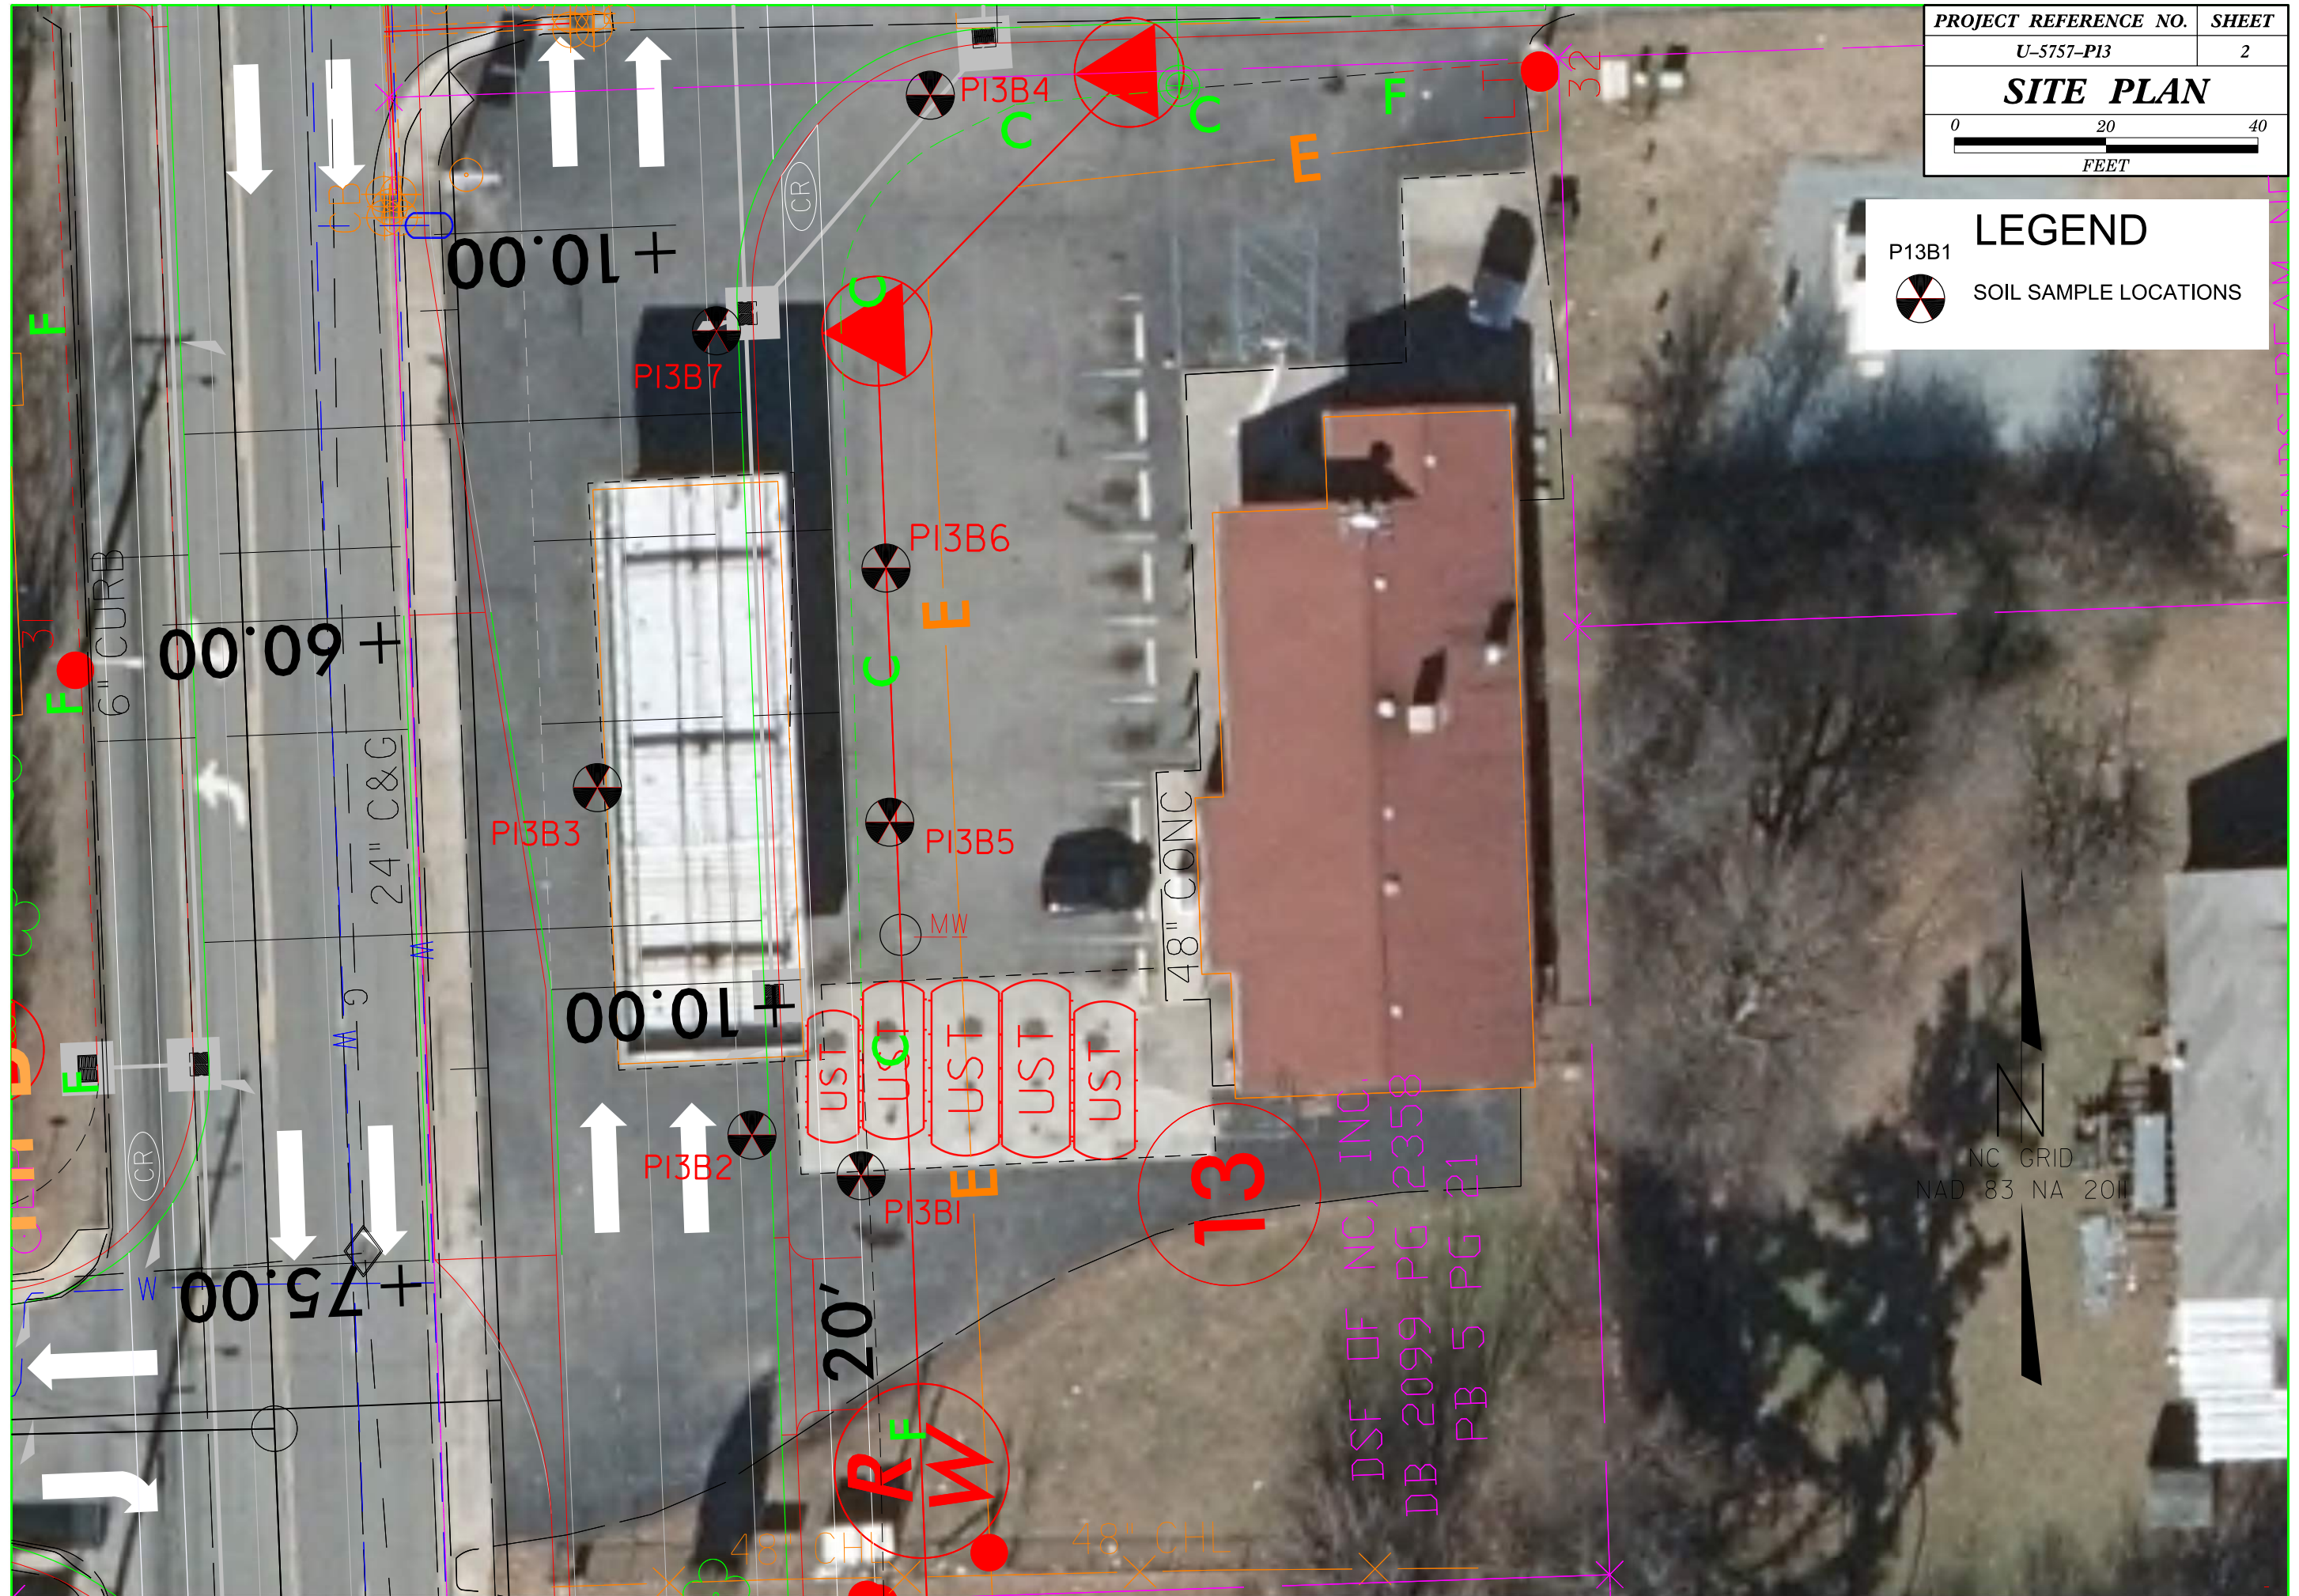
P13B1 SOIL SAMPLE LOCATIONS

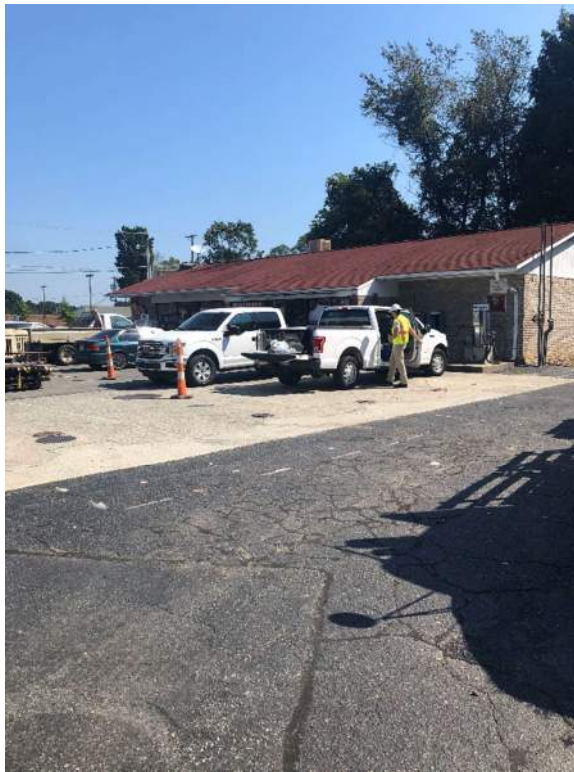
View facing northeasterly toward the convenience store located on the eastern portion of Parcel 13, featuring the UST vent pipes (center-right).

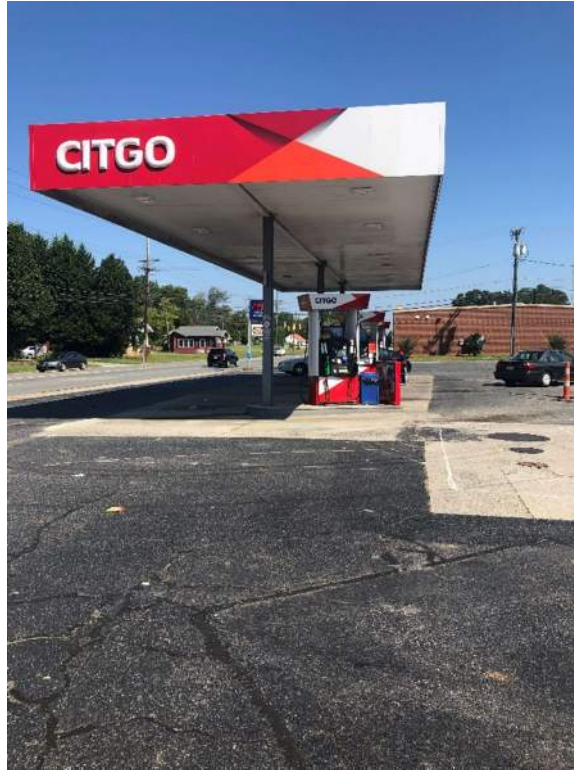
View facing north-northwesterly of the fuel canopy on Parcel 13.

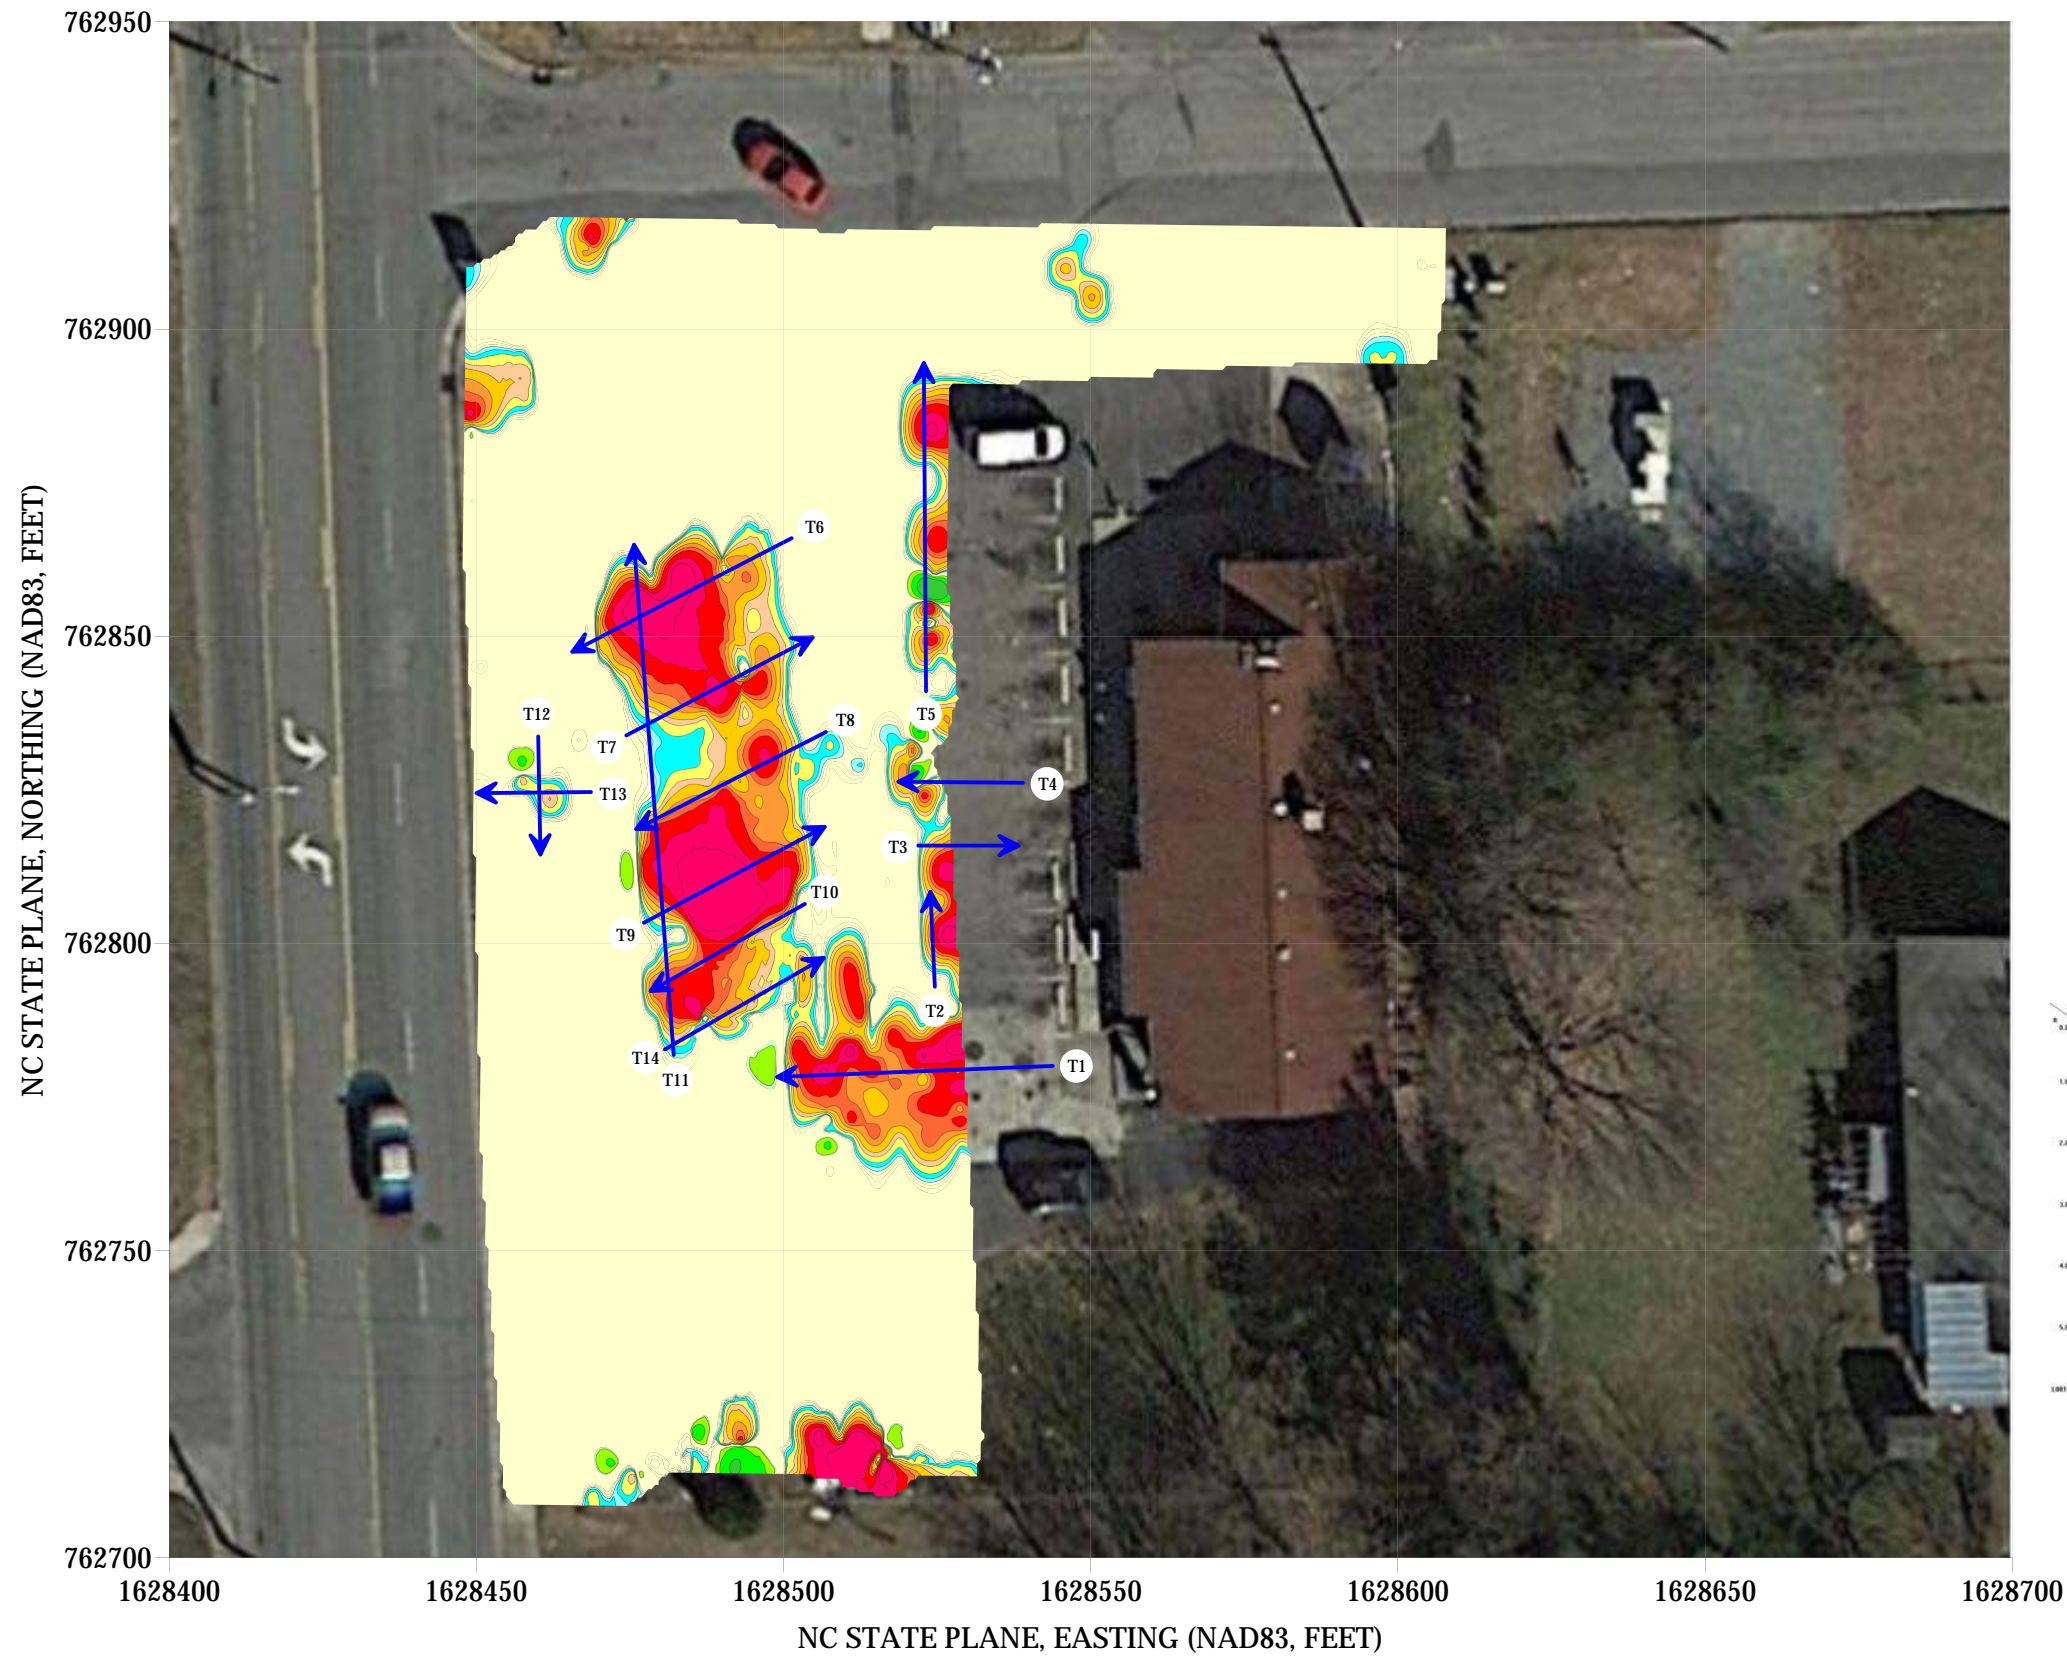
LOCATIONS OF GPR TRANSECTS

GPR Transects 2-5, 6-11, and 14 were performed across areas of interference caused by the pump island and vehicles (EM Anomalies 4 and 9). No evidence of buried structures such as USTs was observed.

GPR Transects 12 and 13 were performed across an area associated with a suspected utility (EM Anomaly 3). These transects recorded evidence of discrete hyperbolic reflectors that were characteristic of a buried utility. No evidence of any buried structures such as USTs was observed.

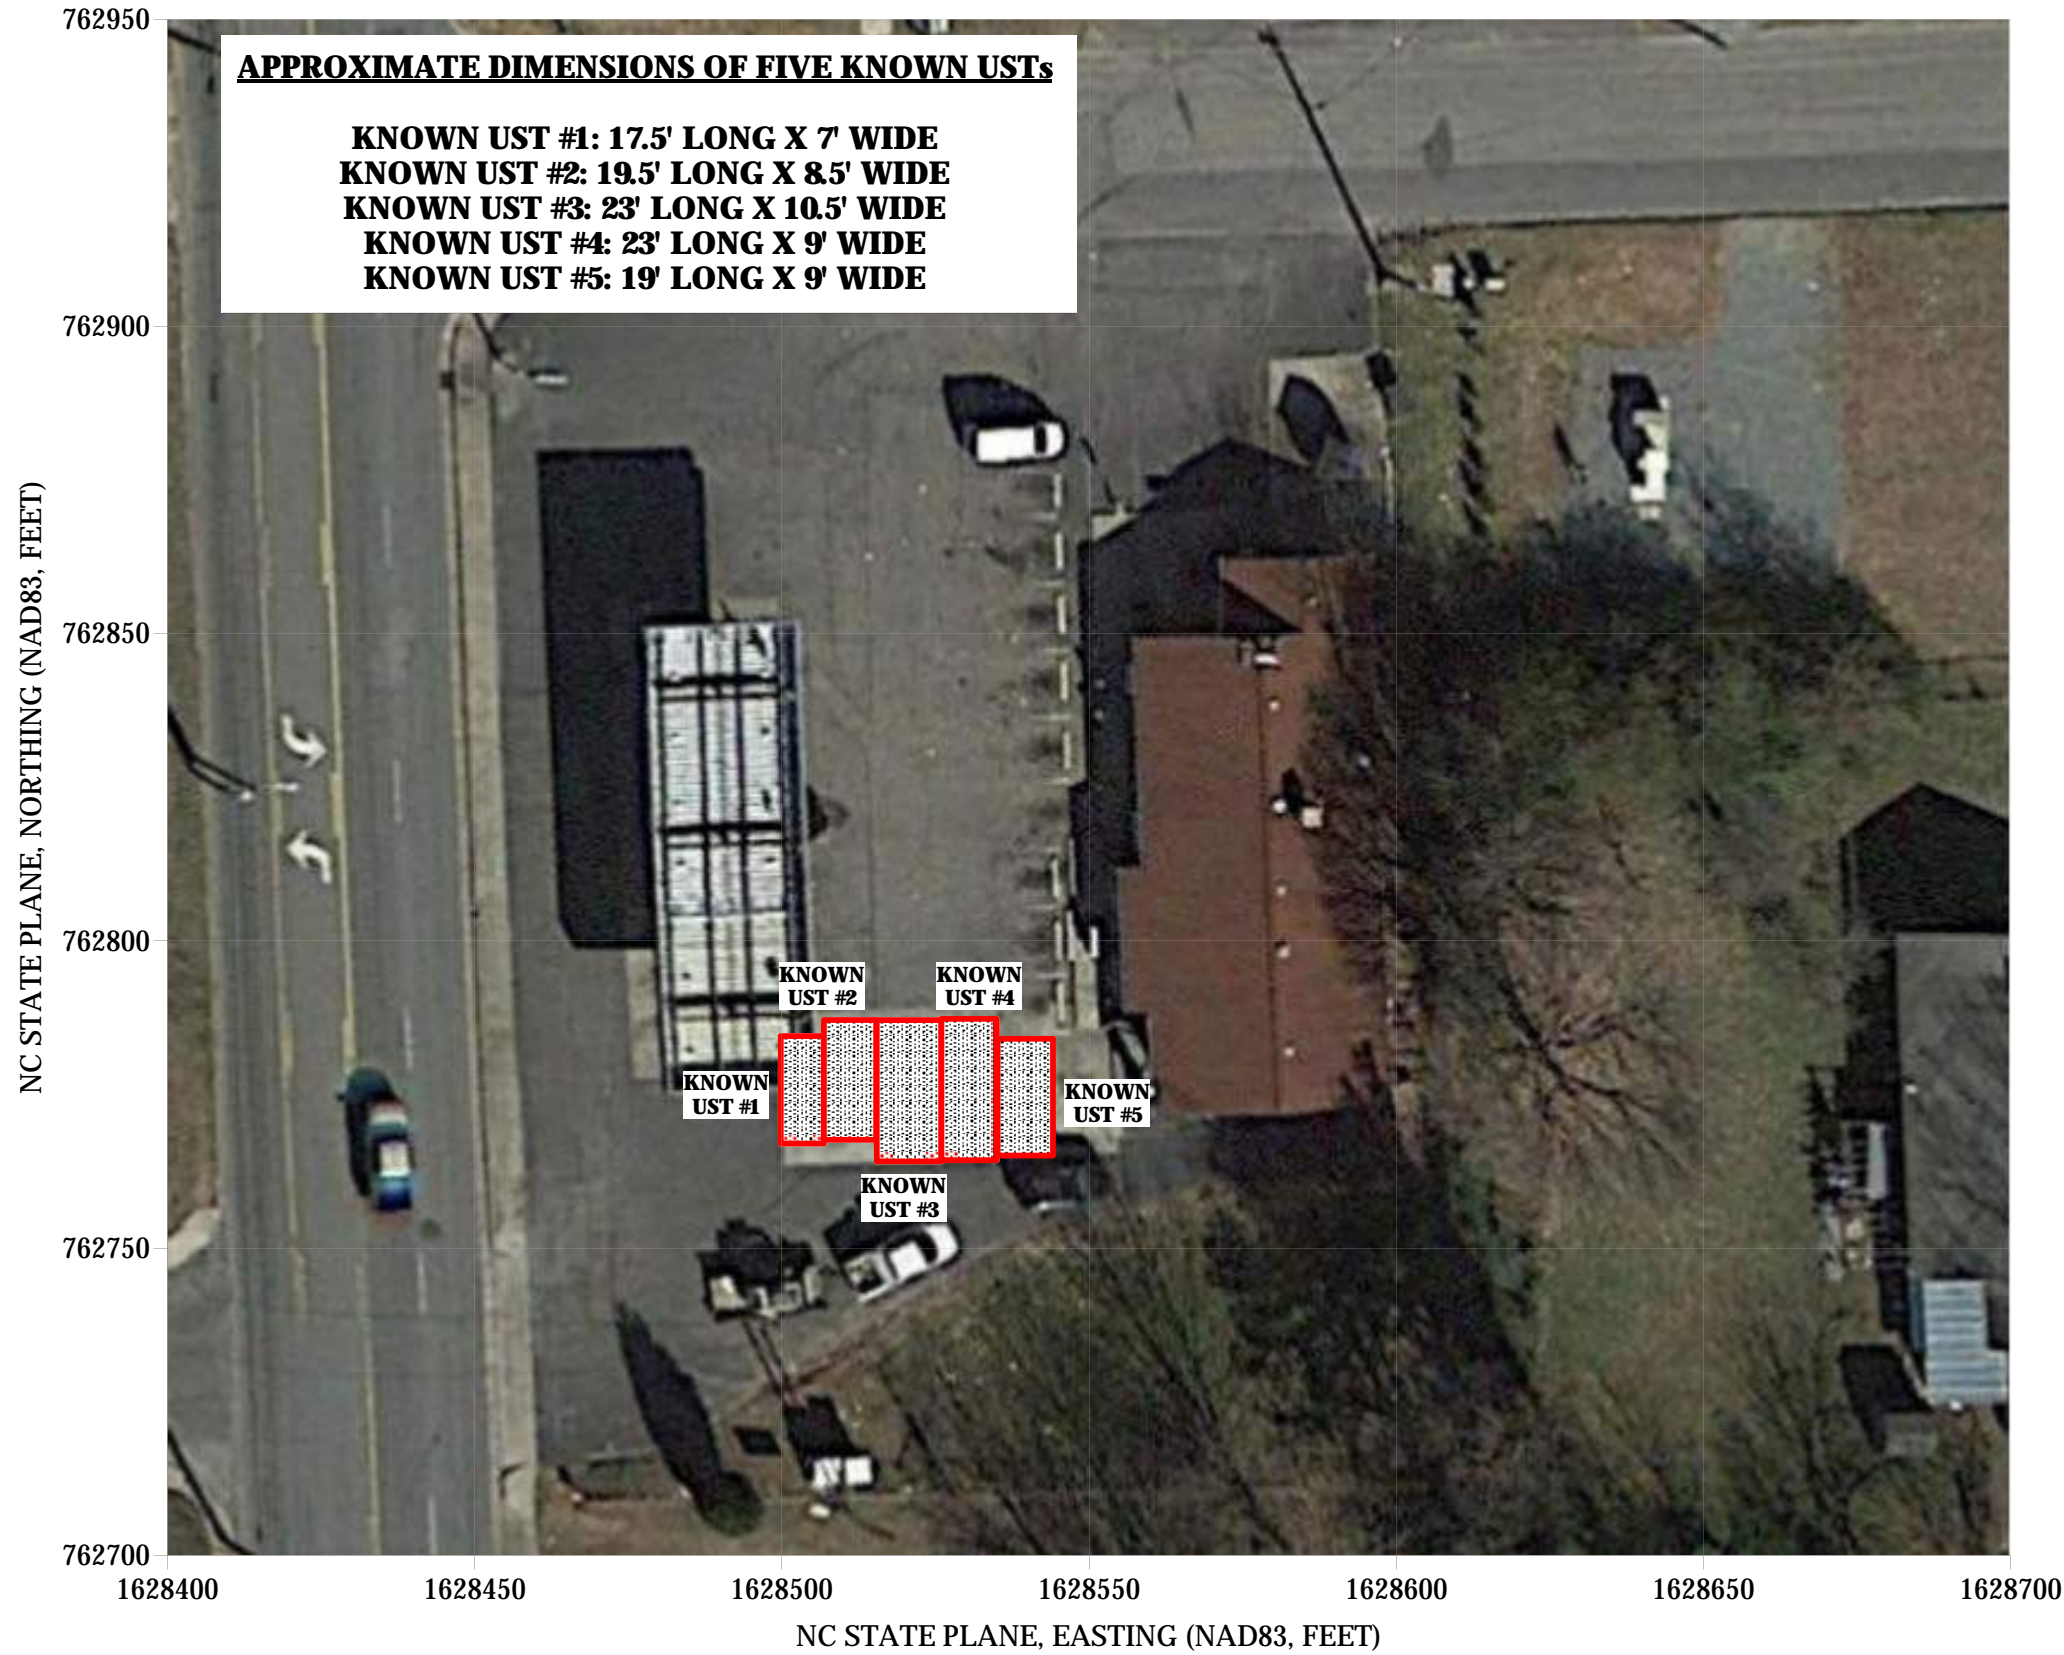
LOCATIONS OF FIVE KNOWN USTs

View of Five Known USTs Facing Approximately East

Collectively, the geophysical data recorded evidence of five known USTs within the survey area at Parcel 13. No evidence of unknown USTs was recorded. **Figure 5** provides an overlay of the metal detection results and the locations of the five known USTs on the NCDOT MicroStation engineering plans for reference.

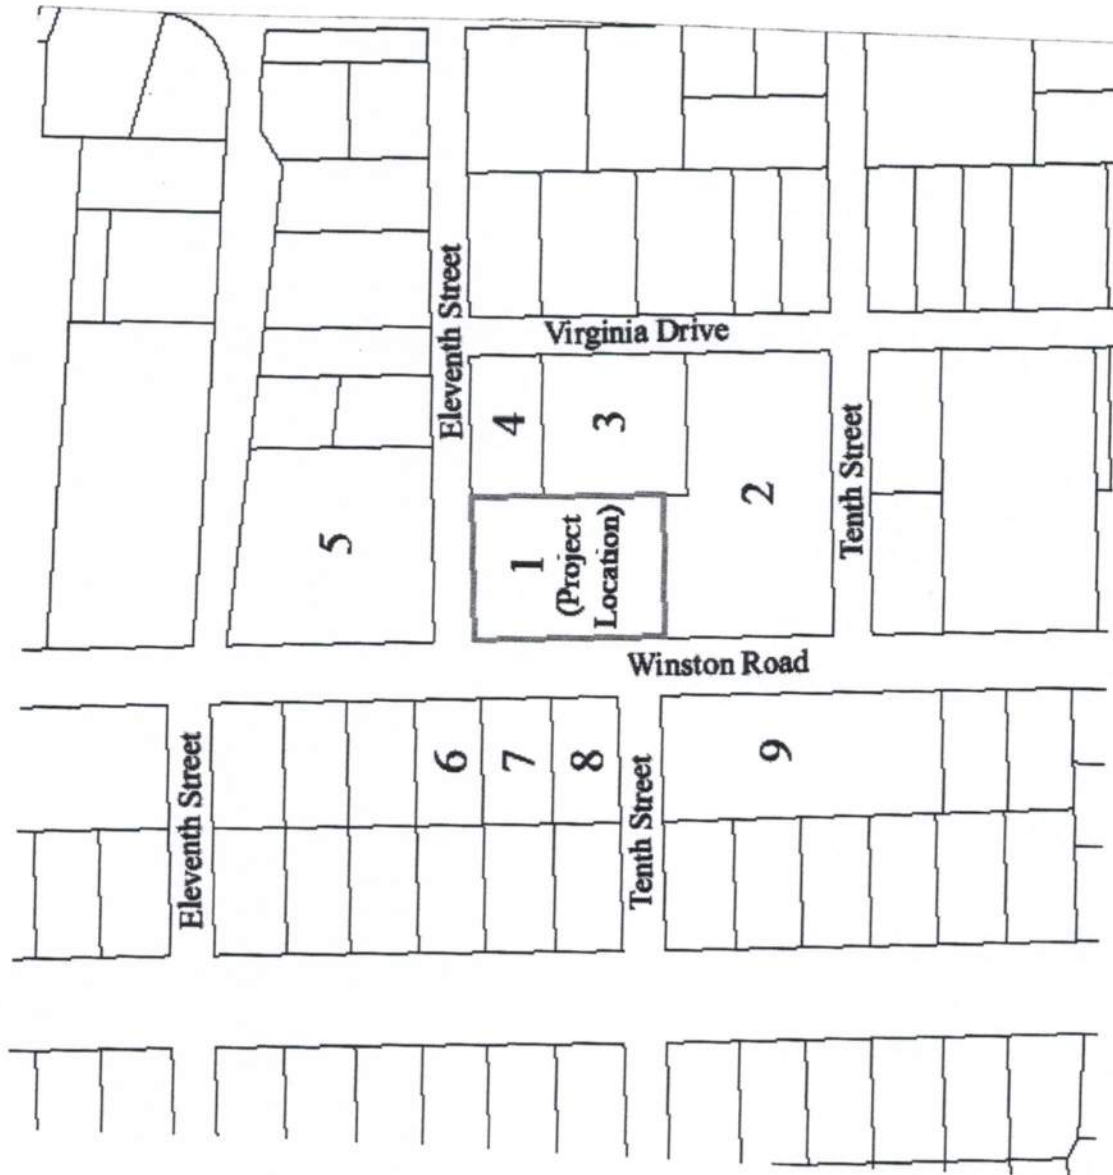
FIGURE 4

Figure 4 illustrates the surrounding properties, and Table 2 contains information regarding the adjacent property owners. This information was obtained from the Davidson County Tax Department's records.

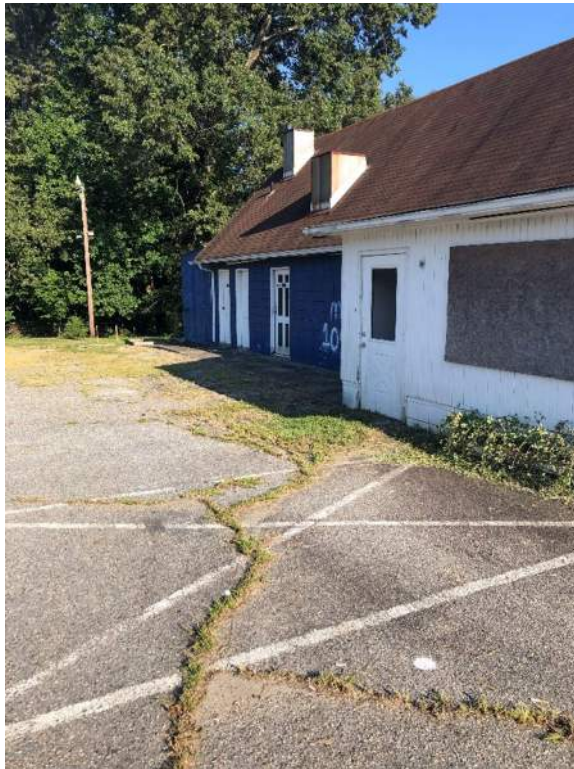
View facing southeasterly toward the vacant building on Parcel 21.

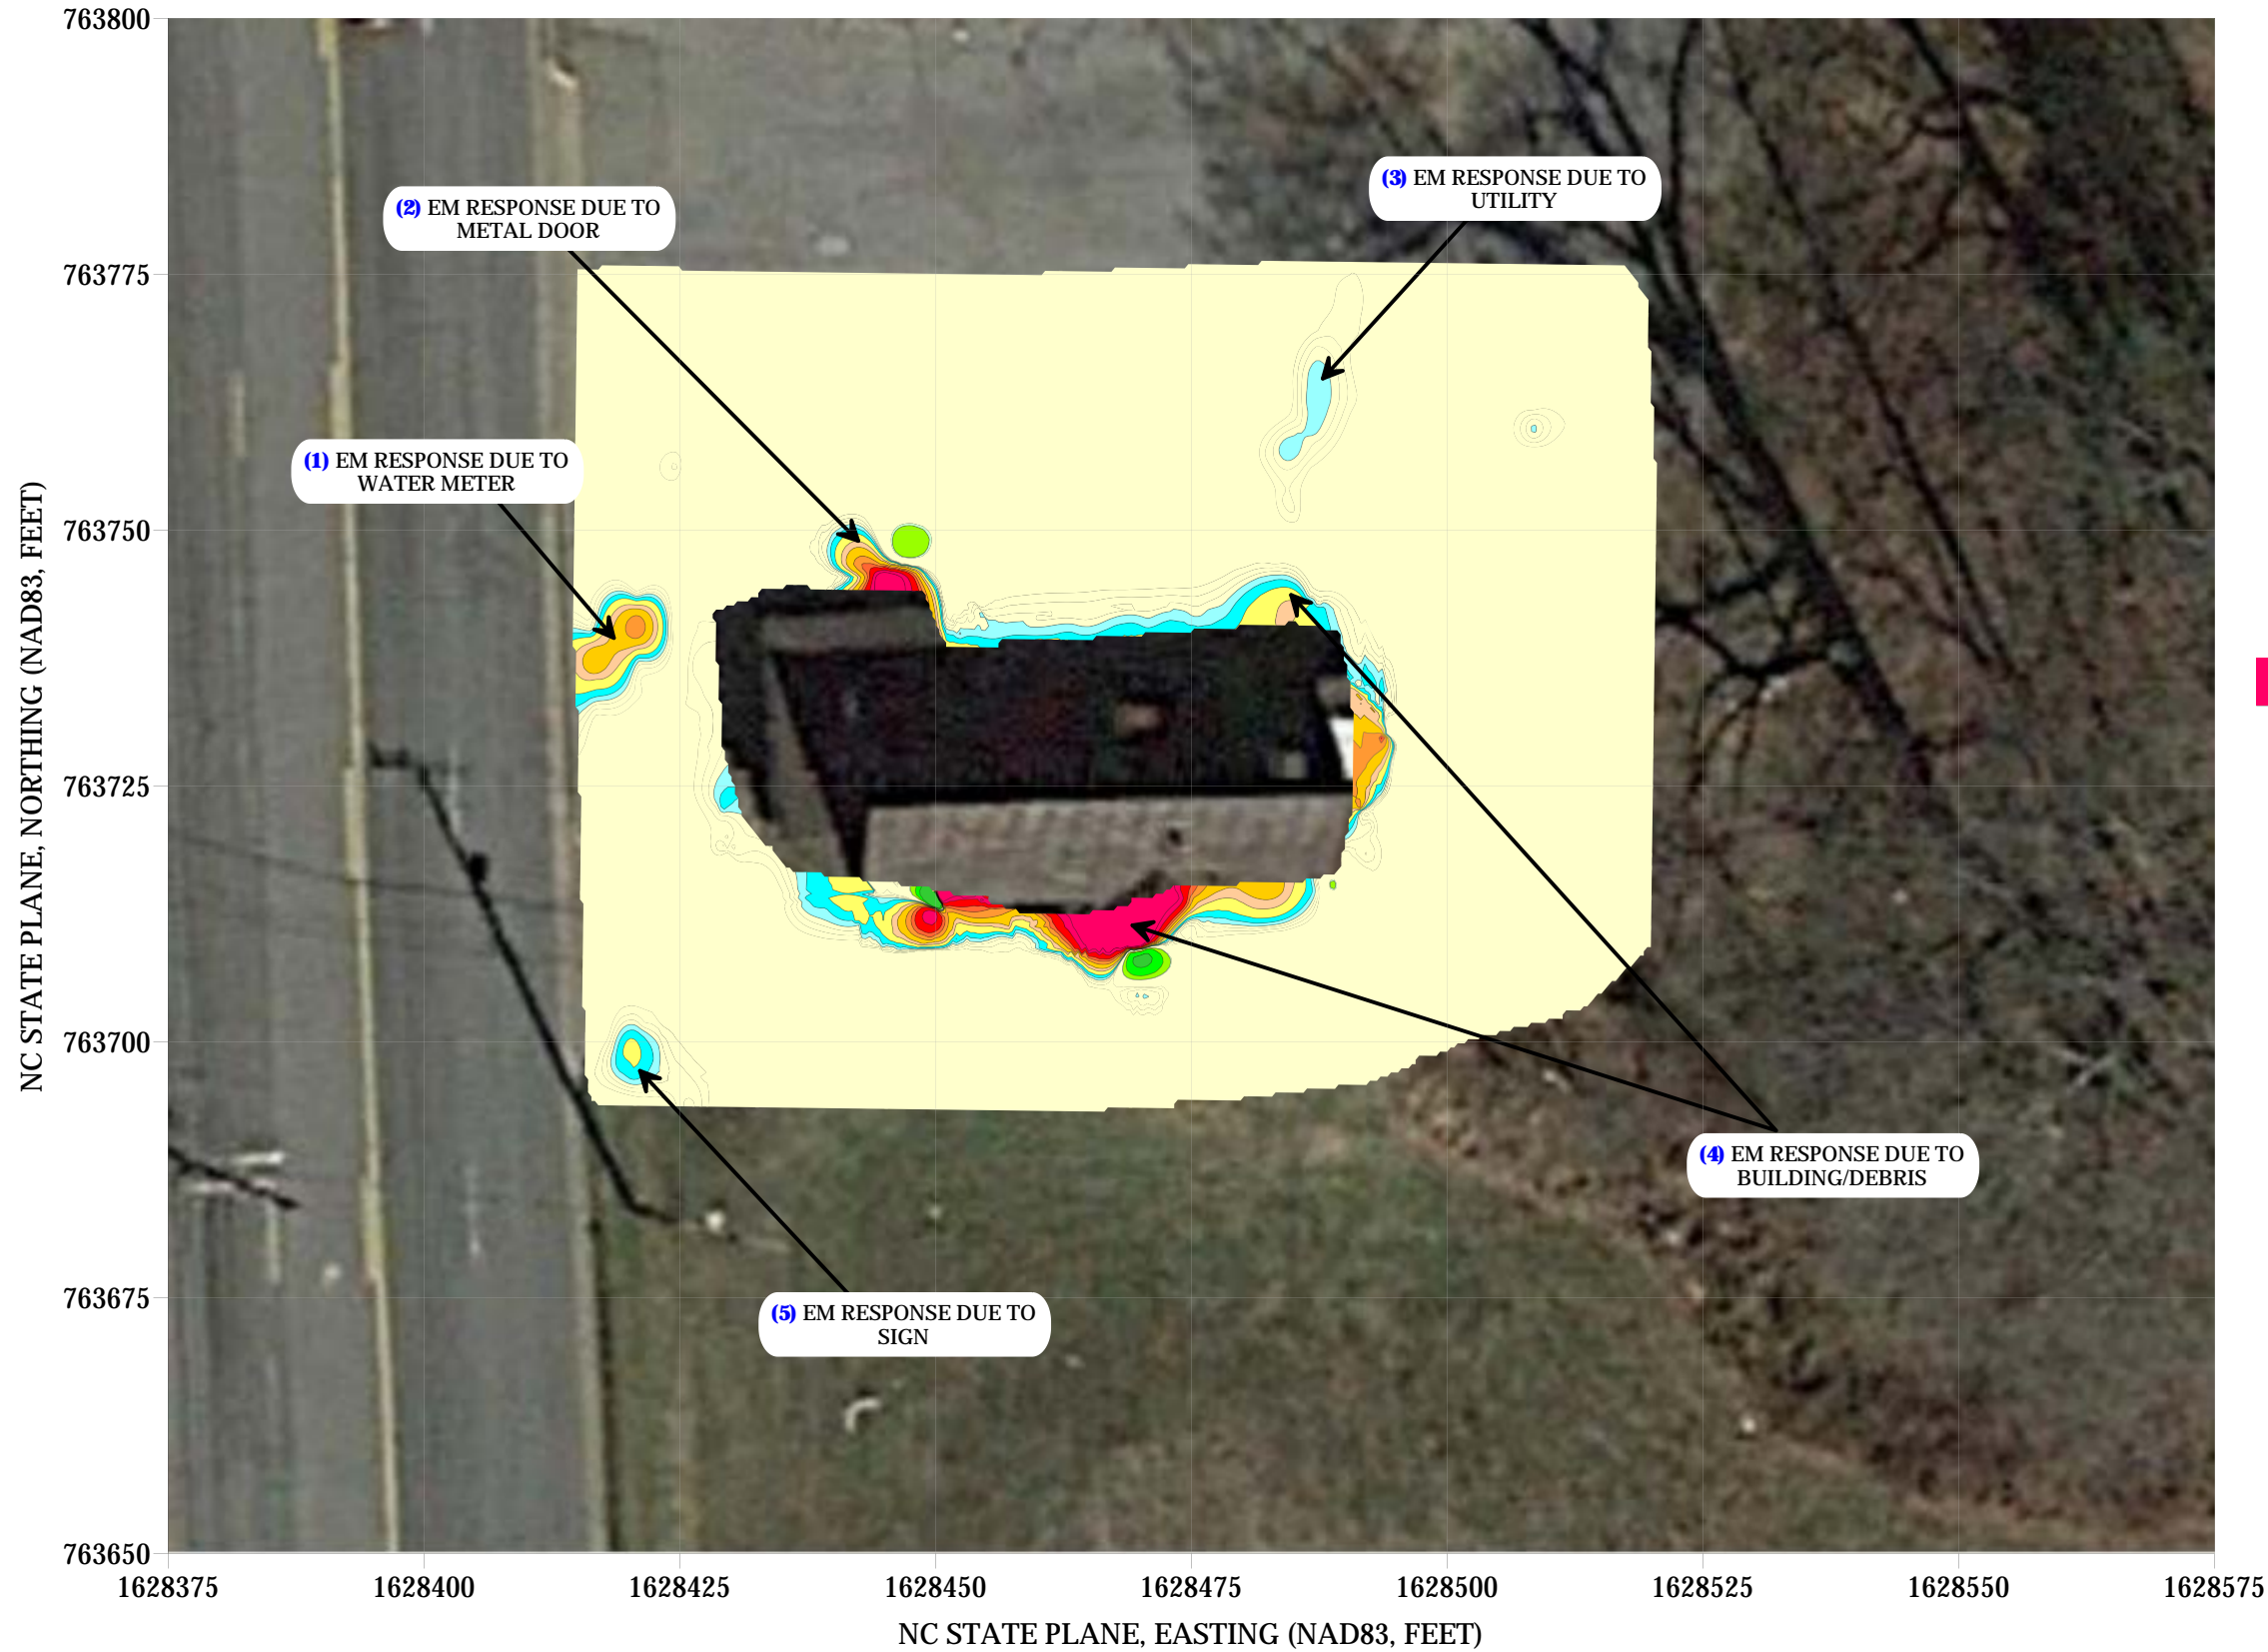
The contour plot shows the differential results of the EM61 instrument in millivolts (mV). The differential results focus on larger metallic objects such as USTs and drums. The EM data were collected on July 15, 2019, using a Geonics EM61-MK2 instrument. Verification GPR data were collected using a GSSI UtilityScan DF instrument with a dual frequency 300/800 MHz antenna on July 16, 2019.

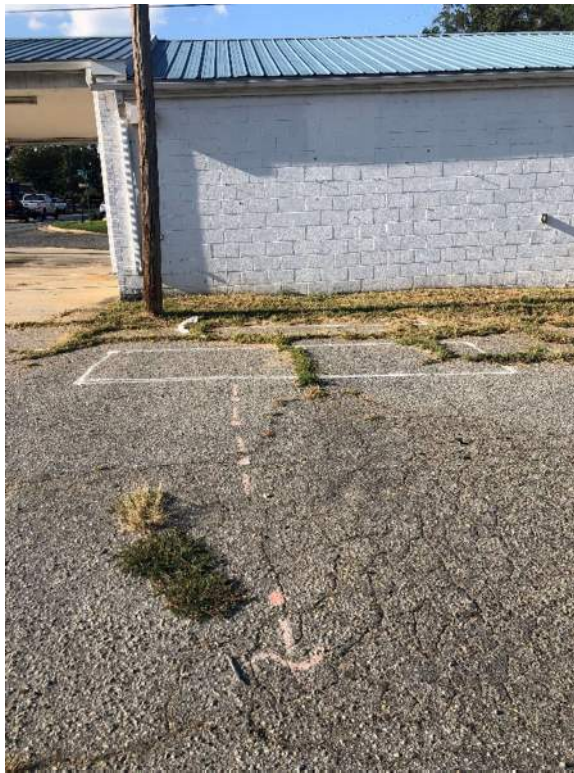
View of the two (2) probable orphan USTs located southwest of the vacant building on Parcel 22.

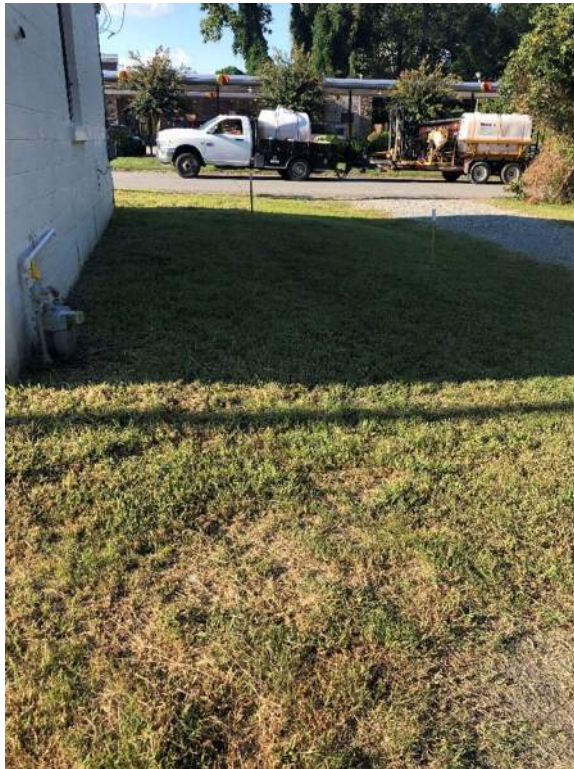
View facing northerly along the eastern wall of the vacant building on Parcel 22 toward Conrad Street.

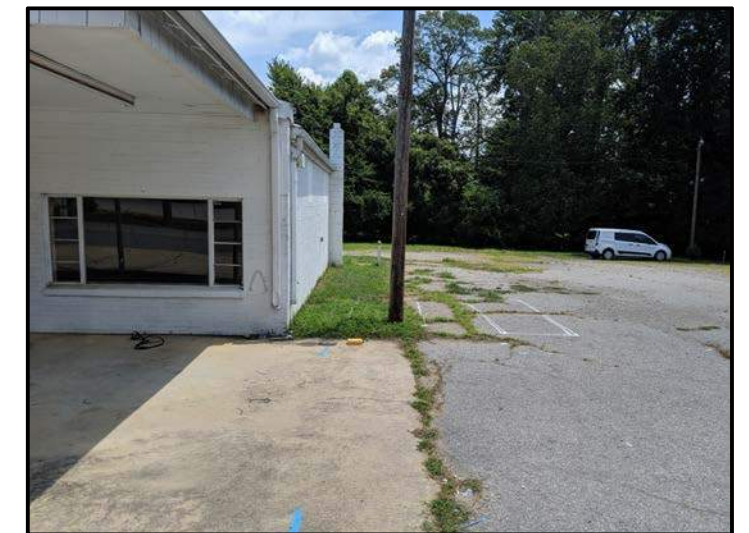
View of Survey Area
(Facing Approximately East)

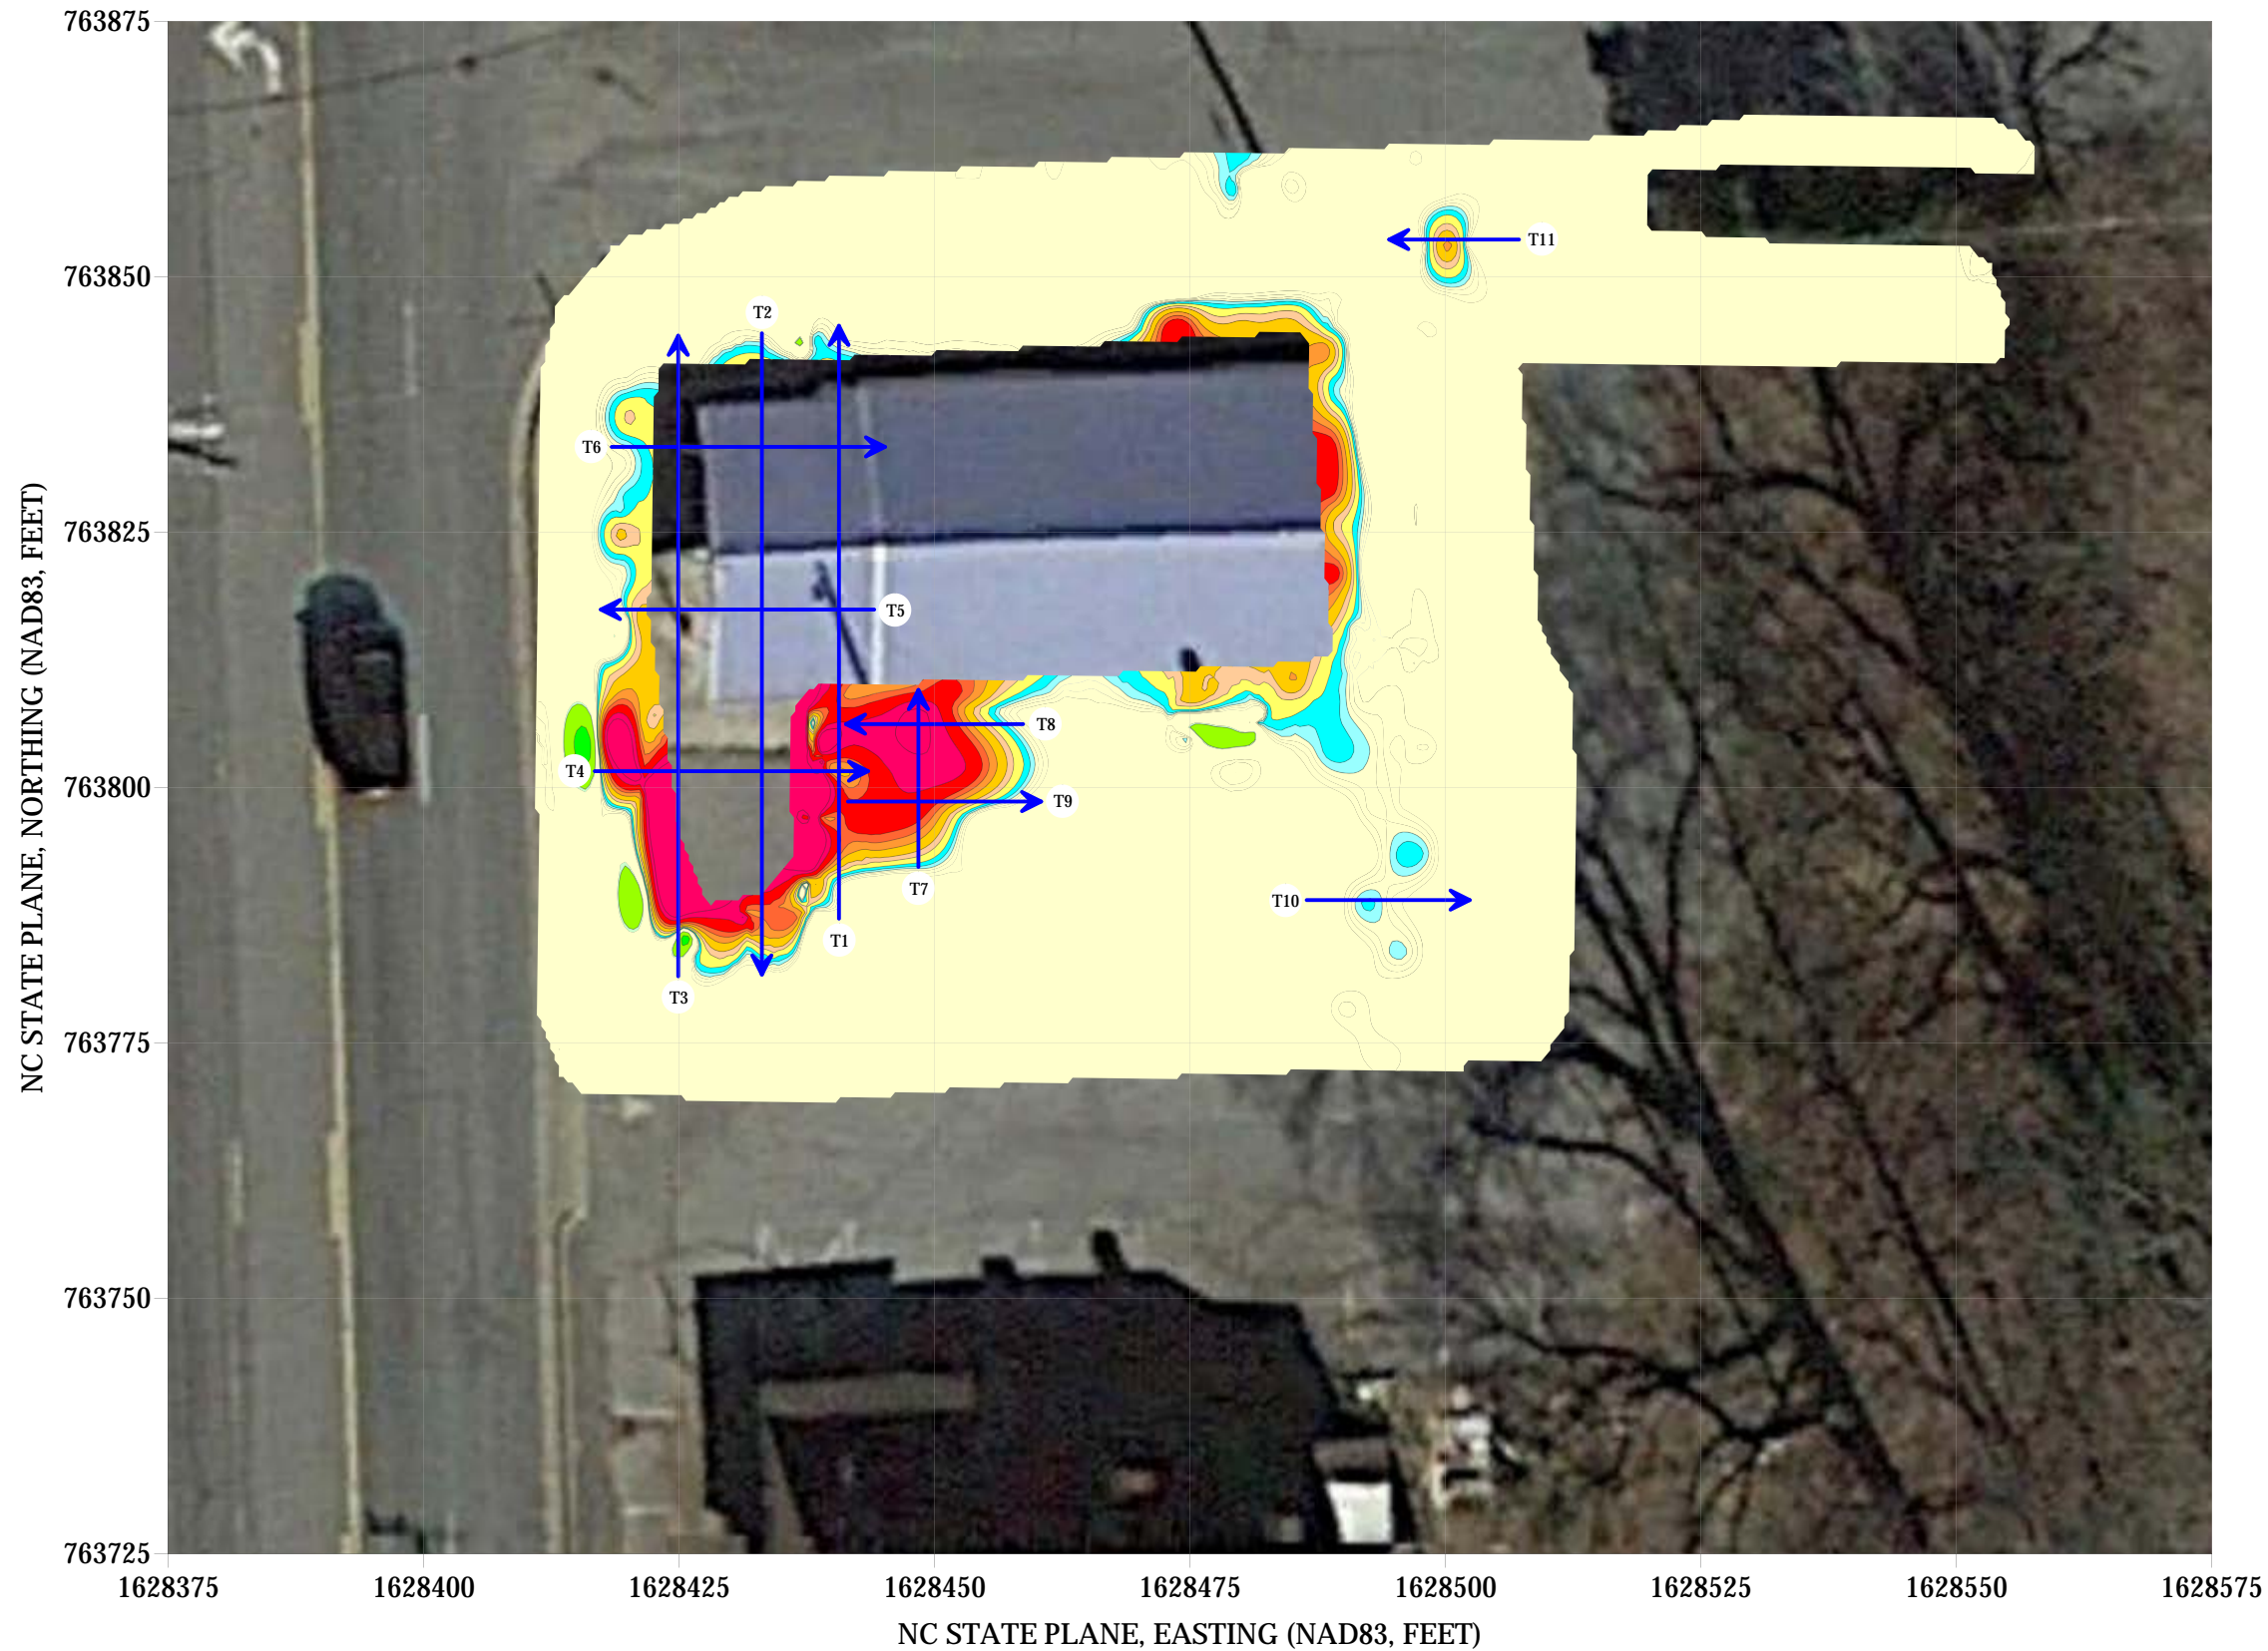
FIGURE 2

GPR Transects 1-6 were performed in a grid-like fashion across areas of interference caused by the building, metal poles and a vehicle (EM Anomalies 1 and 6). No evidence of buried structures such as USTs was observed.

GPR Transects 7-9 were performed across a large high-amplitude EM feature (Anomaly 5) that was observed near the southwest corner of the building. These transects recorded discreet hyperbolic reflectors and isolated high-amplitude lateral reflectors that are

LOCATIONS OF GPR TRANSECTS
