**SUBJECT: Preliminary Site Assessment Report
Parcel 13, DSF of NC, Inc.
WBS Element No. 54035.1.1, TIP No. U-5757
NC 8 (Winston Road) from 9th Street to SR 1408 (Biesecker Rd) in
Lexington. Widen to multi lanes
Kleinfelder Project No. 20201105.001A**

**PRELIMINARY SITE ASSESSMENT REPORT
PARCEL 13 DSF OF NC, INC.
PARCEL 1101200000036
1009 OLD US HIGHWAY 52
LEXINGTON, DAVIDSON COUNTY, NORTH CAROLINA**

**NCDOT WBS ELEMENT 54035.1.1
STATE PROJECT U-5757
NC 8 (WINSTON RD) FROM 9TH STREET TO SR 1408
(BIESECKER RD) IN LEXINGTON. WIDEN TO MULTI LANES**

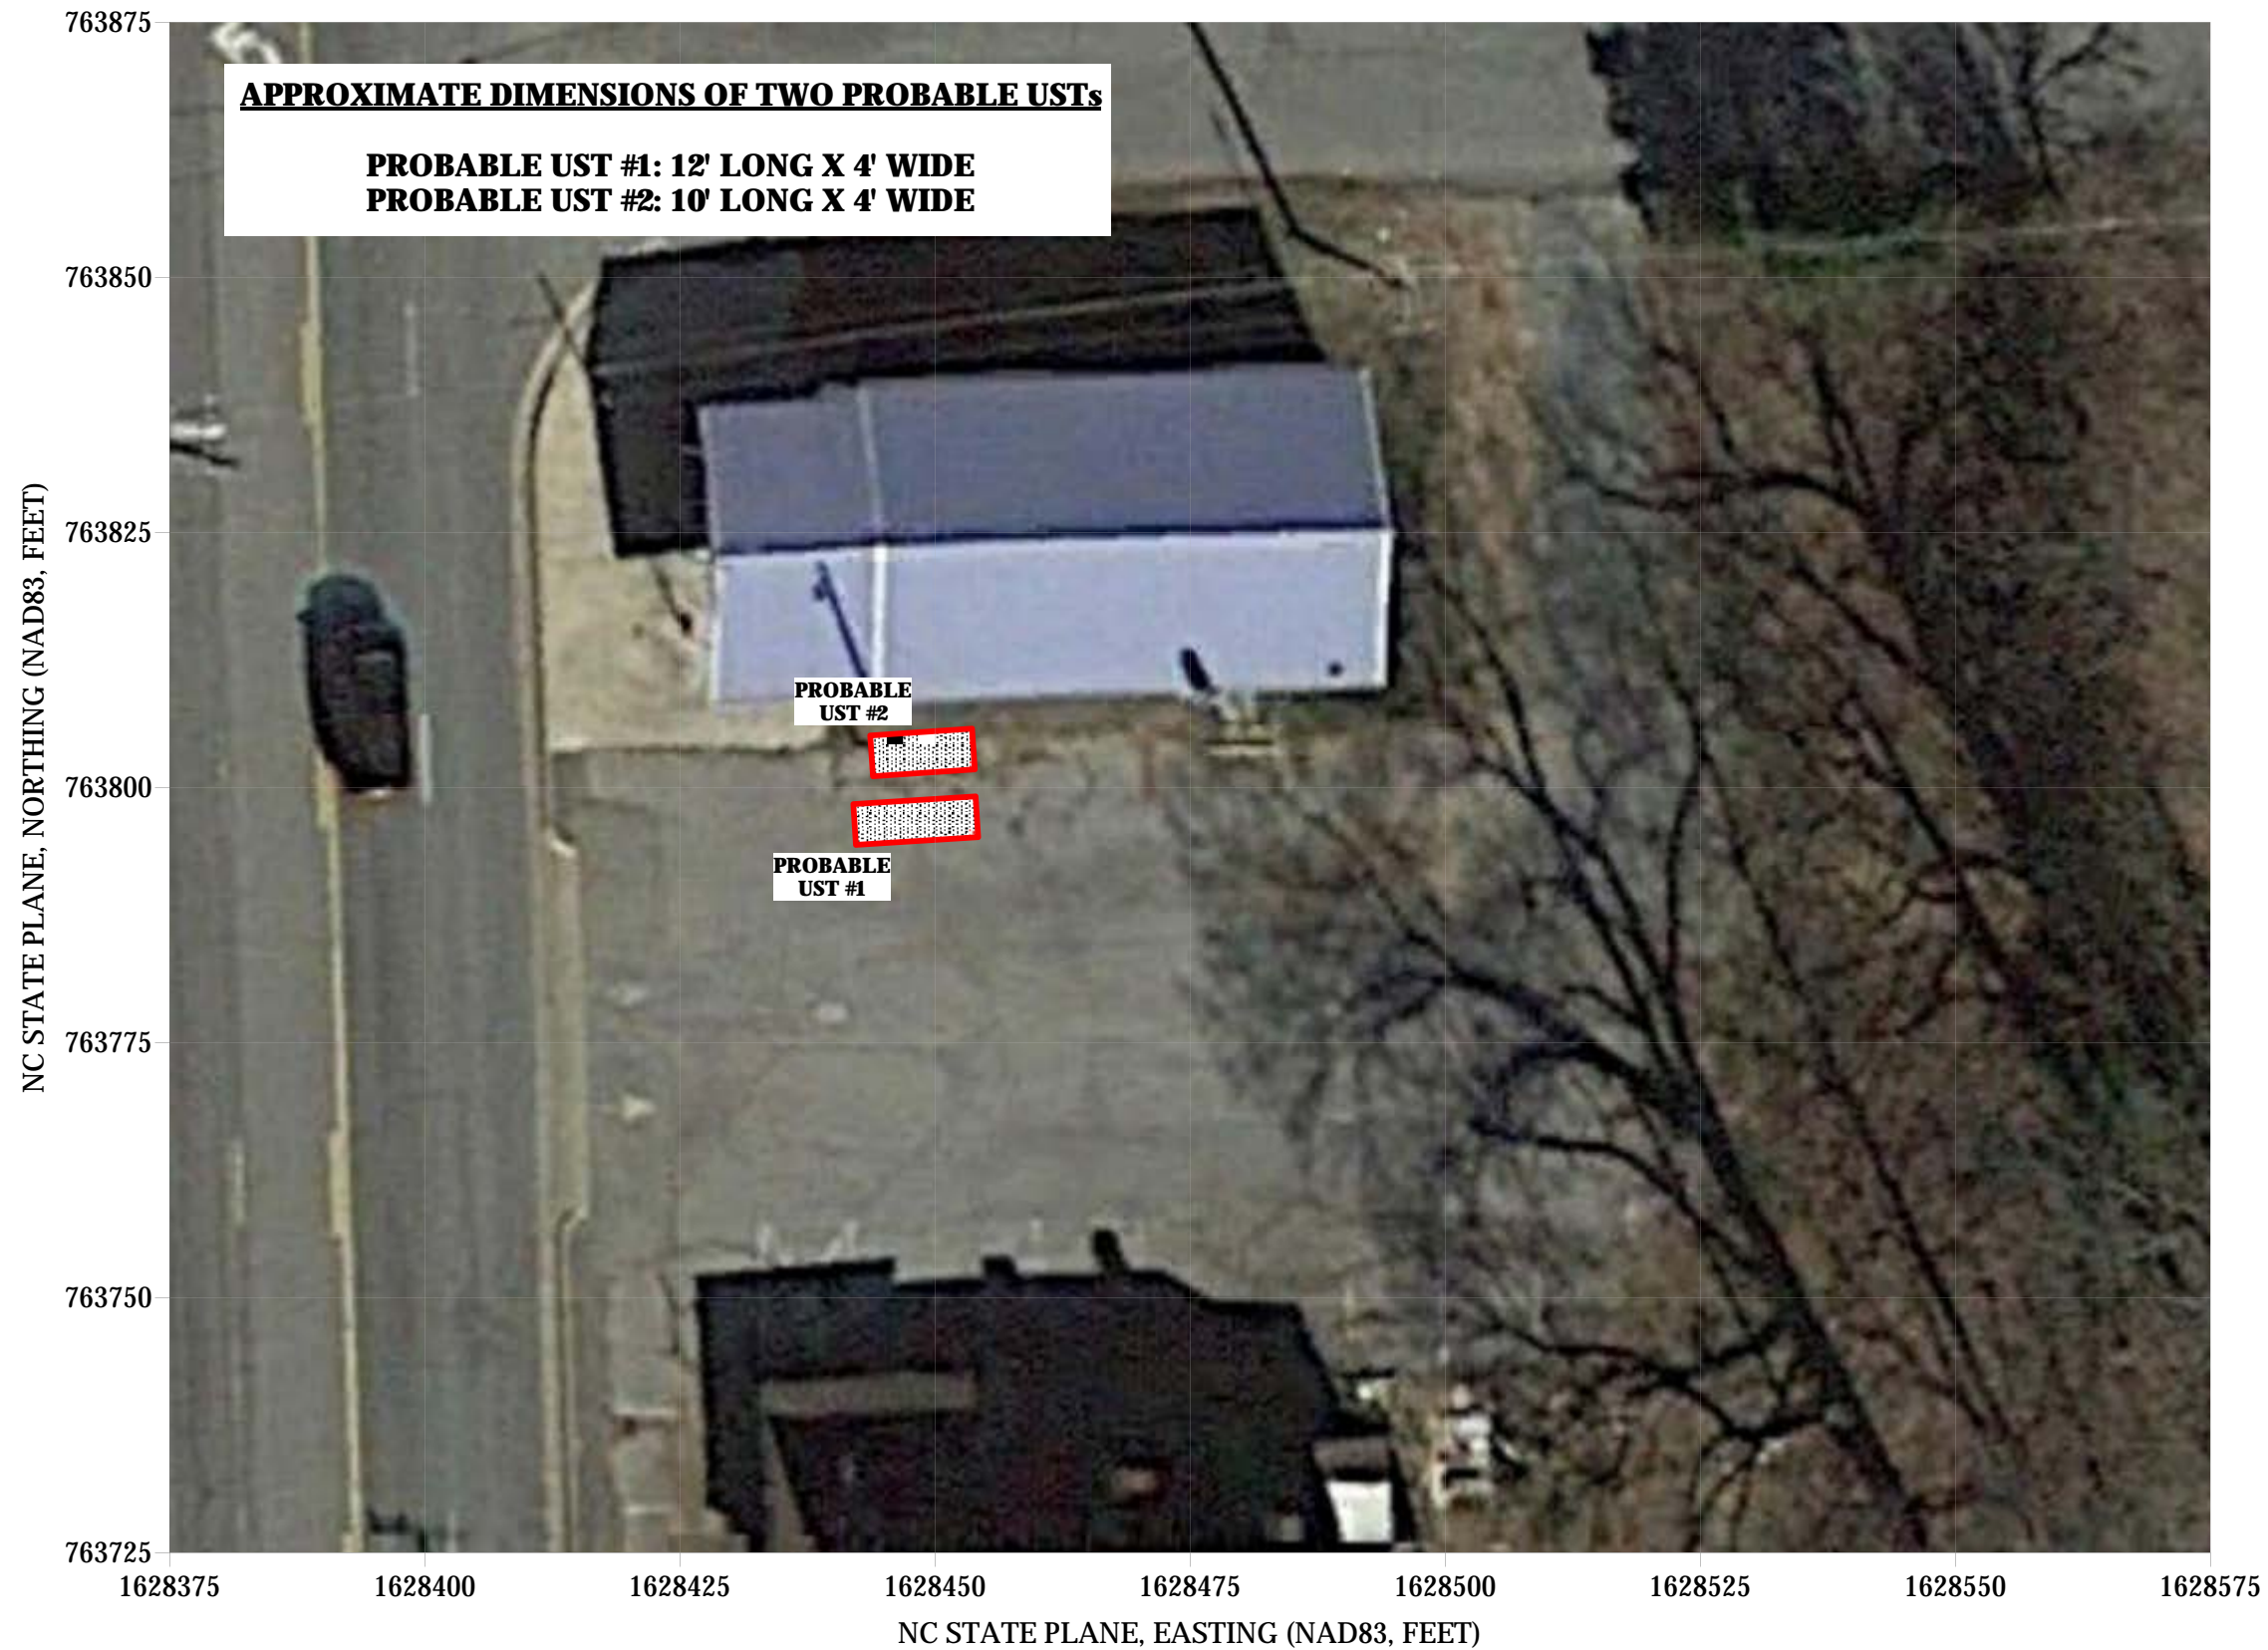
LOCATIONS OF TWO PROBABLE USTs

View of Two Possible USTs Facing Approximately North

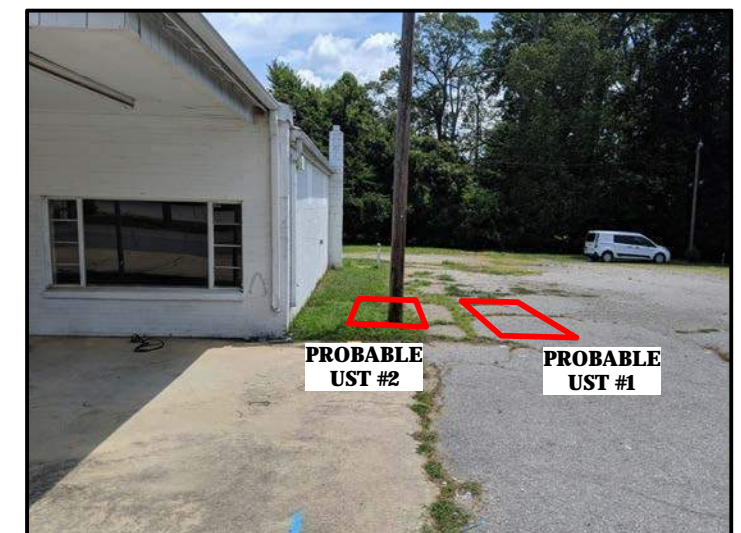
Collectively, the geophysical data recorded evidence of two probable USTs within the survey area at Parcel 22. **Figure 5** provides an overlay of the metal detection results and the locations of the two probable USTs on the NCDOT MicroStation engineering plans for reference.

View of Two Possible USTs Facing Approximately East
