**SUBJECT: Preliminary Site Assessment Report
Parcel 26, VSO, Inc.
WBS Element No. 54035.1.1, TIP No. U-5757
NC 8 (Winston Road) from 9th Street to SR 1408 (Biesecker Rd) in
Lexington. Widen to multi lanes
Kleinfelder Project No. 20201105.001A**

**PRELIMINARY SITE ASSESSMENT REPORT
PARCEL 26 VSO, INC.
PARCEL 110900000002B
1305 WINSTON ROAD
LEXINGTON, DAVIDSON COUNTY, NORTH CAROLINA**

**NCDOT WBS ELEMENT 54035.1.1
STATE PROJECT U-5757
NC 8 (WINSTON RD) FROM 9TH STREET TO SR 1408
(BIESECKER RD) IN LEXINGTON. WIDEN TO MULTI LANES**

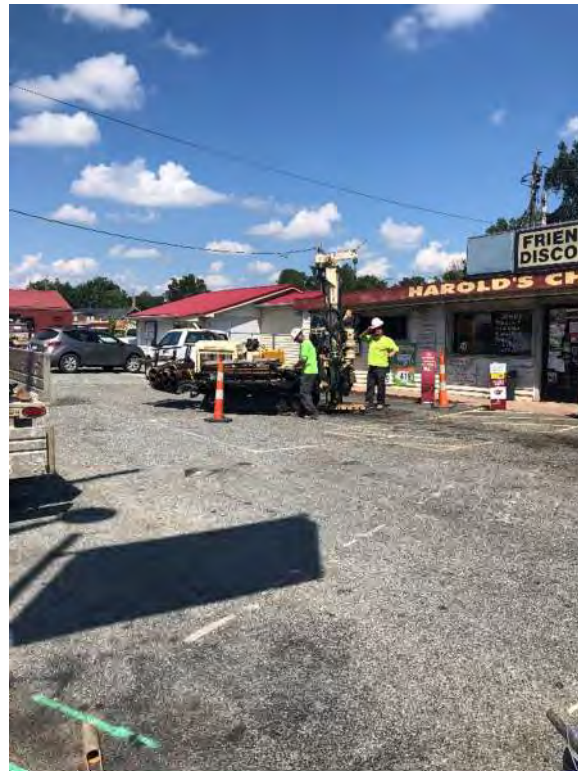
One (1) no confidence anomaly, approximately 12-feet long by 10-feet wide, was located west of the convenience store building on-site within the Project Study Area (No Confidence Anomaly #1). The anomaly lacks the lateral reflector typical of the long axis of a UST, thus the no confidence classification. There were no other EM responses that were not associated with known utilities, vehicles, or other previously known conditions.

View facing northeasterly toward the no confidence anomaly in the western portion of Parcel 26.

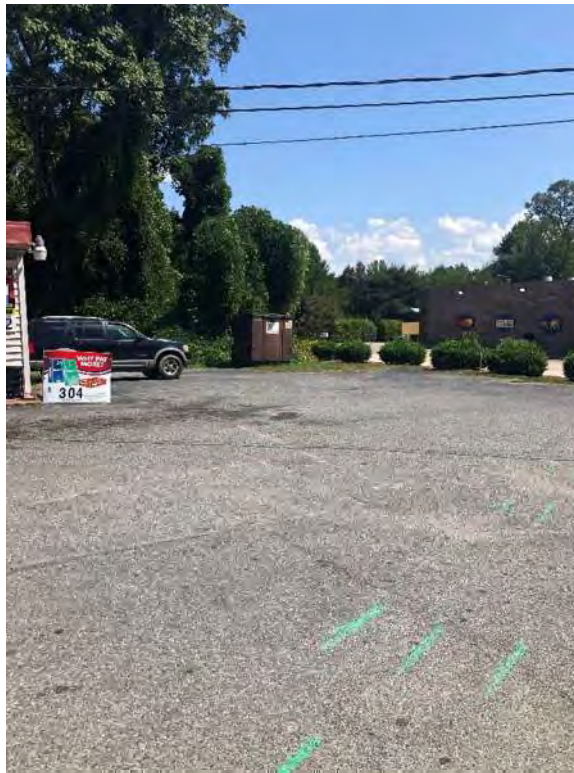
View facing easterly toward the southern portion of Parcel 26, the former UST basin.

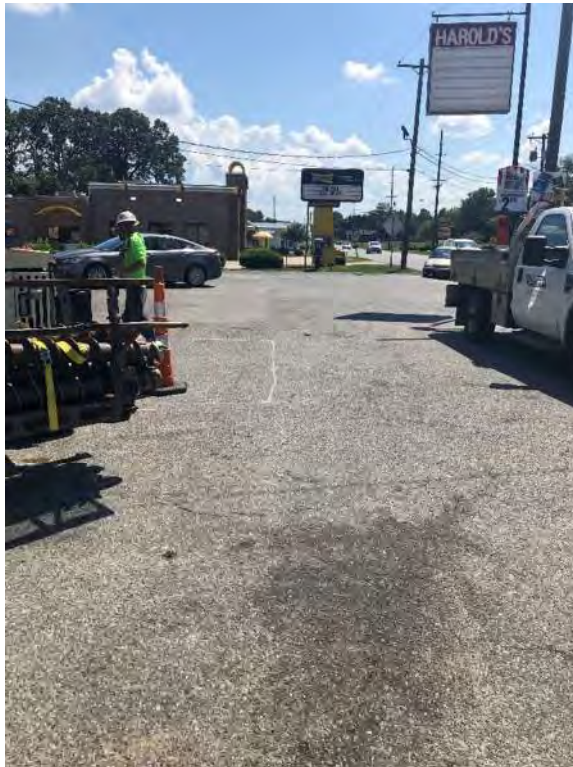
View facing southerly on Parcel 26 toward the four attempted borings which met resistance at 1.5-ft bgs.

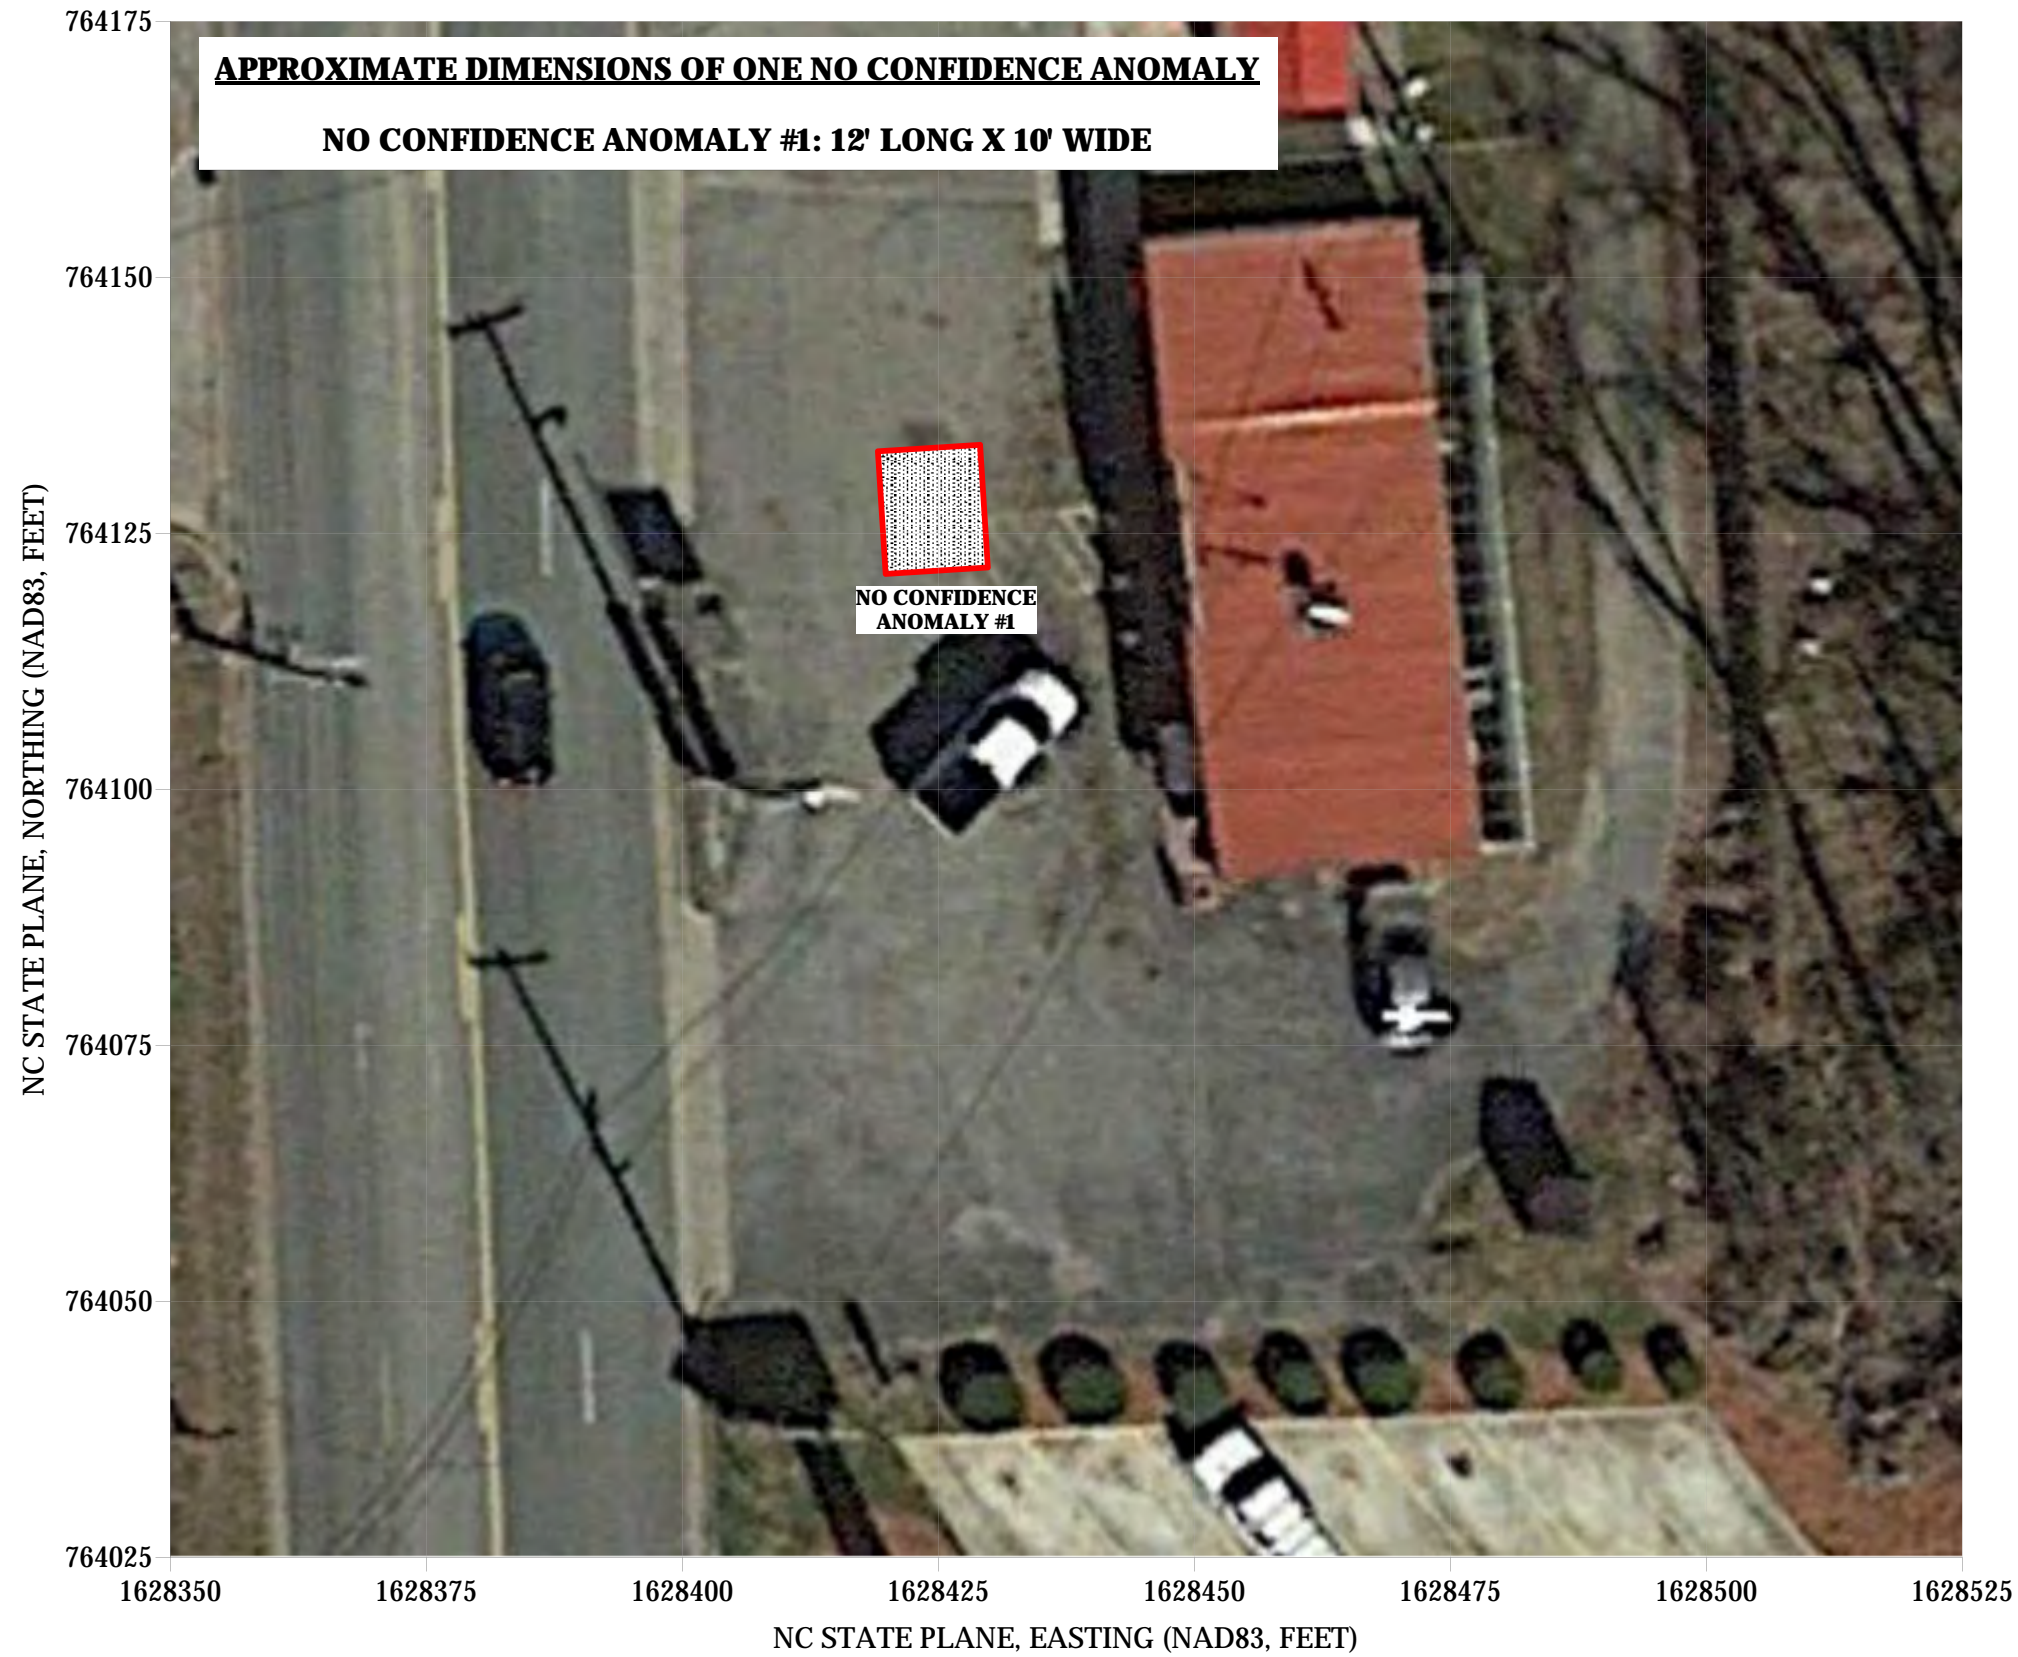
LOCATIONS OF ONE NO CONFIDENCE ANOMALY

Collectively, the geophysical data recorded evidence of one no confidence anomaly within the survey area at Parcel 26. **Figure 5** provides an overlay of the metal detection results and the location of the No Confidence anomaly on the NCDOT MicroStation engineering plans for reference.

View of One No Confidence Anomaly Facing Approximately East
