**SUBJECT: Preliminary Site Assessment Report
Parcel 29, Sam Lem
WBS Element No. 54035.1.1, TIP No. U-5757
NC 8 (Winston Road) from 9th Street to SR 1408 (Biesecker Rd) in
Lexington. Widen to multi lanes
Kleinfelder Project No. 20201105.001A**

**PRELIMINARY SITE ASSESSMENT REPORT
PARCEL 29 SAM LEM
PARCEL 1100900000002A
LEXINGTON, DAVIDSON COUNTY, NORTH CAROLINA**

**NCDOT WBS ELEMENT 54035.1.1
STATE PROJECT U-5757
NC 8 (WINSTON RD) FROM 9TH STREET TO SR 1408
(BIESECKER RD) IN LEXINGTON. WIDEN TO MULTI LANES**

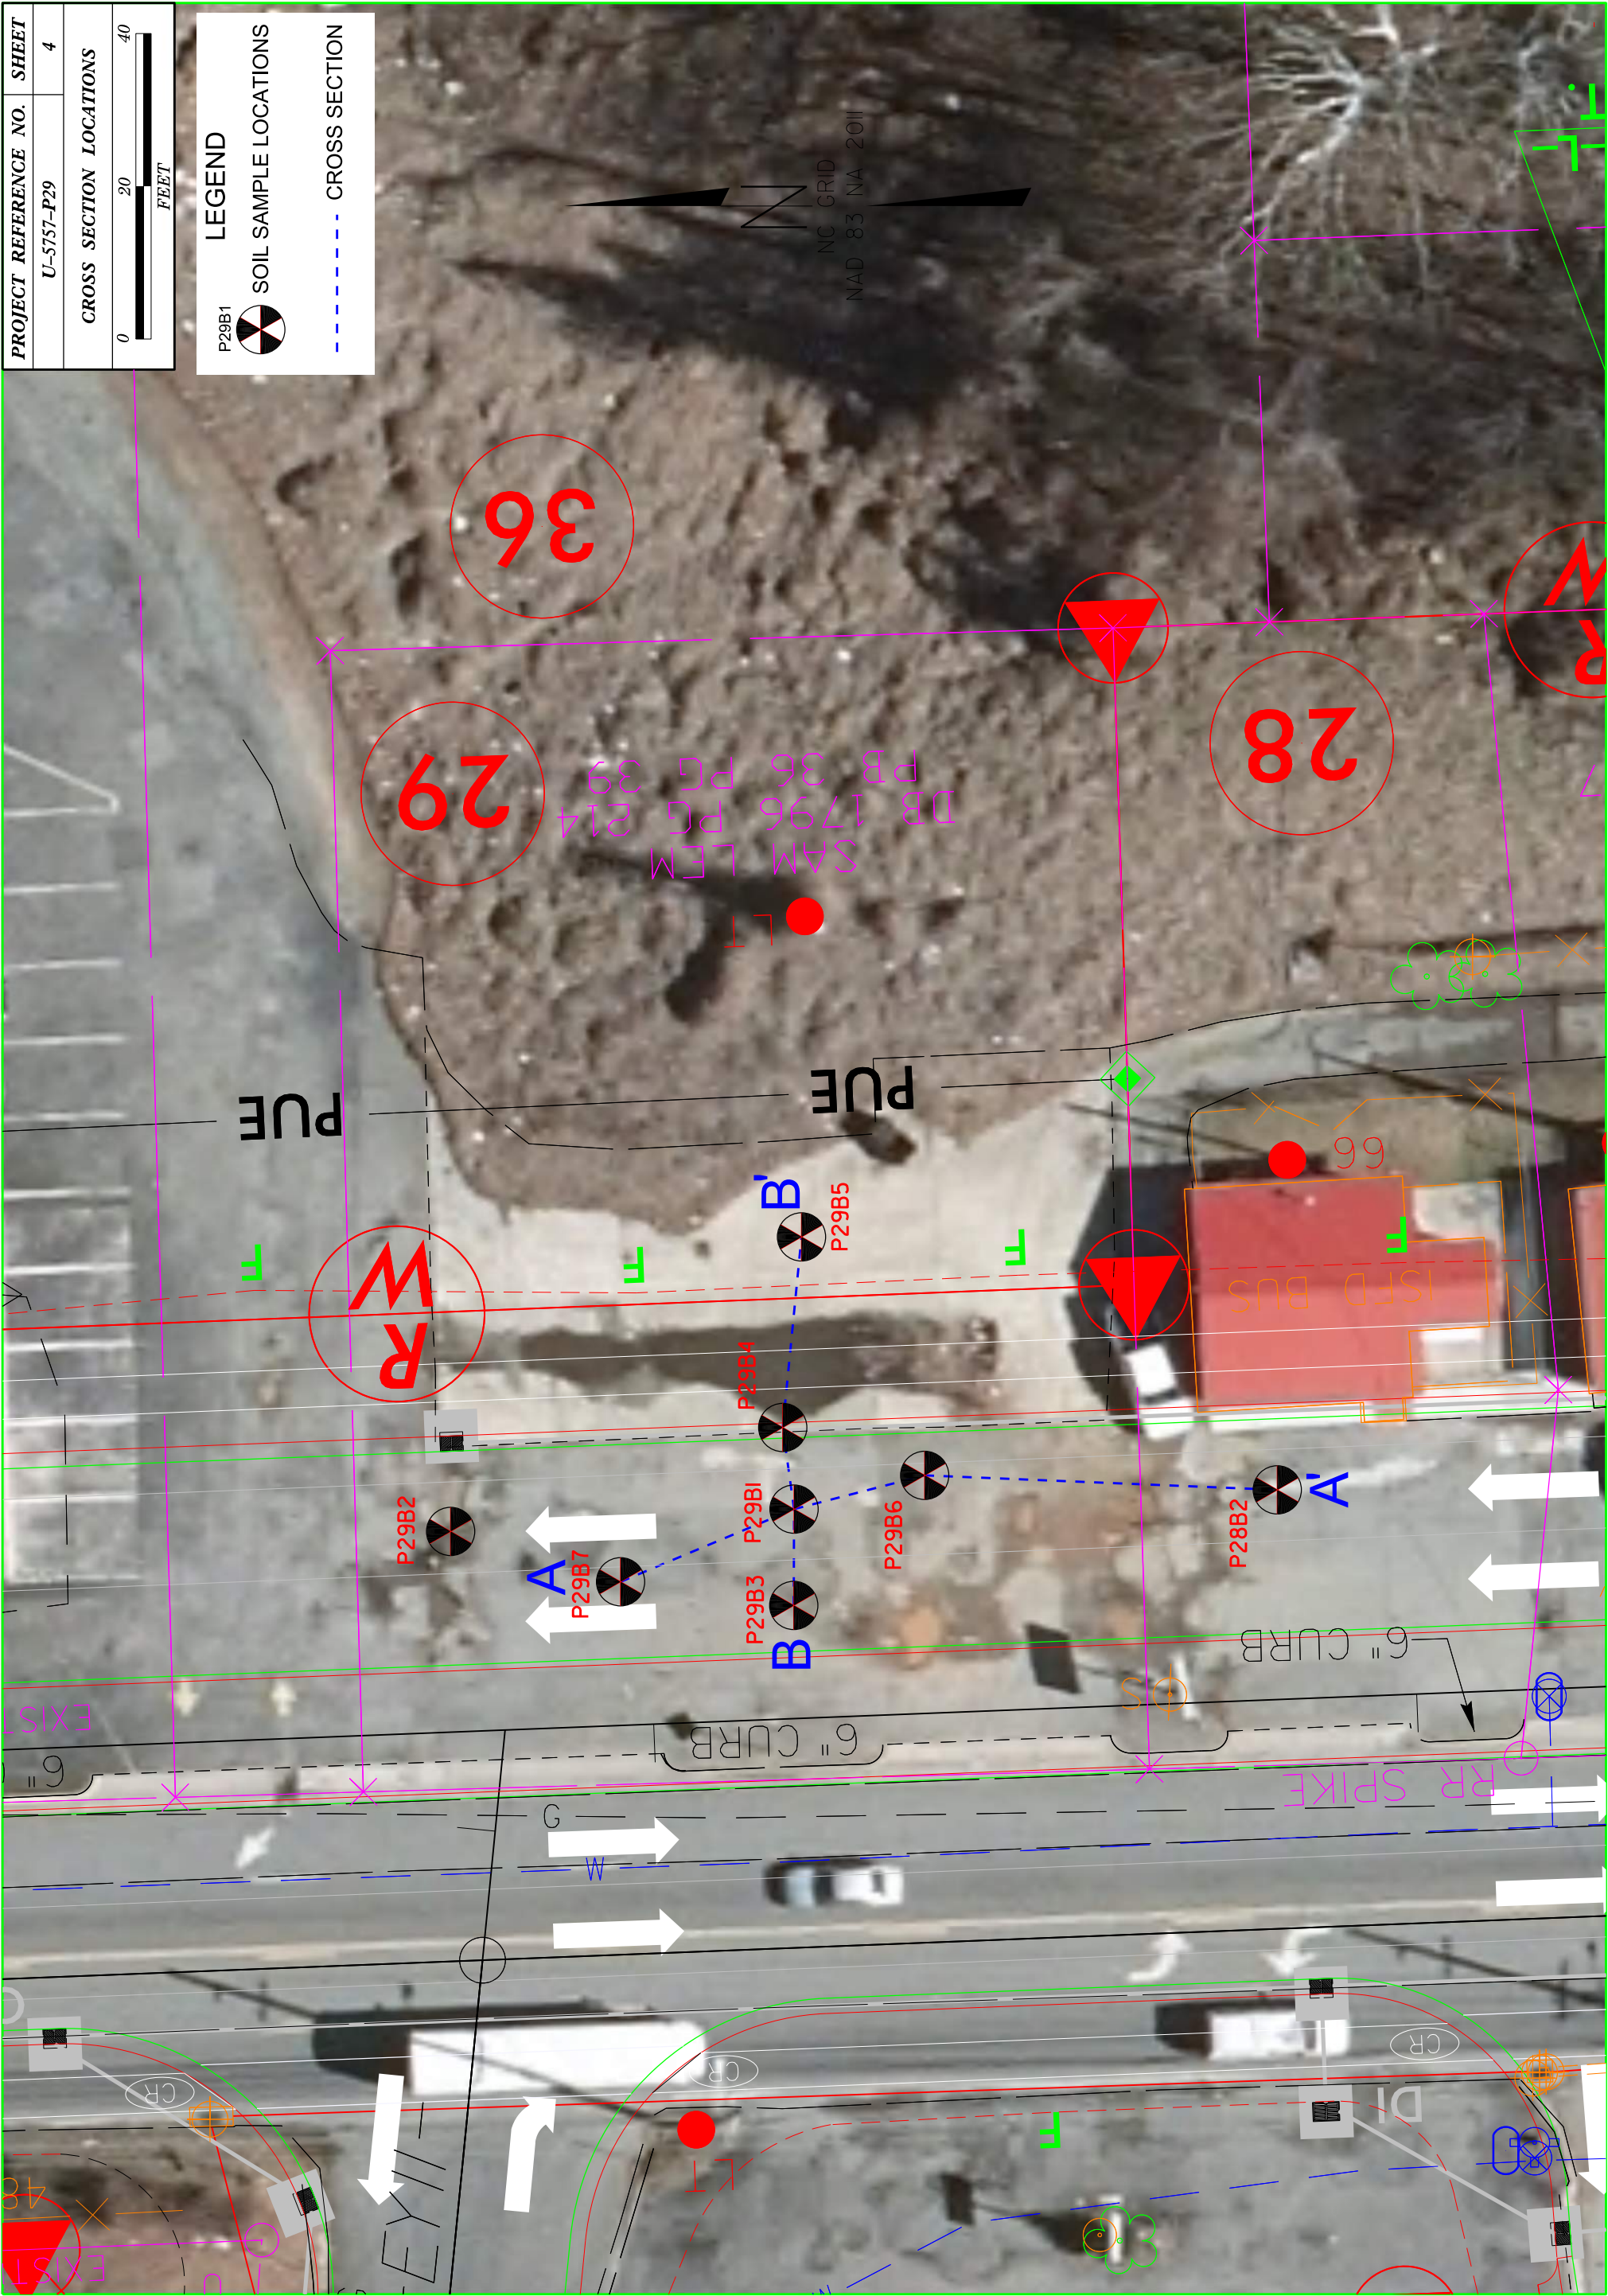
PROJECT REFERENCE NO.	FIGURE NO.
U-5757-P29	5
NORTH TO SOUTH CROSS SECTION LIGHT COAL TAR CONTAMINATION

- Soil impact above the NCDEQ Action Limit for TPH DRO, was detected in borings advanced in the vicinity of the reinforced concrete pad within the public utility easement and the southern parcel boundary. The chemical fingerprint for this impact was identified as Light Coal Tar, and olfactory observations of creosote odors was detected as well as visual observations of woody debris. This suggests the most likely source of the soil impact is buried creosote-treated woody debris. The shallowest occurrence of this debris was noted at approximately 6-ft bgs and the deepest at boring termination, 15-ft bgs.

Based on results of this Preliminary Site Assessment, Kleinfelder recommends that if debris is encountered during construction, excavation of identified creosote-treated wood debris and light coal tar contaminated soil be performed within the Project Study Area on Parcel 29 in Lexington, Davidson County, North Carolina.

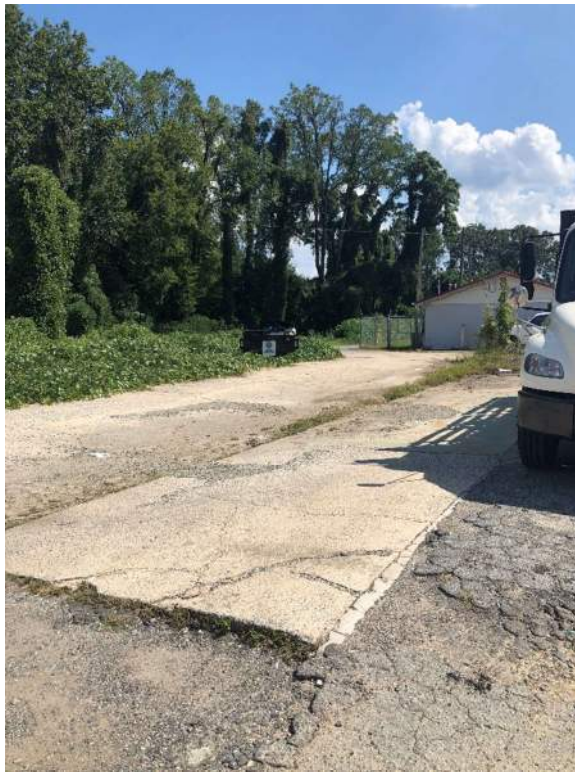
View facing south-southeasterly of the central portion of Parcel 29, the former car wash.

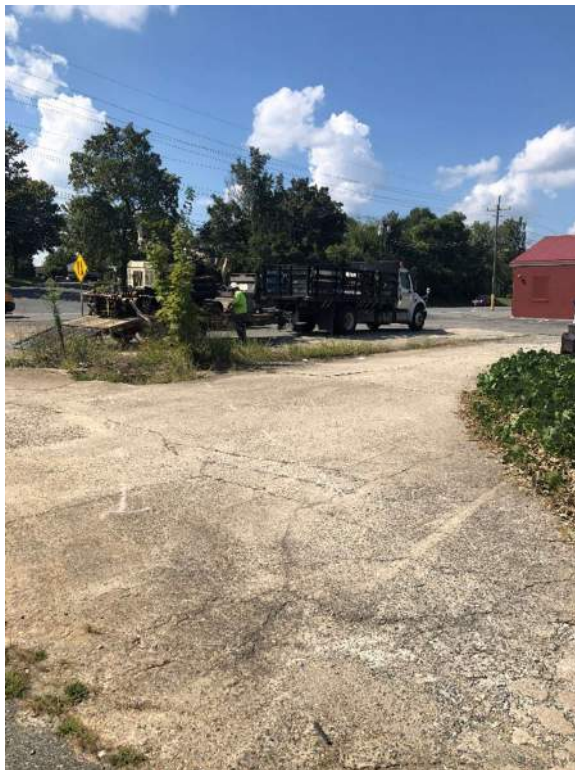
View facing northwesterly of the central portion of Parcel 29.

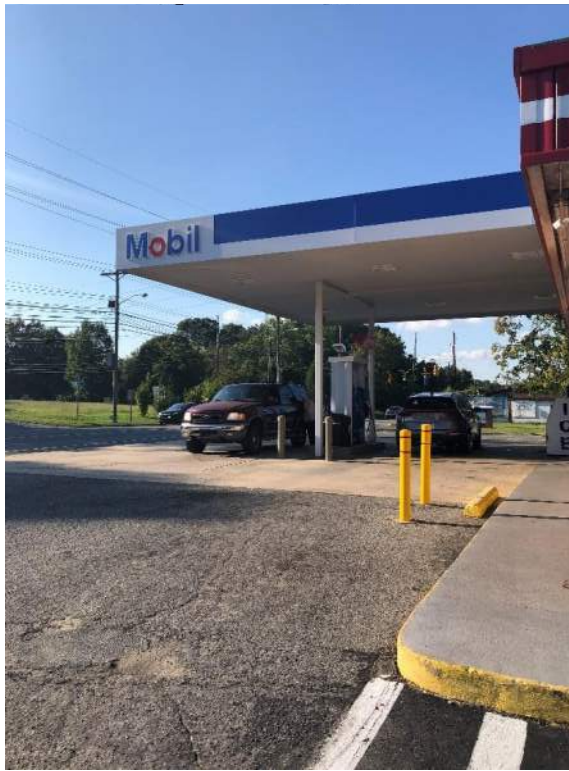
View facing northwest toward the Mobil service station and Winston Road on Parcel 40.

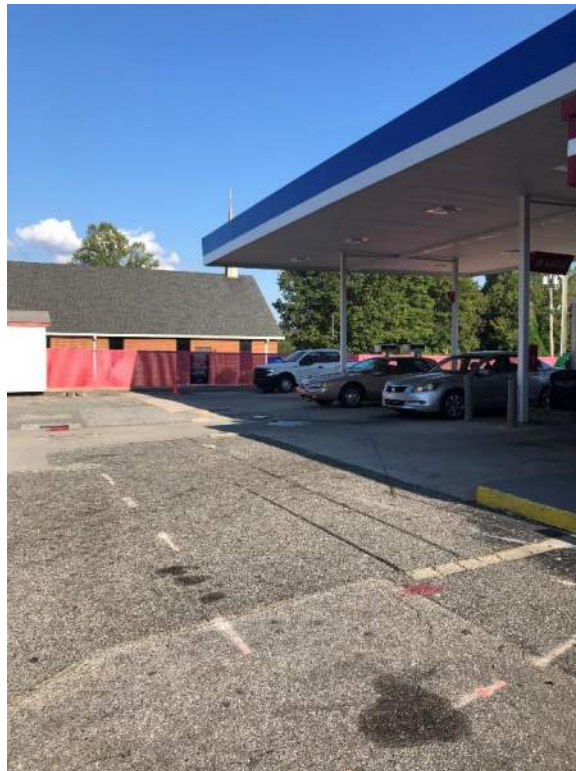
View facing southeast toward fuel islands and the UST basin on Parcel 40.
