**SUBJECT: Preliminary Site Assessment Report
Parcel 65, Laser Investments, LLC
WBS Element No. 54035.1.1, TIP No. U-5757
NC 8 (Winston Road) from 9th Street to SR 1408 (Biesecker Rd) in
Lexington. Widen to multi lanes
Kleinfelder Project No. 20201105.001A**

**PRELIMINARY SITE ASSESSMENT REPORT
PARCEL 65 LASER INVESTMENTS, LLC
PARCEL 11332C00P0020B
1574 OLD US HIGHWAY 52
LEXINGTON, DAVIDSON COUNTY, NORTH CAROLINA**

**NCDOT WBS ELEMENT 54035.1.1
STATE PROJECT U-5757
NC 8 (WINSTON RD) FROM 9TH STREET TO SR 1408
(BIESECKER RD) IN LEXINGTON. WIDEN TO MULTI LANES**

METALLIC UST INVESTIGATION: PARCEL 65 NCDOT PROJECT U-5757 (54035.1.1)

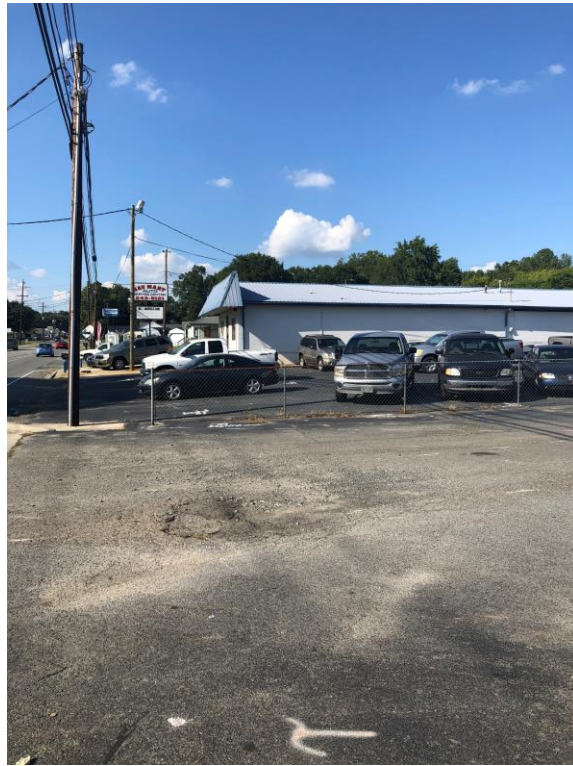
View facing north along Winston Road on Parcel 65.

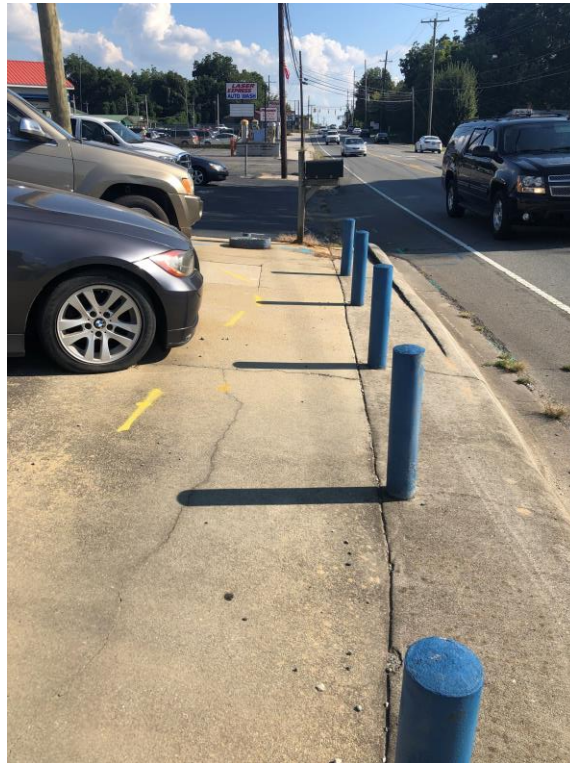
View facing south along Winston Road on Parcel 65.

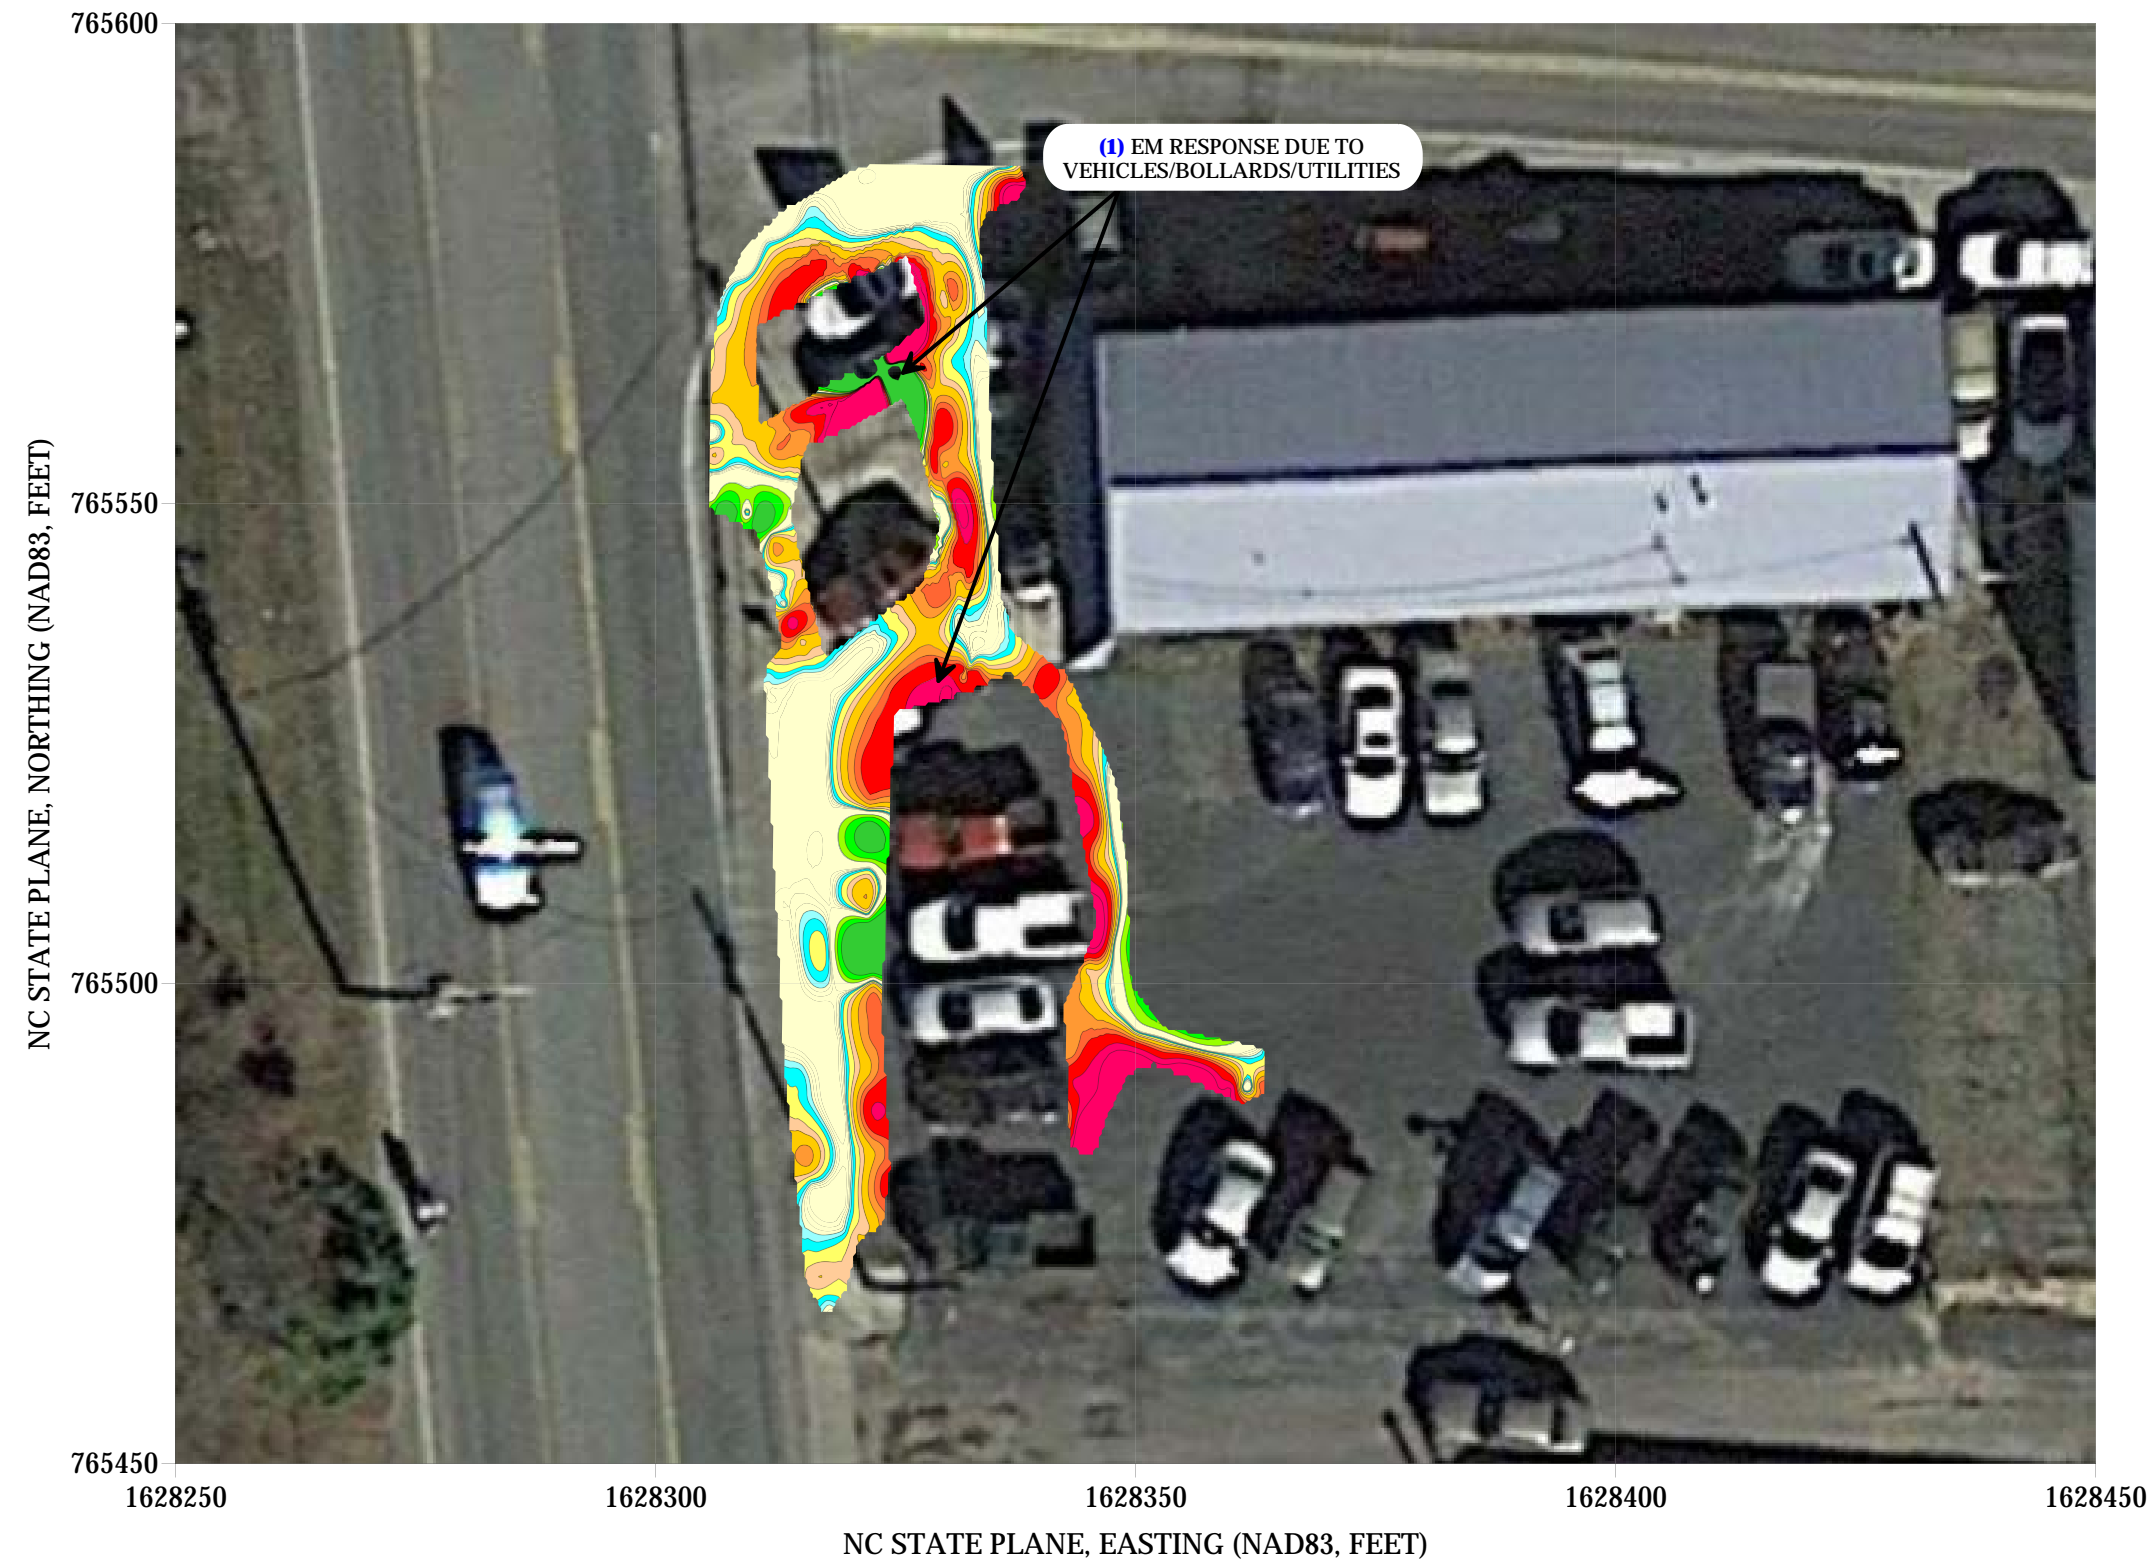
NO EVIDENCE OF METALLIC USTs WAS OBSERVED.

The contour plot shows the differential results of the EM61 instrument in millivolts (mV). The differential results focus on larger metallic objects such as USTs and drums. The EM data were collected on July 16, 2019, using a Geonics EM61-MK2 instrument. Verification GPR data were collected using a GSSI UtilityScan DF instrument with a dual frequency 300/800 MHz antenna on July 18, 2019.

EM61 Metal Detection Response (millivolts)

A contour plot of the EM61 results obtained across the survey area at the property is presented in **Figure 2**. Each EM anomaly is numbered for reference in the figure. The following table presents the list of EM anomalies and the cause of the metallic response, if known:

Metallic Anomaly #	Cause of Anomaly	Investigated with GPR
1	Vehicles/Bollards/Utilities	✓

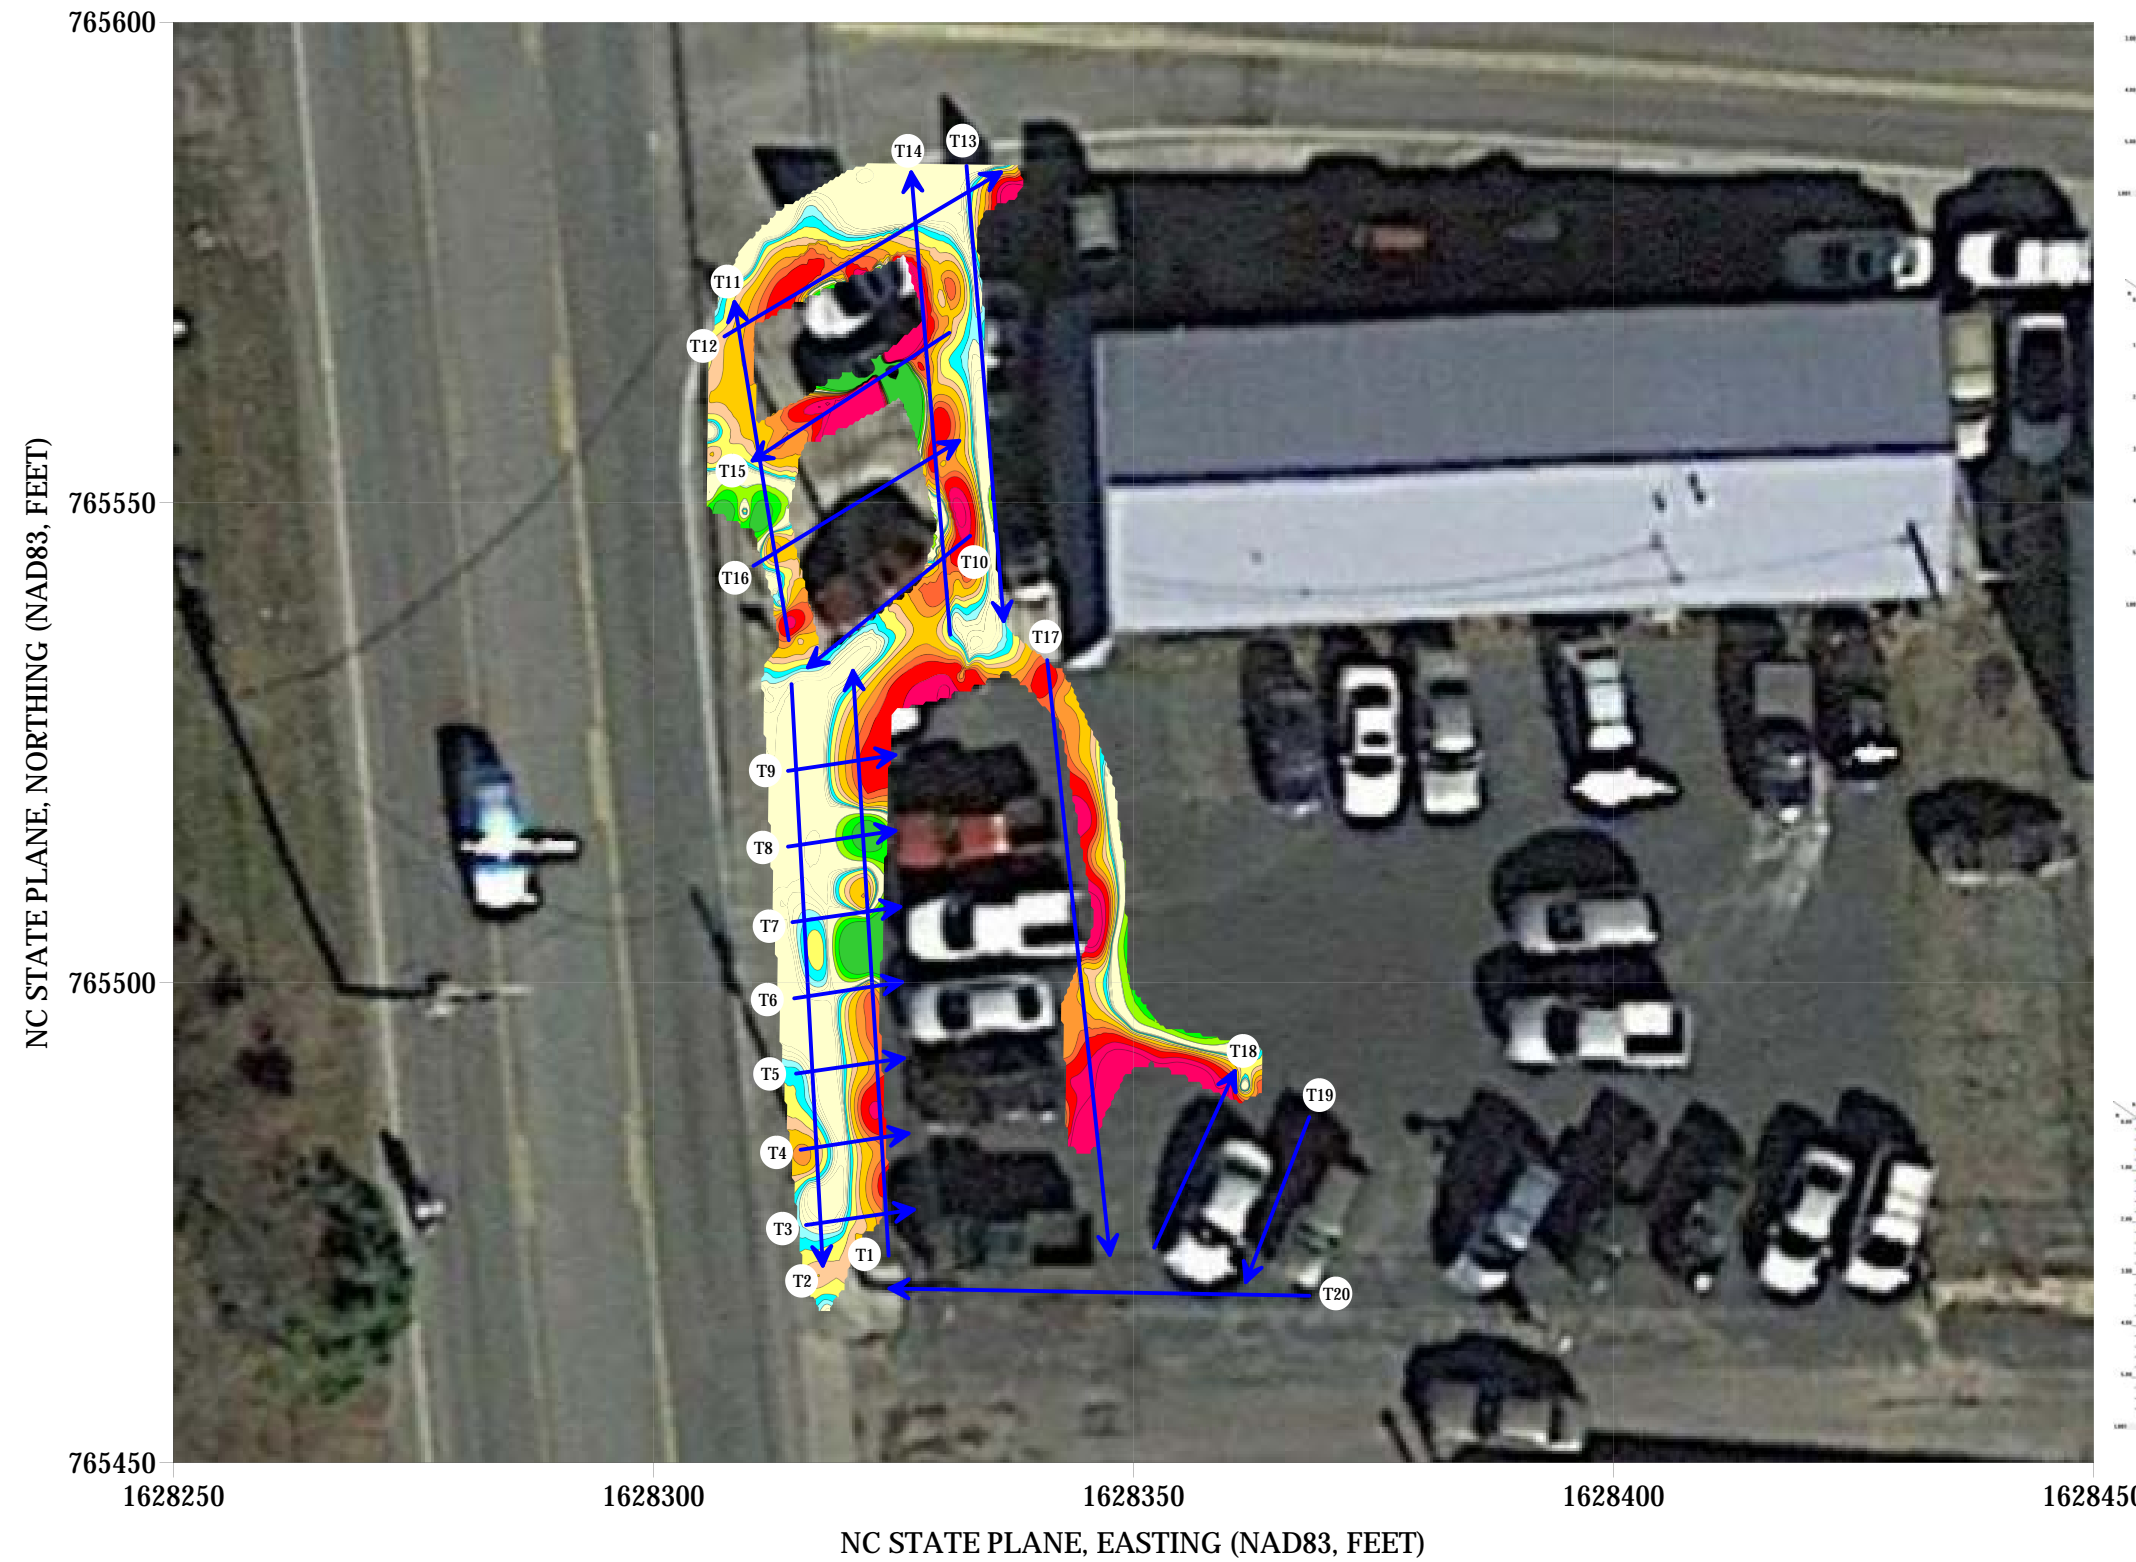
LOCATIONS OF GPR TRANSECTS

GPR Transects 1-20 were performed in a grid-like fashion across the site in areas associated with interference from vehicles, bollards, and suspected utilities (EM Anomaly 1). No evidence of any significant structures such as USTs was observed, verifying that the EM anomaly was the result of interference from the vehicles and bollards. GPR also verified the presence of the utilities.
