**North Carolina Department of Transportation  
Phase II Investigation  
State Project: R-5709  
WBS Element: 50205.1.1  
Hoke County**

**Parcel 285  
Gregory Lowery Property  
10575 NC 211 Highway  
Aberdeen, North Carolina  
October 27, 2021**

**Wood Environment & Infrastructure Solutions, Inc.  
Project: 20478R5709**

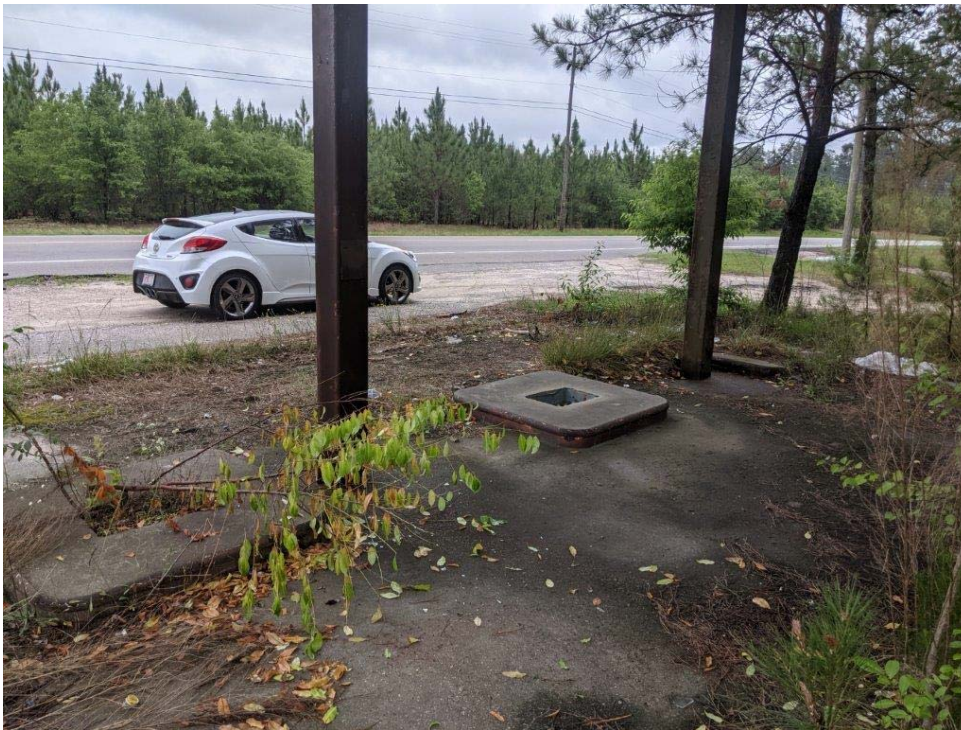
**Photograph 3:**  
Suspected dispenser  
islands at parcel 285,  
facing southeast.

Based on these Phase II Investigation results, Wood recommends no further soil investigation. Wood notes that the former dispenser islands and probable buried fuel piping located within the investigation area lie within the ROW and thus should be removed, in general accordance with the NCDEQ guidelines.

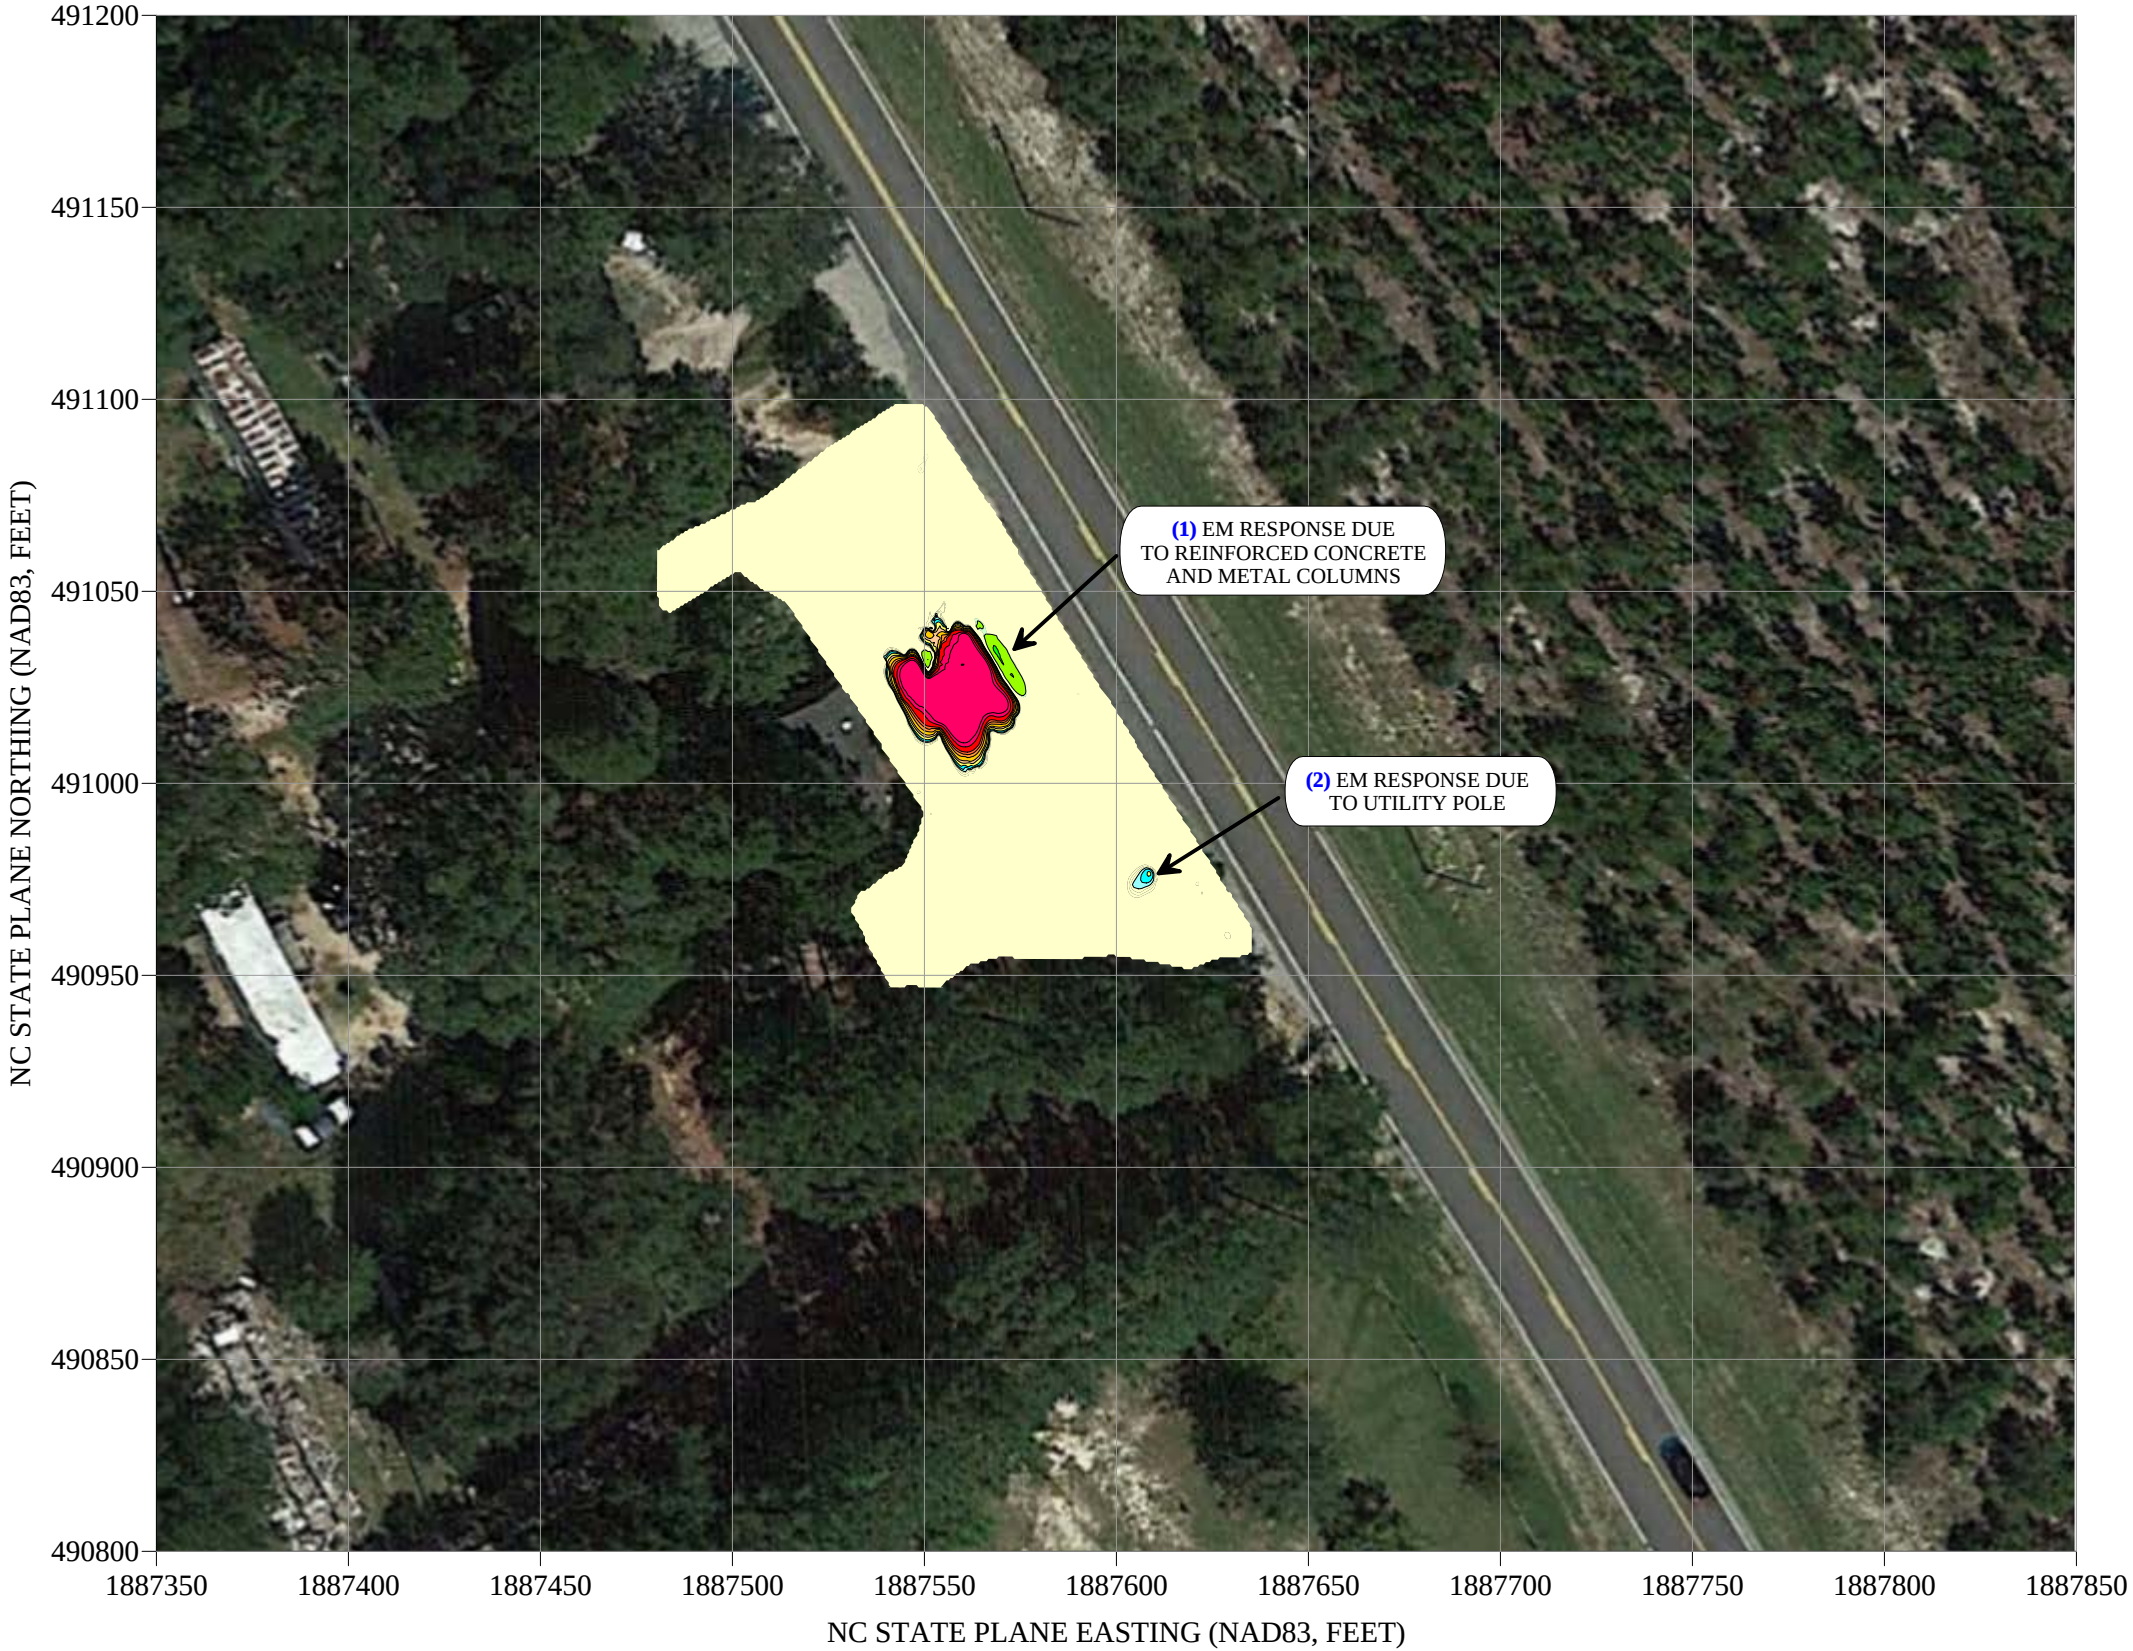
EM61 METAL DETECTION RESULTS

**NO EVIDENCE OF METALLIC USTs WAS OBSERVED.**

The contour plot shows the differential results of the EM61 instrument in millivolts (mV). The differential results focus on larger metallic objects such as USTs and drums. The EM data were collected on August 10, 2021, using a Geonics EM61-MK2 instrument. Verification GPR data were collected using a GSSI SIR 4000 instrument with a 350 MHz HS antenna on August 11, 2021.

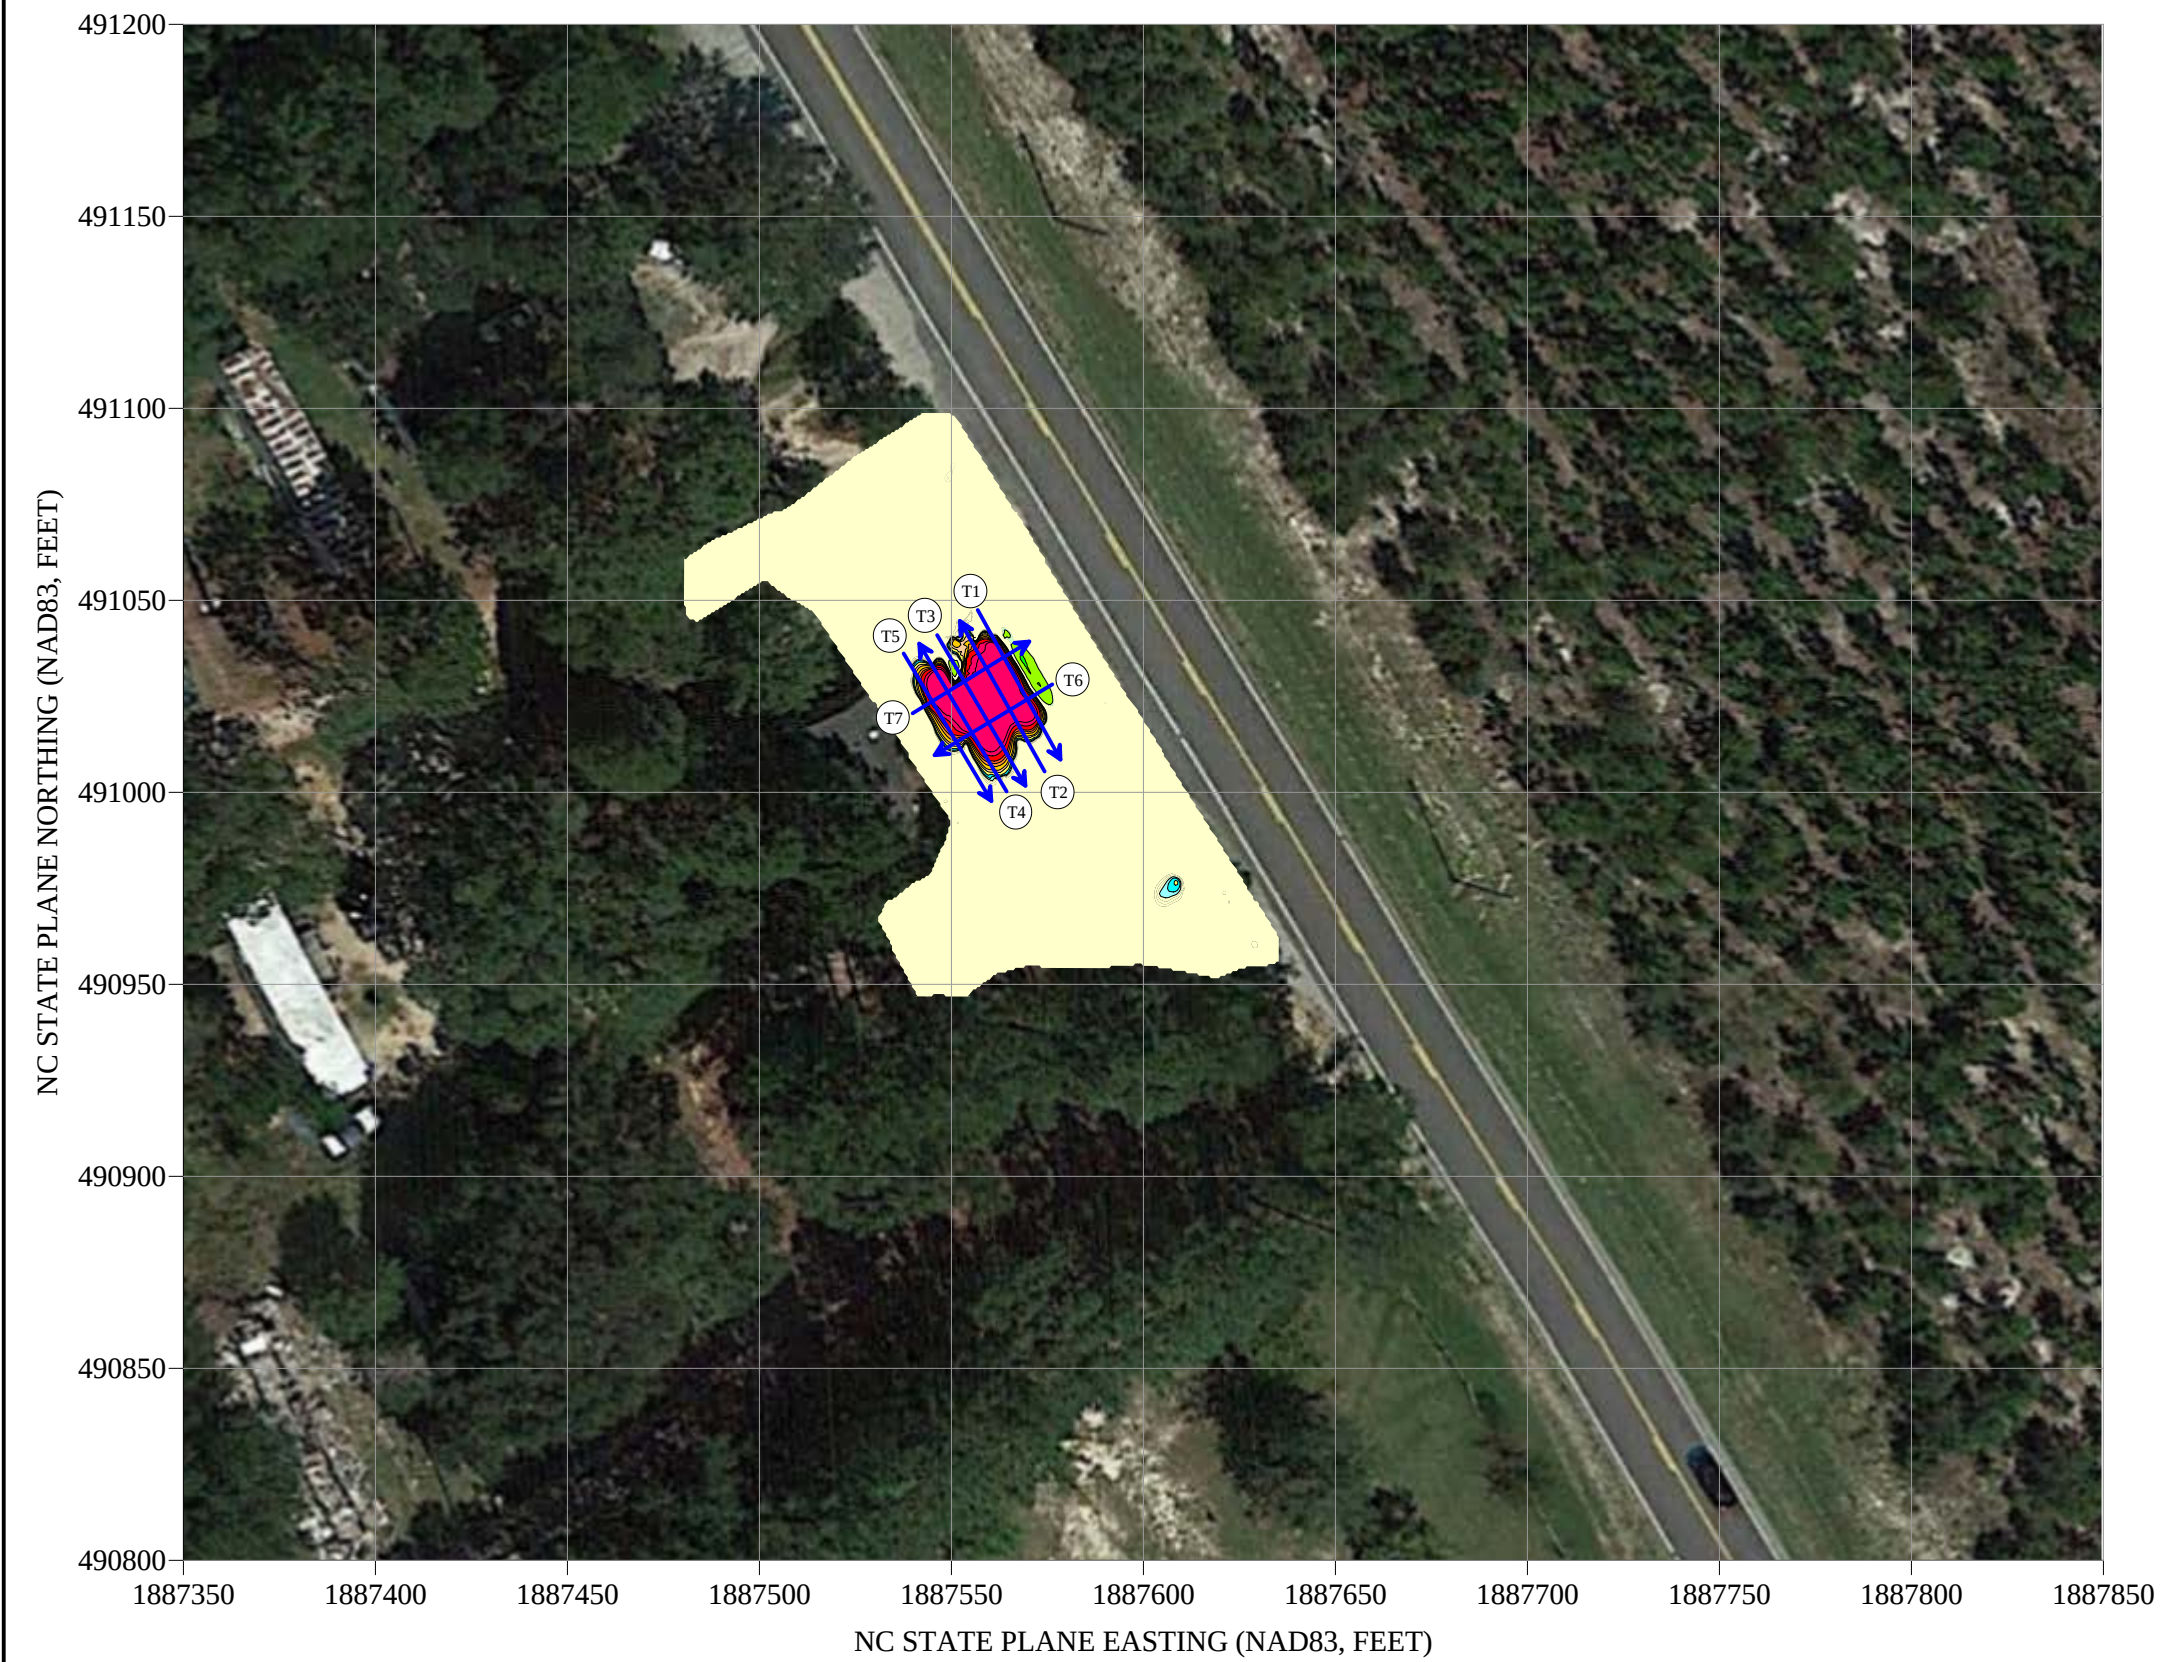
GPR TRANSECT LOCATIONS

**Figure 3** presents the locations of the formal GPR transects performed at the property as well as select transect images. All of the transect images are included in **Appendix A**. A total of seven formal GPR transects were performed at the site. GPR Transects 1-7 were performed across the reinforced concrete and around the metal columns beneath the canopy. GPR confirmed the presence of reinforcement and showed evidence of buried utilities beneath the canopy. No evidence of any significant structures such as USTs was observed.

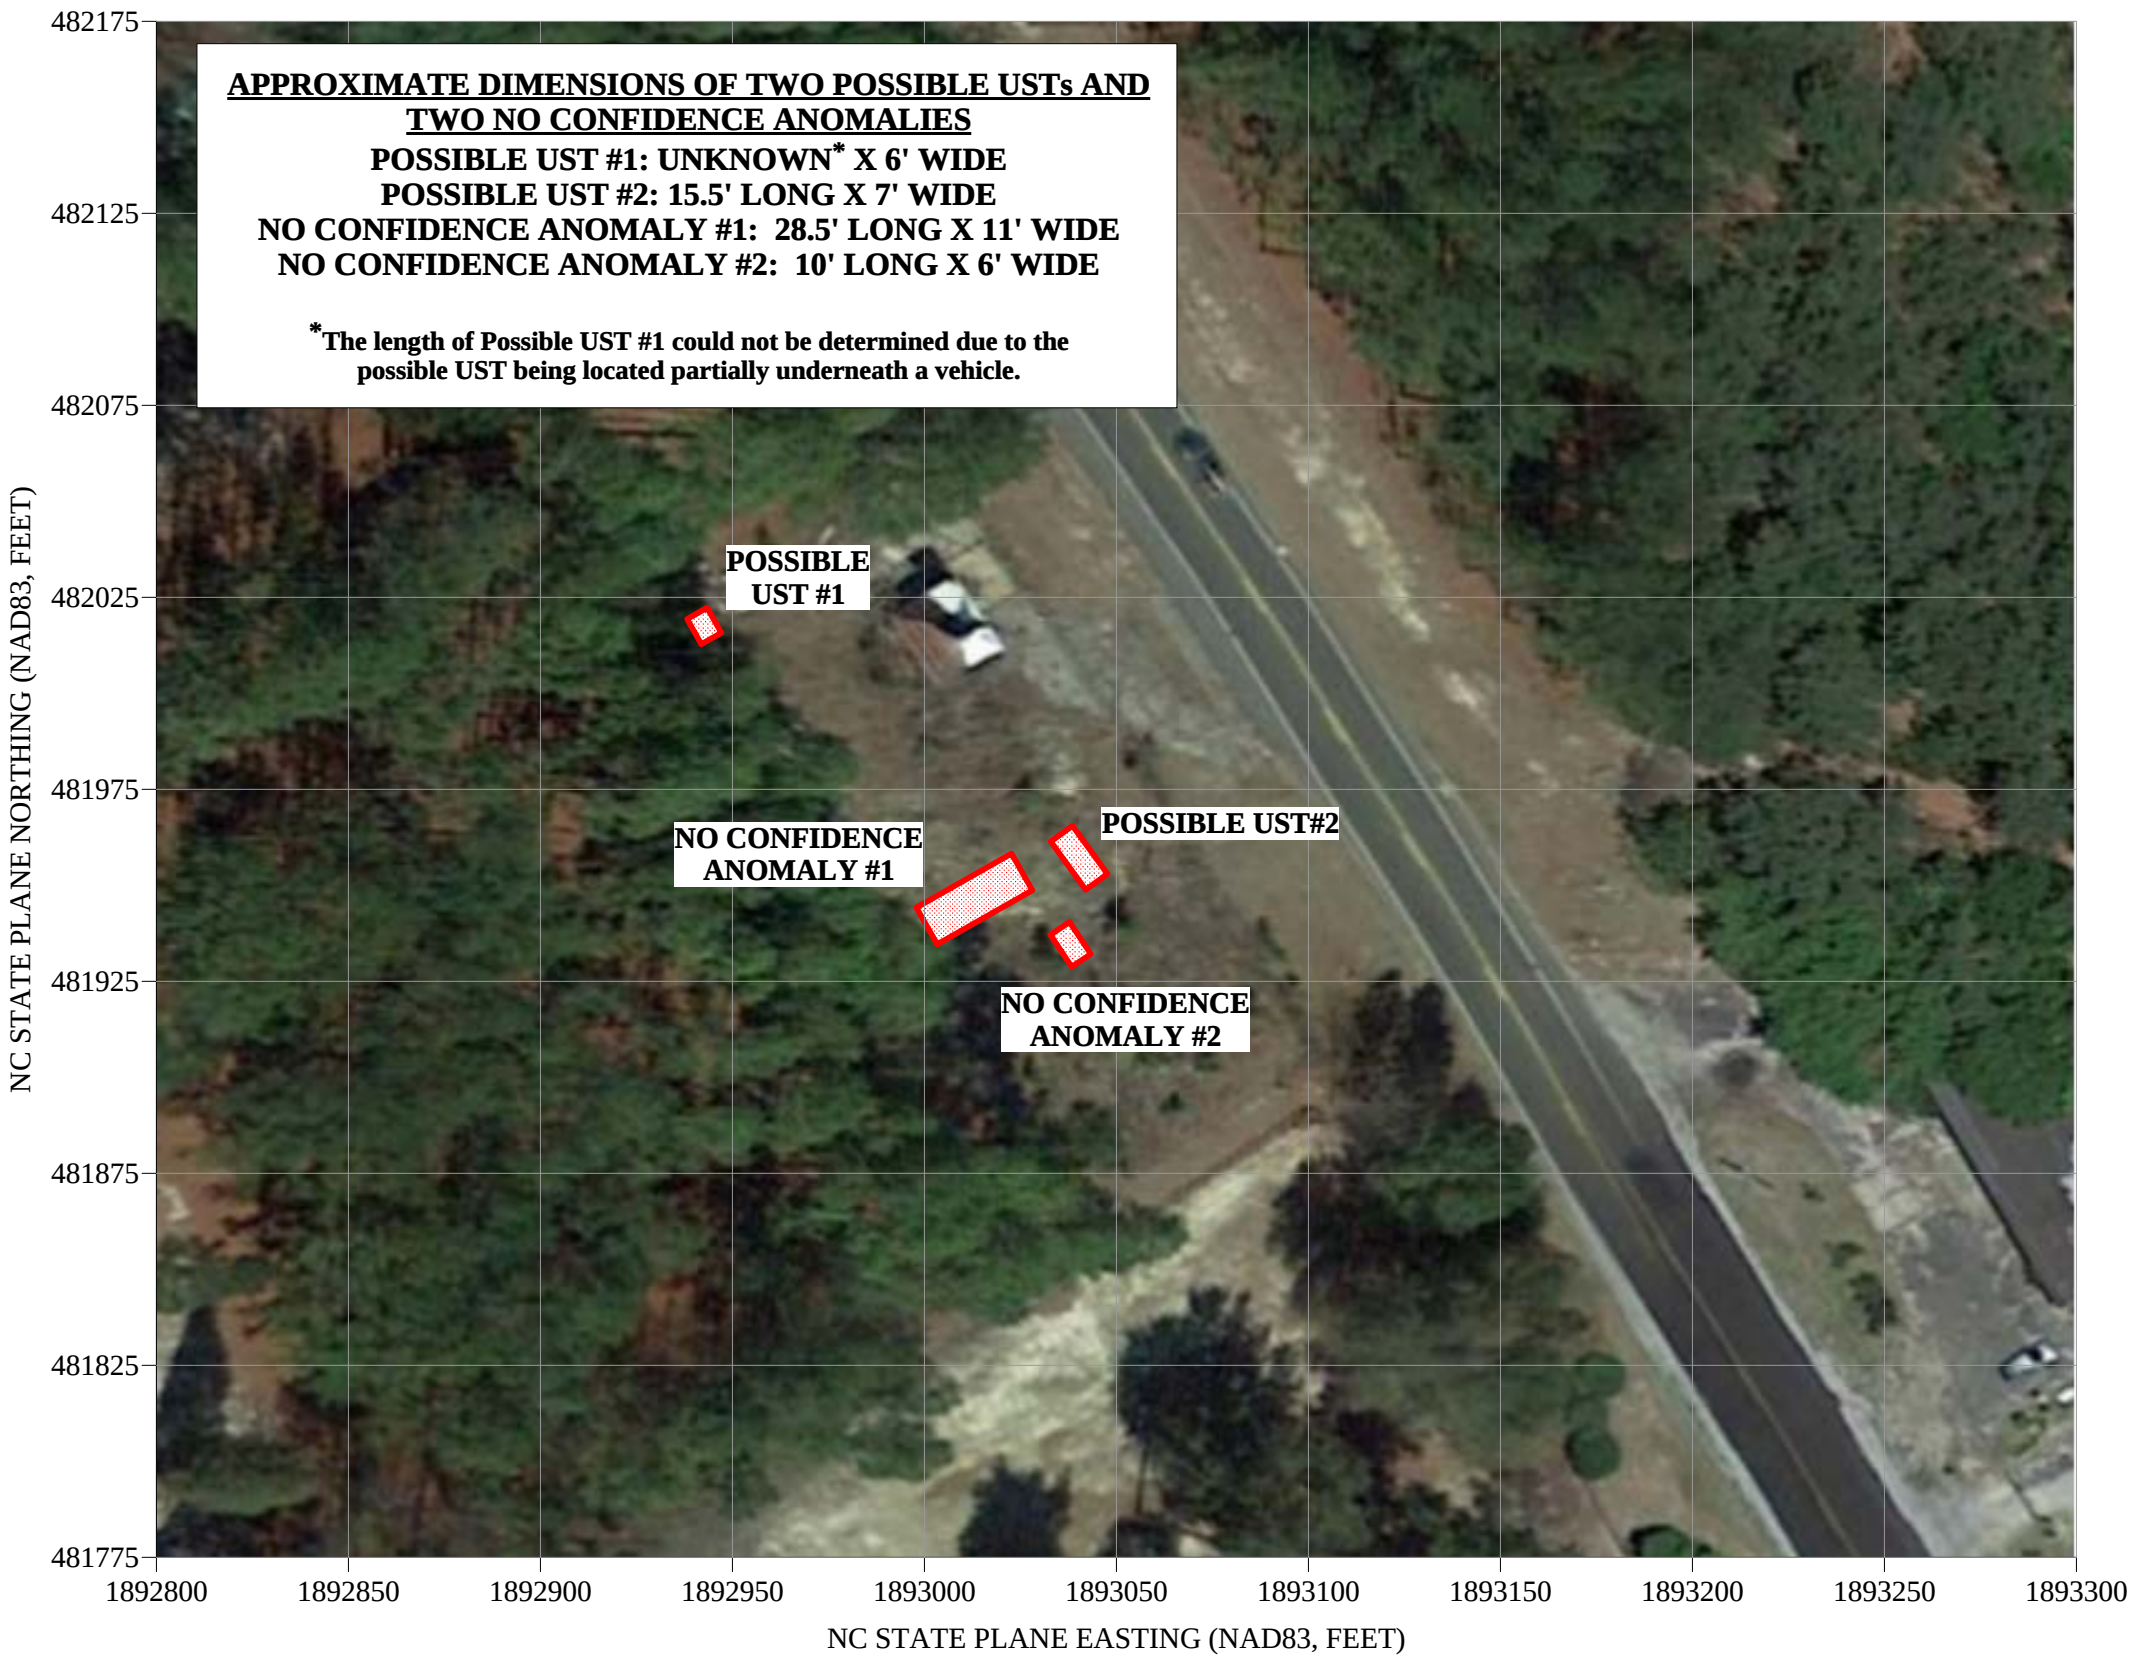
LOCATIONS OF TWO POSSIBLE USTs AND TWO NO CONFIDENCE ANOMALIES

- Wood personnel used a stainless-steel hand auger and a shovel to confirm the depths of the two possible USTs. The tops of possible USTs #1 and #2 were measured at approximately 1.5 feet and 2 feet bgs, respectively. It was noted that the tops of each possible UST were flatter in shape than expected for a buried tank and may indicate objects other than tanks at these locations; however, further excavation is needed to determine the full nature of the buried objects.

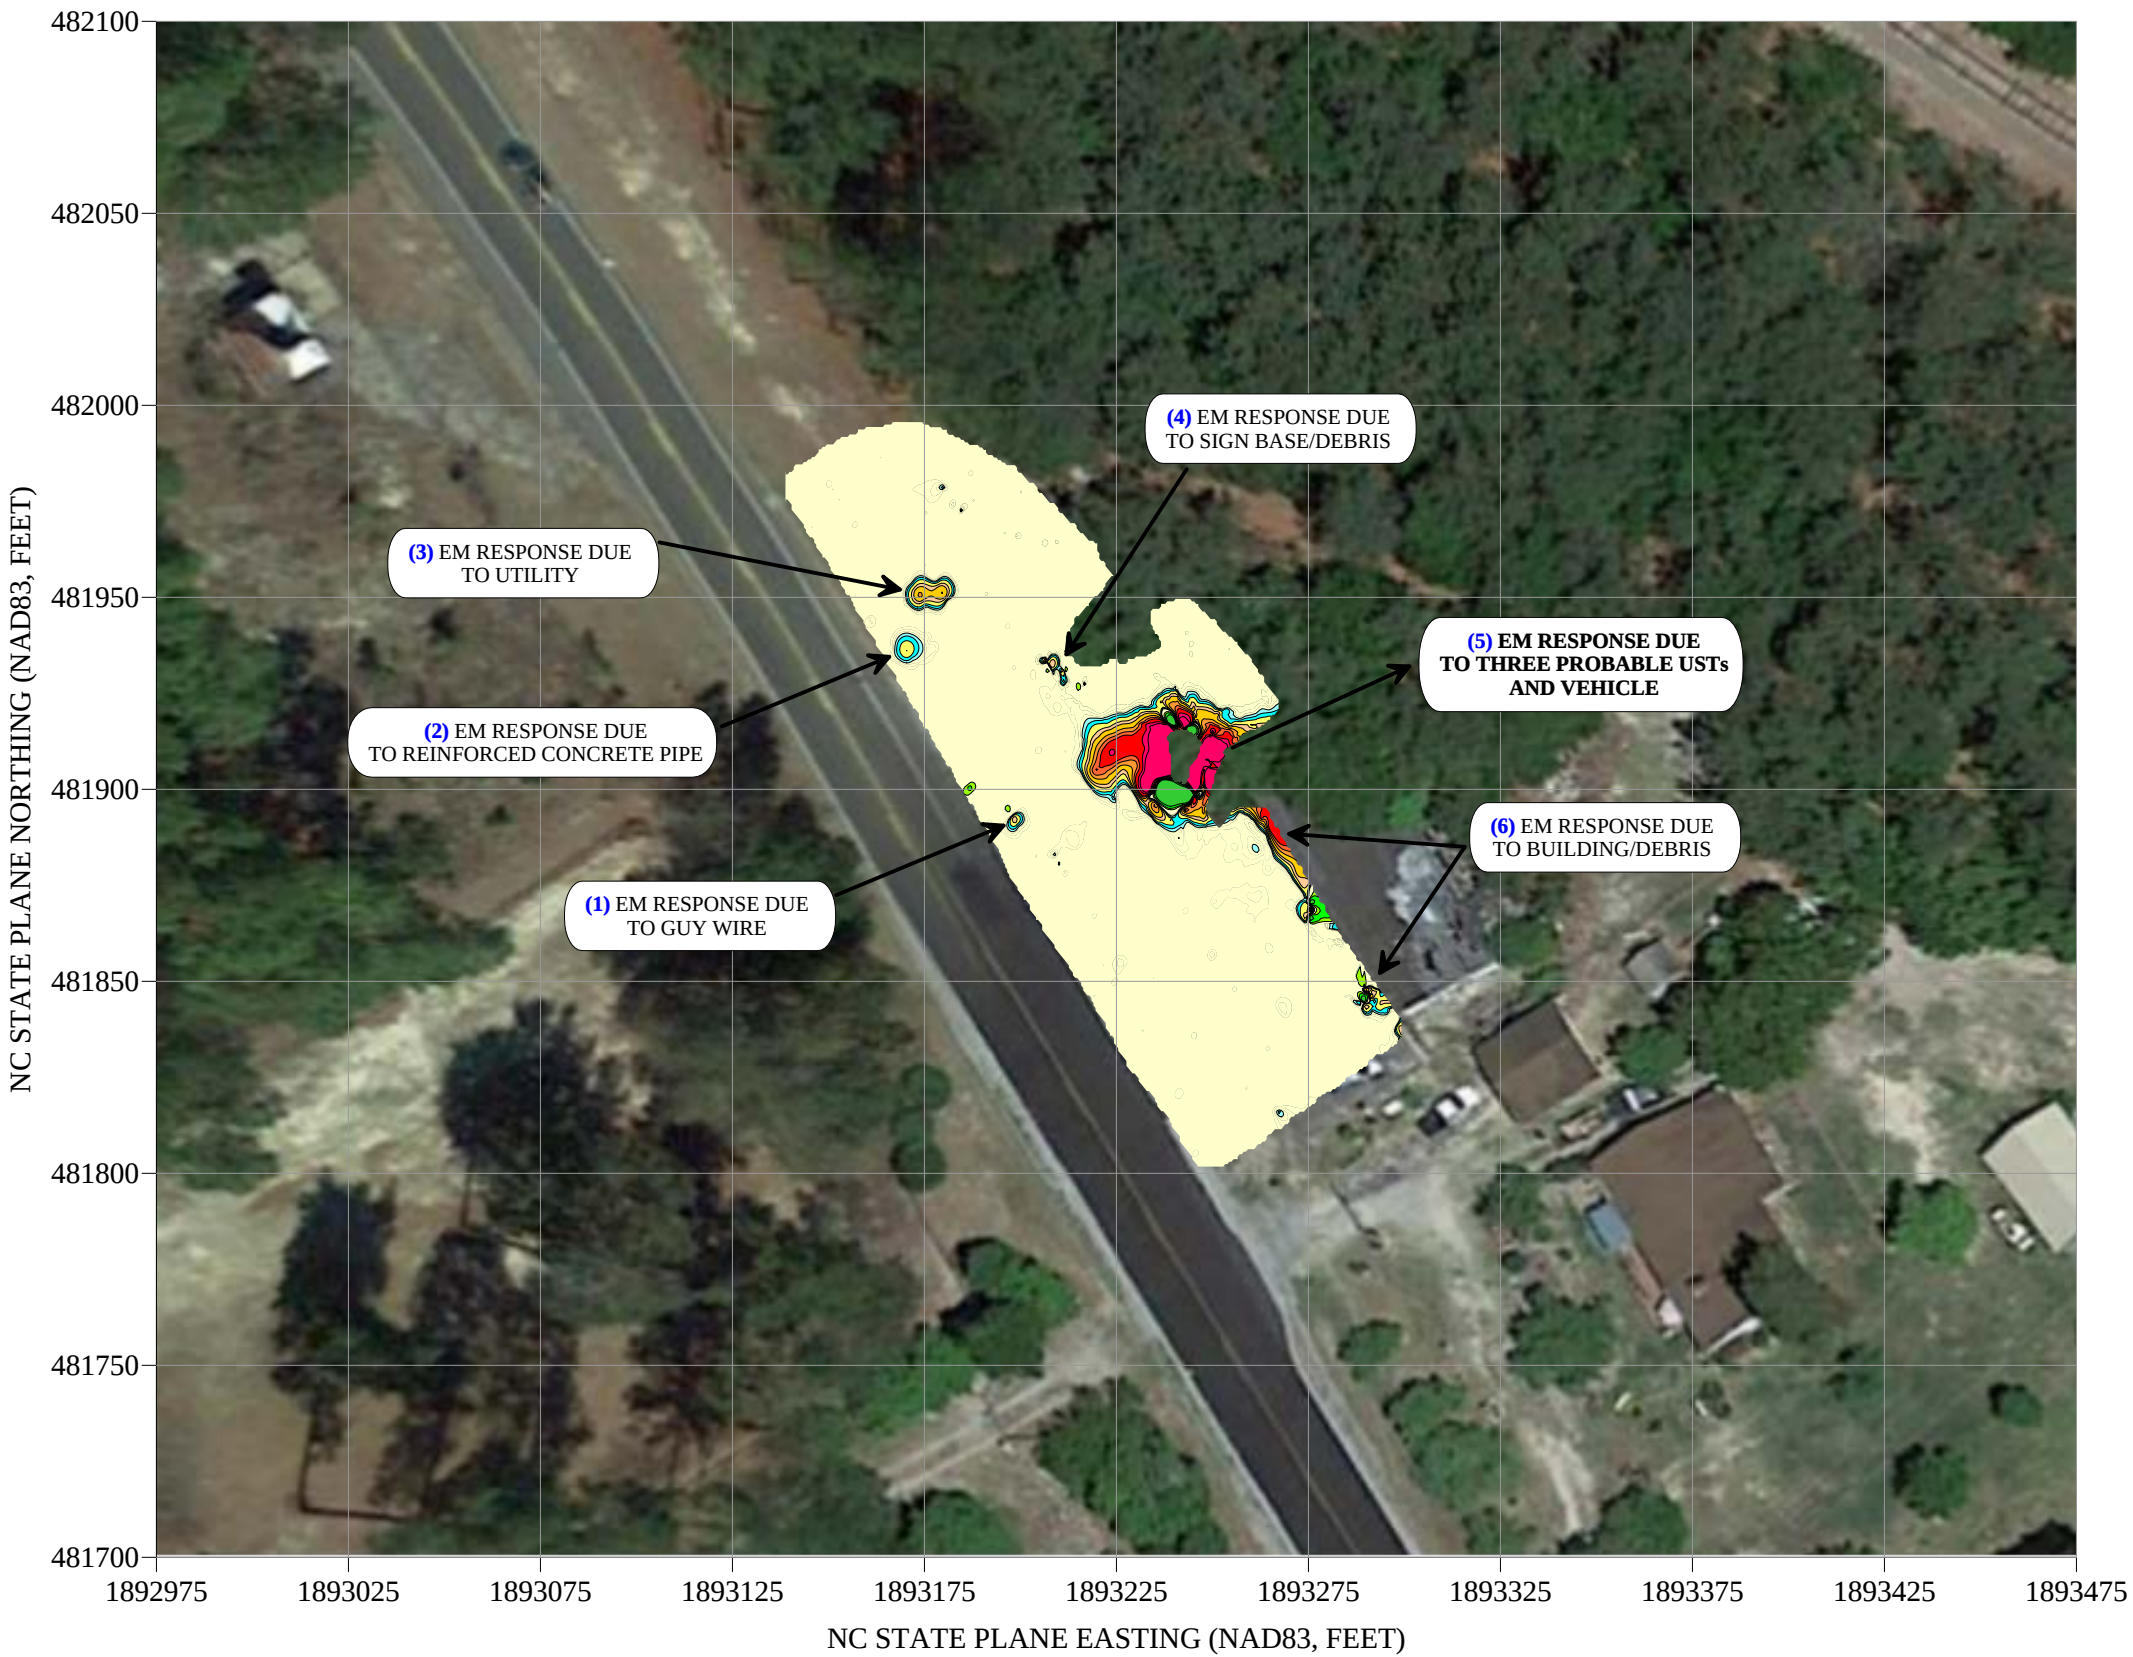
EM61 METAL DETECTION RESULTS

EVIDENCE OF THREE PROBABLE METALLIC USTs WAS OBSERVED.

The contour plot shows the differential results of the EM61 instrument in millivolts (mV). The differential results focus on larger metallic objects such as USTs and drums. The EM data were collected on August 11, 2021, using a Geonics EM61-MK2 instrument. Verification GPR data were collected using a GSSI SIR 4000 instrument with a 350 MHz HS antenna on August 12, 2021.

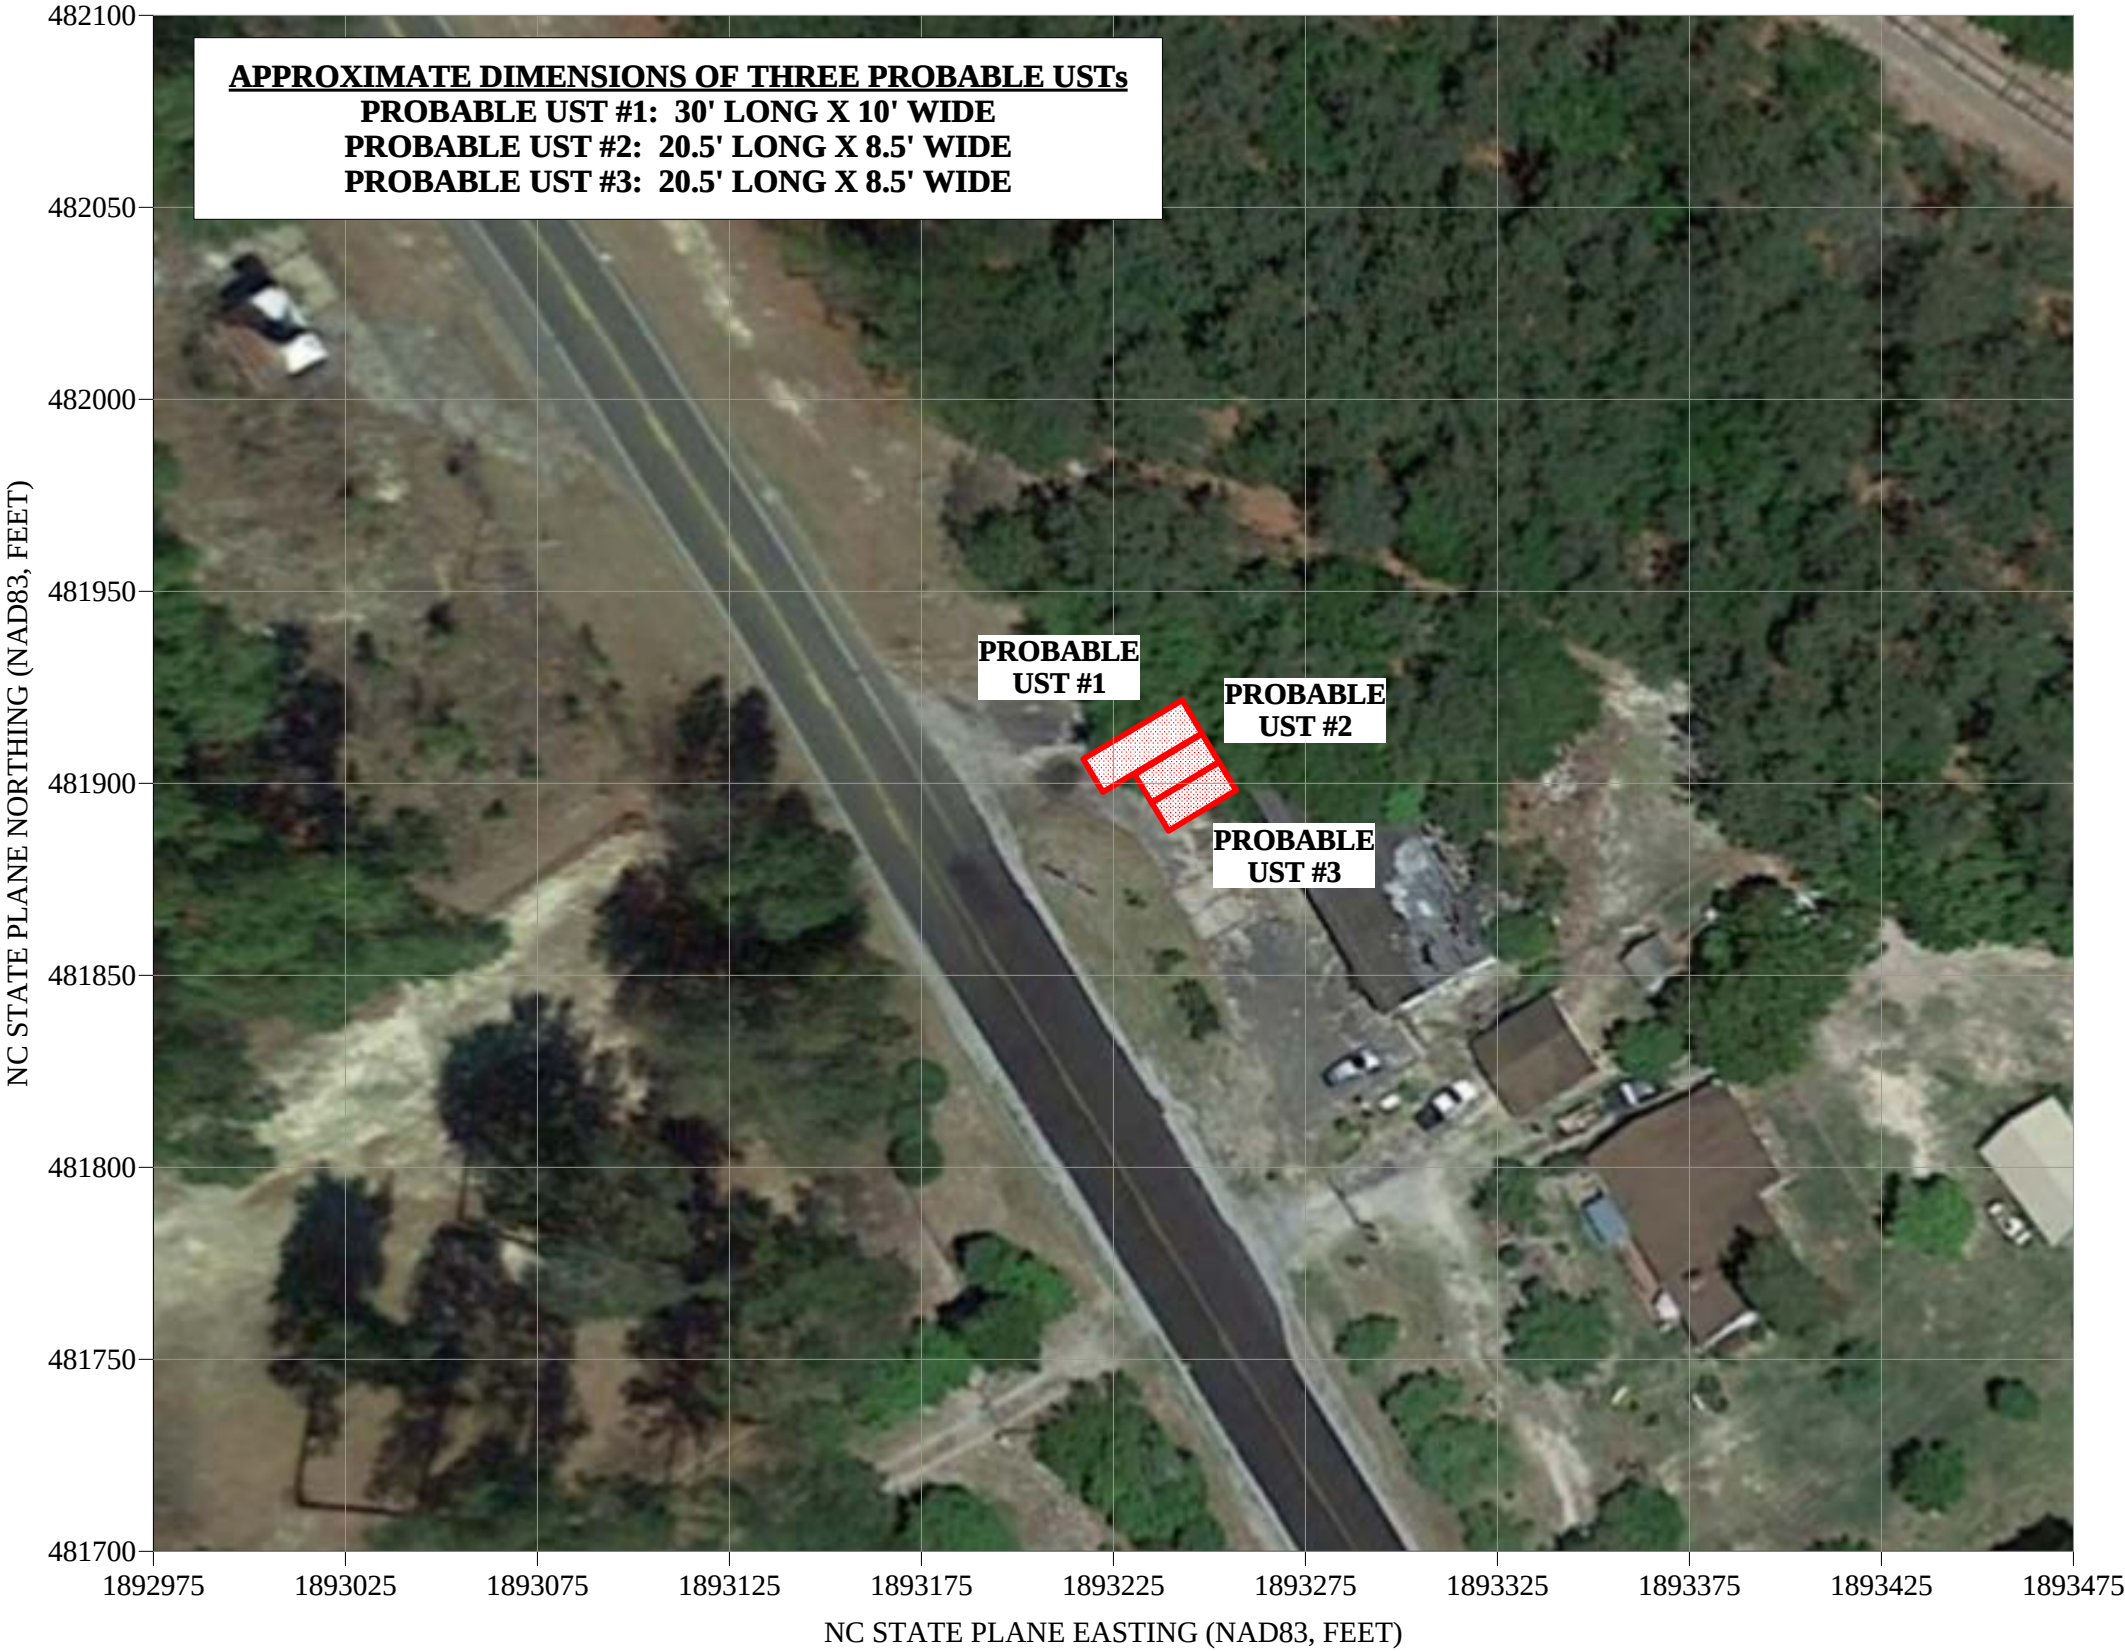
LOCATIONS AND SIZES OF THREE PROBABLE USTs

View of Three Probable USTs  
(Facing Approximately East)

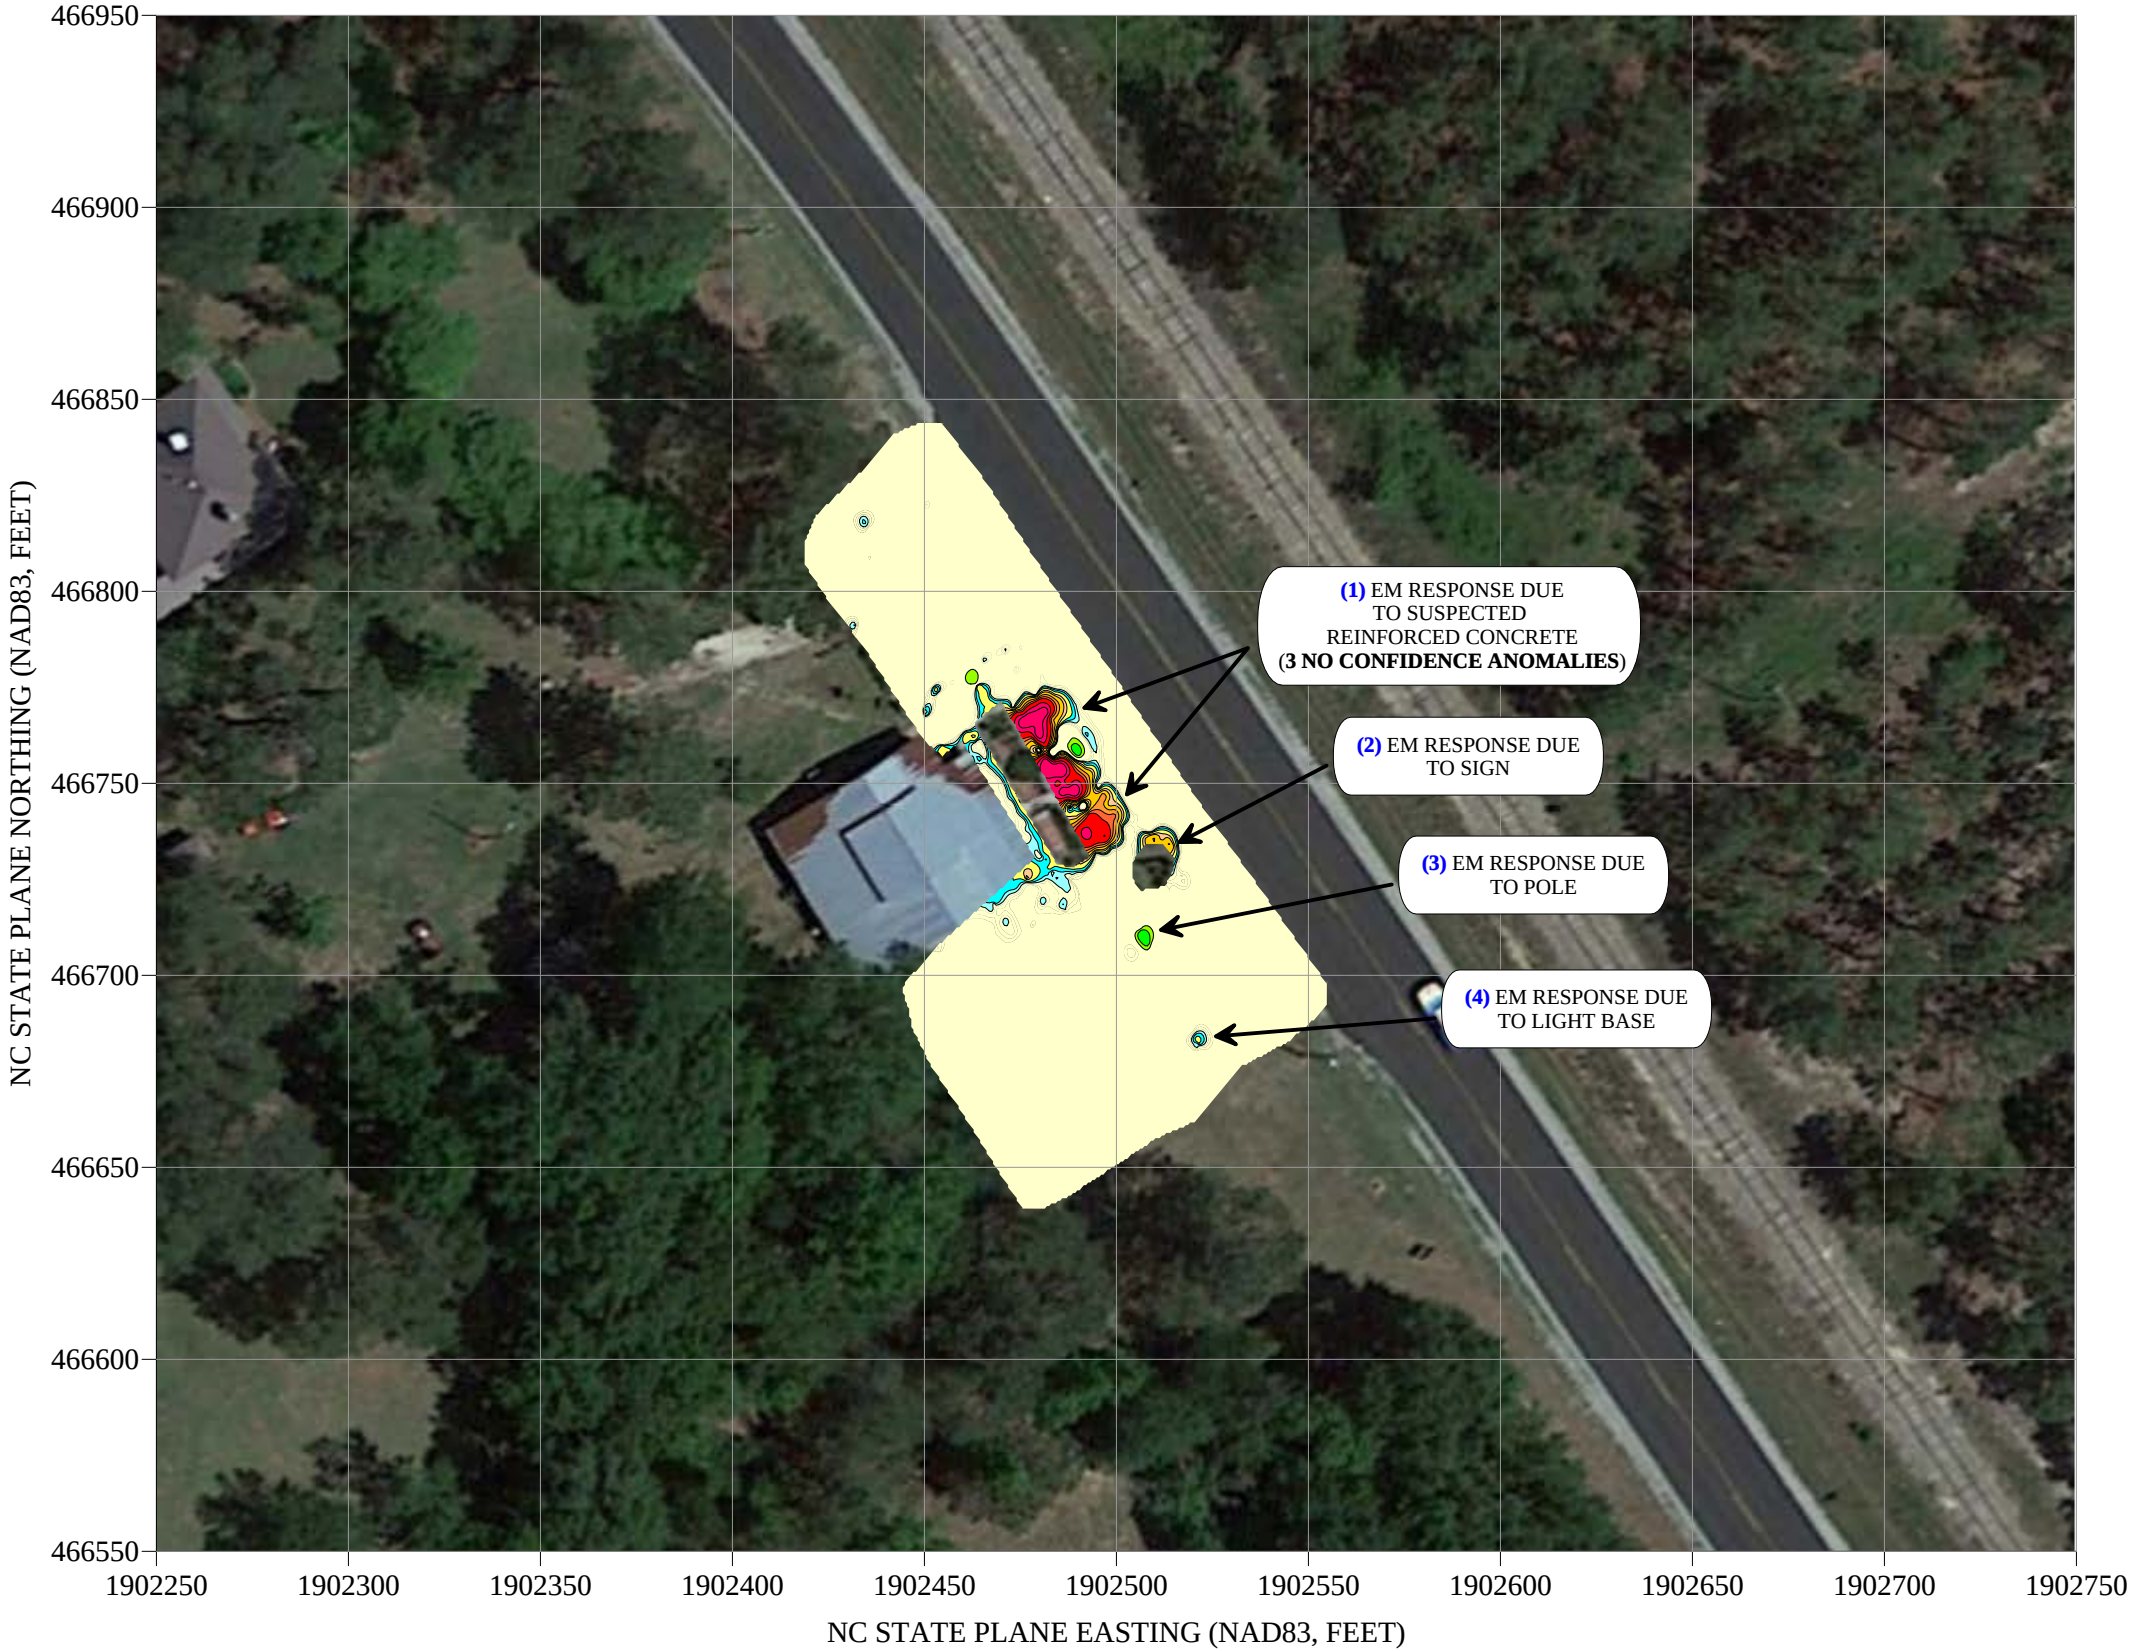
EM61 METAL DETECTION RESULTS

EVIDENCE OF THREE NO CONFIDENCE ANOMALIES WAS OBSERVED.

The contour plot shows the differential results of the EM61 instrument in millivolts (mV). The differential results focus on larger metallic objects such as USTs and drums. The EM data were collected on August 11, 2021, using a Geonics EM61-MK2 instrument. Verification GPR data were collected using a GSSI SIR 4000 instrument with a 350 MHz HS antenna on August 12, 2021.
