**North Carolina Department of Transportation  
Phase II Investigation  
State Project: R-5709  
WBS Element: 50205.1.1  
Hoke County**

**Parcel 285  
Gregory Lowery Property  
10575 NC 211 Highway  
Aberdeen, North Carolina  
October 27, 2021**

**Wood Environment & Infrastructure Solutions, Inc.  
Project: 20478R5709**

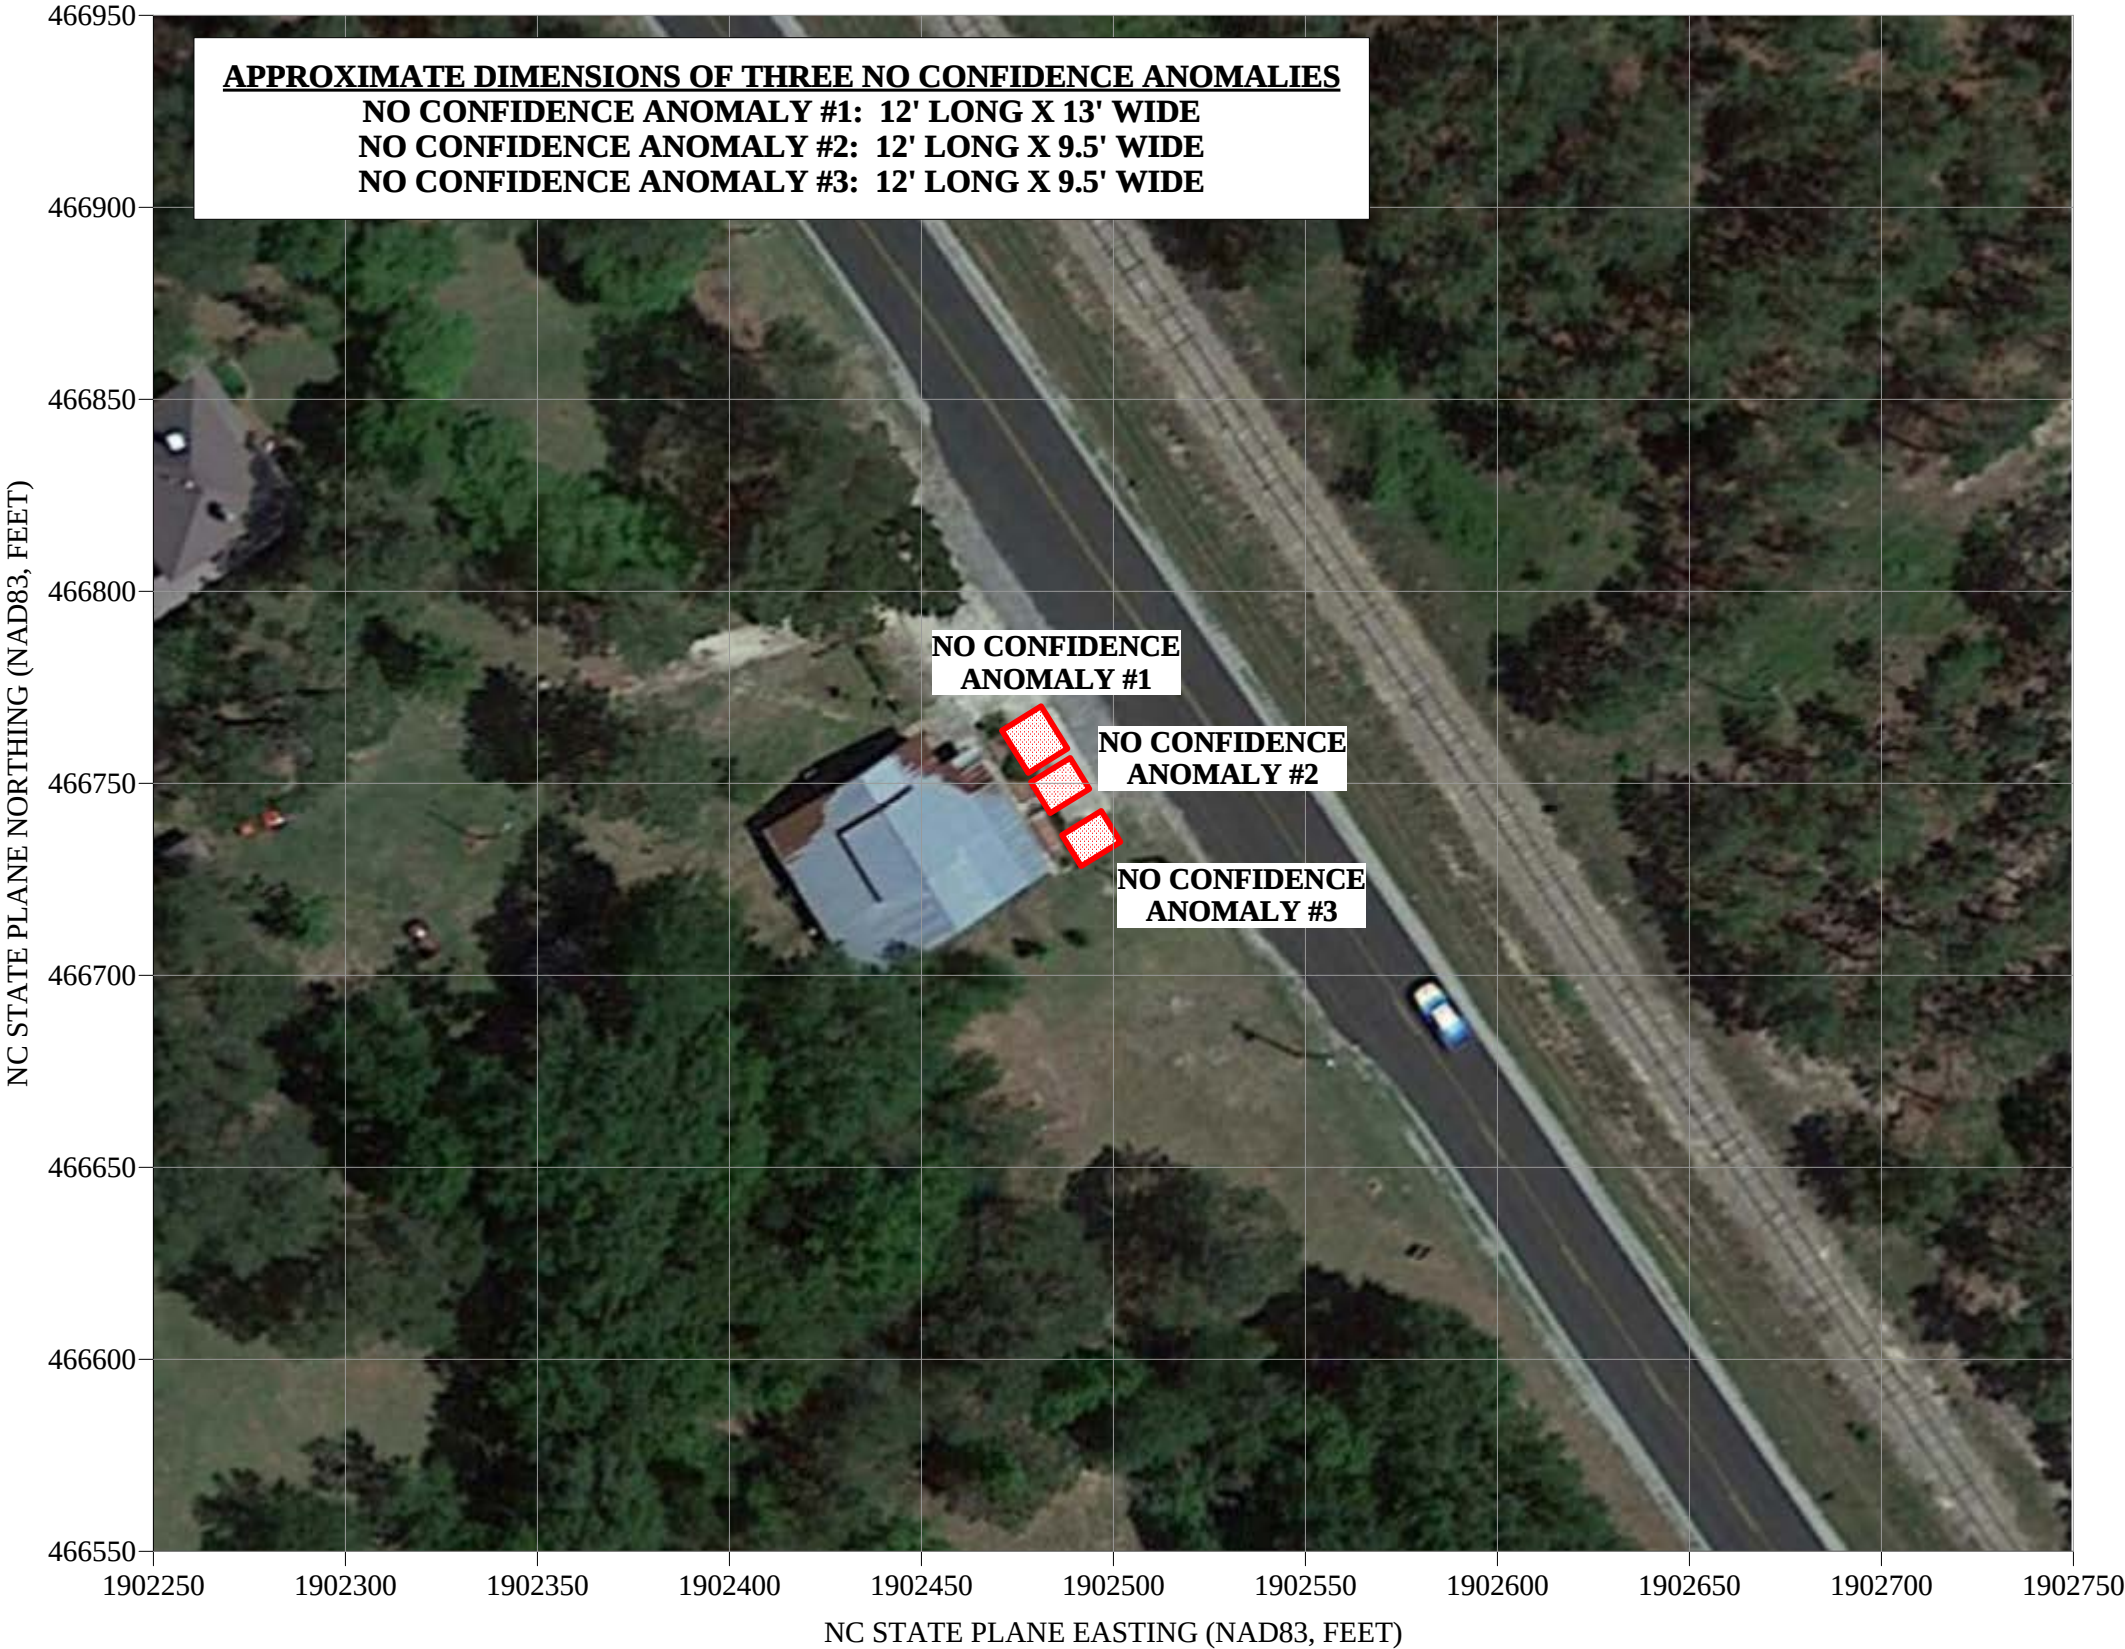
LOCATIONS AND SIZES OF THREE NO CONFIDENCE ANOMALIES

View of Three No Confidence Anomalies  
(Facing Approximately Northwest)
