**North Carolina Department of Transportation  
Phase II Investigation  
State Project: R-5709  
WBS Element: 50205.1.1  
Moore County**

**Parcel 79  
Robert L. Schloegl Property  
9820 NC 211 Hwy  
Aberdeen, North Carolina  
October 21, 2021**

**Wood Environment & Infrastructure Solutions, Inc.  
Project: 20478R5709**

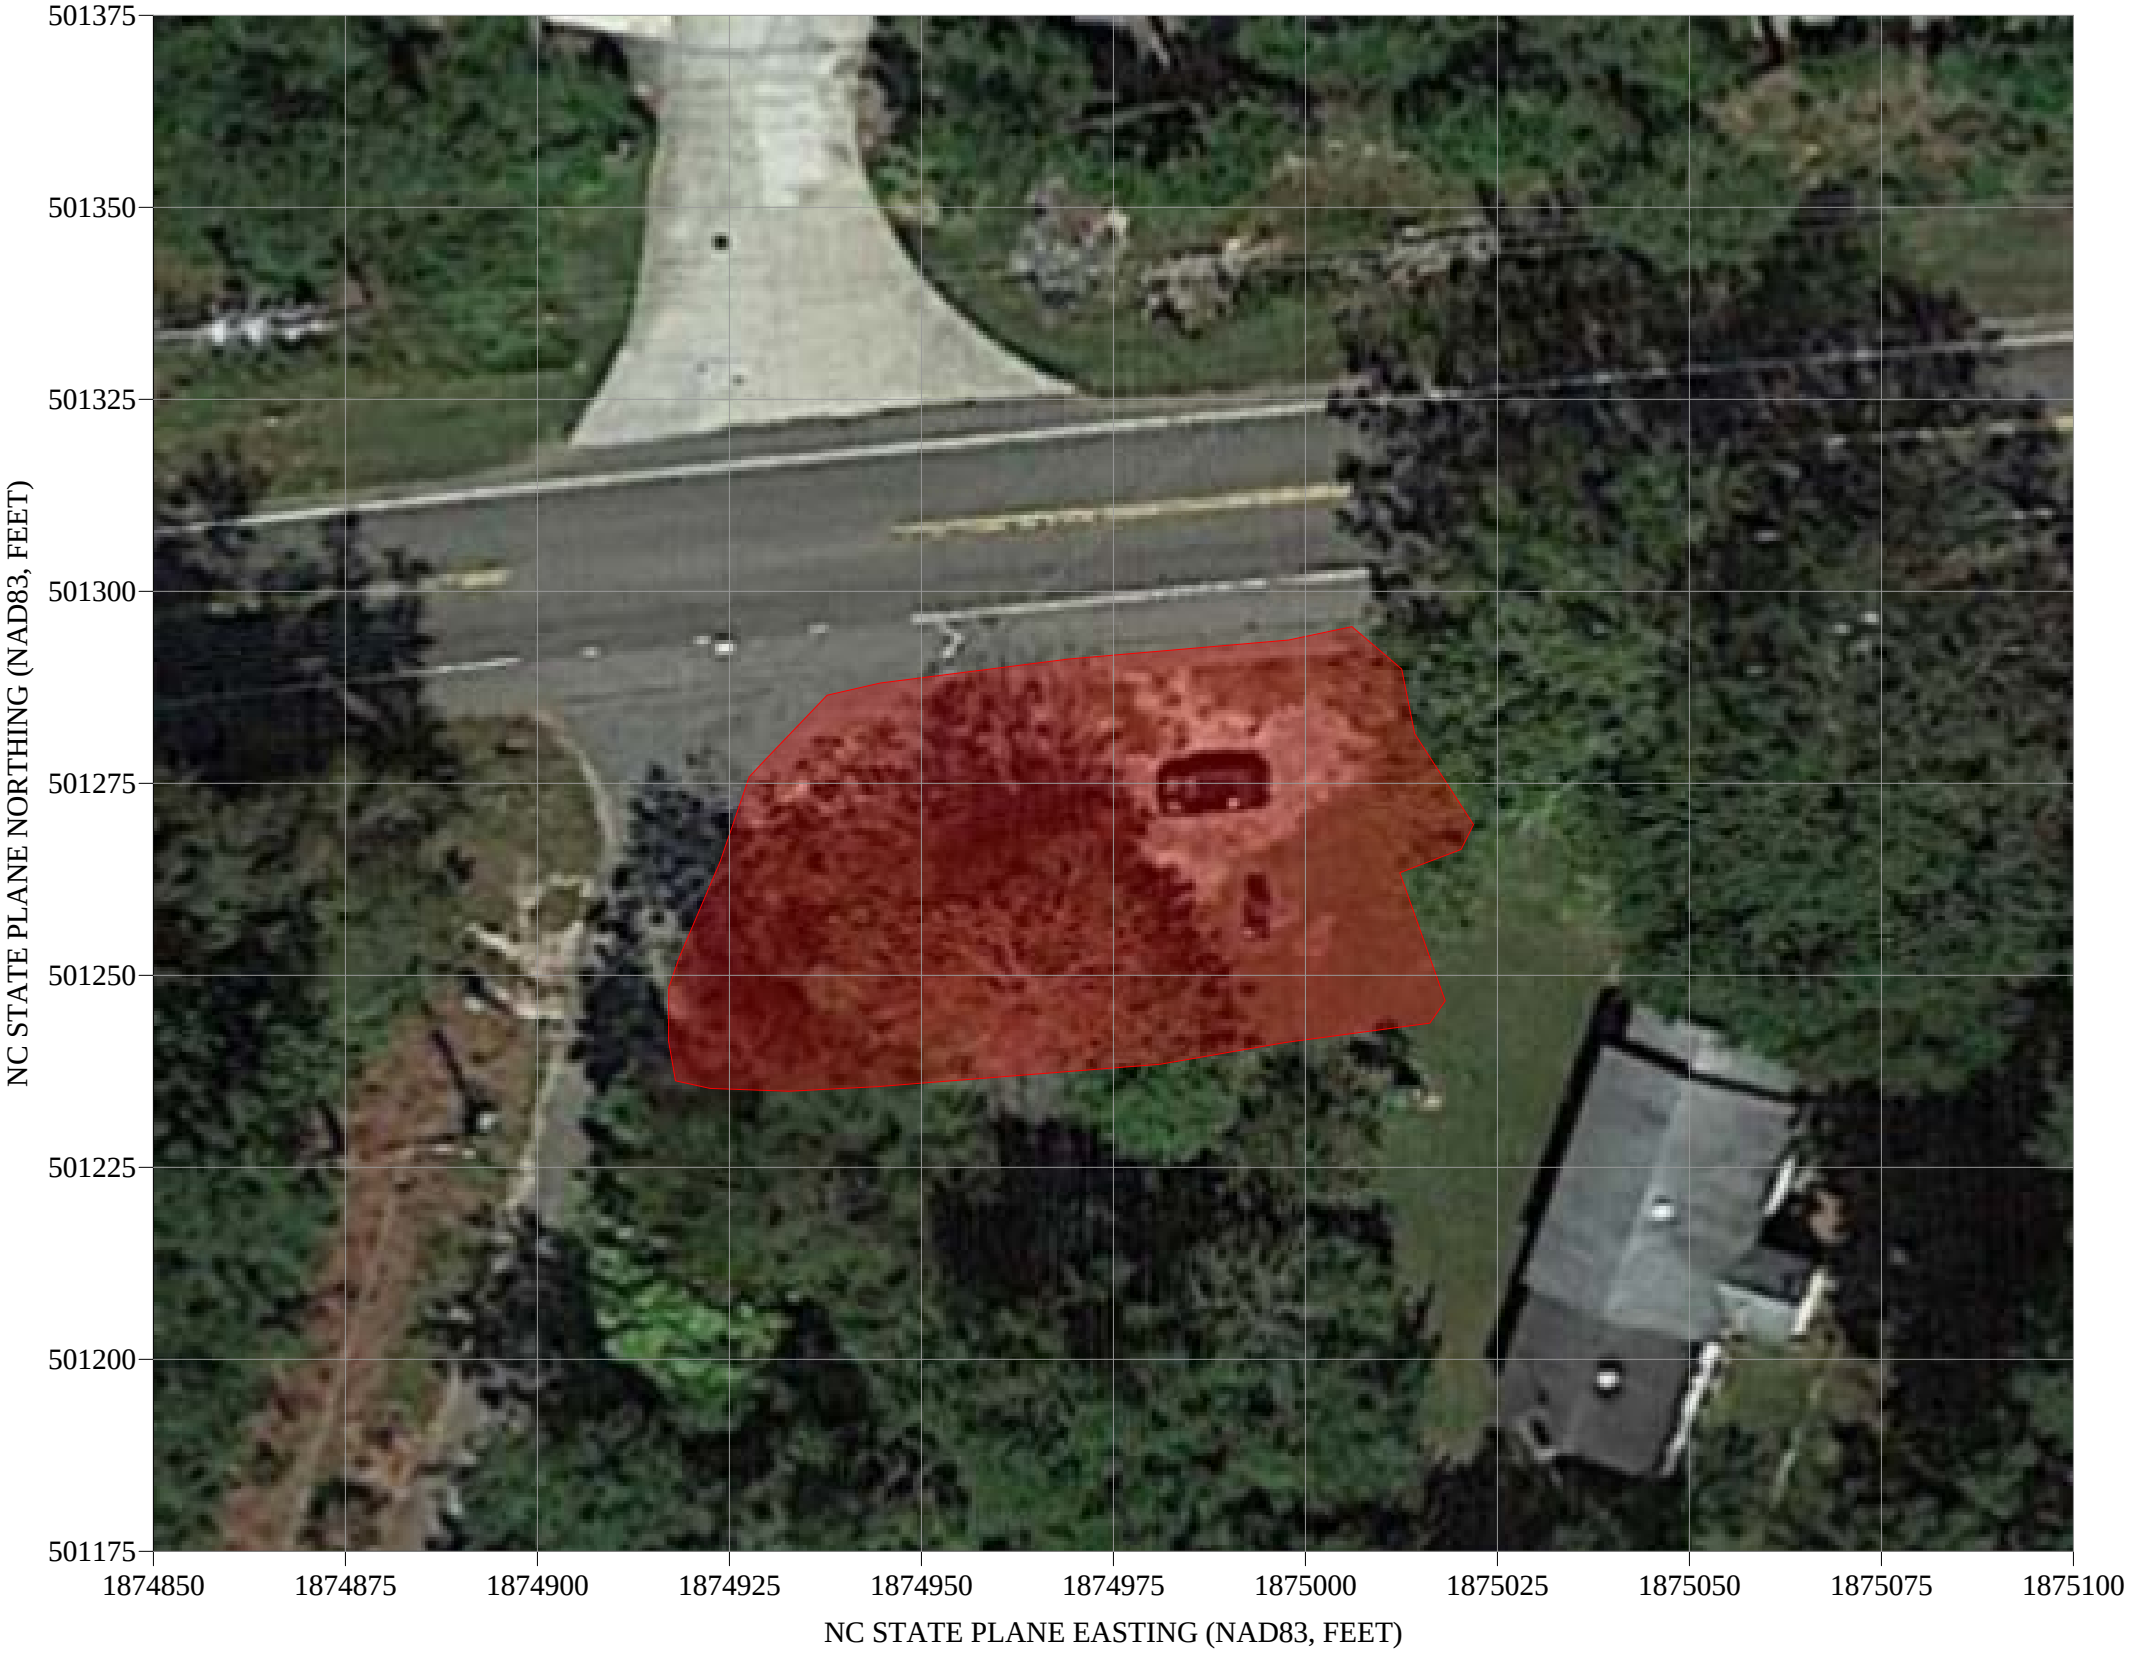
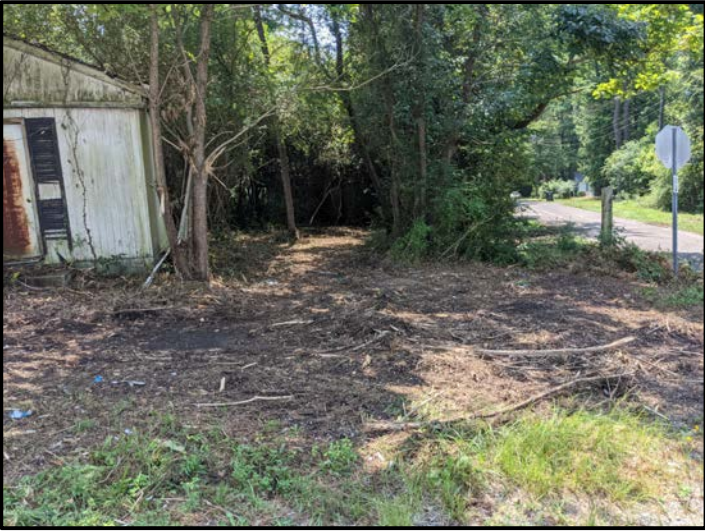
View of Survey Area (Facing Approximately South)

The site consisted of a vacant lot with a deteriorated structure surrounded by grass, gravel, and dirt surfaces. An aerial photograph showing the survey area boundaries and ground-level photographs are shown in **Figure 1**.

APPROXIMATE BOUNDARIES OF GEOPHYSICAL SURVEY AREA

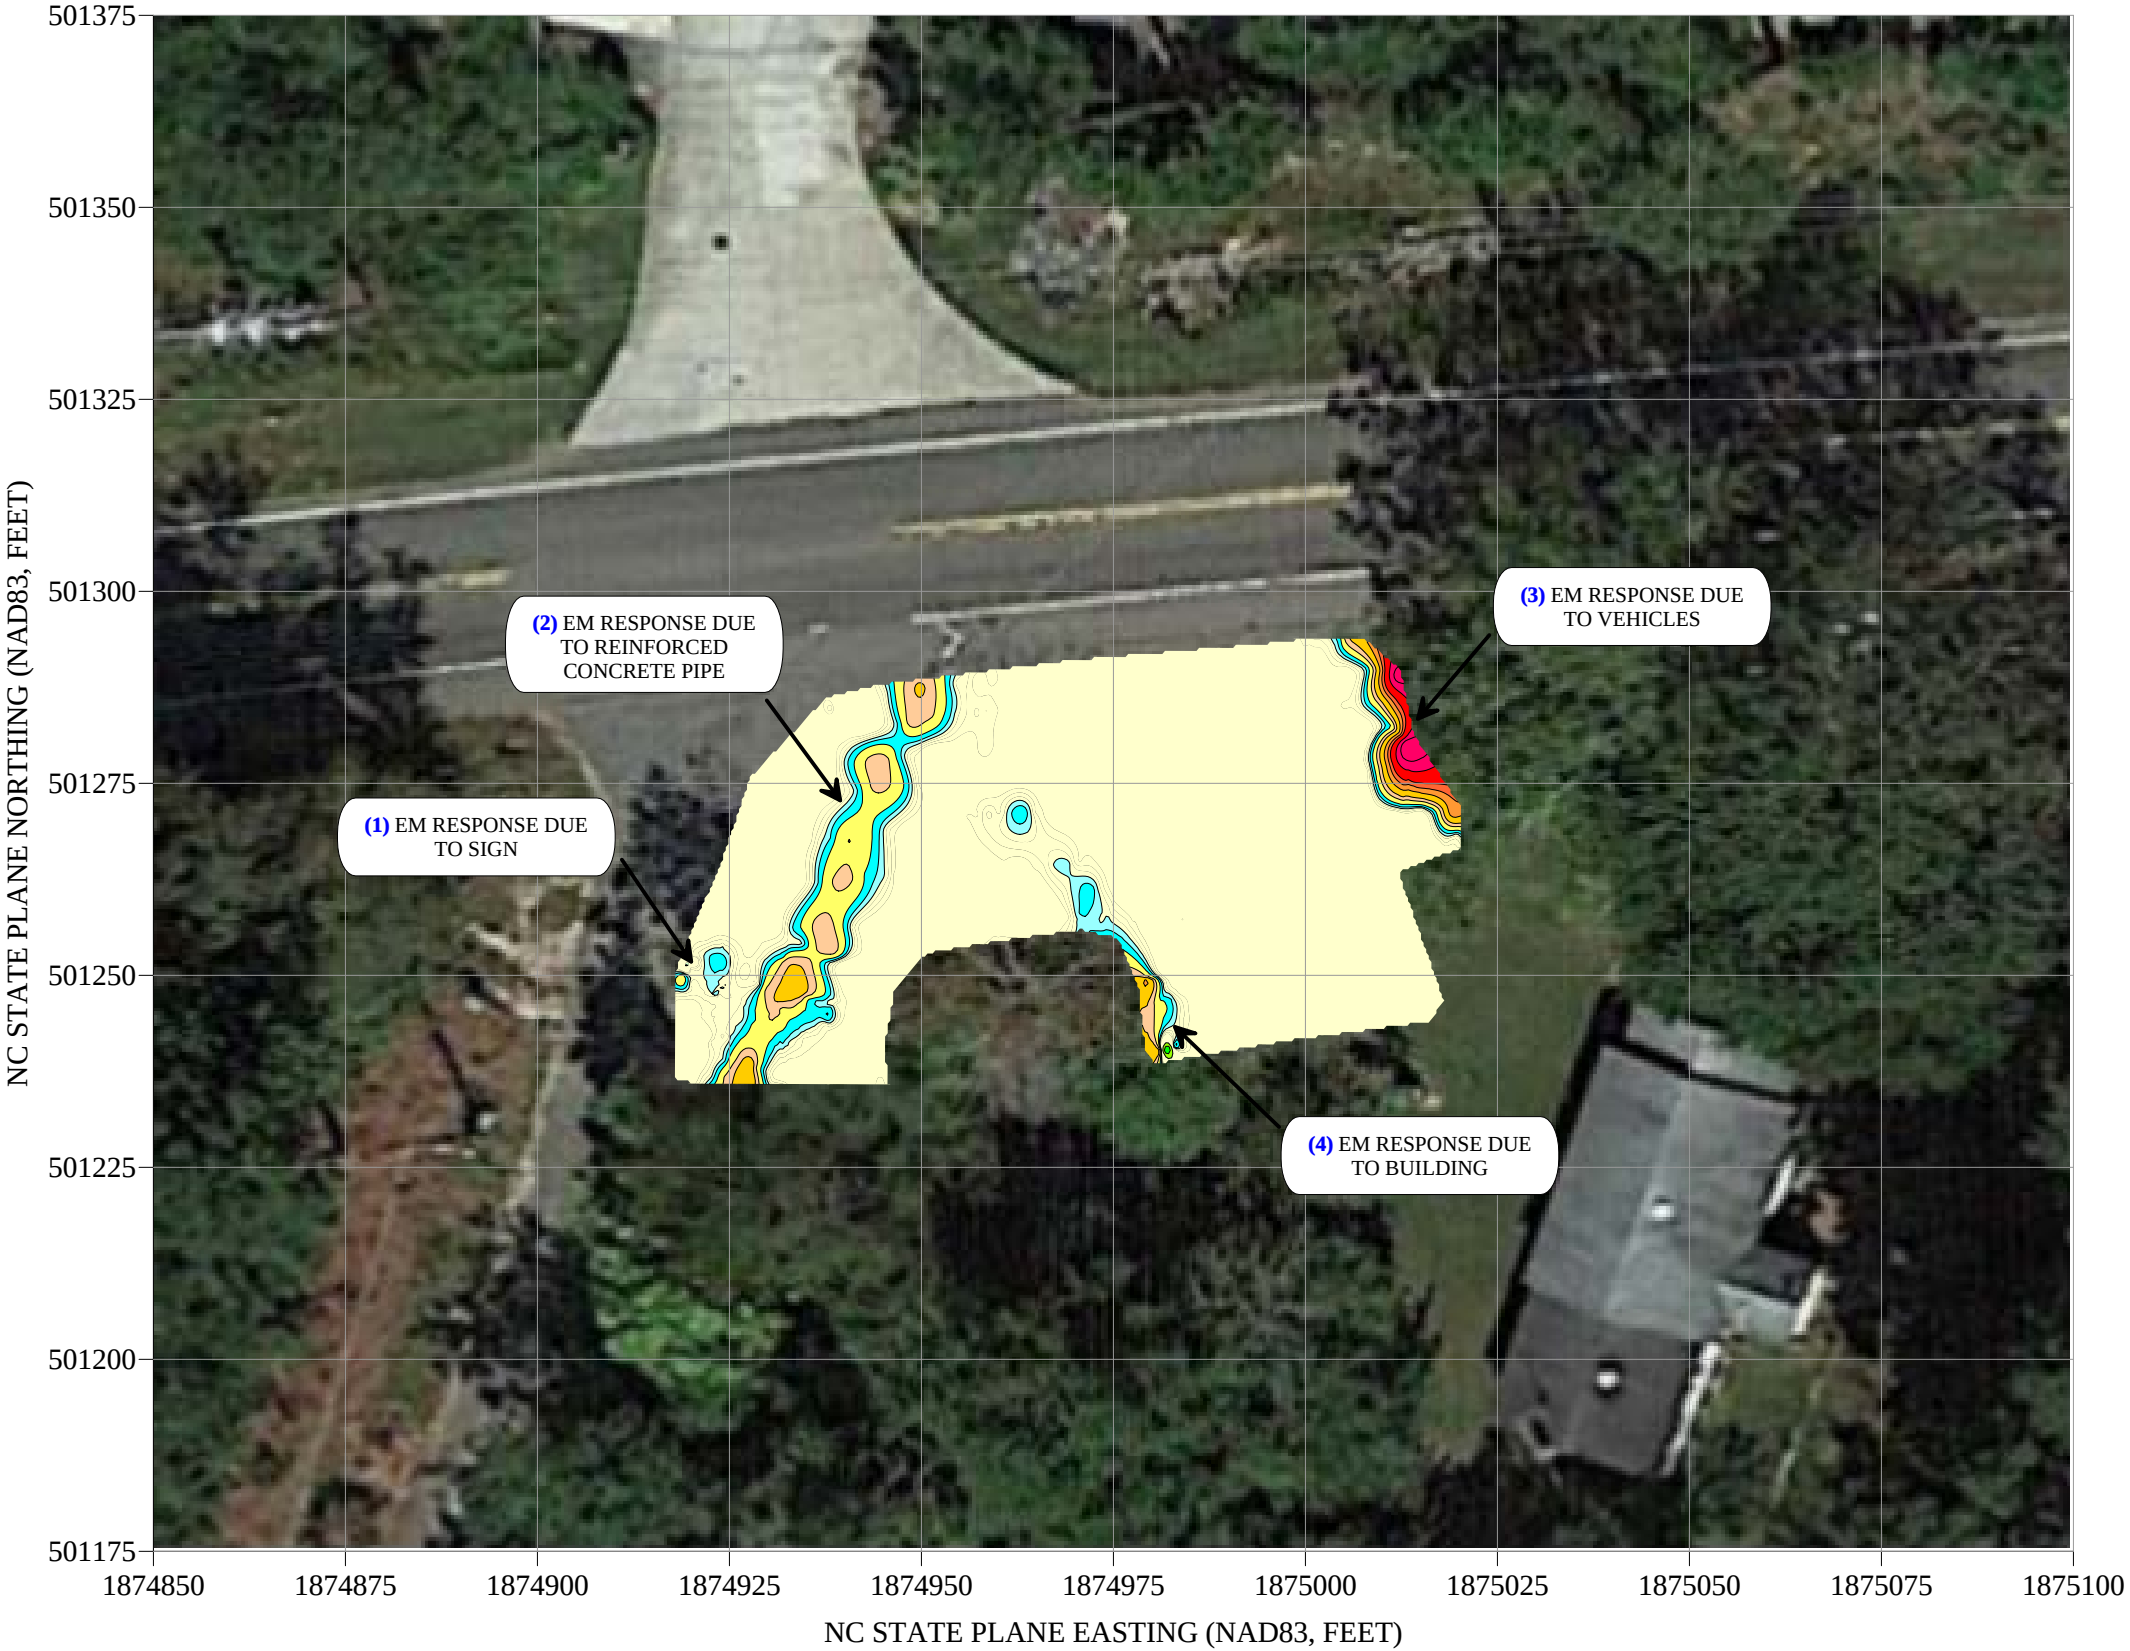
EM61 METAL DETECTION RESULTS

NO EVIDENCE OF METALLIC  
USTs WAS OBSERVED.

The contour plot shows the differential results of the EM61 instrument in millivolts (mV). The differential results focus on larger metallic objects such as USTs and drums. The EM data were collected on August 10, 2021, using a Geonics EM61-MK2 instrument. Verification GPR data were collected using a GSSI SIR 4000 instrument with a 350 MHz HS antenna on August 12, 2021.

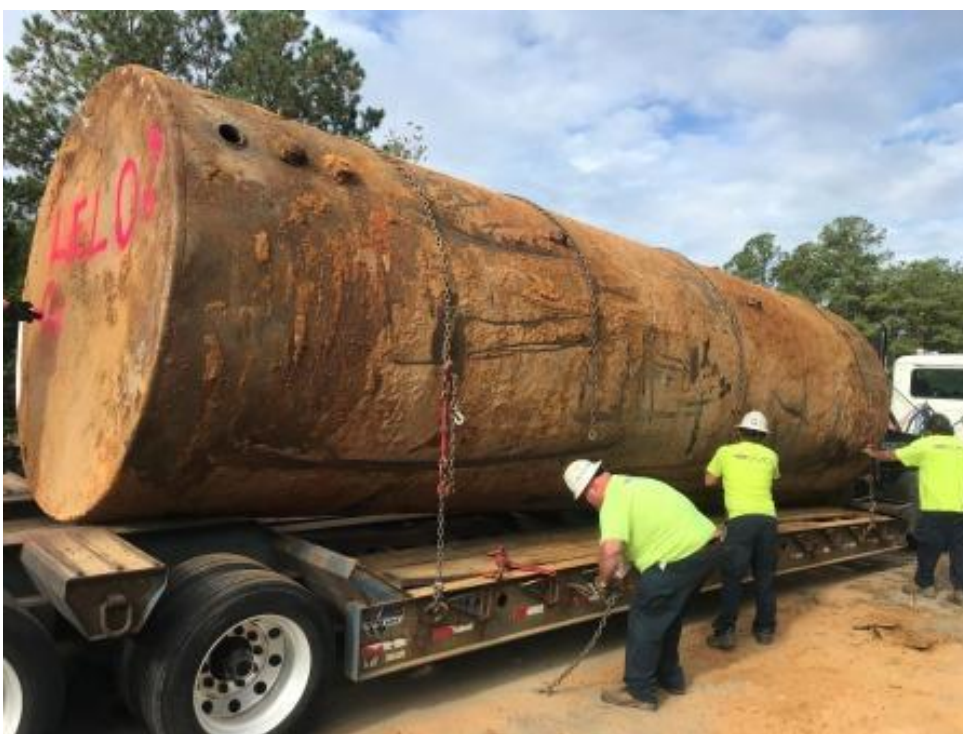
**Photograph 6:**  
EVO loading UST#1 on  
trailer. UST was in good  
condition, no holes or  
pitting.

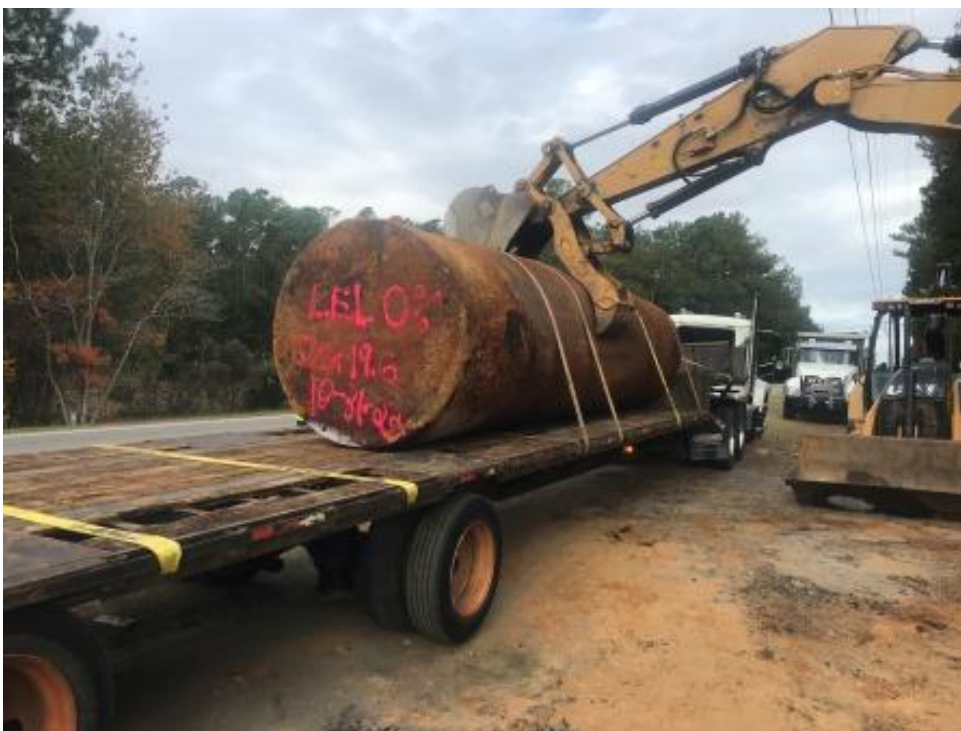
**Photograph 7:**  
EVO loading UST#2 on trailer. UST was in good condition, no holes or pitting.

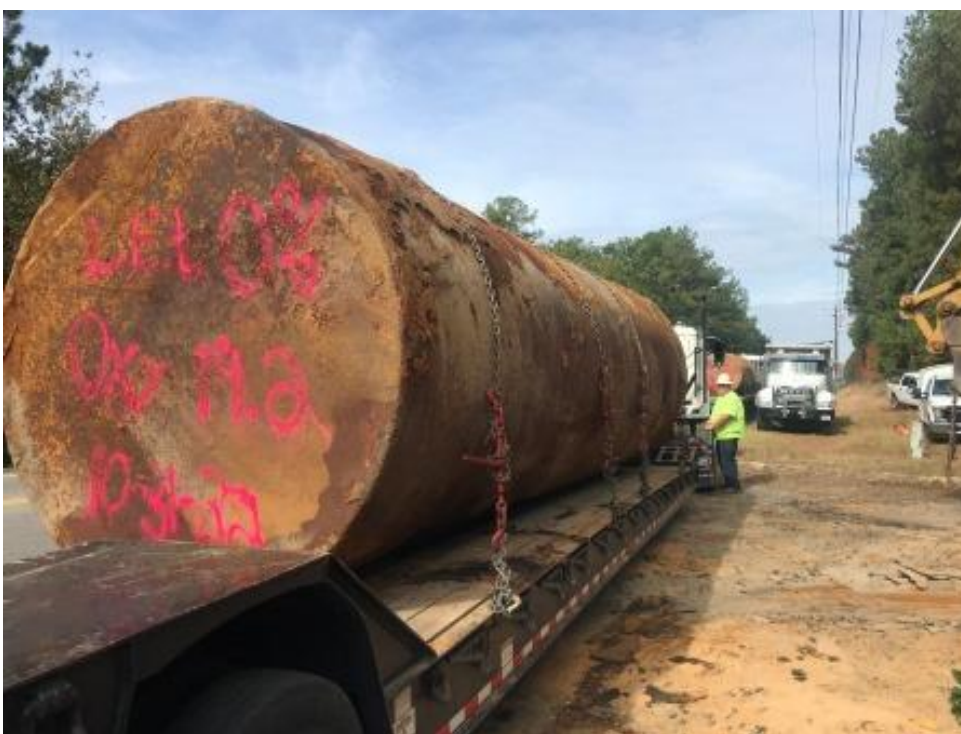
**Photograph 8:**  
Evo loading UST#3 on to trailer. UST in good condition, no pitting or holes.

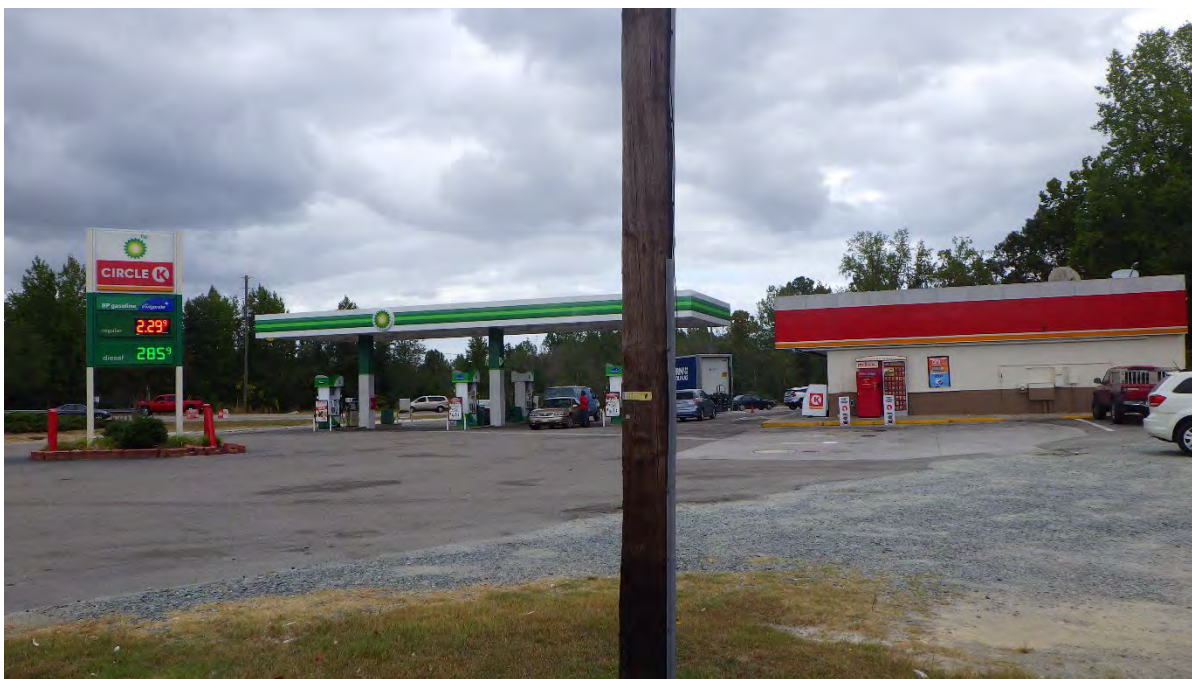
This is an active gas station with four USTs permitted in use at the site. Monitoring wells and remediation wells were observed on site and one groundwater incident is recorded in NCDEQ's UST incident database.

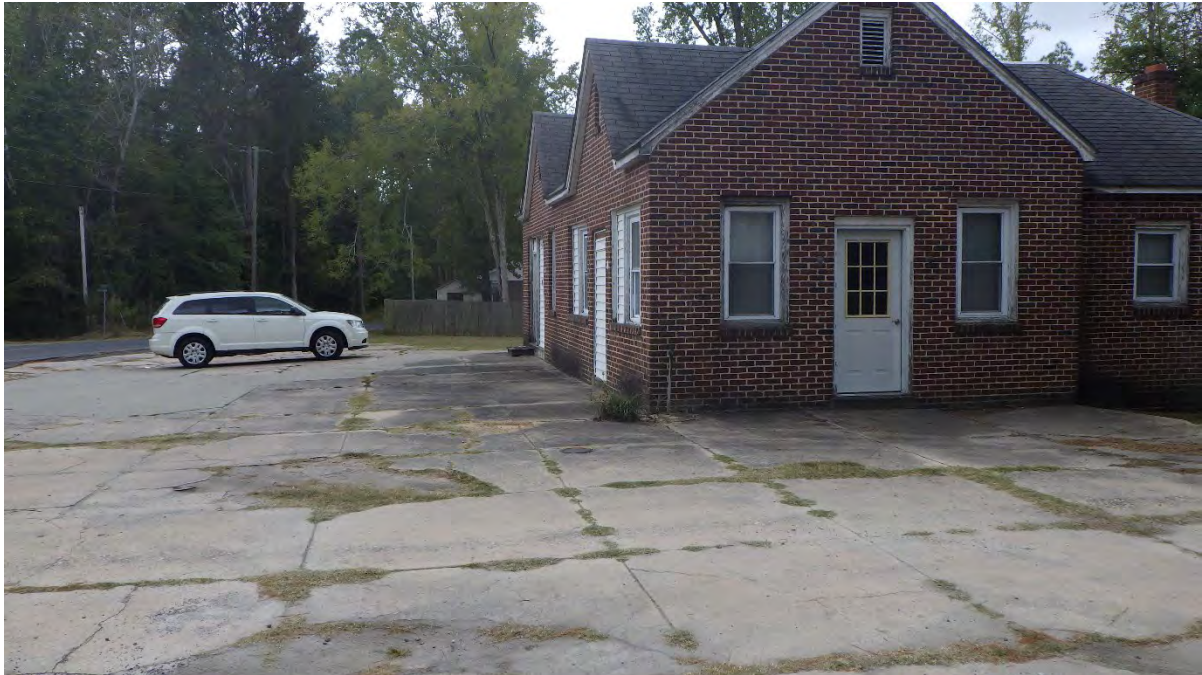
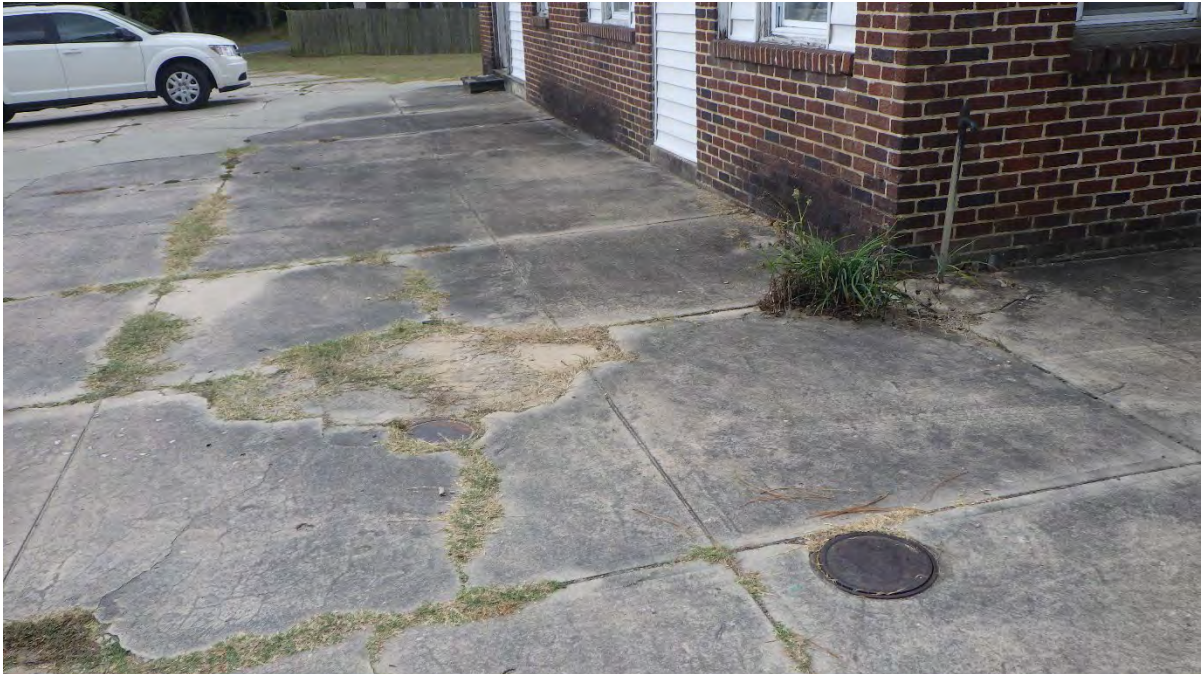
This is a former gas station with at least 2 small USTs observed on site. The store building was probably built in 1930s and is in fair condition. No monitoring wells were observed on site and no incident record can be located in NCDEQ's database.

*UST fill port with cover*

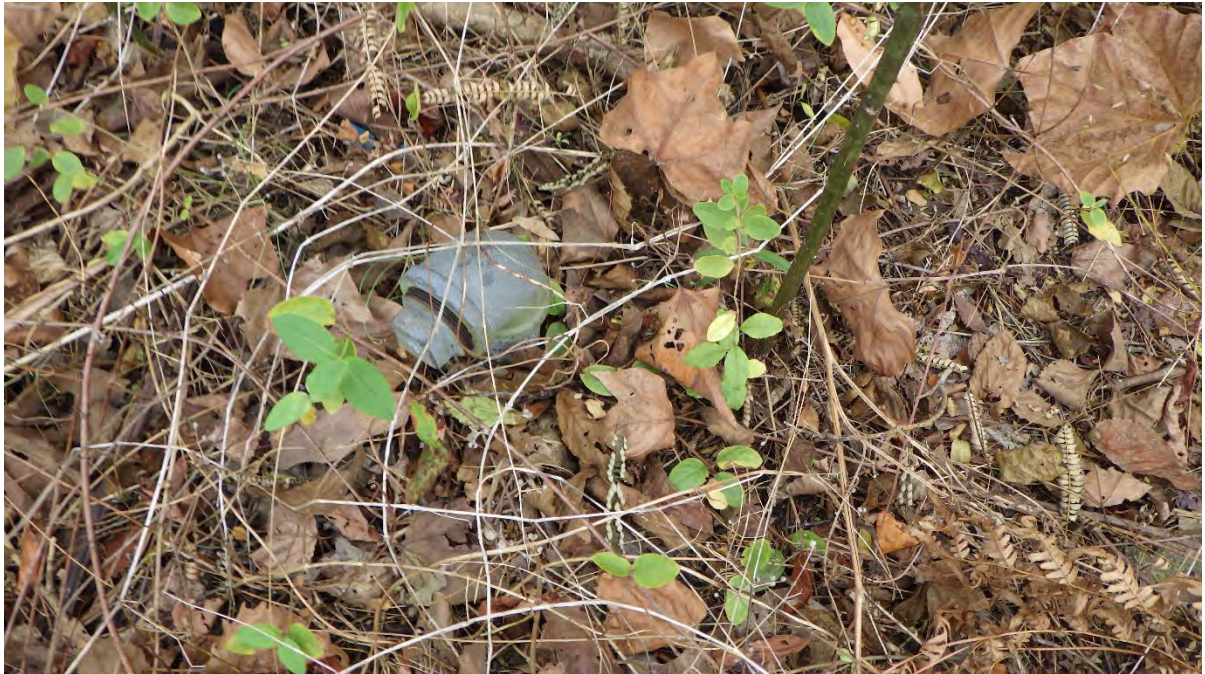
This is an old former gas station with former dispenser island remains on site (under the trees in front of the building). The store building was in poor condition and probably built in 1930s or earlier. Two small USTs probably still remain underneath the island and no monitoring wells were observed on site. No incident record can be located in NCDEQ's database.

*UST features in the dispenser island area*

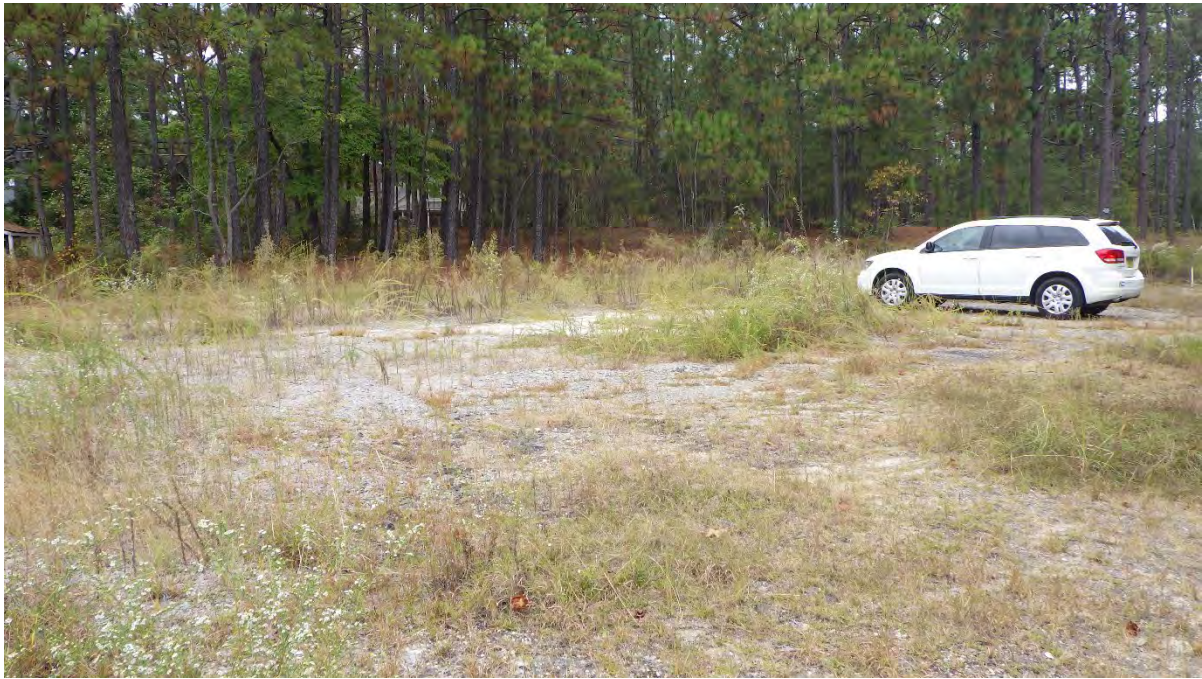
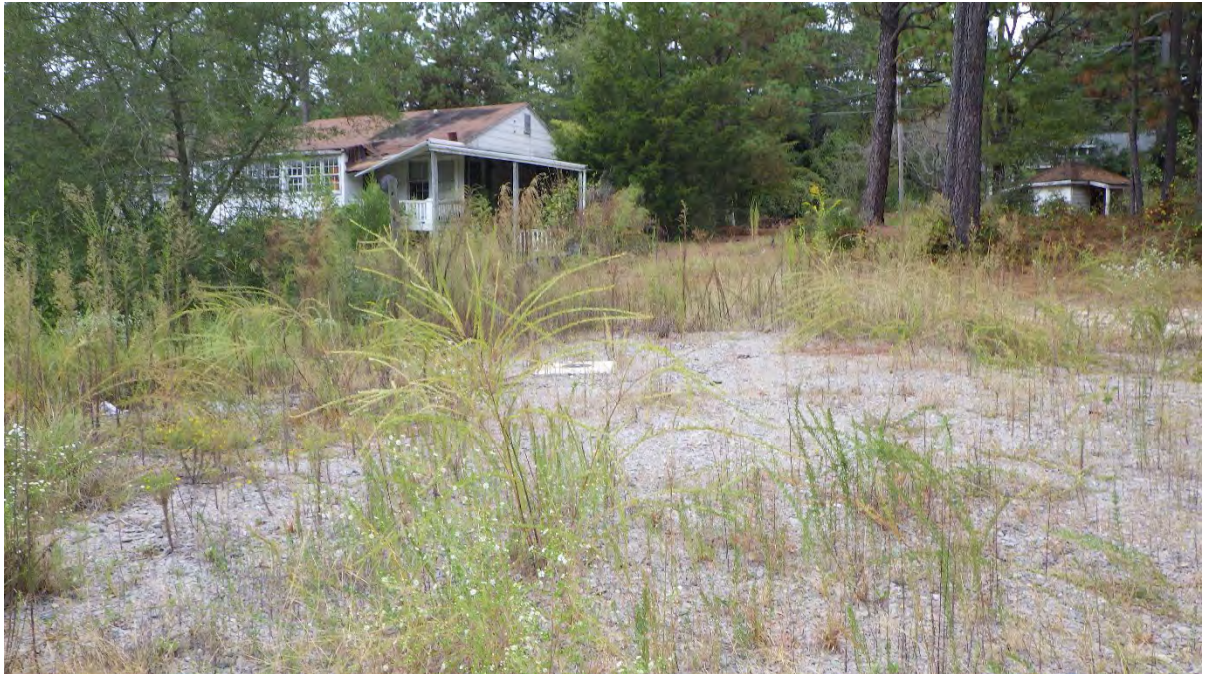
This is a vacant lot with building foundation remained on site. It was a possible former gas station with USTs removed. One monitoring well observed on site and no incident record can be located in NCDEQ's database.

*UST removal area.*

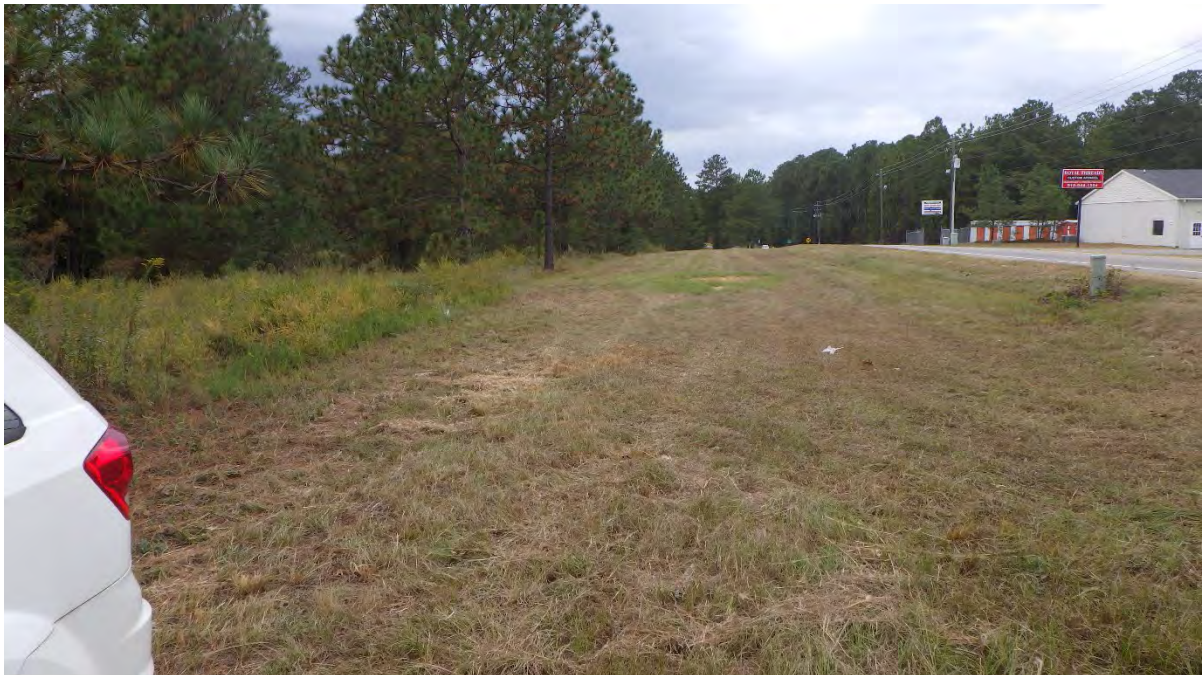
This is a vacant lot owned by a railroad company. There was a KAISER CHEMICAL building removed from the site years ago. Soils contaminated with pesticides were identified by EPA and soil excavation were completed in 1996 and 1997. One monitoring well was observed on site, and no USTs observed on site.

*Monitoring well*

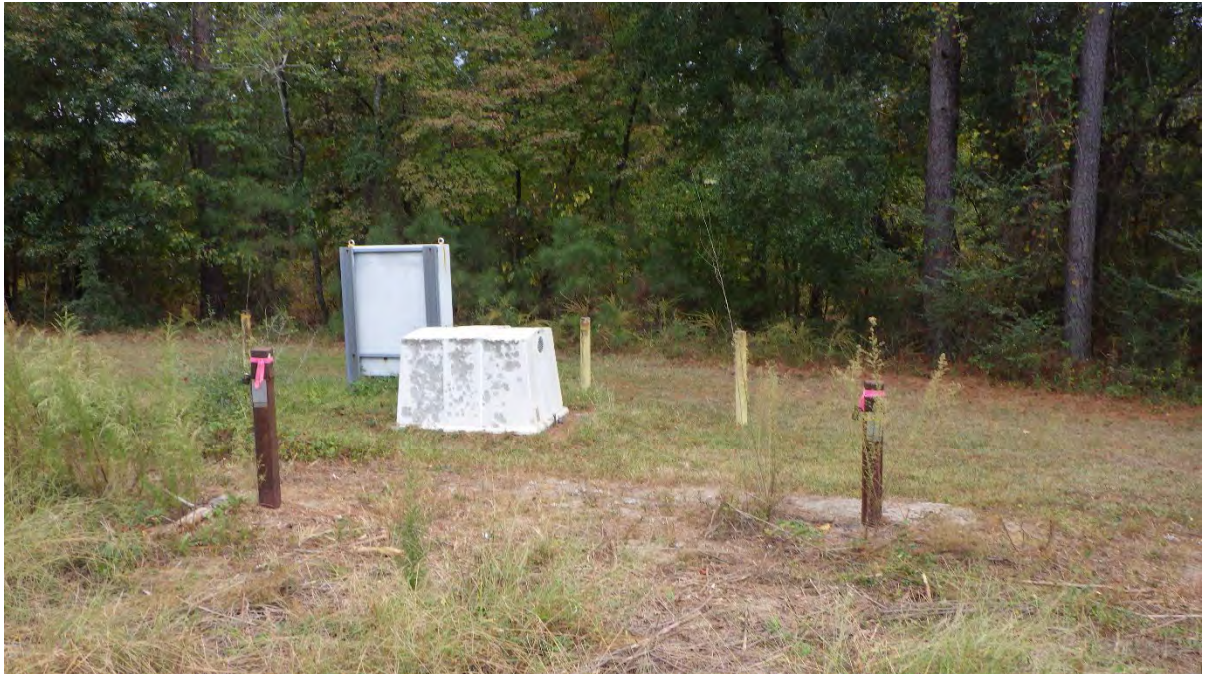
This is a large track of wooded vacant lot. The contamination on this site is directly related to site 5 (GEIGY CHEMICAL) activities. Superfund soil removal (see site 5 figures) and groundwater clean-up action have occurred at this site. Multiple groundwater monitoring wells and remediation systems were observed over the site.

*Remediation/monitoring wells*

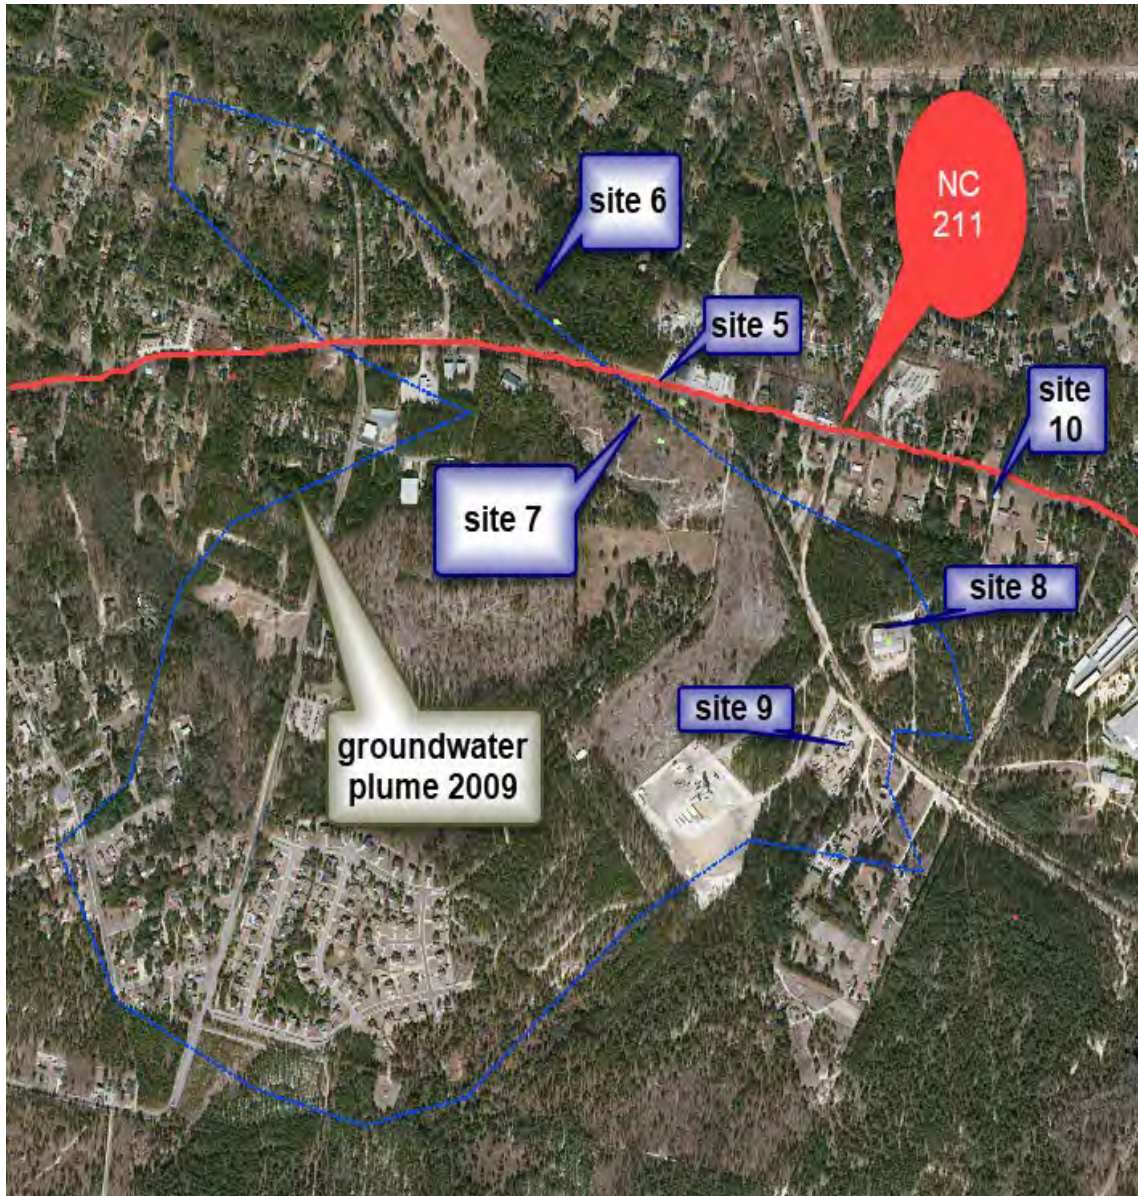
*Location of this site (site 10) and other superfund associated sites. Blue line is approximate groundwater plume (2009).*

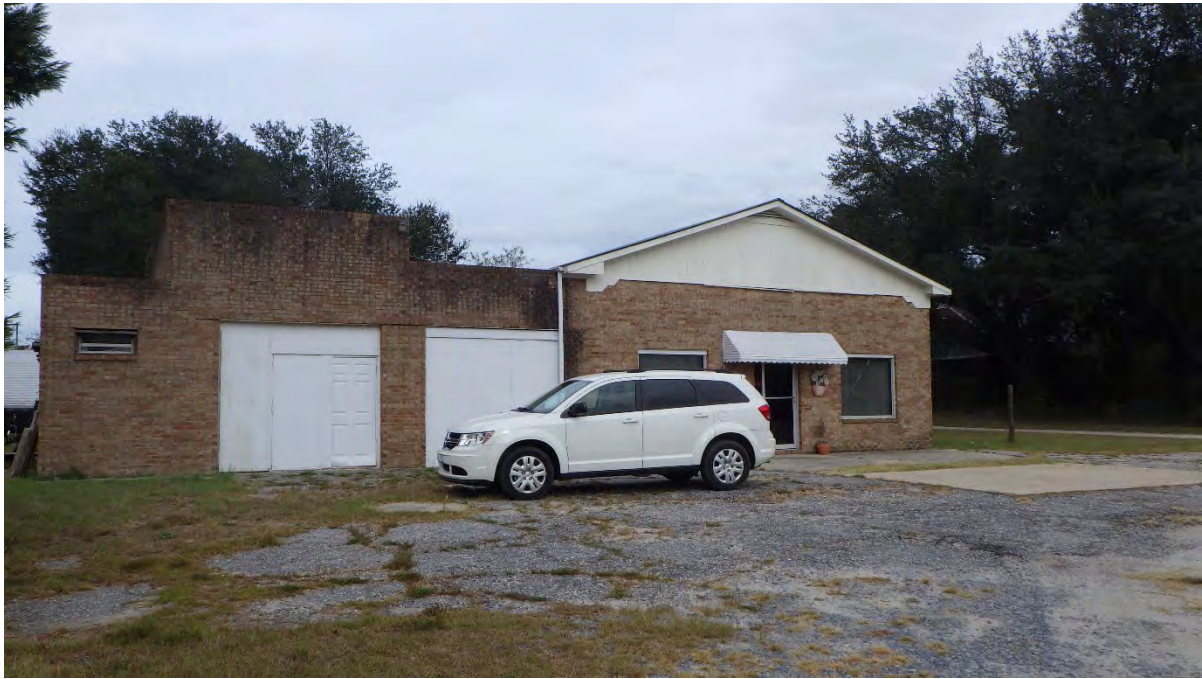
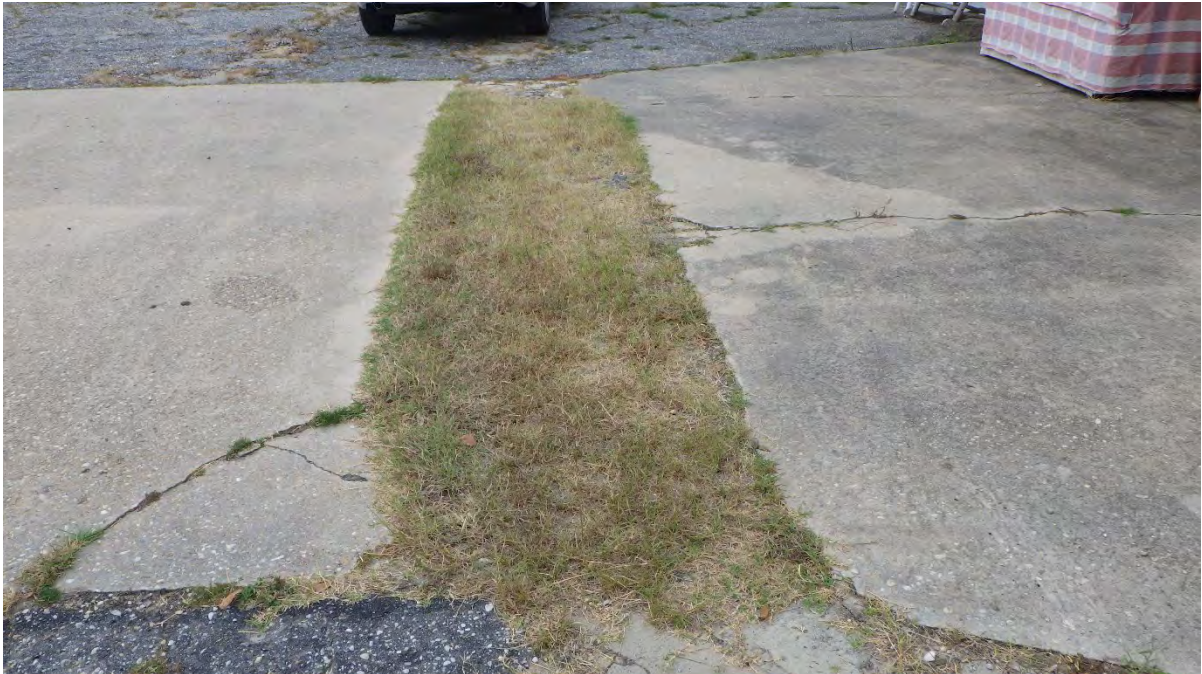
This is a fabric retail store and a possible former gas station with possible dispenser islands (removed). No monitoring wells or USTs were observed on site. No incident record can be located in NCDEQ's database.

*Possible former disperser island location.*

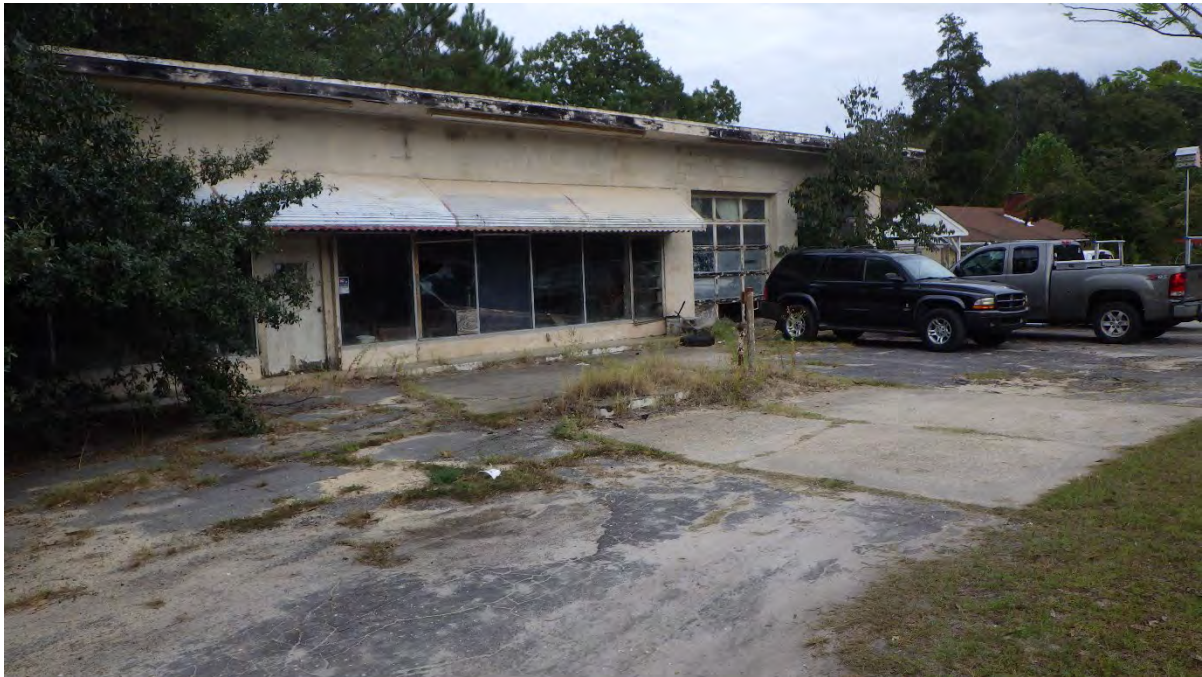
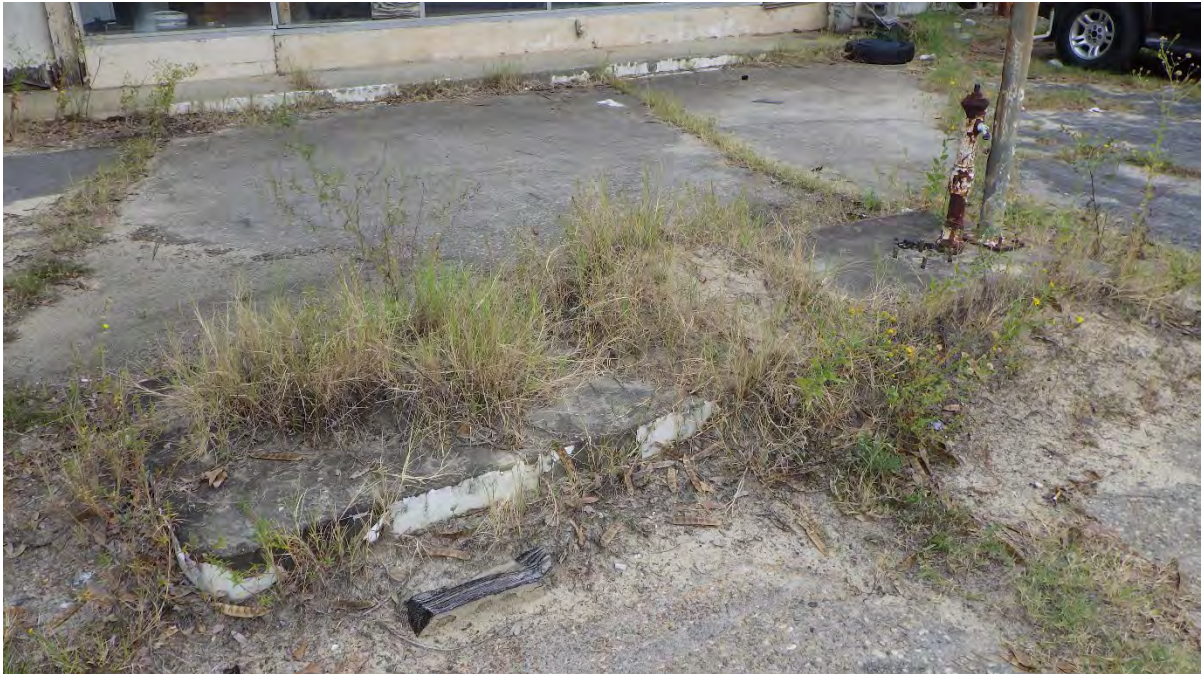
This is an abandoned retail store and a possible former gas station with possible dispenser island remains. No monitoring wells or USTs were observed on site. No incident record can be located in NCDEQ's database.

*Possible UST disperser island.*
